West Newton Armory

1137 Washington St, Newton, Massachusetts 02465

Report of Facility Condition Assessment

Project 100060875

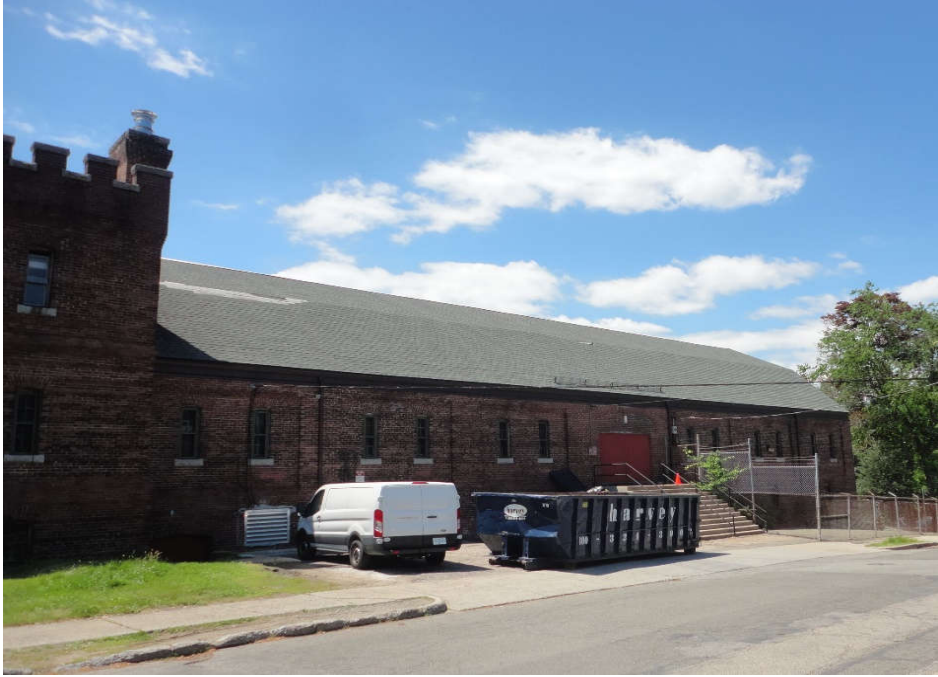
Photograph No. S-02

Landscaping and parking at
southeast corner

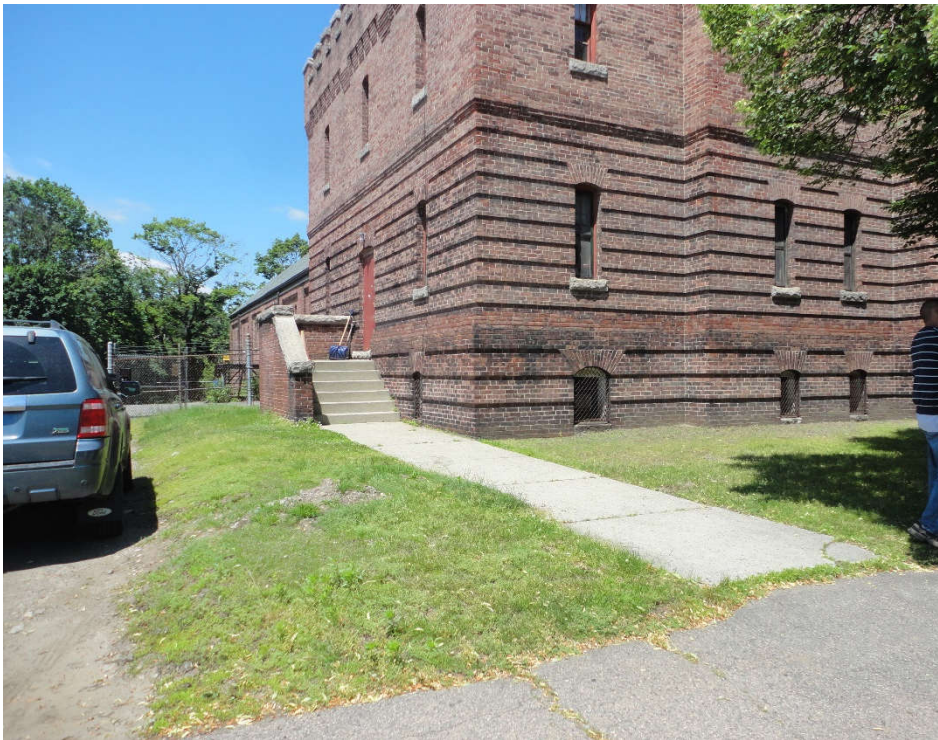
Photograph No. S-03

The site perimeter fencing is in fair condition. At the east and west of the site, the fencing is aged and in a generally deteriorated state. The metal posts and chain-link fence were corroded and starting to separate, the barbed wire strands were generally in fair condition, but the framing appeared to be bent in the east. The fencing in the north showed signs of aging but was in fair condition. Based upon the condition of the fencing and gates at the property, we recommend completing repairs in areas where the chain-link fence had separated from the metal posts. Security can be increased with repairs to the east metal framing of the barbed wire strands.

East side of building with and chain-link fencing

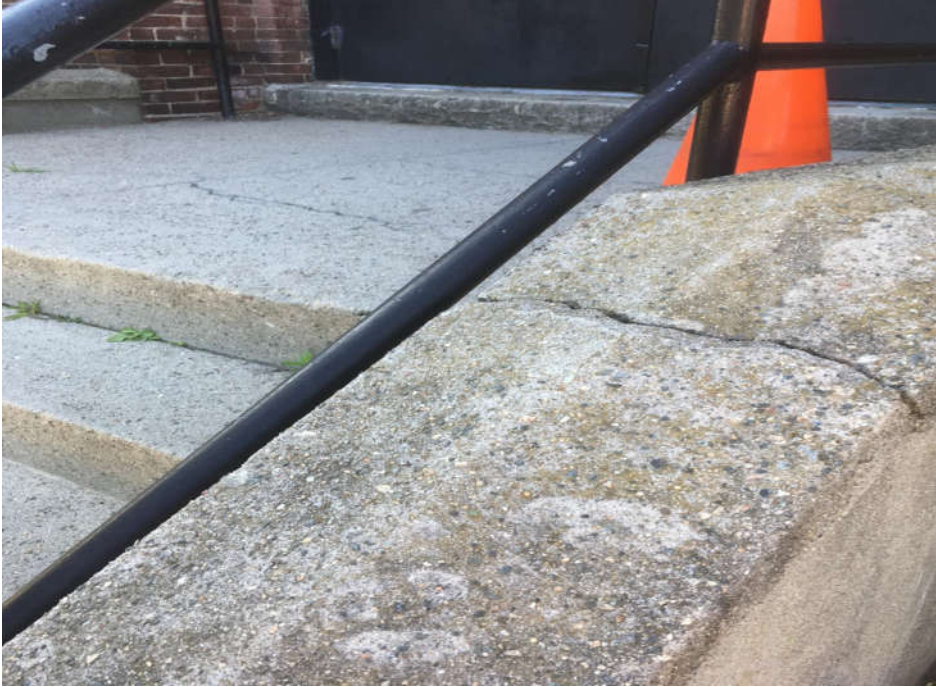
Photograph No. S-04

Egress stair at southeast corner of building

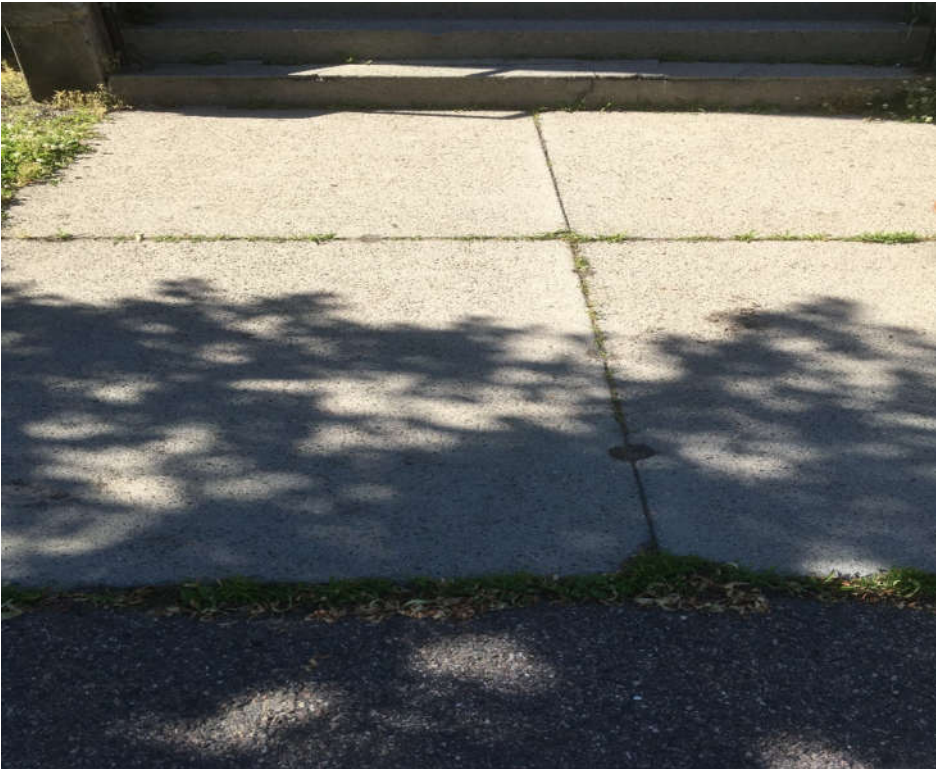
Photograph No. S-05

The cheek wall associated with the concrete stairs at the south entrance showed signs of minor cracking. The areaway in the east with collapsed concrete is clearly in critical condition and a lack of railings for safety and protection is deemed unsafe for the public. The areaway is not located within the enclosed perimeter fencing.

Damaged cheek wall and concrete landing at main south entrance

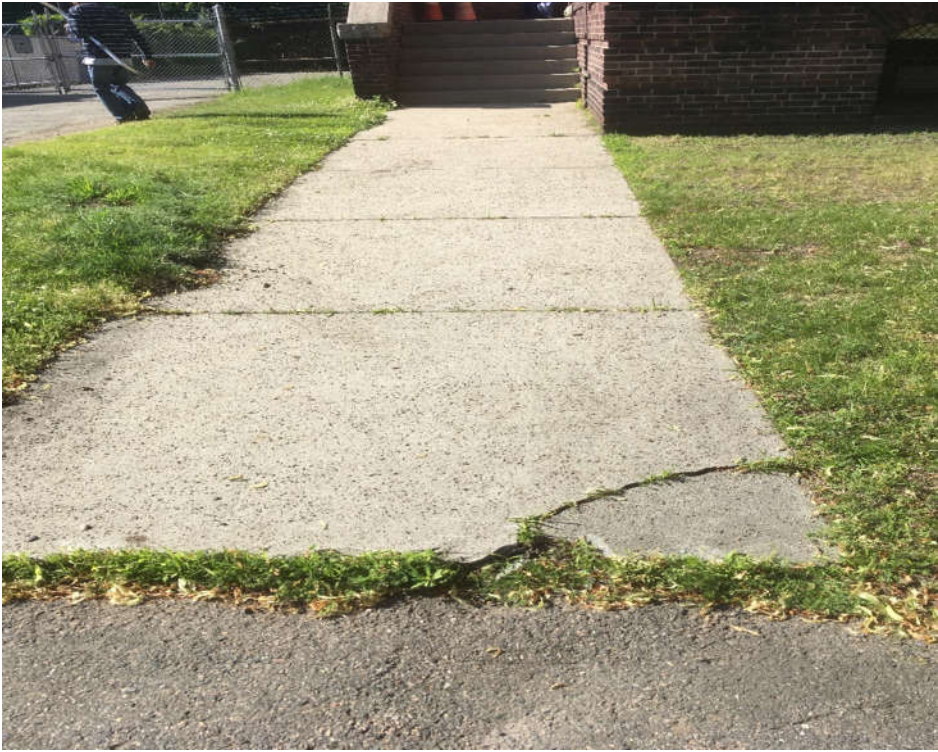
Photograph No. S-06

Generally, the concrete walkways and steps were in fair to poor condition. There was cracking located in multiple cast-in-place concrete walkways in the south and should be replaced immediately.

Concrete walkway at main south entrance

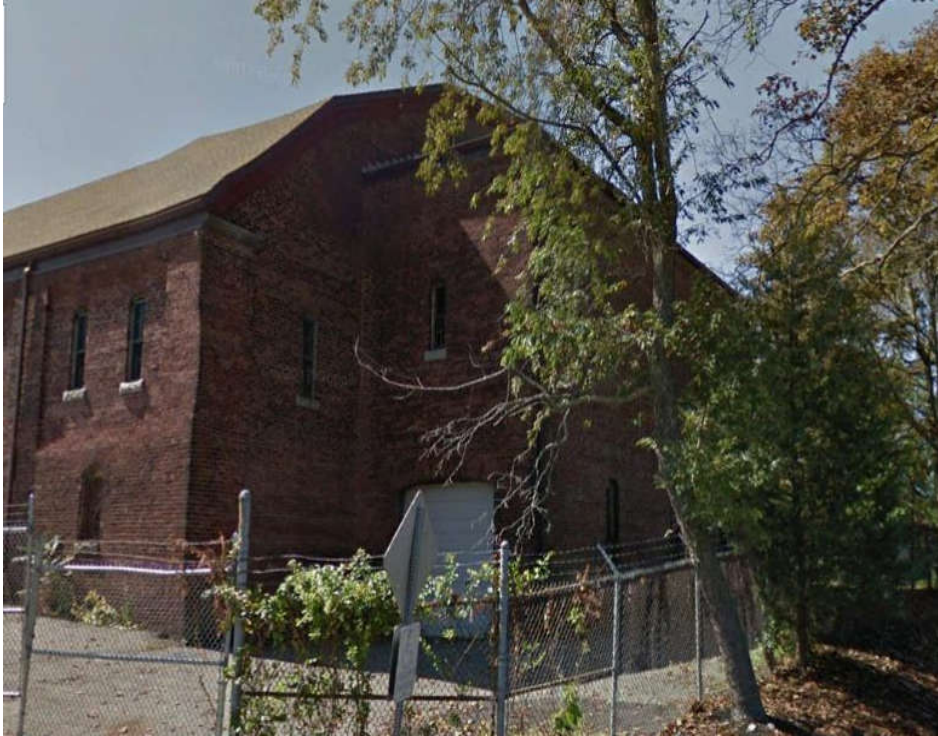
Photograph No. SEC-01

Chain-Link Fencing

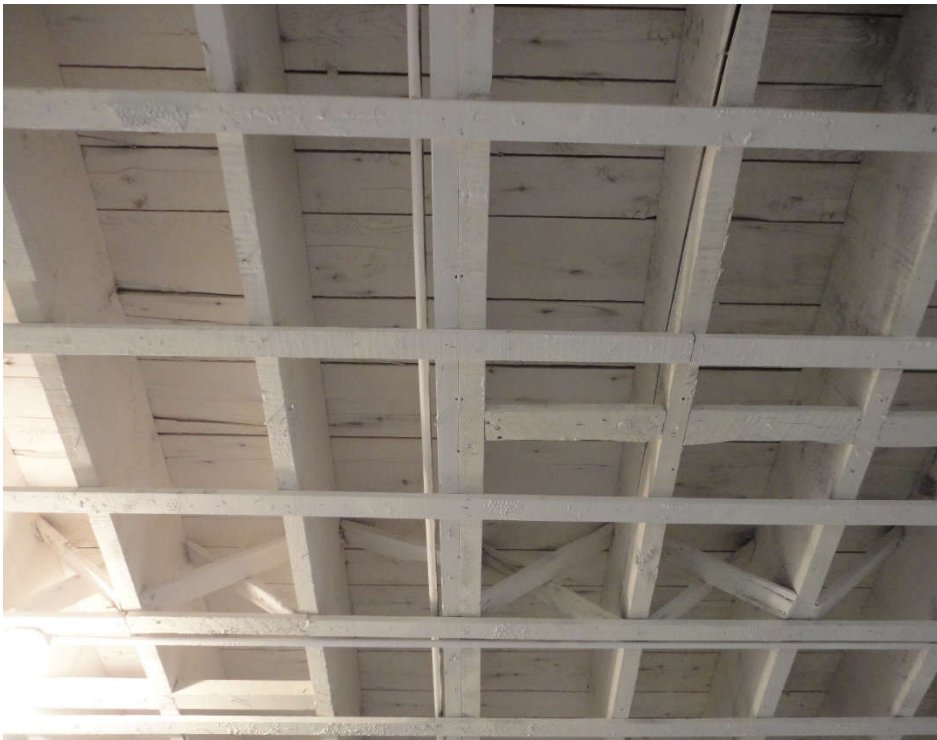
Photograph No. ST-02

Typical 2x12 wood floor joists, strapping, metal lath and plaster ceiling system

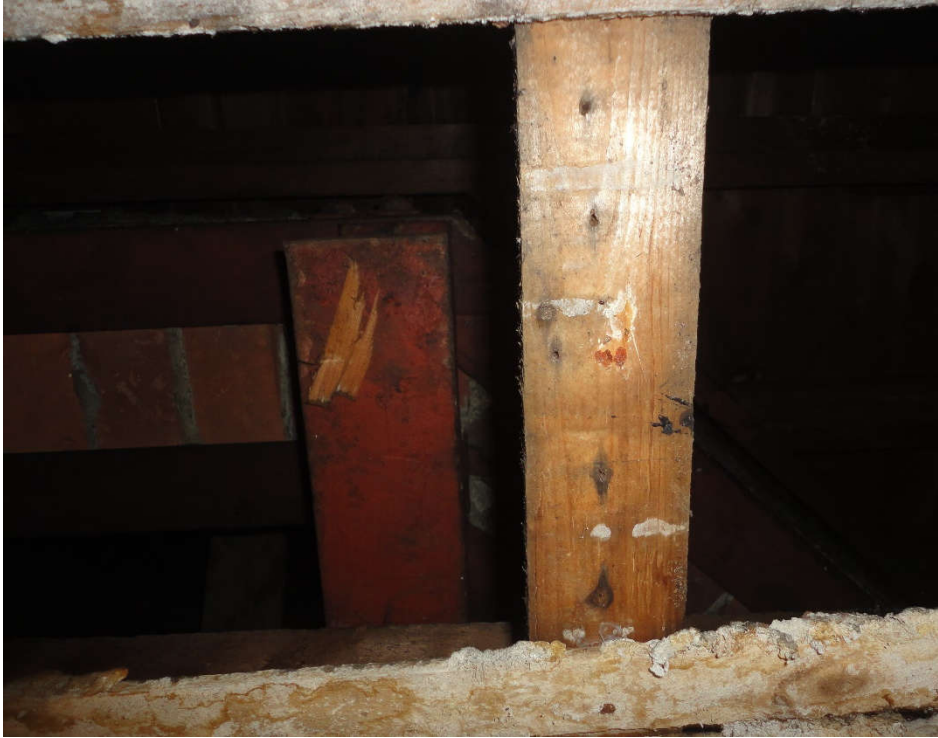
Photograph No. ST-03

Similar 2x12 wood framing structure at Drill Hall floor

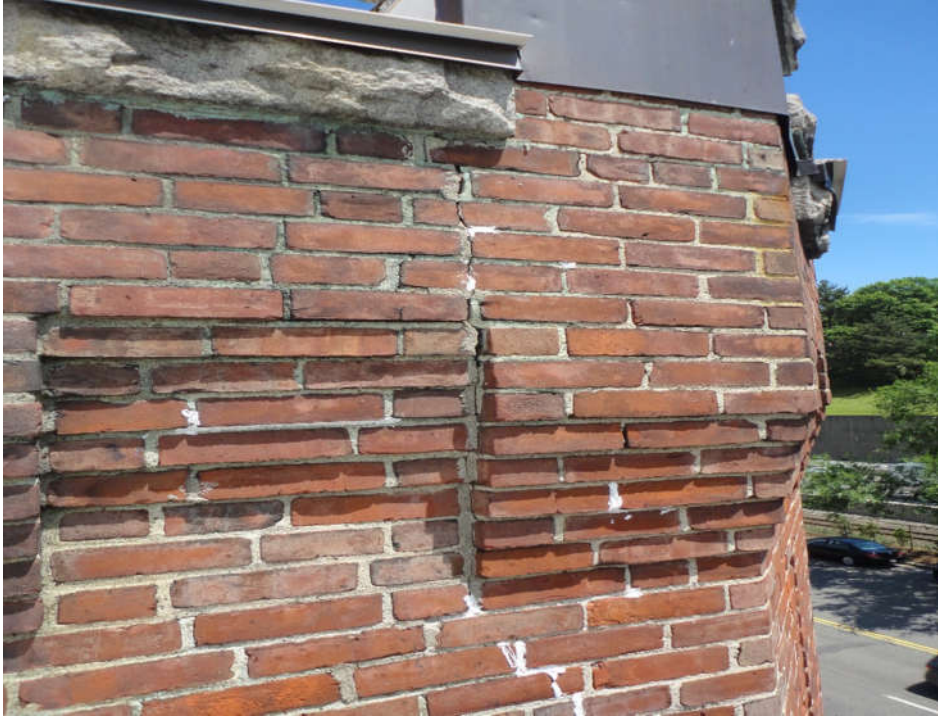
Photograph No. EXT-04

North side crenelated parapet with step cracking in brick

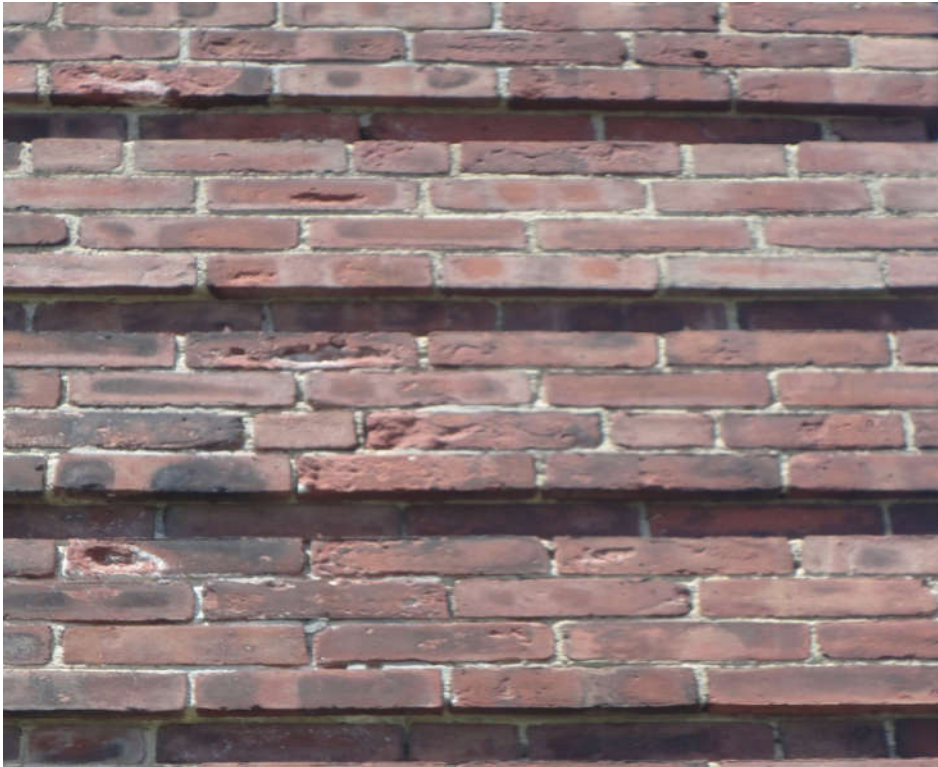
Photograph No. EXT-05

Stepped brick at the south turret with brick cracking, evidence of previous mortar repairs

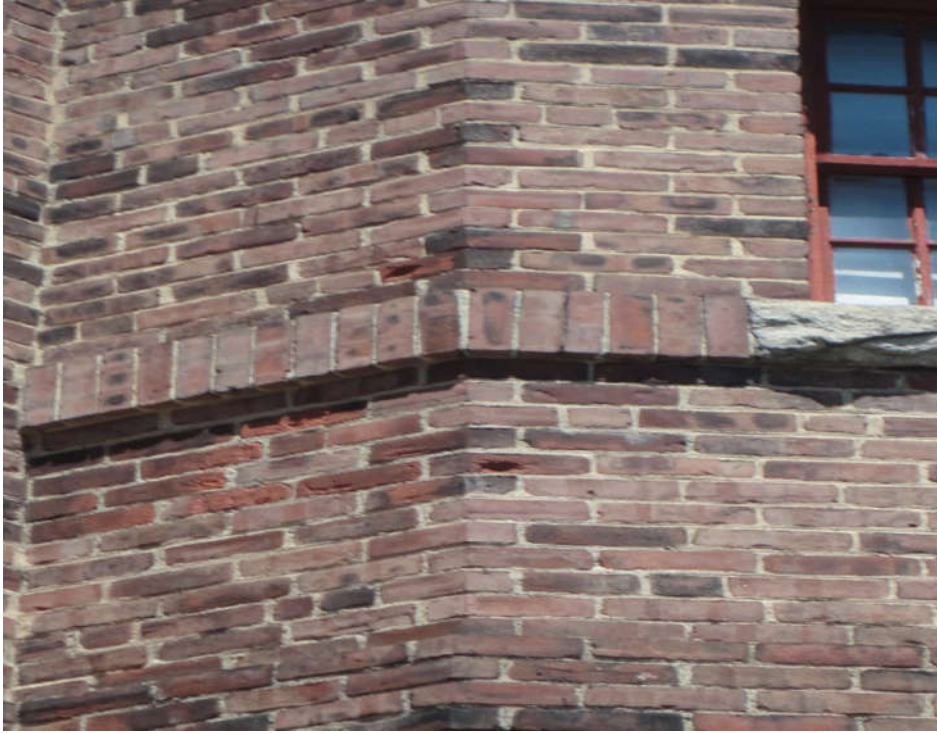
Photograph No. EXT-06

Banding at south elevation with spalled brick

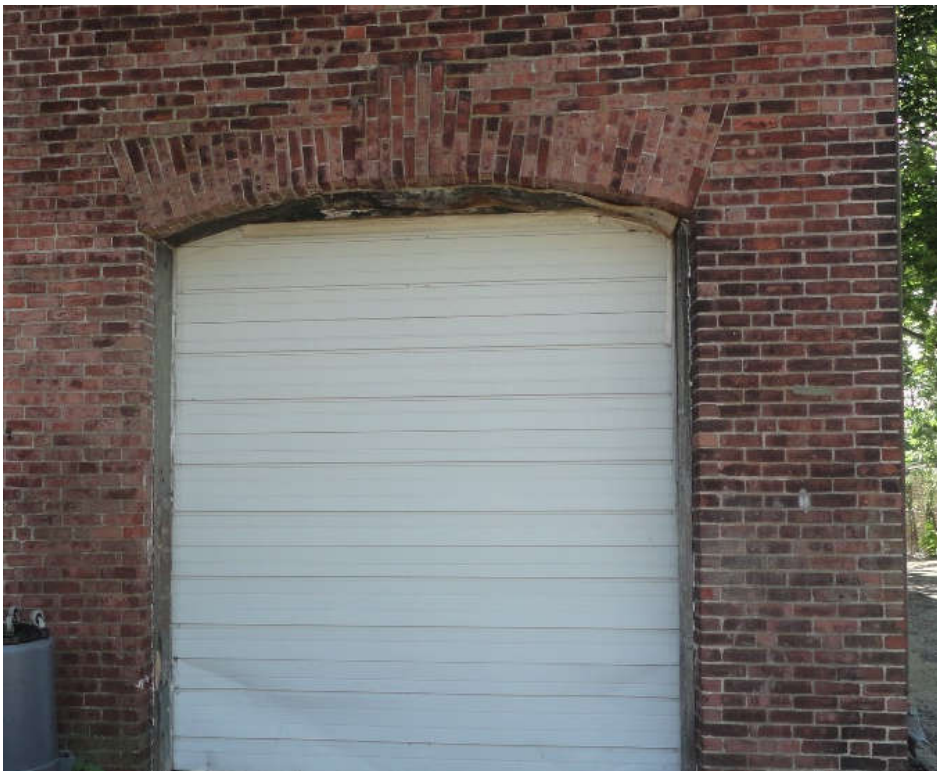
Photograph No. EXT-07

Spalled brick at south elevation
