TRIP ENGINEERING SERVICES, LLC  
433 Main Street, Suite 4  
Hudson, MA 01749  
www.tripiengineering.com

Project 190203.00 - Additional Investigation for Façade Repairs and Maintenance –  
Coleman Houses I and II, 677 Winchester Street, Newton, MA  
Subject Summary Report

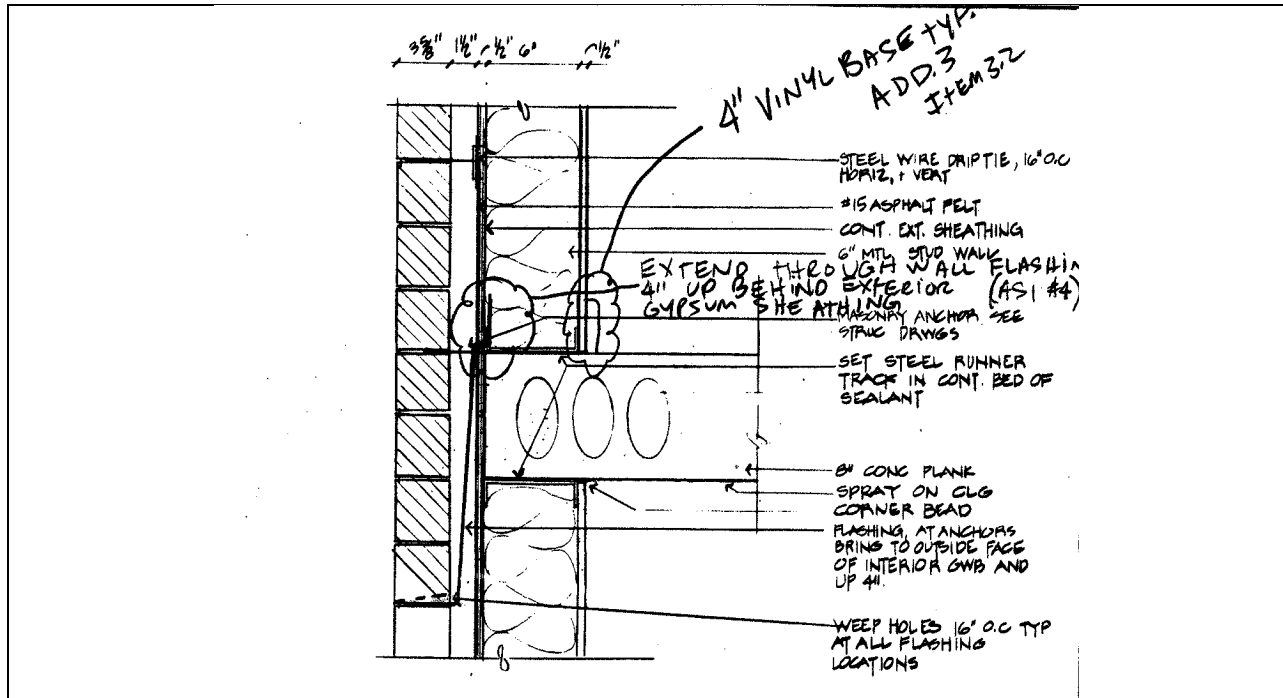
Figure 1 - Typical Non-Bearing Exterior Wall Detail (Drawing A-13, Coleman I)

The Construction Drawings for Coleman I show that the exterior walls typically consist of 3-5/8" face brick, 1-1/2" cavity with asphalt felt paper on 1/2" gypsum sheathing and 6" steel stud backup (Figure 1). The exterior brick wythe is shown connected to the steel studs with steel wire ties at 16" on center vertically and horizontally (Figure 1). Where the exterior brick wythe clads the lateral load resisting shear walls, the construction is shown consisting of a 2" cavity, which includes 1" of rigid insulation and 7-5/8" concrete block masonry backup. The brick wythe is shown connected to the concrete block (CMU) with steel wire ties at 16" on center vertically, no horizontal spacing is shown (Figure 2).

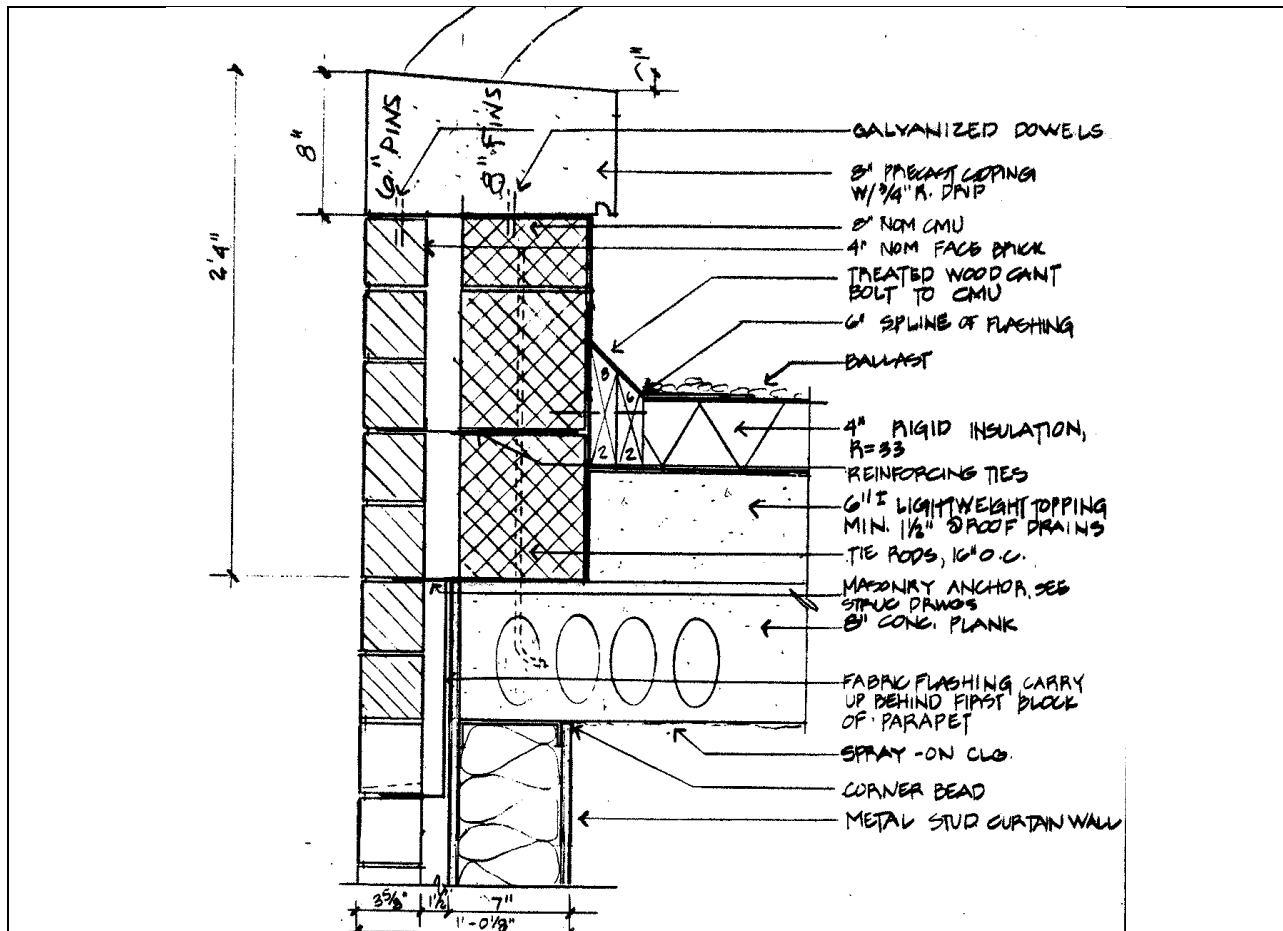
Figure 3 - Typical Exterior Wall Parapet (Drawing A-13, Coleman I)

The parapet section detail shows a precast concrete cap bridging between 8" nominal CMU backup and 4" nominal face brick with a 1-1/2" cavity. Through-wall flashing is shown installed in the bed joint eight courses down from the cap stone (Figure 3). We understand that during previous roofing work the original precast capstone was removed and the current metal cap flashing on wood blocking was installed.

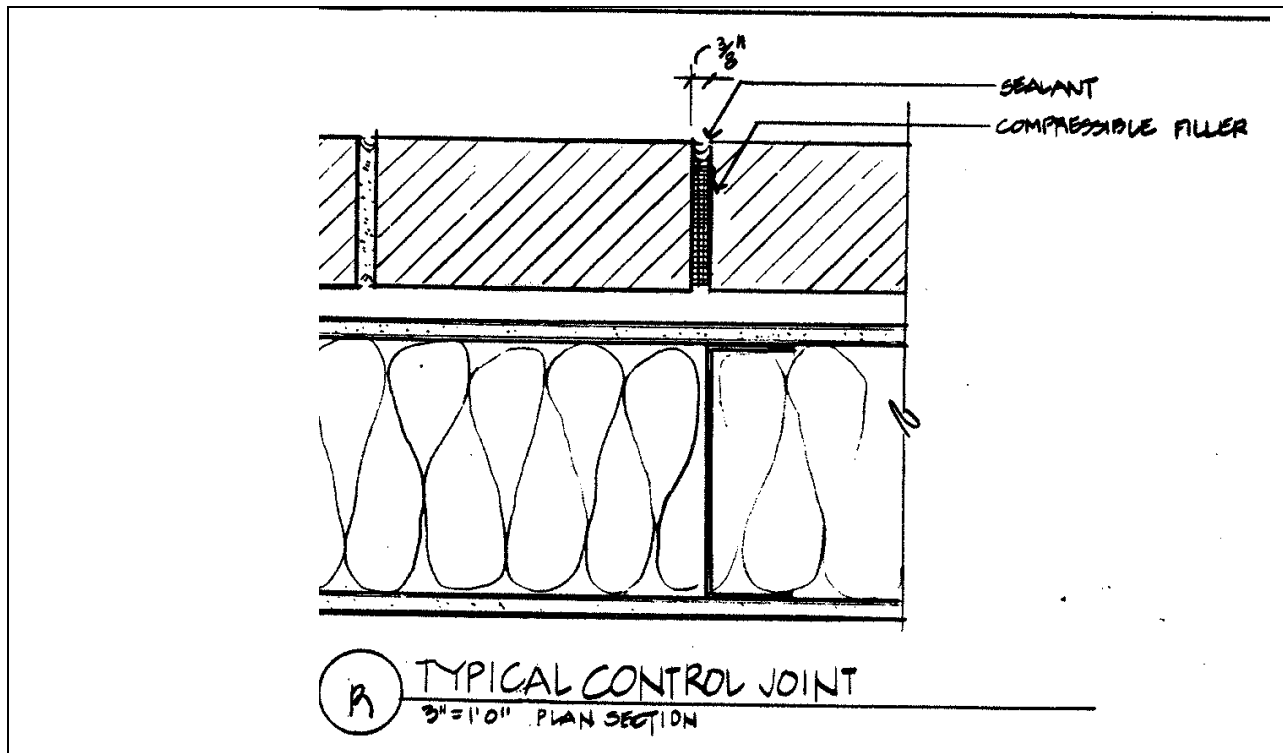
Figure 4 - Typical Expansion Joint Detail (Drawing A-13, Coleman I)

The masonry expansion joint detail is detailed on the wall plan section showing a 3/8" wide joint filled with compressible filler and sealant (figure 4).

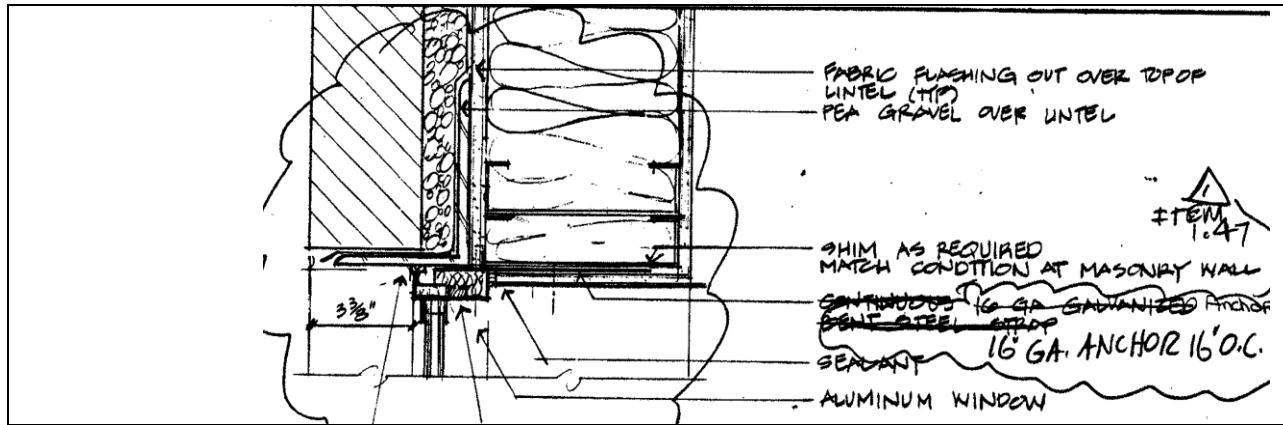
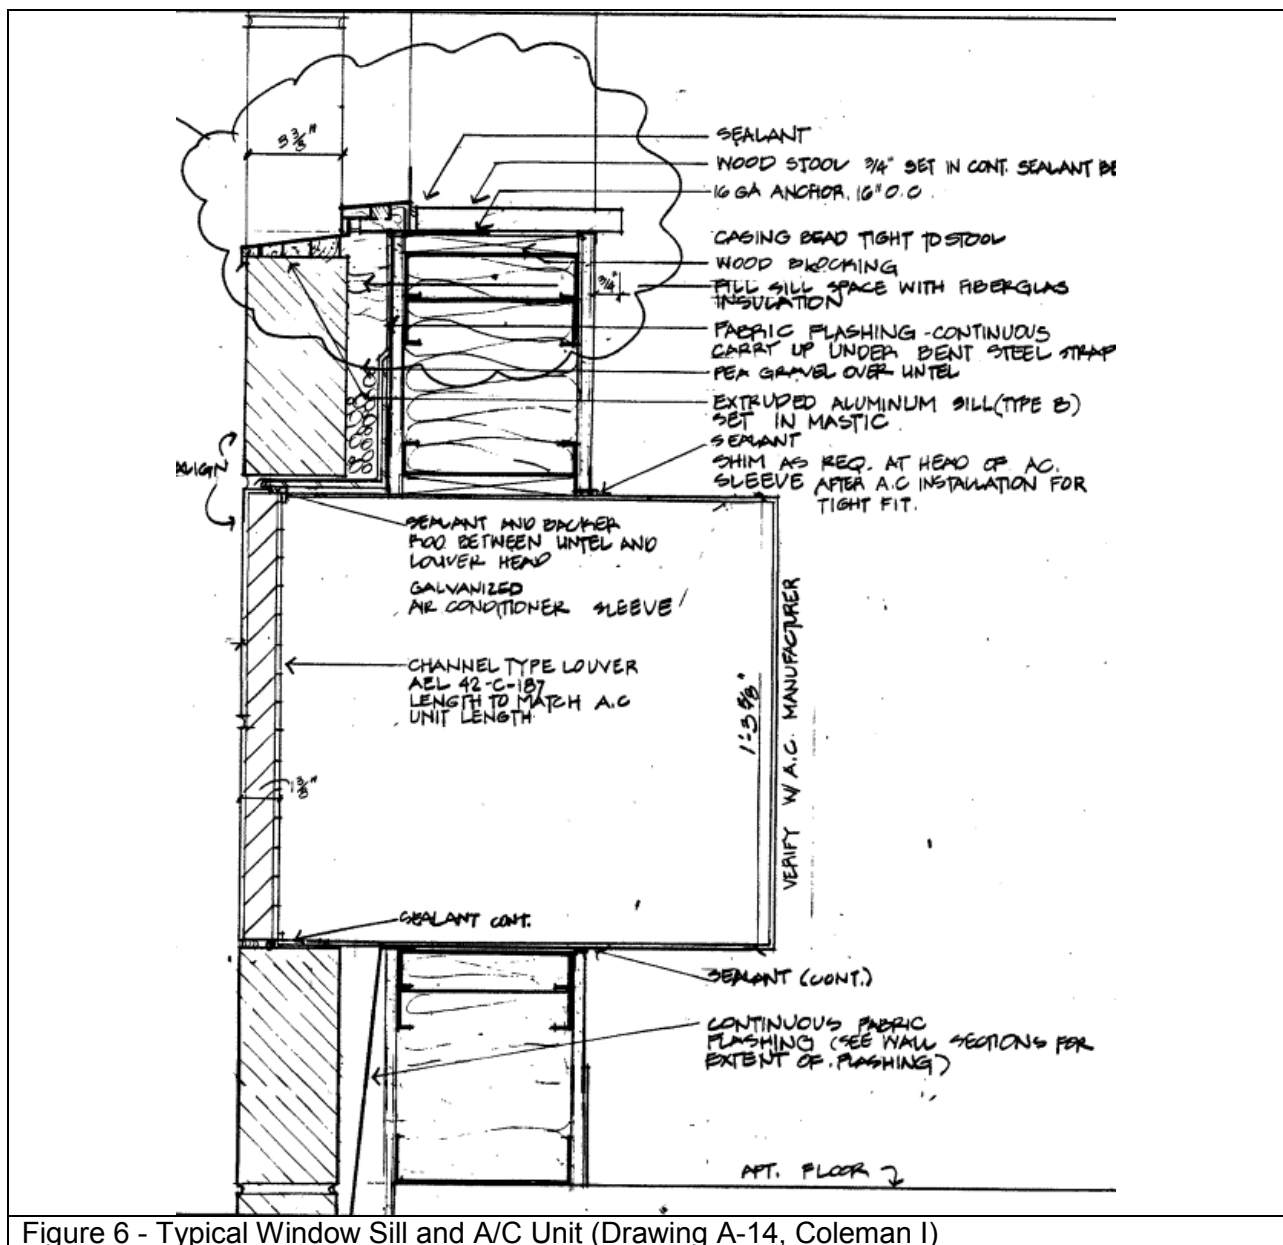
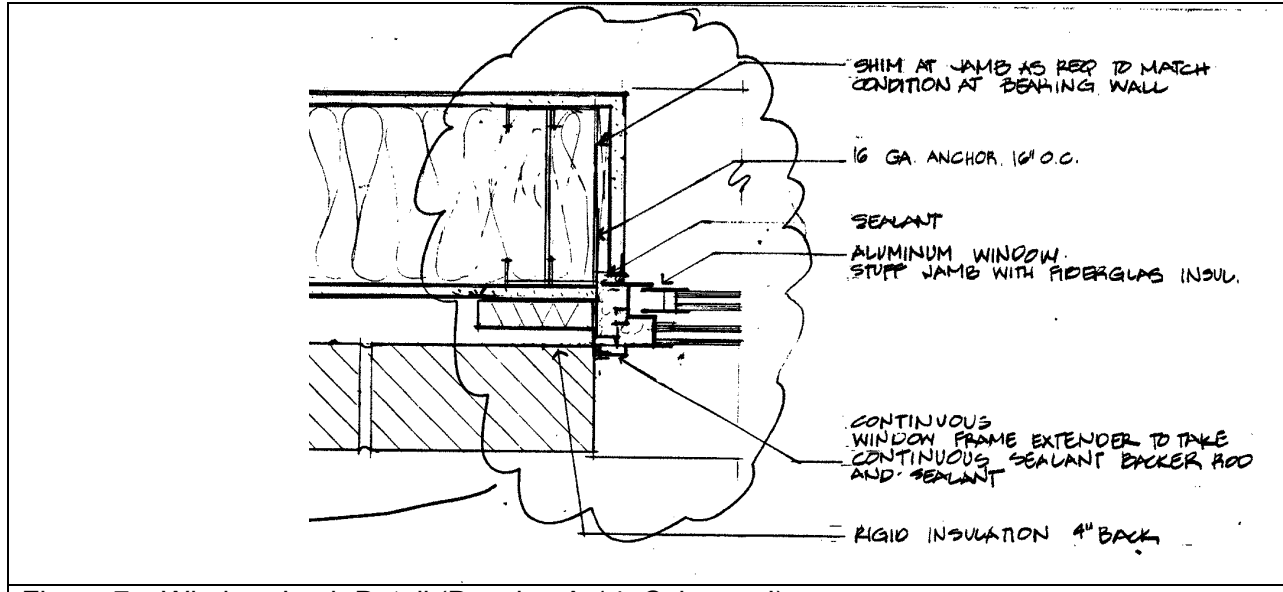
The drawings show aluminum-framed sash windows attached to the backup structure at the head, sill and jambs, with an extruded aluminum sill supported on the brick exterior wythe. A floating steel lintel is shown at the window head supporting the brick above. The lintel is shown covered by fabric flashing and the cavity above the lintel is shown filled with pea gravel (Figures 5 to 7).

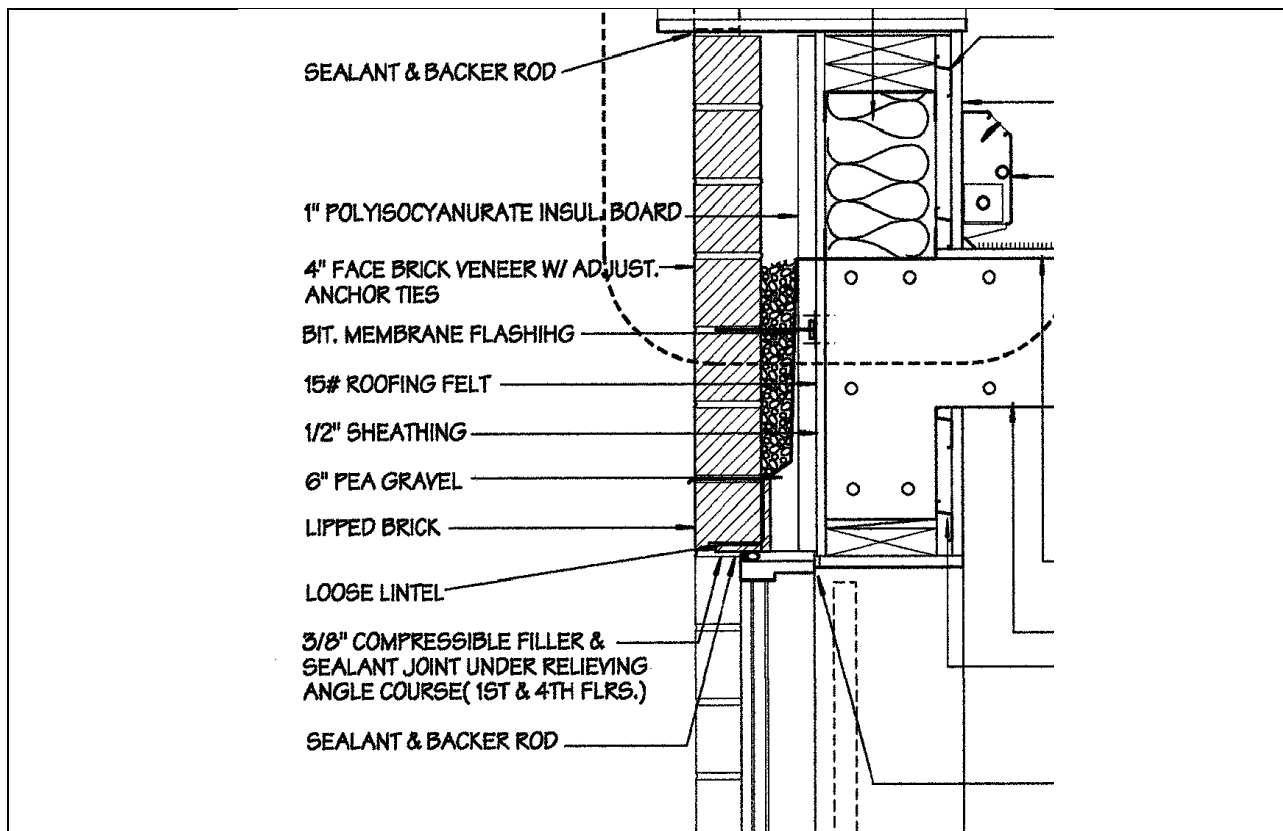
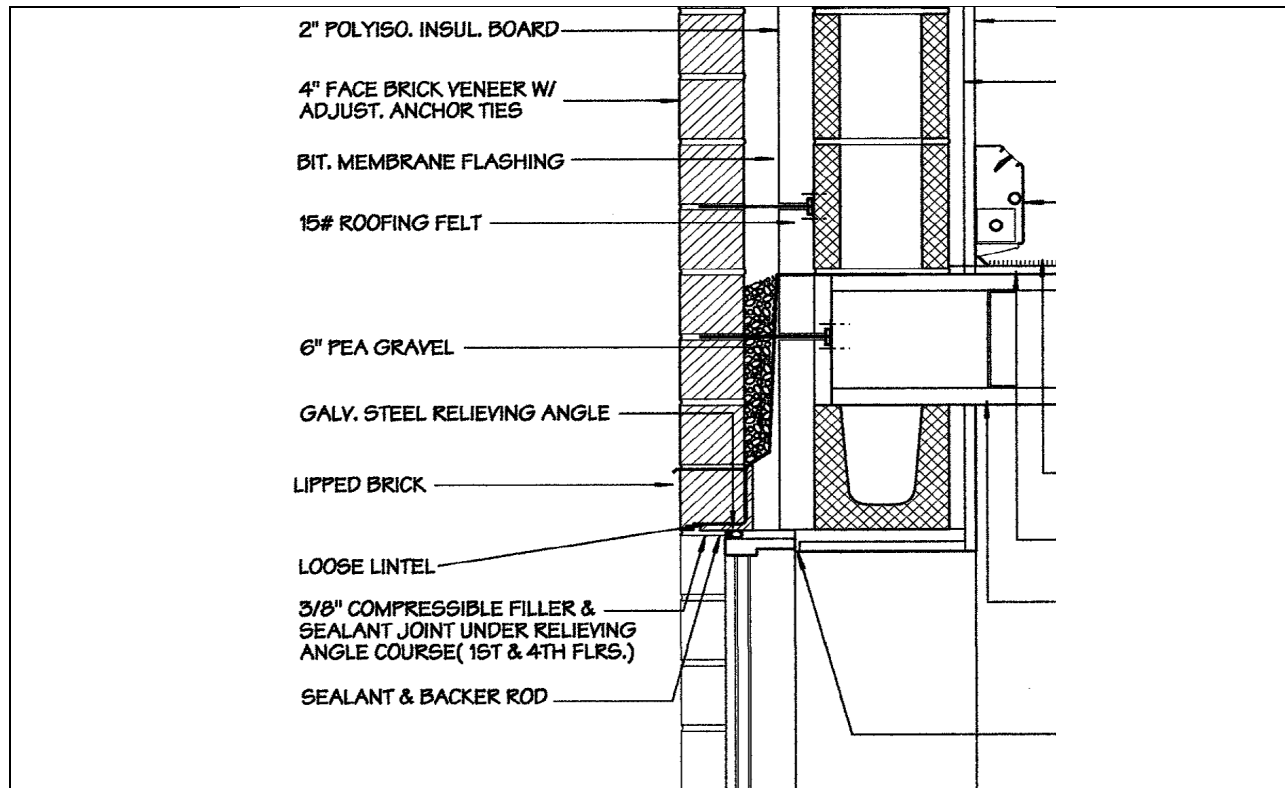
The Construction Drawings for Coleman II show the exterior walls consist of 3-5/8" face brick, 2" air space, 1" rigid insulation with asphalt felt paper on 1/2" gypsum sheathing and 6" steel stud backup. The exterior brick wythe is shown connected to the steel studs with adjustable ties. Where the exterior brick wythe clads CMU shear walls, the wall construction consists of a 1" air space, 2" rigid insulation and 7-5/8" concrete block masonry backup. The exterior brick wythe is noted as connected to the concrete block backup with adjustable ties. No spacing for the wall ties is provided (Figures 8 and 9).

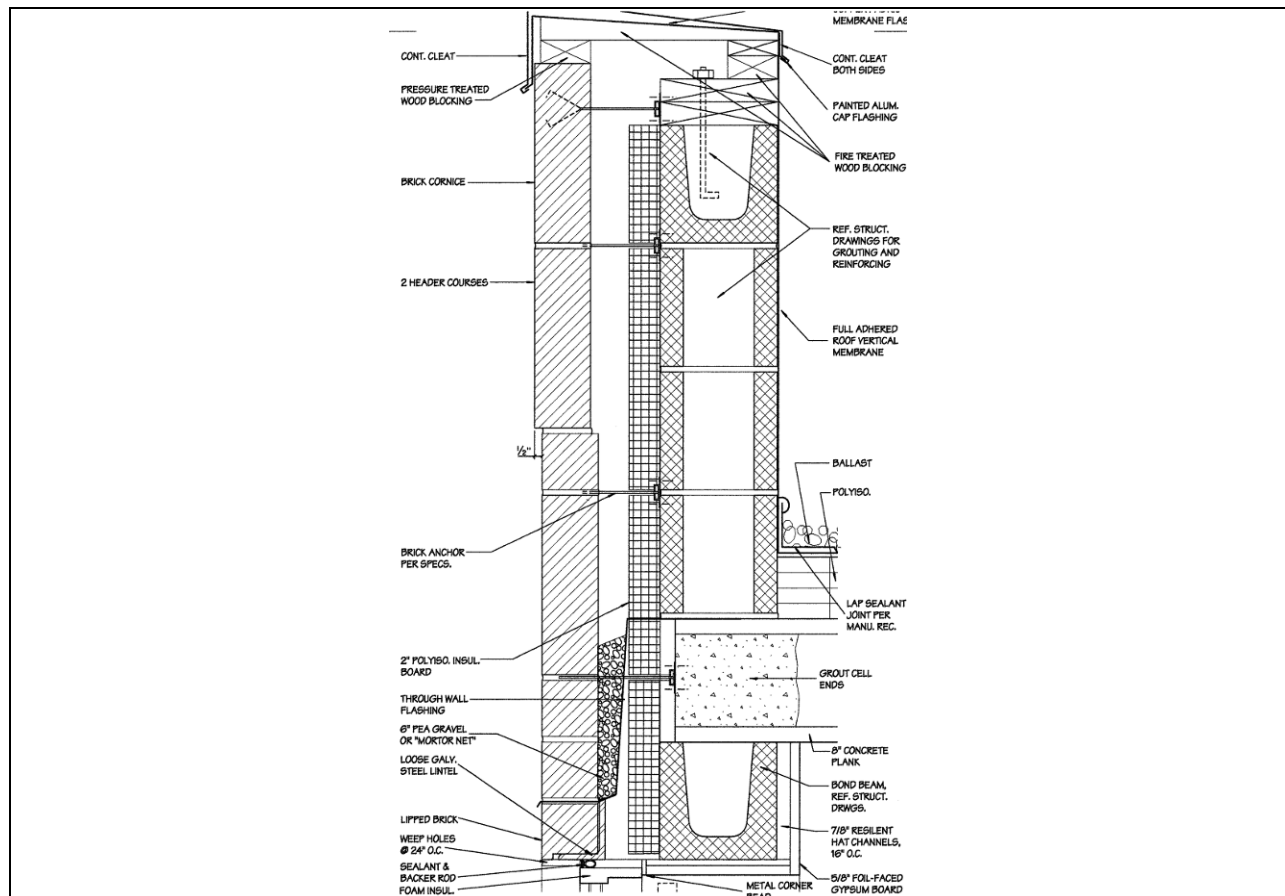
Figure 10 - Typical Exterior Wall Parapet (Drawing SKA6.3, Coleman II)

The parapet section detail shows 4" nominal face brick with three courses of soldier-laid brick with a single stretcher course between the top two soldier courses and lower soldier course (Figure 10). The parapet backup is 8" nominal CMU with 2" of polyiso insulation, an air space (no dimension shown) and 4" nominal face brick. Through-wall flashing is shown installed in the bed joint one course up from the loose window head lintel (Figure 10).

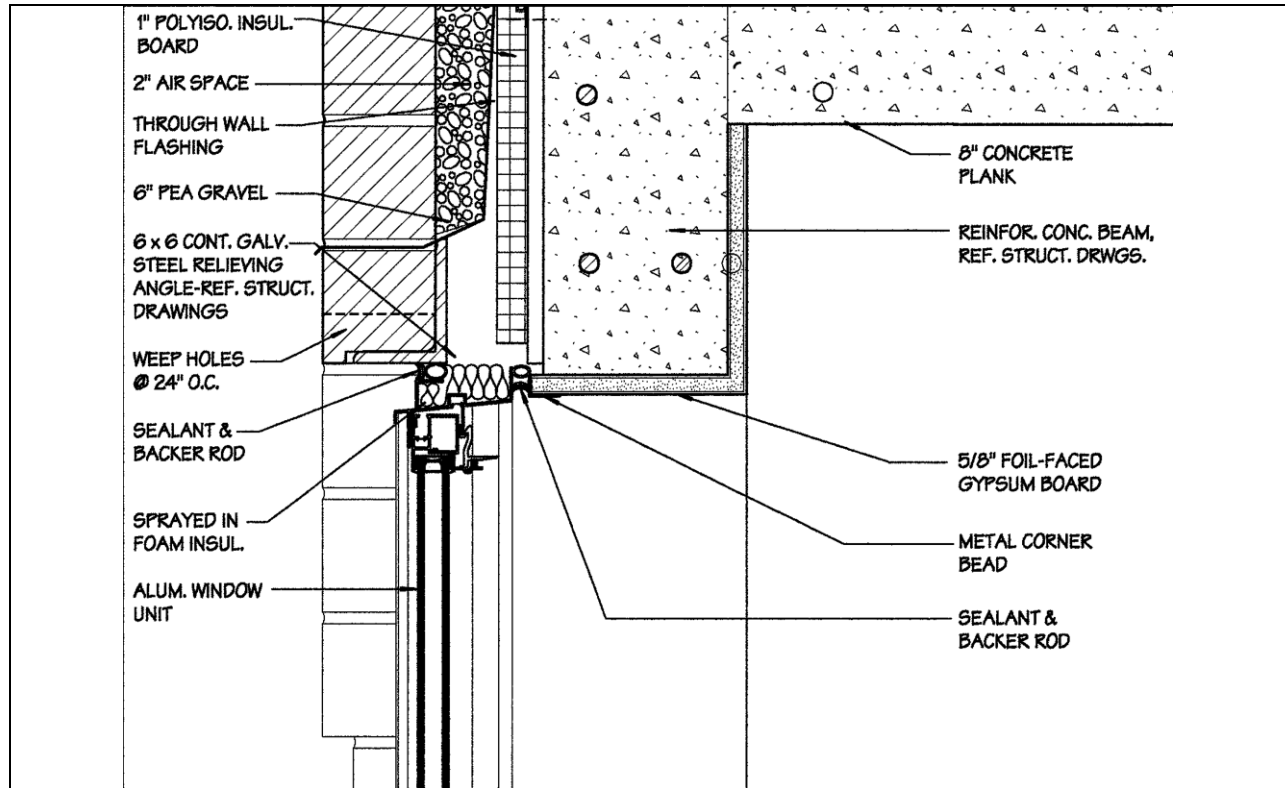
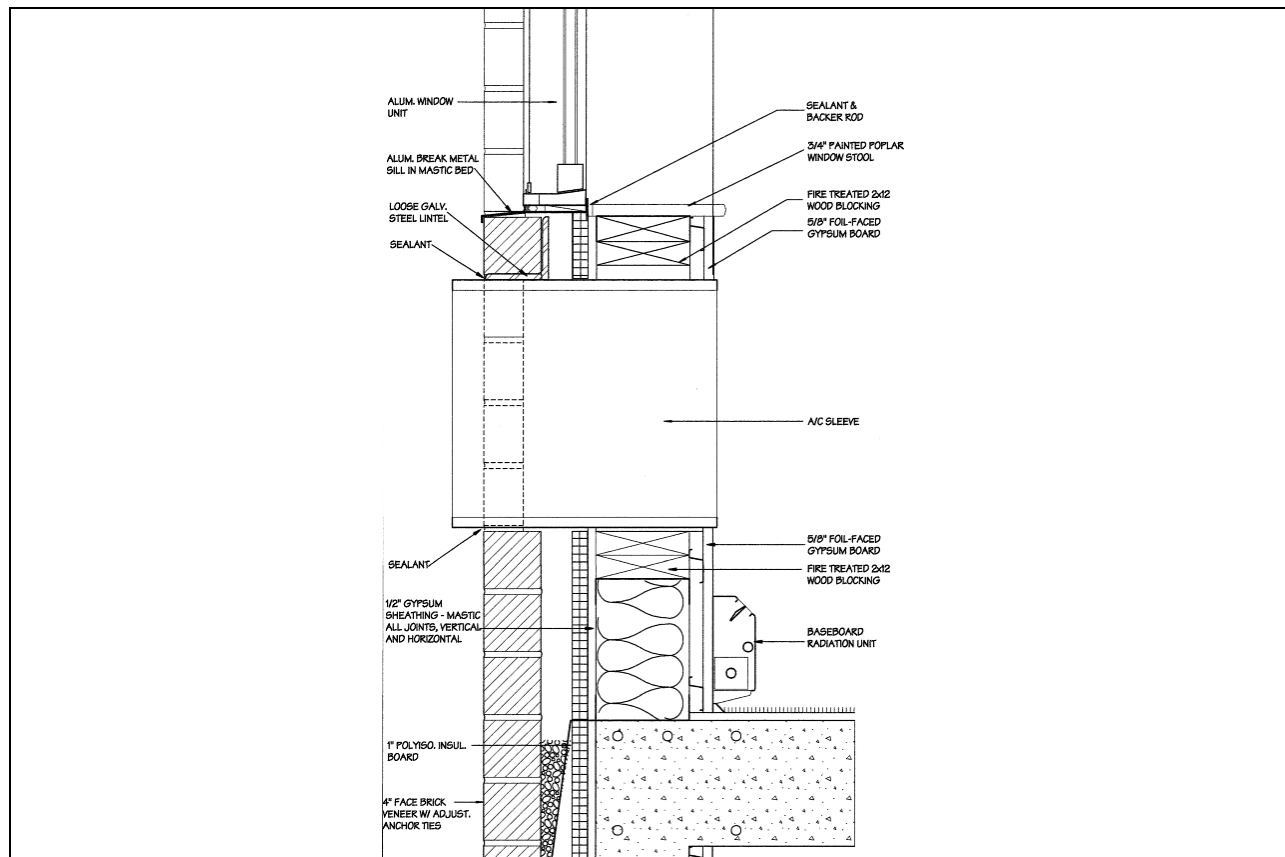
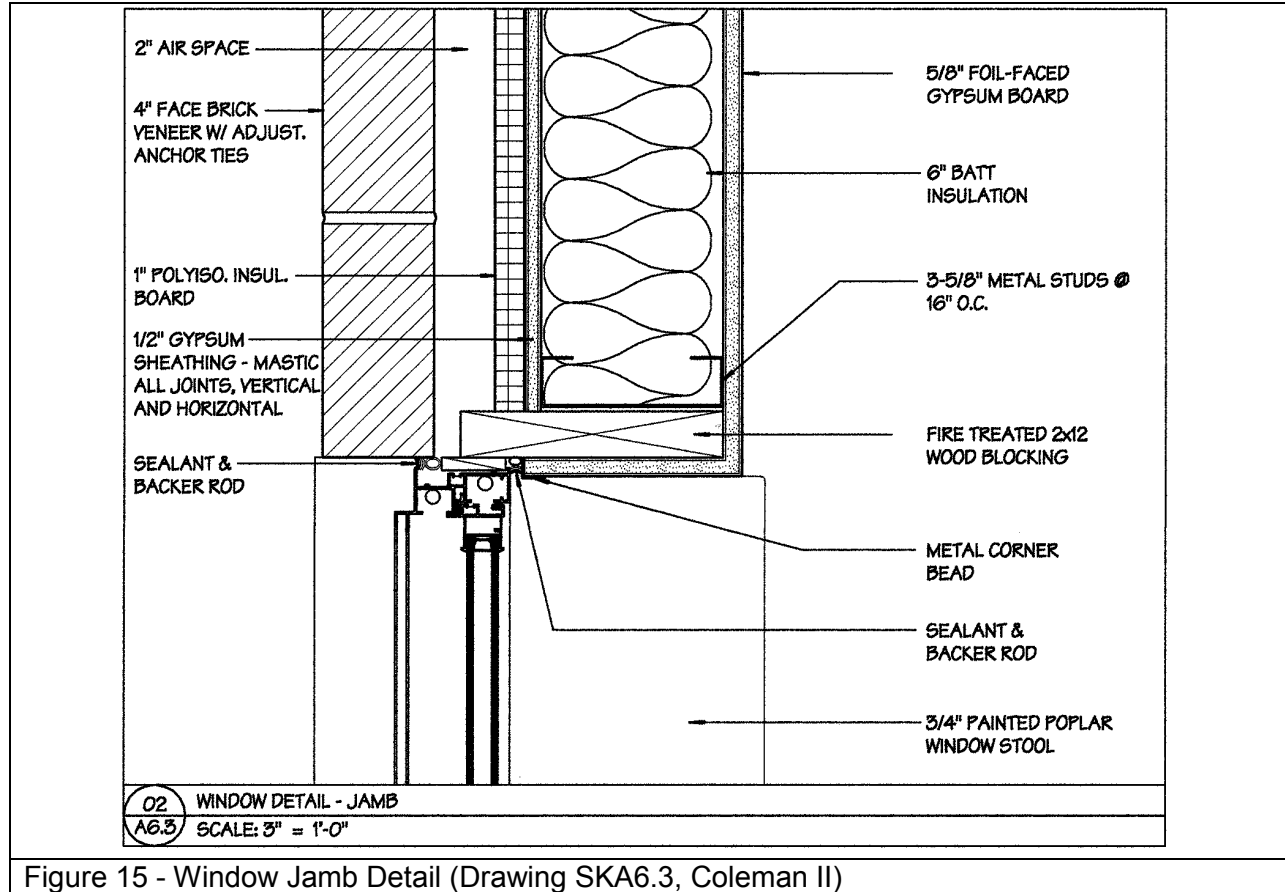
The drawings show aluminum-framed windows framed by wood blocking at the sill and jambs, but no attachment to the backup structure is shown. A break metal aluminum sill is shown supported on the brick exterior wythe that extends under the window frame and noted to turn up at the jambs. A floating steel lintel is shown at the window head supporting the brick above. Through-wall flashing is shown one course above the floating steel head lintel and the cavity above the flashing is shown filled with pea gravel (Figures 13 to 15).
