**CAPITAL NEEDS ASSESSMENT (CNA)
COLEMAN HOUSE I AND II
677 WINCHESTER STREET
NEWTON, MASSACHUSETTS 02459**

2017-0846

SEPTEMBER 21, 2017

MAY 24 AND 25, 2017

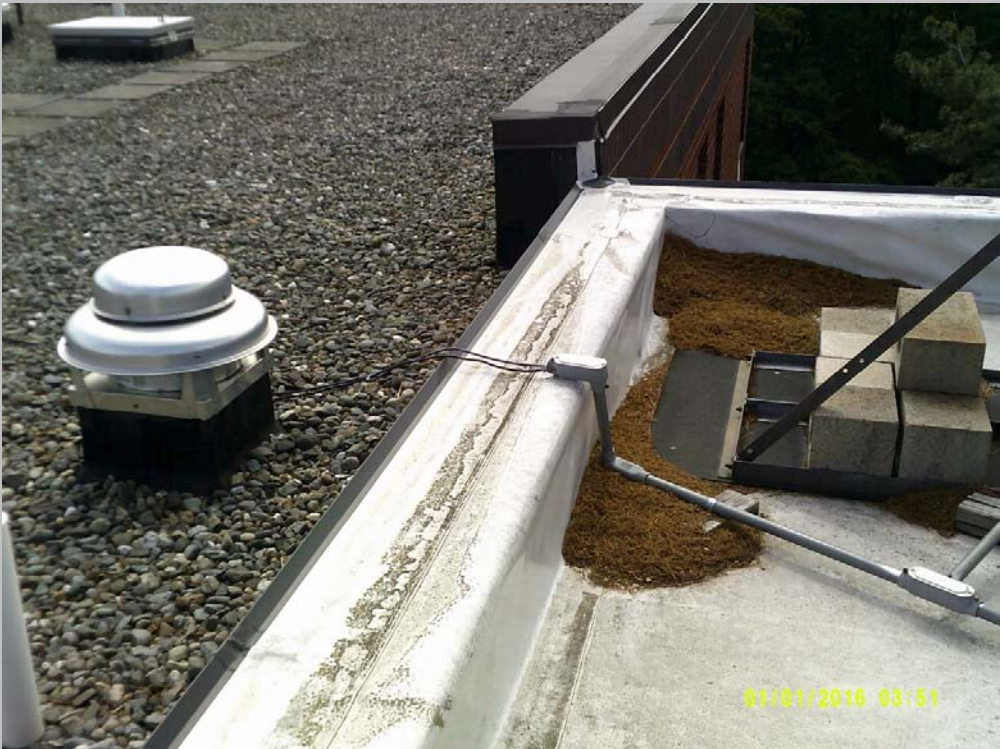
PHOTO #11

SECT	NON-CRITICAL REPAIR (12-MONTH PROPERTY CONDITION)	TOTAL
Coleman House I		
3.3.4	1. It was observed during the inspection that two (2) corners of the roof area over Coleman I had debris from the surrounding trees accumulating. In order to preserve the integrity of the roofing material and internal drainage system, removal of the debris is required. This repair can be completed by the onsite maintenance staff so no cost is associated. (1 Each @ No Cost, Repair)	No Cost

Coleman House I roof with tree debris (Non-Critical Repair)

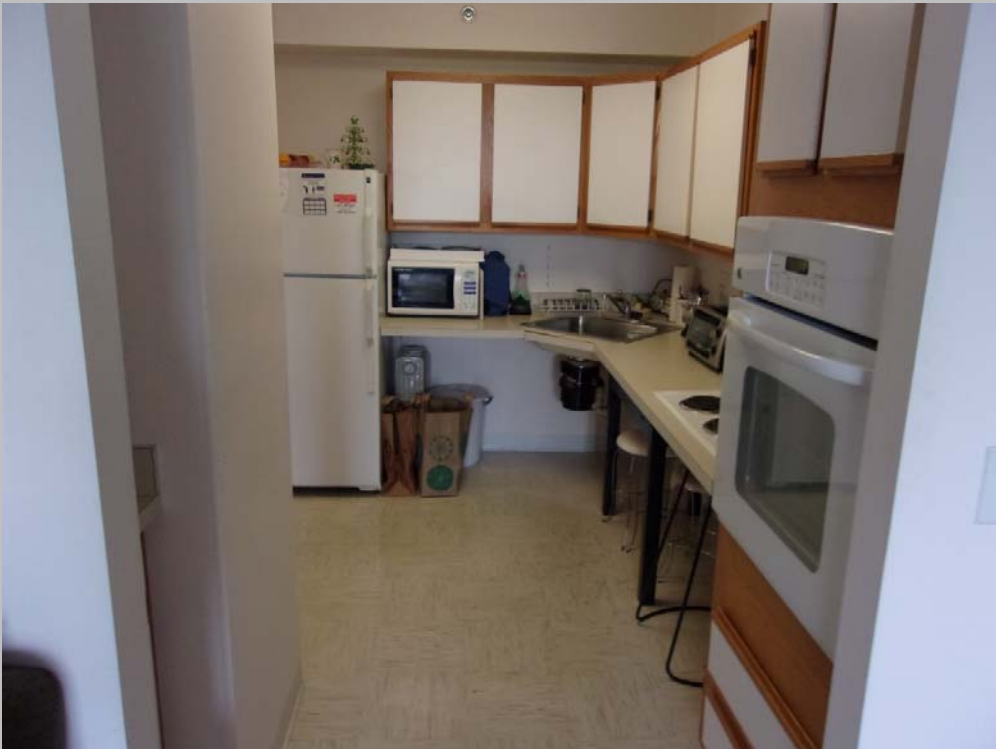
PHOTO #25

Coleman House II		
Coleman House II - ACCESSIBILITY		
7.1	1. It was observed in handicap dwelling units 532, 432, and 332 that there was not any scald and abrasion protection under the kitchen sink. In order to comply with Uniform Federal Accessibility Standards (UFAS), the installation of scald and abrasion protection at is required. (3 Each @ \$35.00, Repair)	\$105.00

Coleman II handicap dwelling unit without scald and abrasion protection under sink (Critical Repairs)

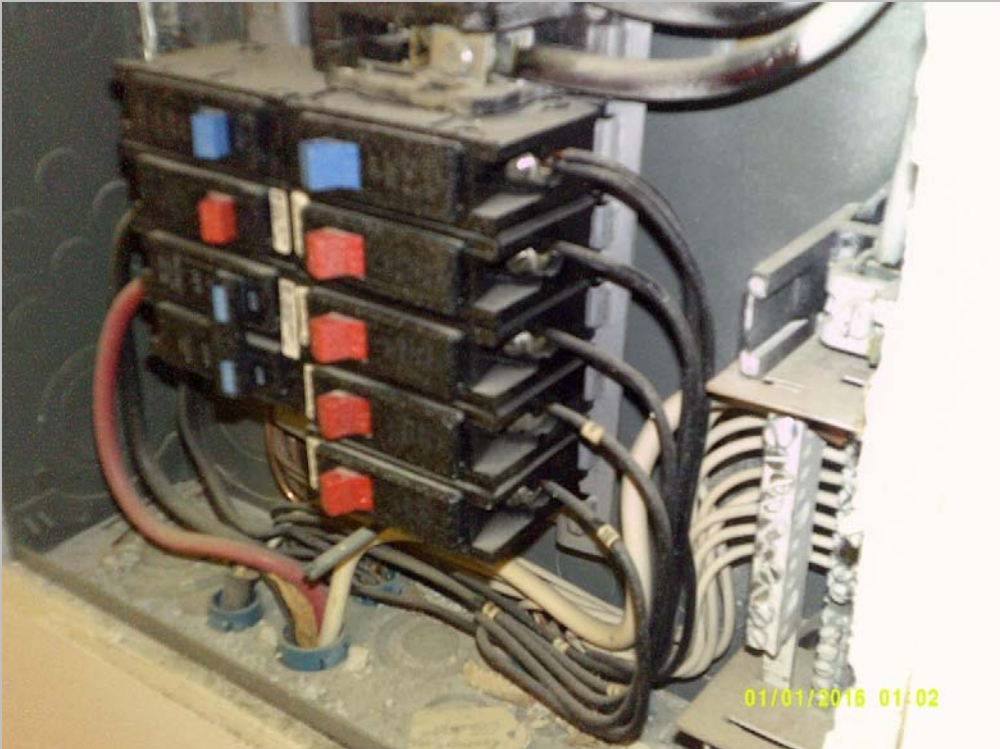
PHOTO #32

3.4.4	2. It was observed during the inspection that two (2) breakers in each electrical panel are double tapped. In order to be compliant with NEC, it is required that a licensed electrician repair the double tapped breakers by either installing additional breakers or pig tailing the wiring to provide only one (1) wire tapped into the breaker. (100 Each @ \$50.00, Repair)	\$5,000.00
Coleman House I - ACCESSIBILITY

Top right breaker double tapped in Coleman I dwelling unit (Critical Repair)

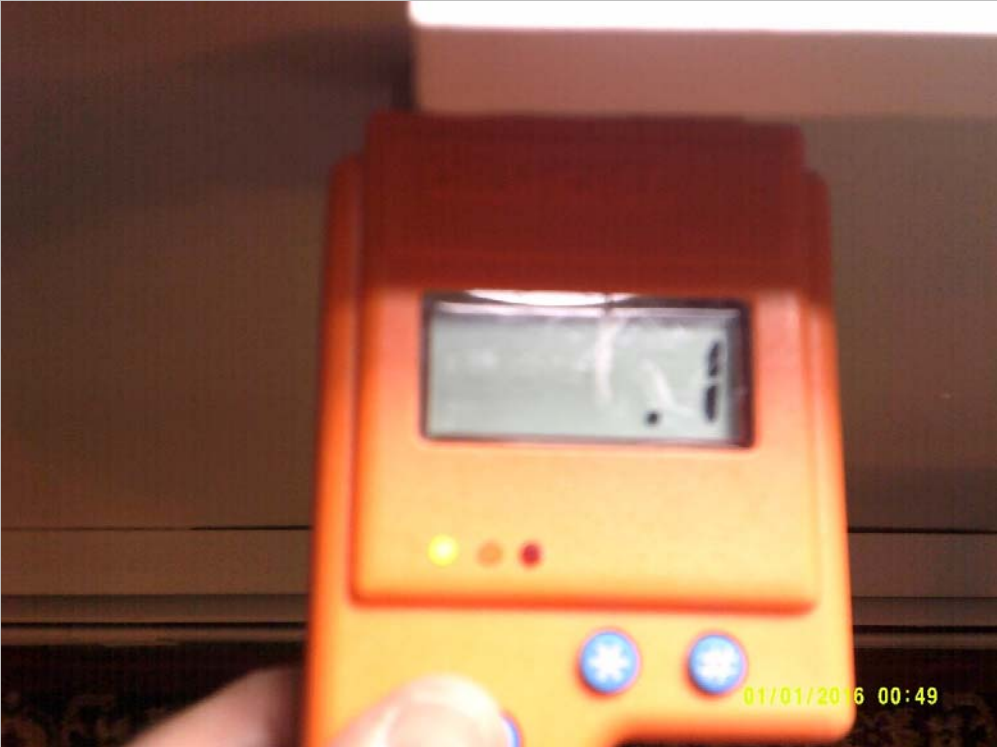
PHOTO #33

Low moisture reading in Coleman I

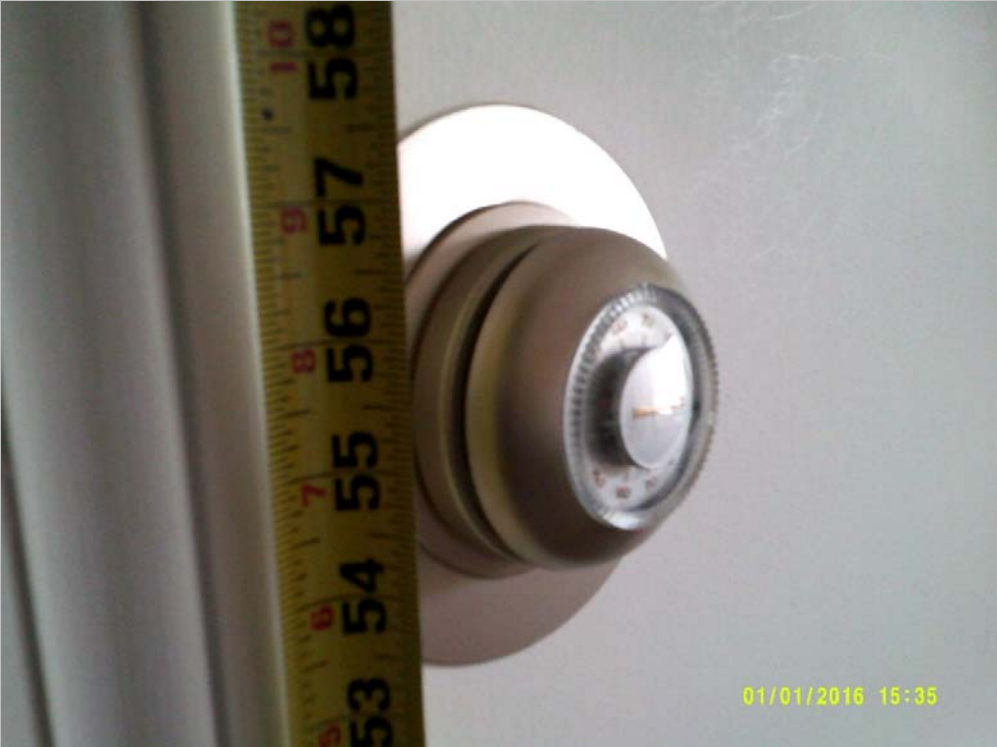
PHOTO #34

7.1	6. It was observed during the inspection that the thermostat height in handicap dwelling units 523, 423, 323, 223 and 123 were mounted at fifty four inches (54") above the finished floor. The thermostat control must be lowered to a maximum height of forty eight (48") in order to be compliant with UFAS. (5 Each @ \$75.00, Level 1 Alterations)	\$375.00

7.1	3. It was observed during the inspection that the thermostat height in the dwelling units were mounted at approximately 54-inches above the finished floor. The thermostat control must be lowered to a maximum height of 48-inches in order to comply with the Fair Housing Act (FHA). (46 Each @ \$75.00, Level 1 Alterations)	\$3,450.00

Dwelling unit thermostat mounted above 48" (Critical Repair)

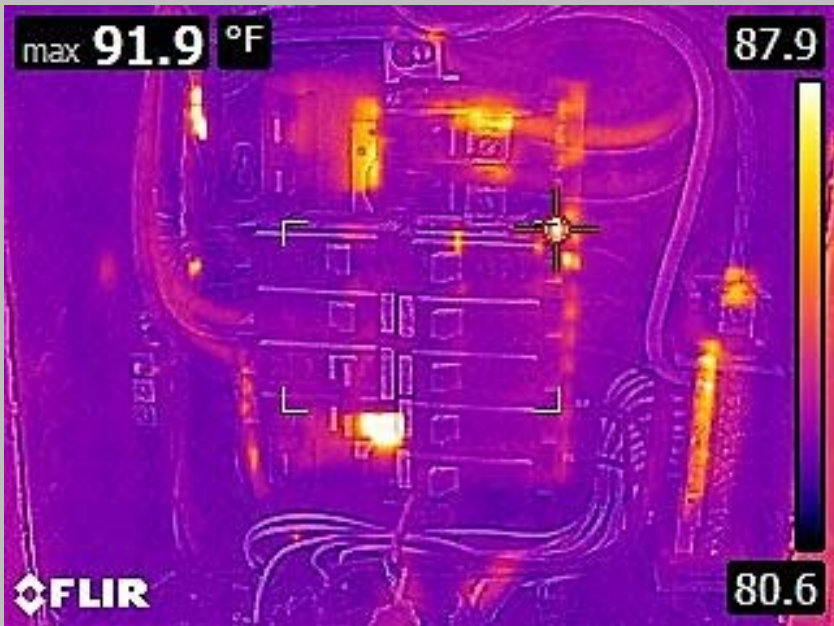
PHOTO #37

Thermal Image of Dwelling Unit Breaker Panel with Low Temperature Reading

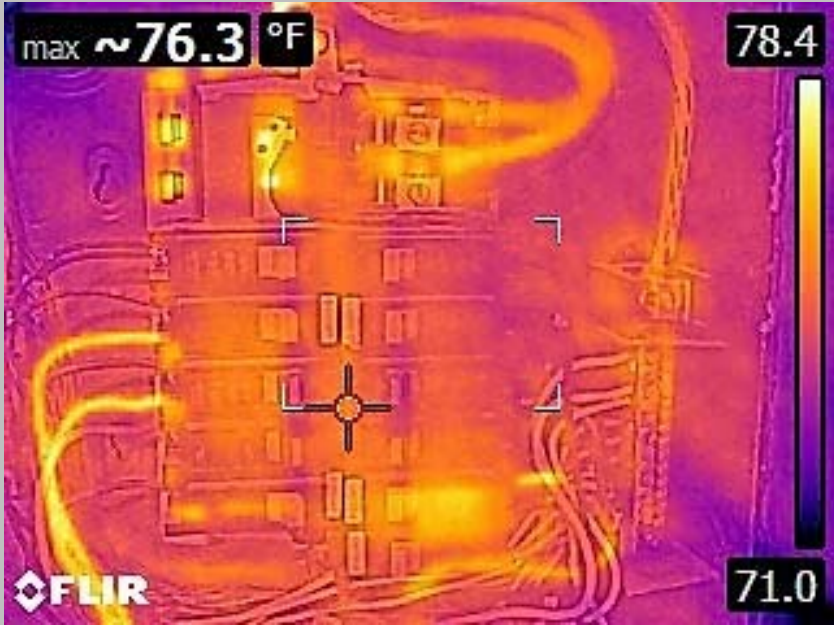
PHOTO #38

Thermal Image of Dwelling Unit Breaker Panel with Low Temperature Reading

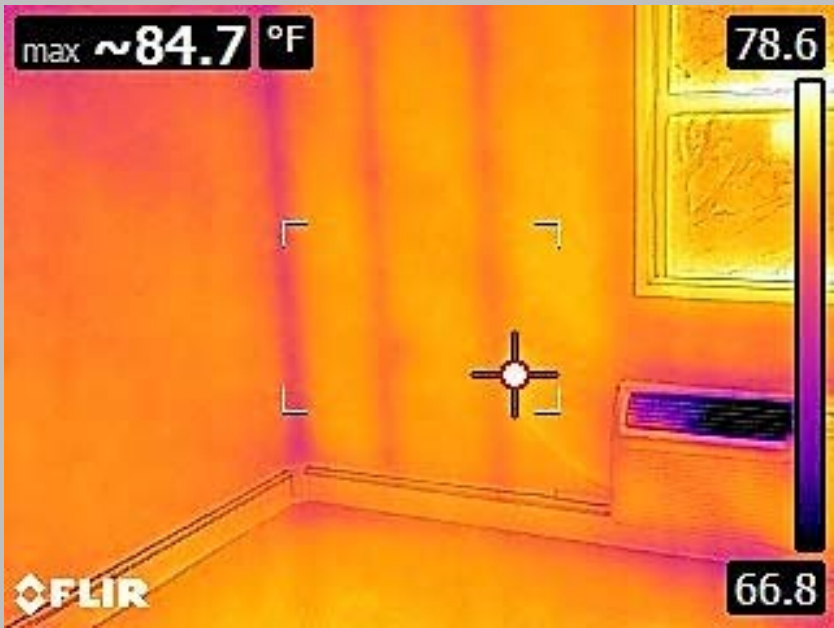
PHOTO #39

Thermal Image of Dwelling Unit Exterior Wall Without any Moisture Detected

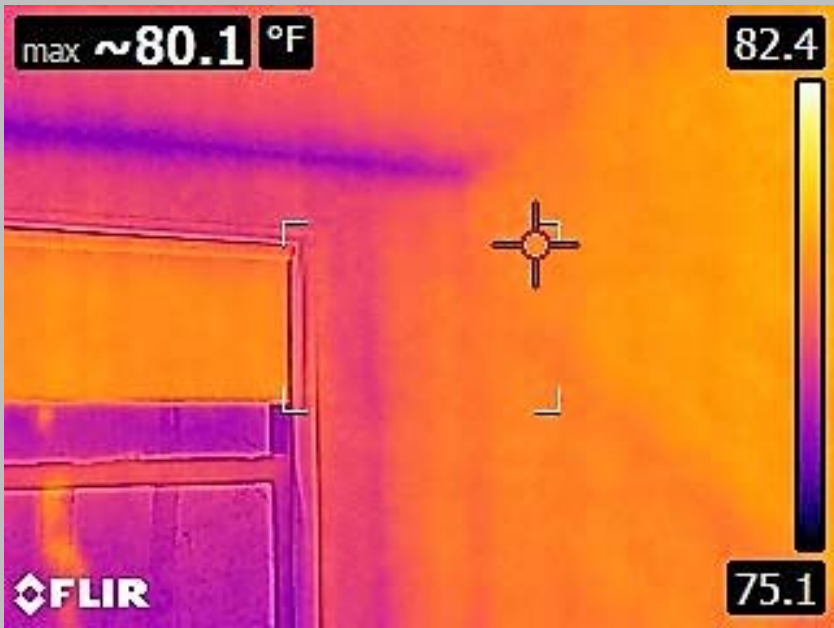
PHOTO #40

Thermal Image of Dwelling Unit Exterior Wall, Window, And Ceiling Without any Moisture Detected
