**677 WINCHESTER STREET AND
333 NAHANTON STREET,
NEWTON, MASSACHUSETTS
PHASE I ENVIRONMENTAL SITE ASSESSMENT**

**Appendix A
PHOTOGRAPHS OF THE PROPERTY AND VICINITY**

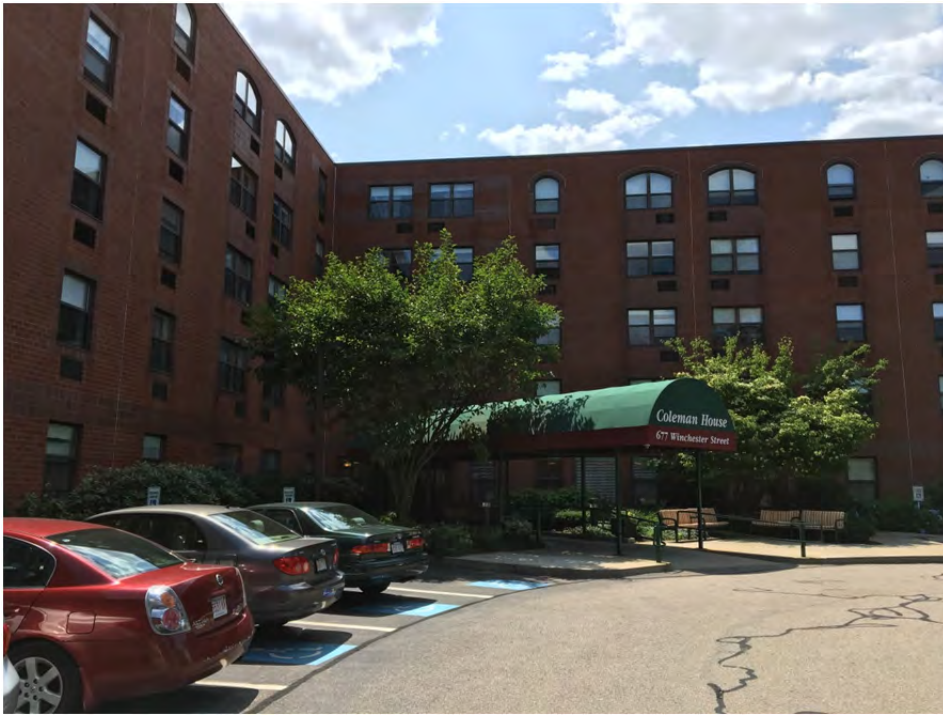
Photograph 1

Location on Property:
Front of the 677 Winchester building, as viewed from the parking lot with a view toward the west.

Key Observations in Photograph:
Property building condition and construction.

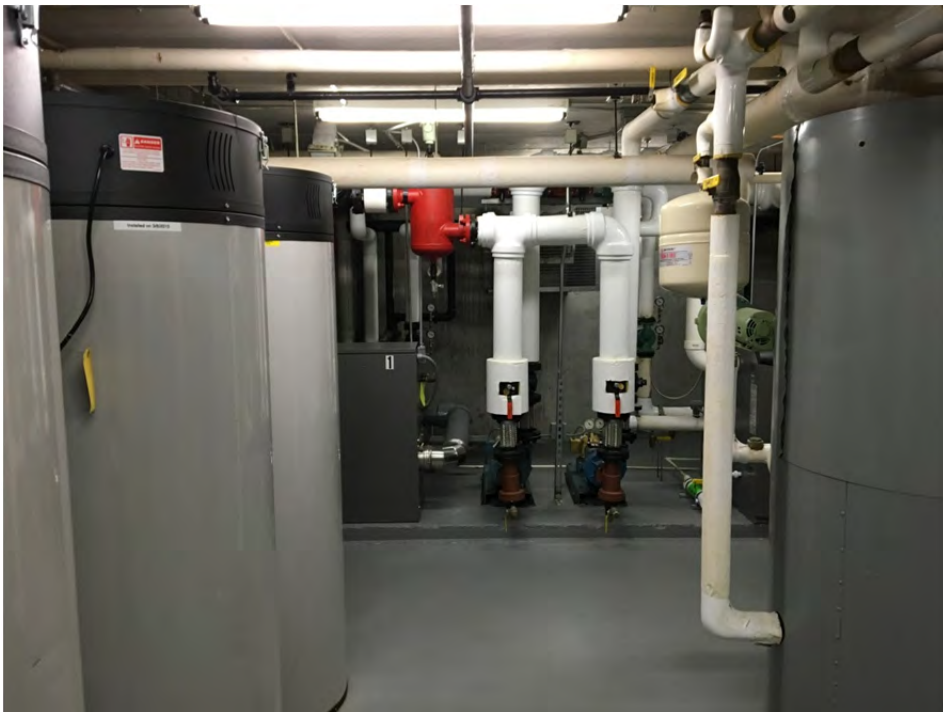
Photograph 2

Location on Property:
One of two boiler rooms in 677 Winchester building.

Key Observations in Photograph:
Condition of boiler room, fuel source.

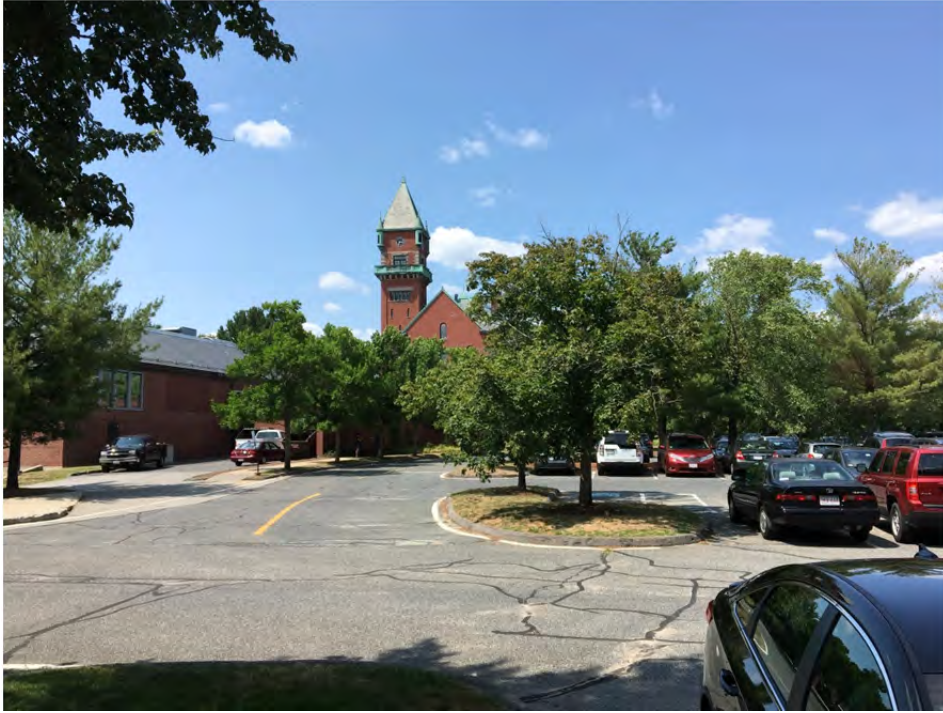
Photograph 3

Location on Property:
View of parking lot and 333 Nahanton Street property, with a view toward the north.

Key Observations in Photograph:
Property condition and construction.

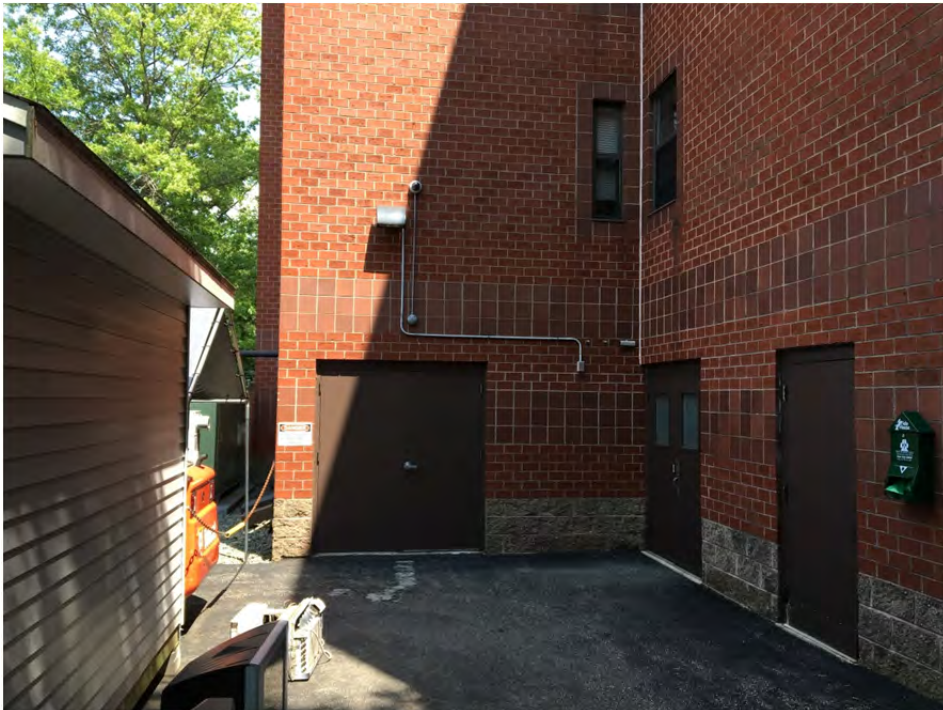
Photograph 4

Location on Property:
Rear, northwest corner of 677 Winchester St, with view of access to one of two boiler rooms.

Key Observations in Photograph:
Property building condition and construction.

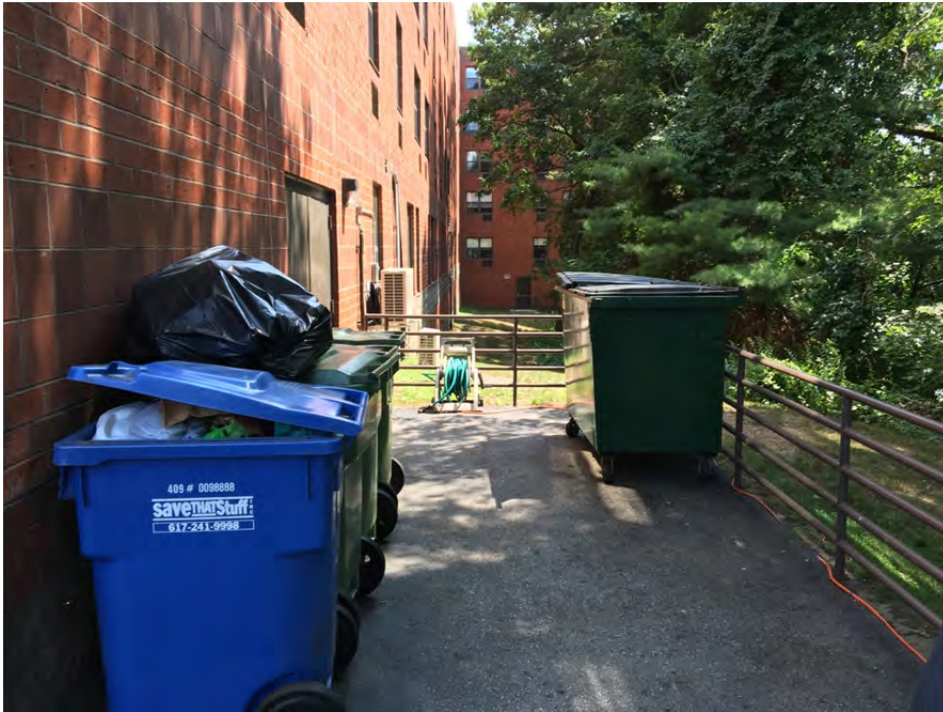
Photograph 5

Location on Property:
Rear west side of 677 Winchester building, with a view toward the south.

Key Observations in Photograph:
Property building condition and construction, solid waste removal.

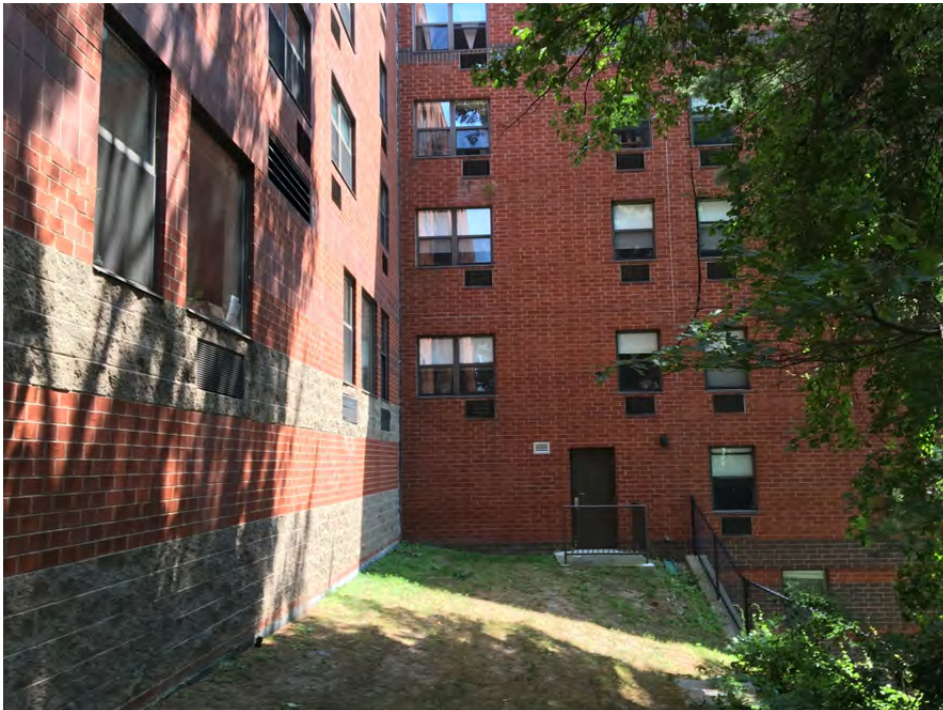
Photograph 6

Location on Property:
Rear west side of the 677 Winchester building, with view toward the south.

Key Observations in Photograph:
Property building condition and construction, general topography of the property.

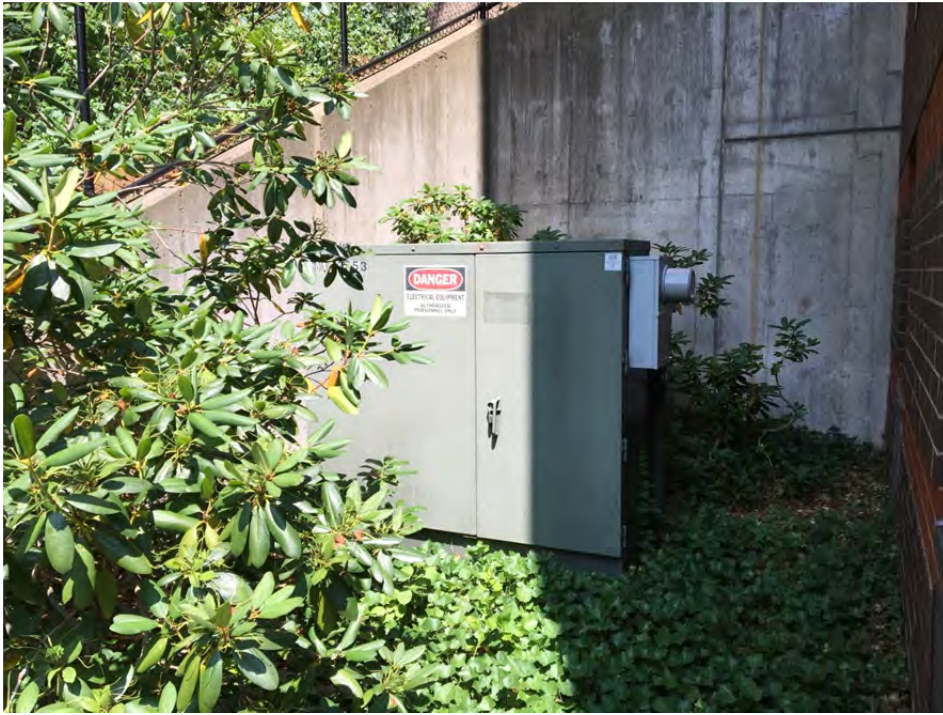
Photograph 7

Location on Property:
Pad-mounted transformer at the rear, west side of the building.

Key Observations in Photograph:
Transformer condition and location.

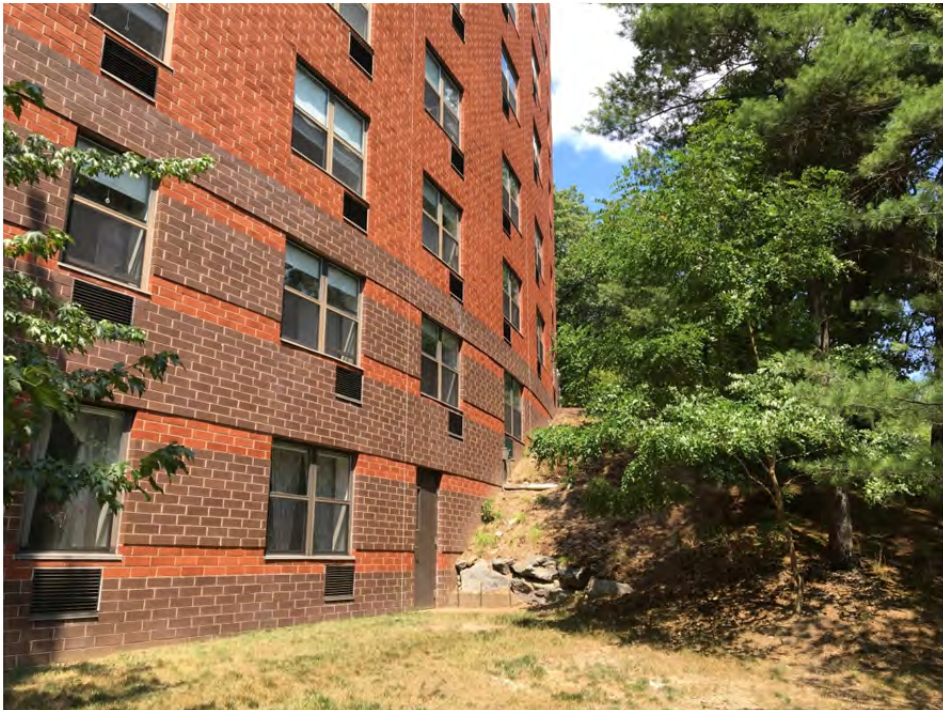
Photograph 8

Location on Property:
South side of 677 Winchester Street building, near Winchester Street.

Key Observations in Photograph:
Building construction and condition.

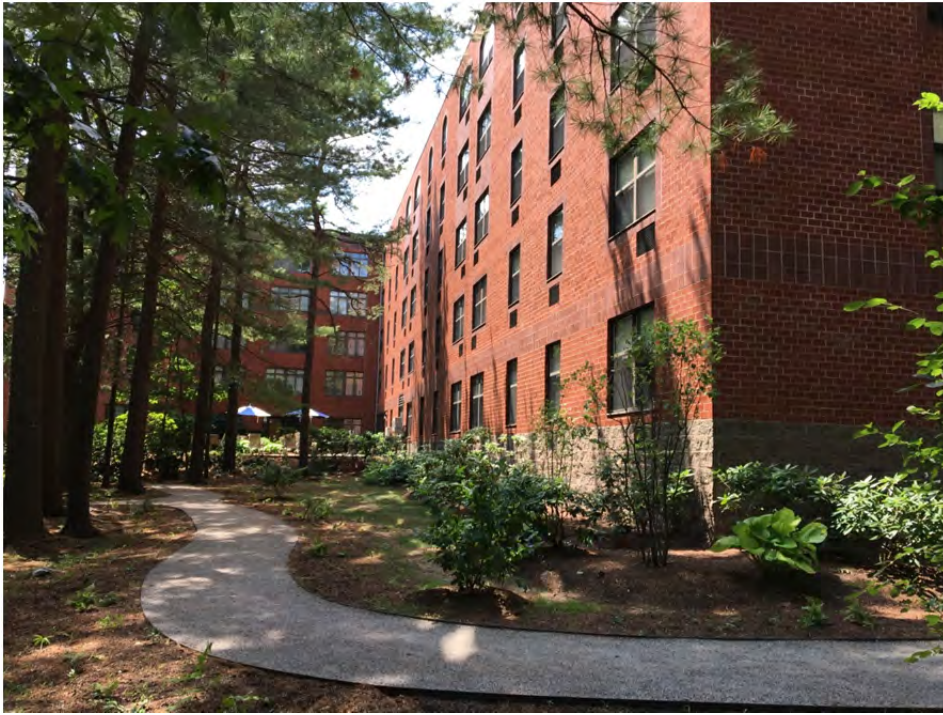
Photograph 9

Location on Property:
Southeast corner of 677
Winchester Street building, with a
view toward the west.

Key Observations in Photograph:
Building construction and
condition, landscaping.

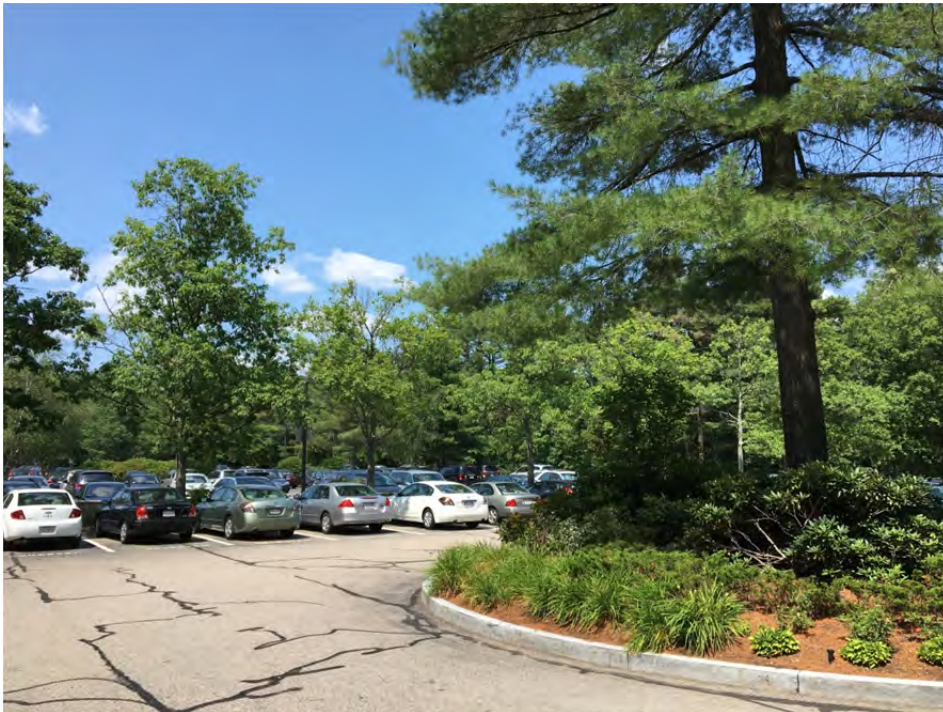
Photograph 10

Location on Property:
Parking lot located to the
northwest of the 677 Winchester
Street building.

Key Observations in Photograph:
General condition and
topography of Property.

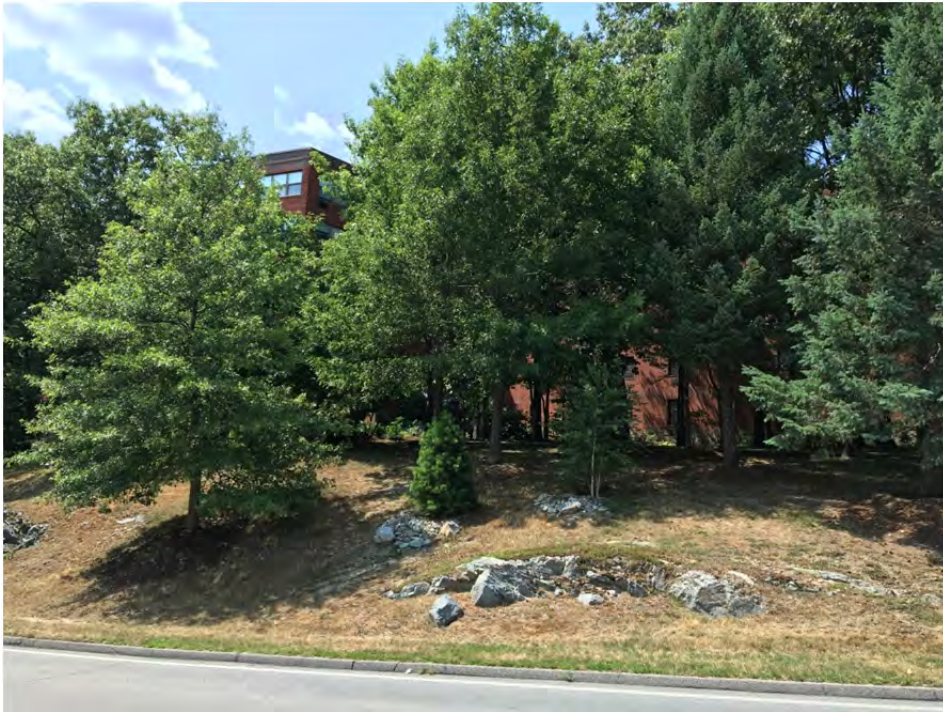
Photograph 11

Location on Property:
Subject Property, including 677 Winchester Street building, as viewed from across Winchester Street.

Key Observations in Photograph:
Topography of Property with bedrock outcrops.

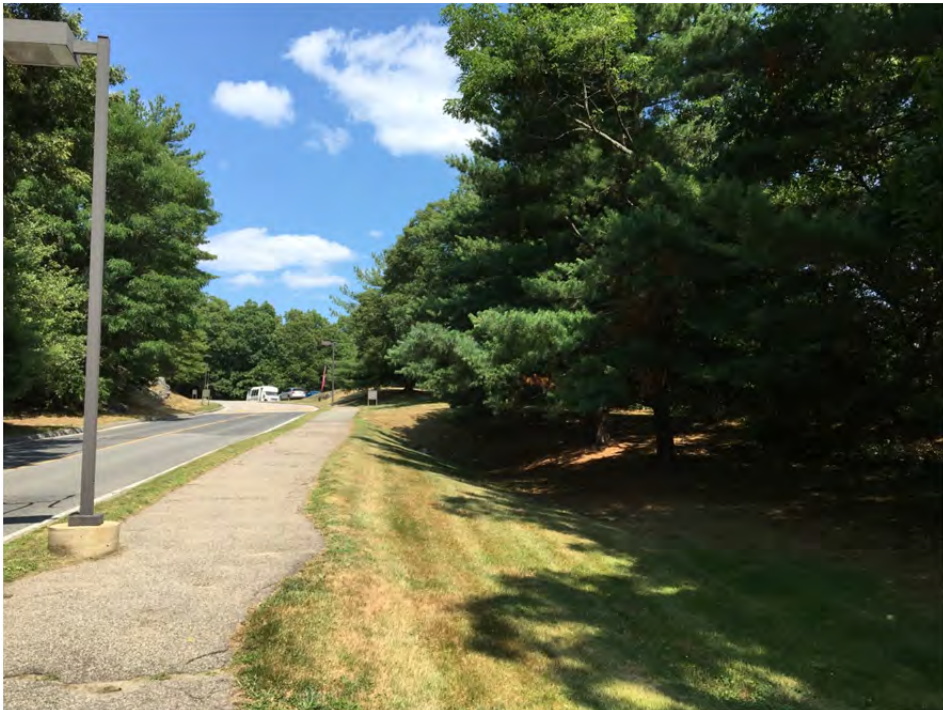
Photograph 12

Location on Property:
Along Winchester Street, near entrance from Nahanton Street.

Key Observations in Photograph:
Topography of Property.

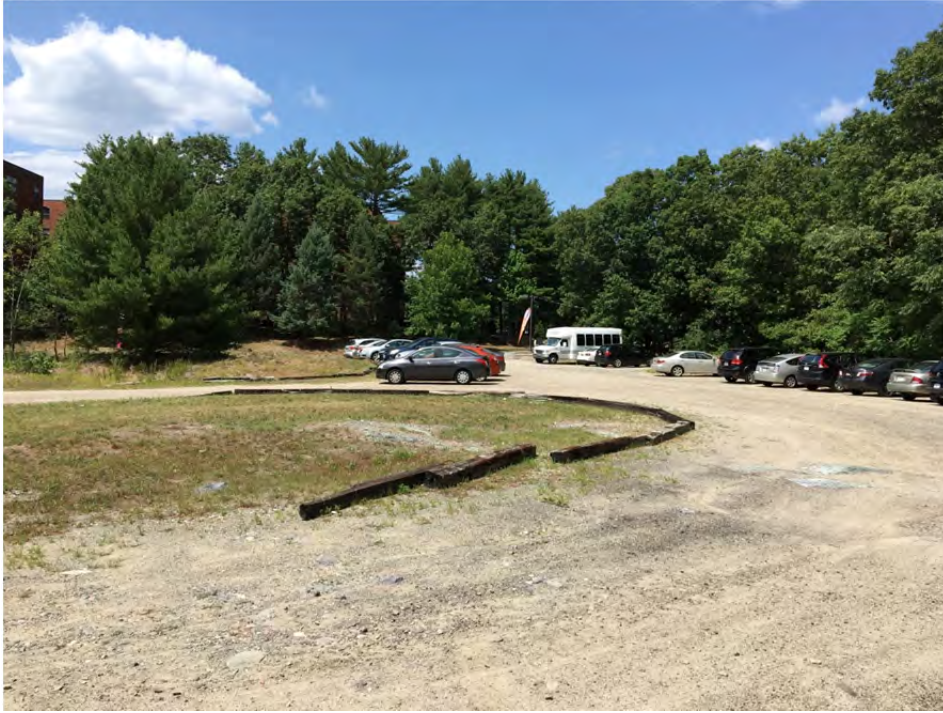
Photograph 13

Location on Property:
Open unpaved parking lot area of subject Property south of the 677 Winchester Street building, south of Winchester Street.

General condition and visible bedrock outcrop.

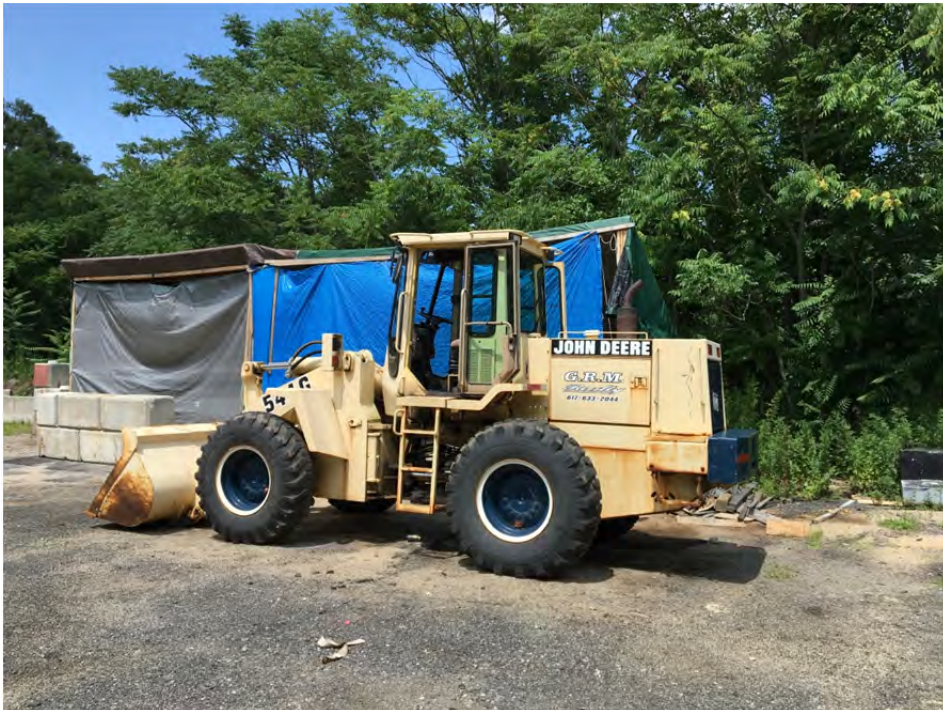
Photograph 14

Location on Property:
Southern portion of the Property, south of unpaved parking lot.

Storage of sand/salt and front loader.

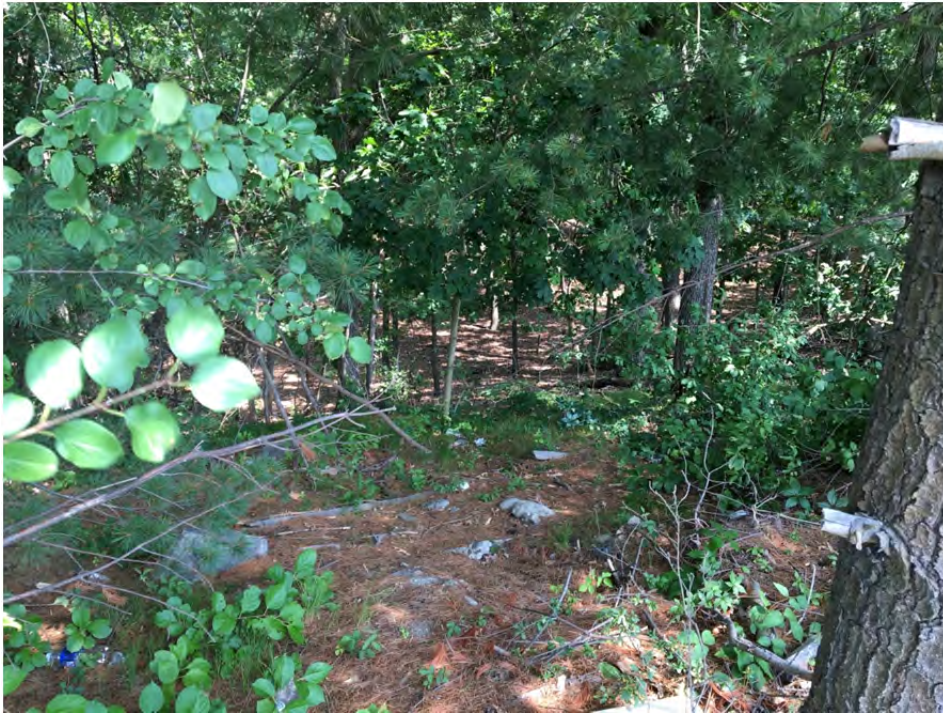
Photograph 15

Location on Property:
Wooded area west of unpaved parking area.

Key Observations in Photograph:
General condition of wooded areas surrounding Property.
