**NEWTON PUBLIC BUILDINGS SURVEY  
PHASE II – ANALYSIS OF HISTORICAL SIGNIFICANCE**

**Cabot Elementary School**

Address: 229 Cabot Street  
Year of Construction: 1929

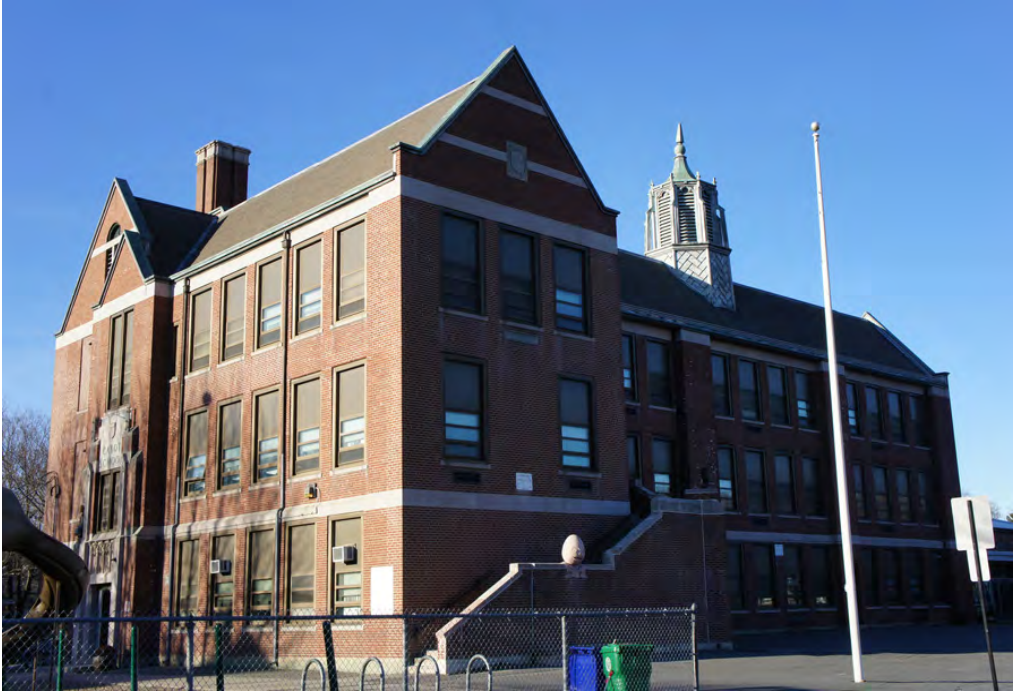
Figure 2: The tall windows set in a simple rhythm around the perimeter of the building were designed to provide daylight deep into the building. This function, as well as the aesthetic character of the building, was greatly affected by the installation of inappropriately designed replacement windows.

- Replace windows with more historically appropriate windows. Coordinate with daylighting and ventilation strategy.
- Repair or replace in kind the bent, misshapen copper louvers at the north side of the ell.

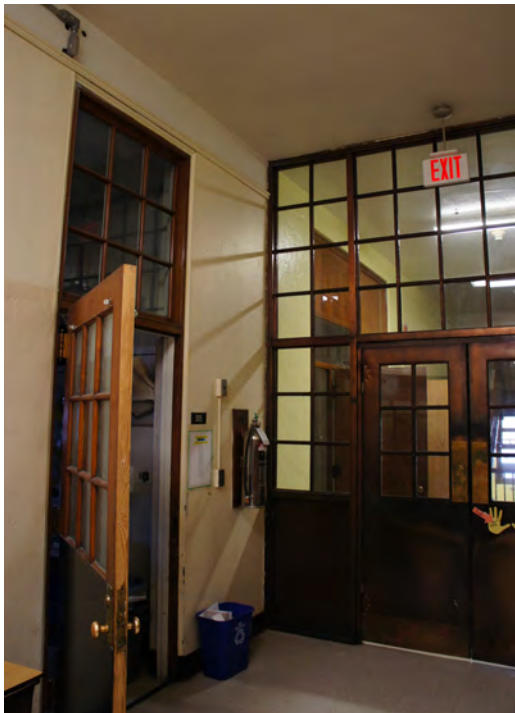
Figure 3: Typical classroom door and stairwell/corridor dividing wall.

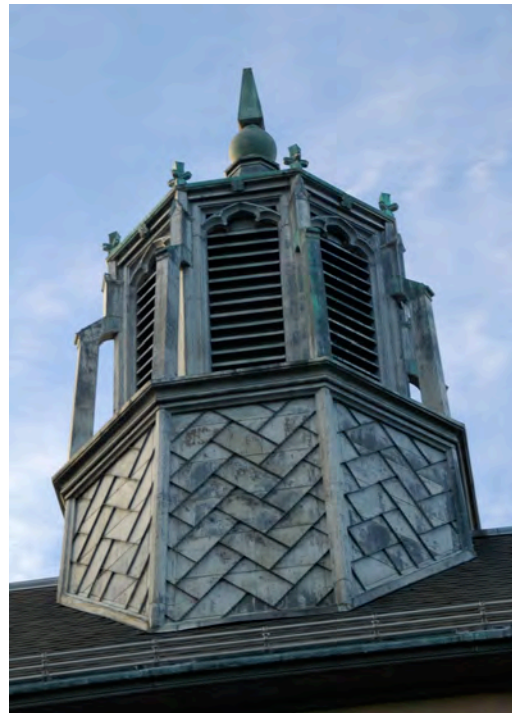
Figure 4: Close-up view of cupola.

- The roof and cupola were not accessible for the survey, and therefore only inspected where visible from ground. Inspect the full roof and repair as necessary.
