Re: **June 2018 Follow-Up Inspection  
MA03414 Bulloughs Pond Dam  
Newton, Massachusetts**  
(Pare Project No.:09124.56/152)

**Commonwealth of Massachusetts  
Department of Conservation and Recreation  
Office of Dam Safety Follow-up Dam Inspection Form**

**Dam Name:** Bulloughs Pond Dam  
**Dam Owner:** Unknown

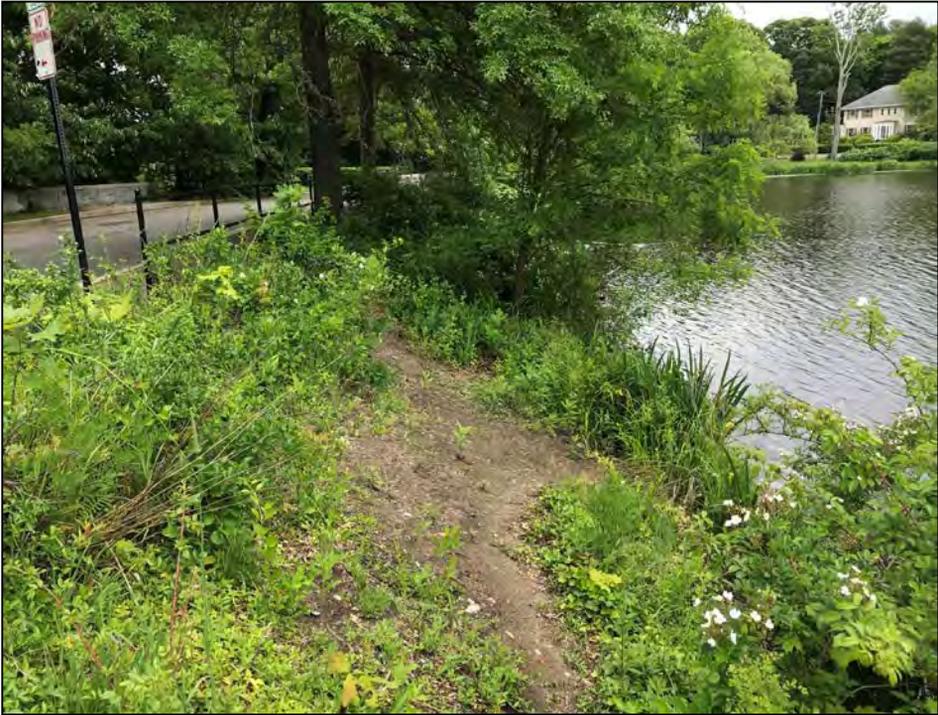
Photo No. 1: Upstream slope right of the low level outlet.

2. Install adequate surface protection including riprap along the upstream slope and grass along the downstream slope.
3. Repair the low-level outlet downstream headwall.
4. Provide adequate scour protection along the banks of the downstream channel.
5. Repoint the joints of the spillway training walls.

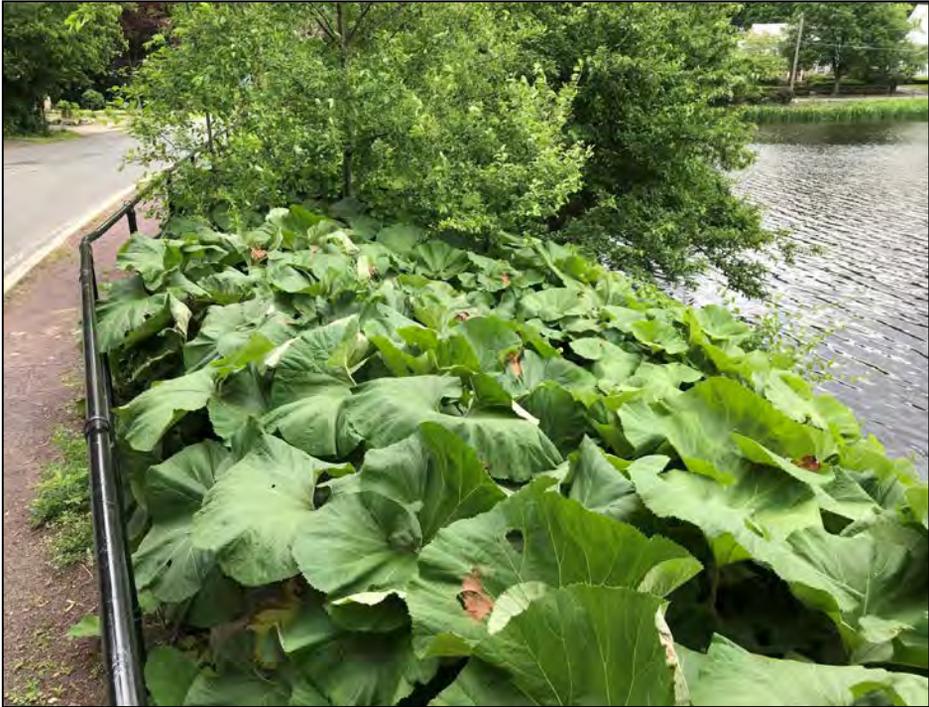
Photo No. 2: Upstream slope right of the spillway.

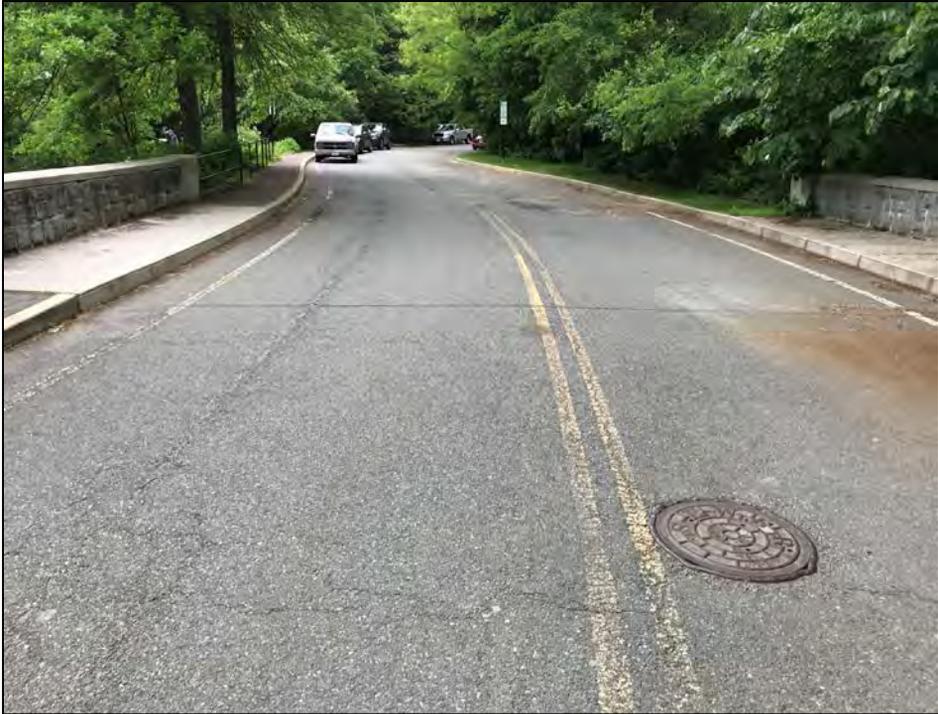
Photo No. 3: Crest from near the right abutment looking left.

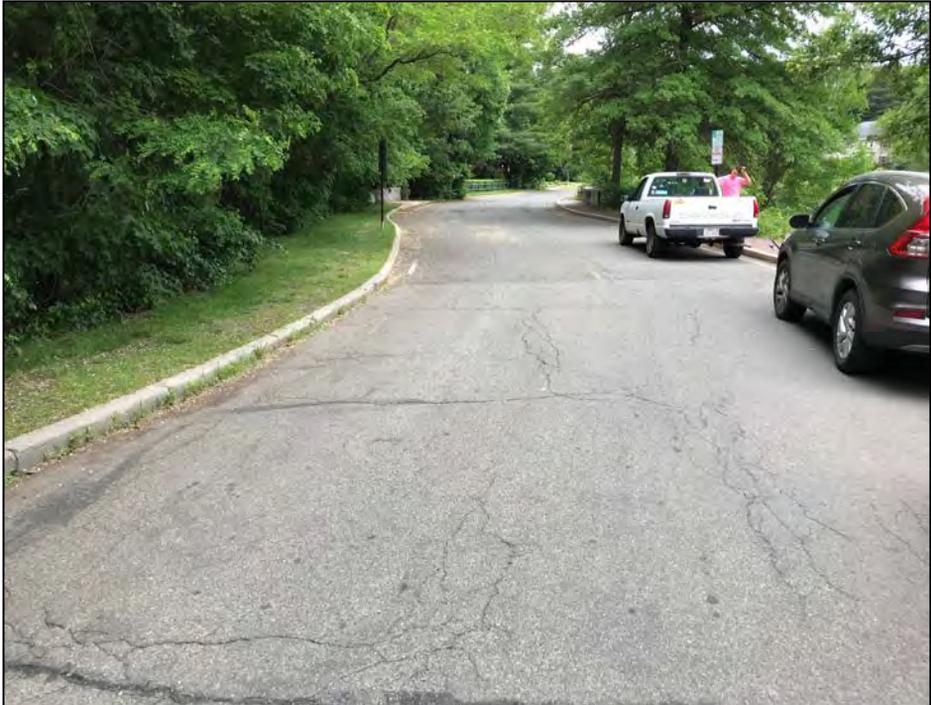
Photo No. 4: Crest from near the left abutment looking right.

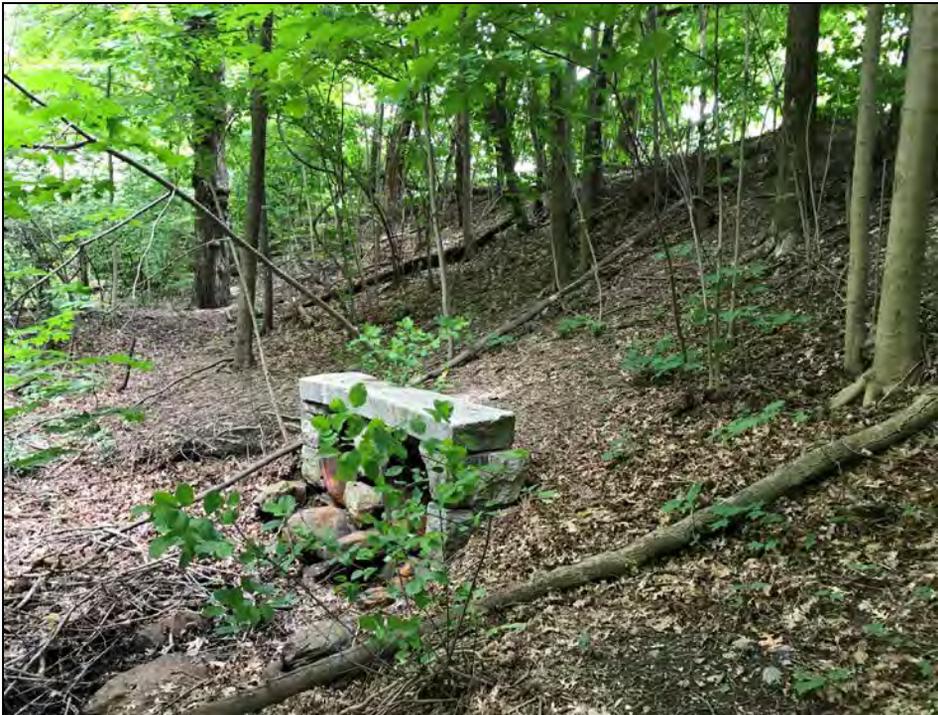
Photo No. 5: Downstream slope from near the left abutment.

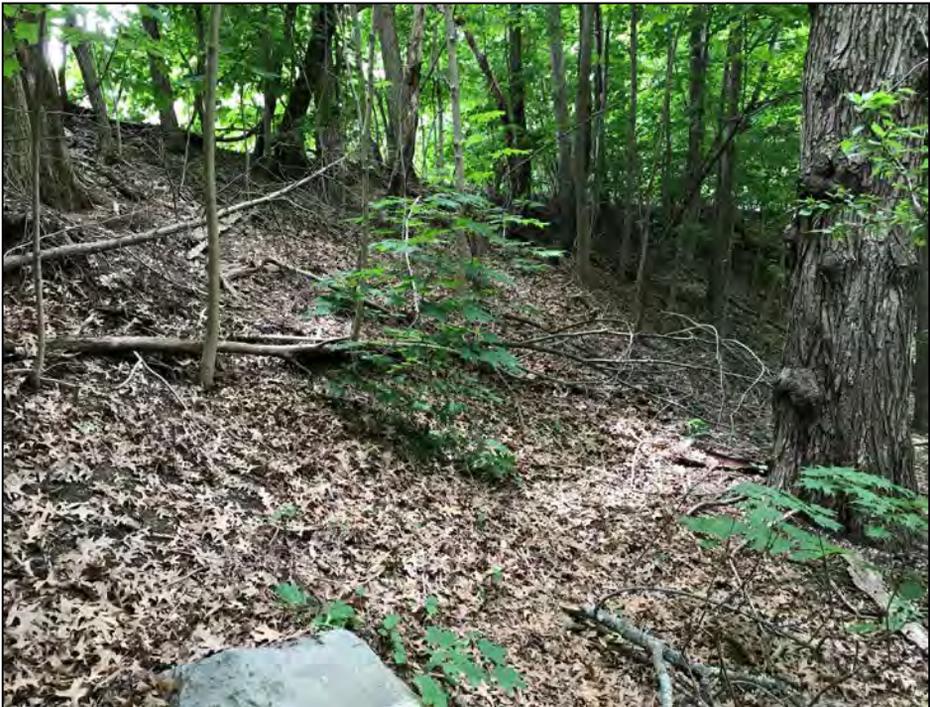
Photo No. 6: Downstream slope from left of the spillway looking left.

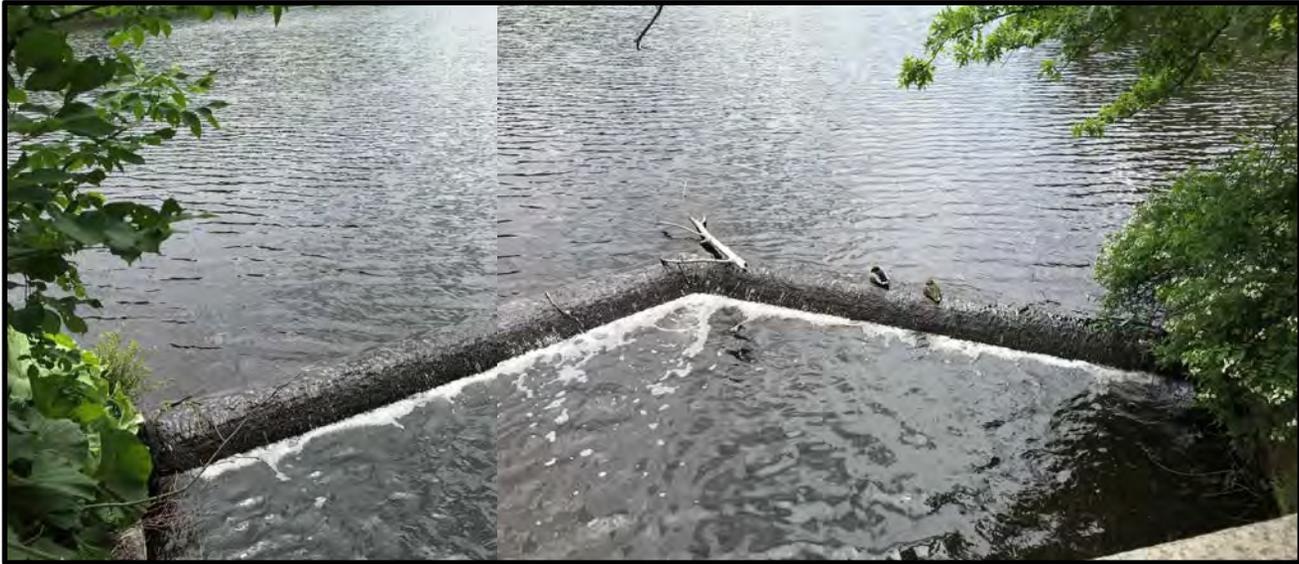
Photo No. 7: Overview of the spillway weir.

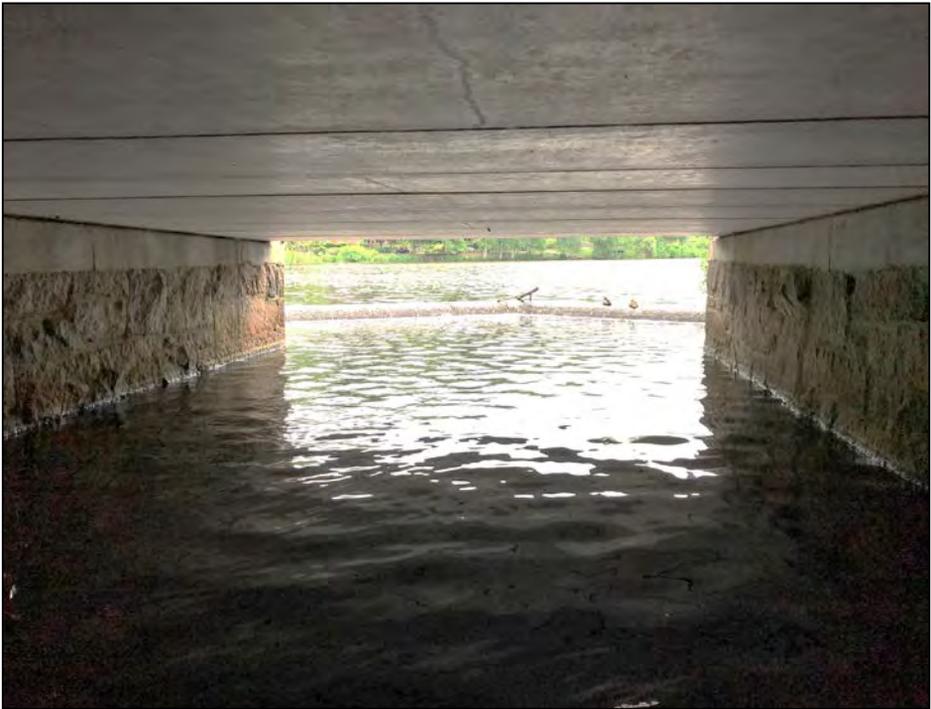
Photo No. 8: Spillway from downstream.

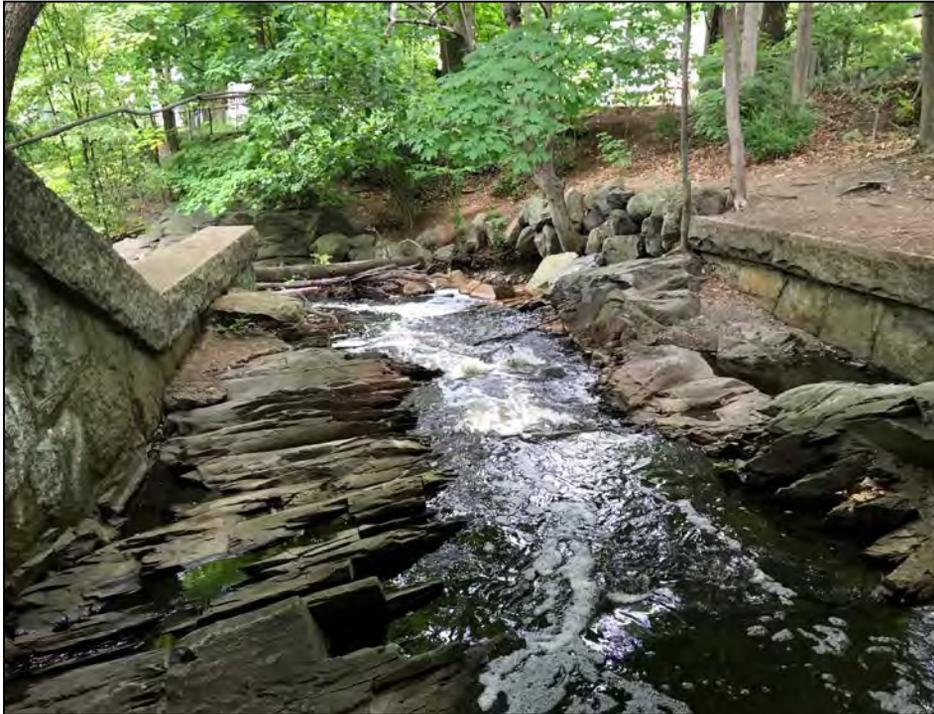
Photo No. 9: Downstream channel at the spillway.

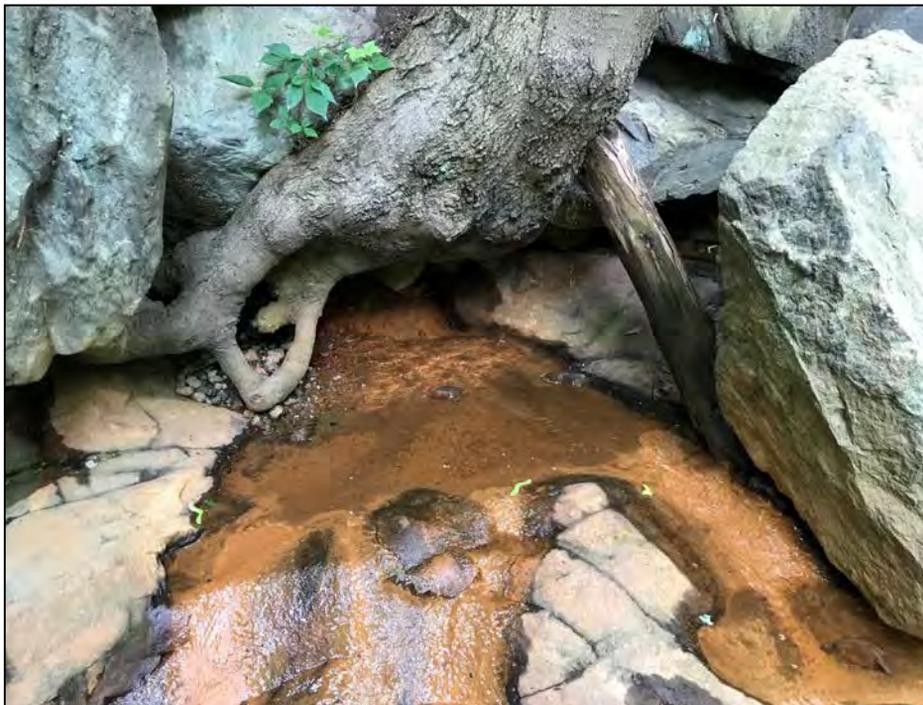
Photo No. 10: Iron oxide stained flow from the downstream bank along the right side of the downstream channel.

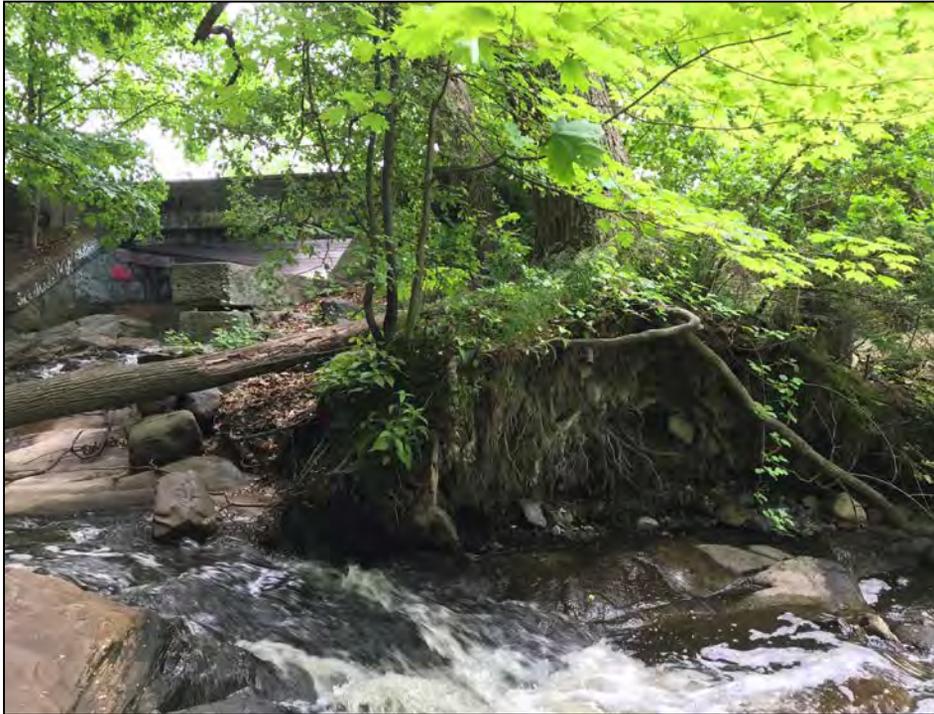
Photo No. 11: Erosion of the left bank beneath a leaning tree along the left side of the downstream channel.

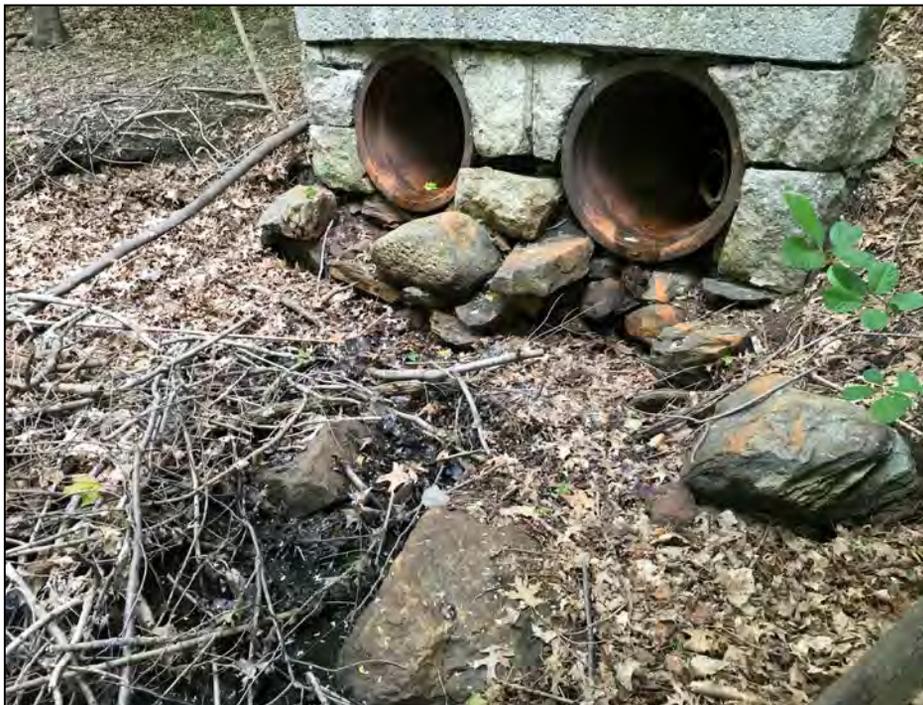
Photo No. 12: Low level outlet discharge headwall and standing water in the downstream channel.
