PHASE II REPORT FOR BULLOUGH'S POND DAM

Newton, MA

May 22, 2020

Phase II Engineering Evaluation and Alternatives Analysis

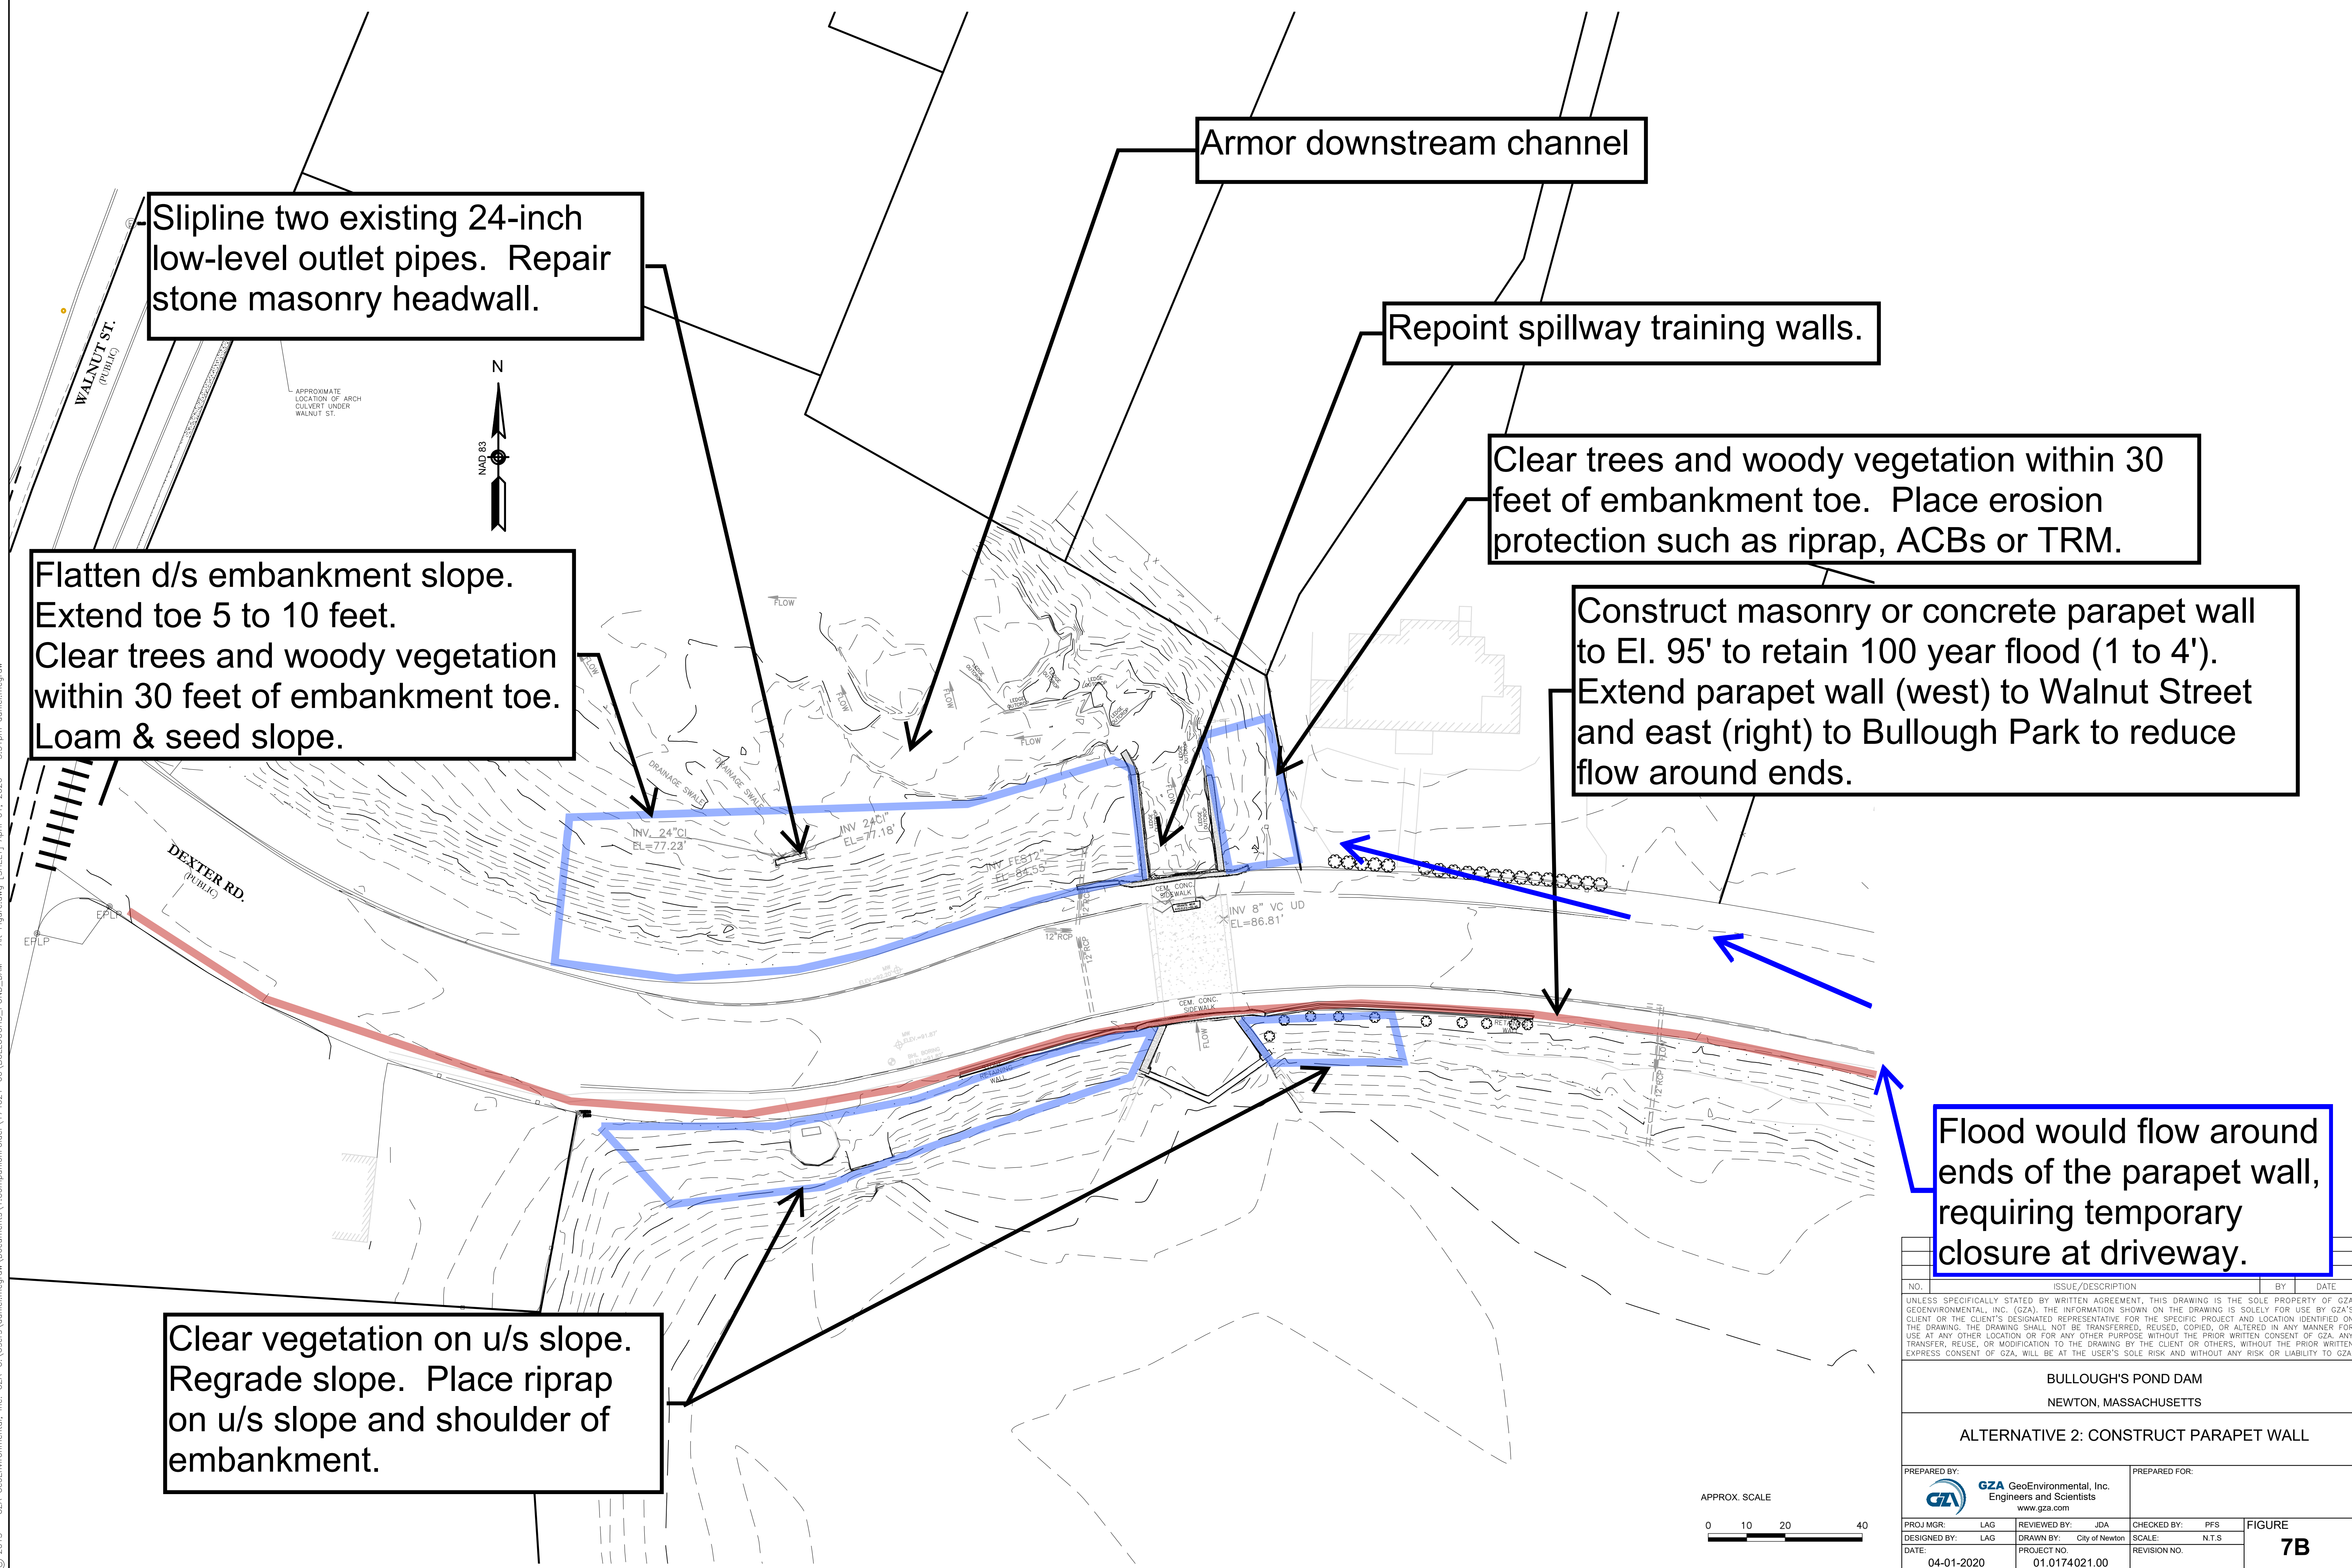
Flood would flow around ends of the parapet wall, requiring temporary closure at driveway.

Slipline two existing 24-inch low-level outlet pipes. Repair stone masonry headwall.

Armor downstream channel

Clear vegetation on u/s slope. Regrade slope. Place riprap on u/s slope and shoulder of embankment.

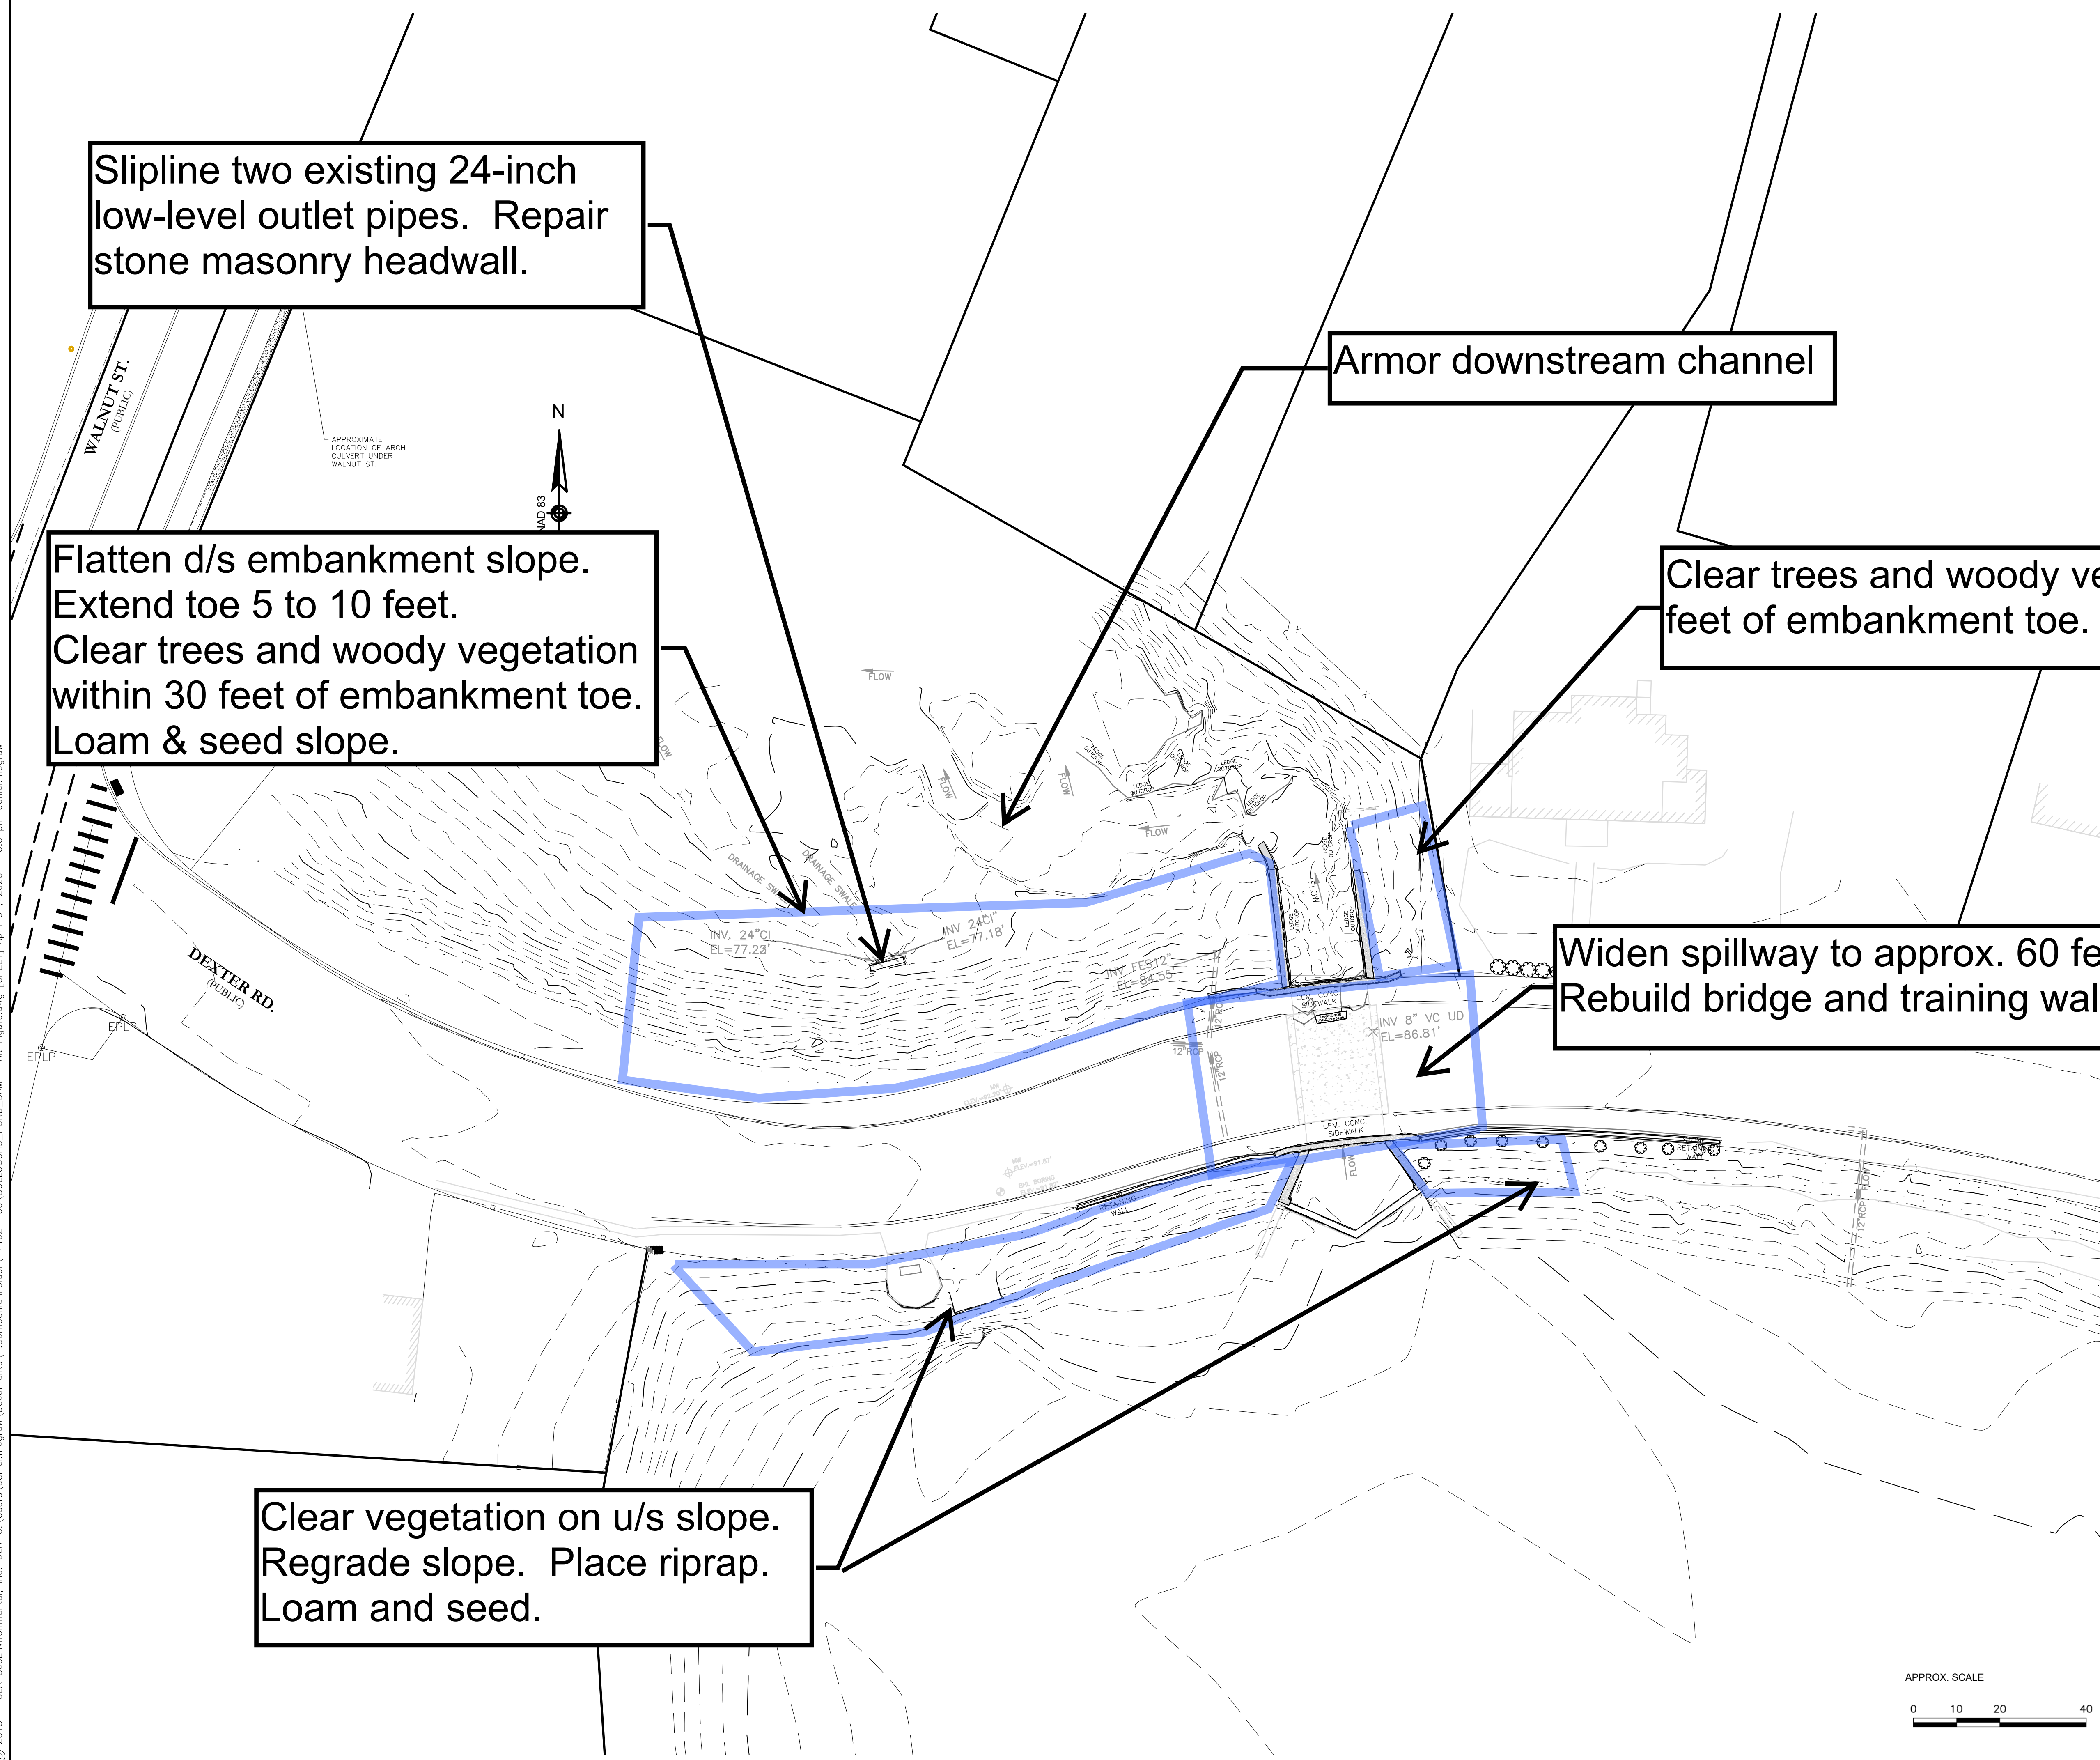
Note: Articulated Concrete Blocks (ACBs) shown on d/s slope. Other materials that may be considered include Turf Reinforcement Mats (TRMs), Riprap, Gabions, and HydroTurf®.

Slipline two existing 24-inch low-level outlet pipes. Repair stone masonry headwall.

Armor downstream channel
