Franklin Elementary School Existing Conditions Report

Existing Site Conditions

Building System Existing Conditions

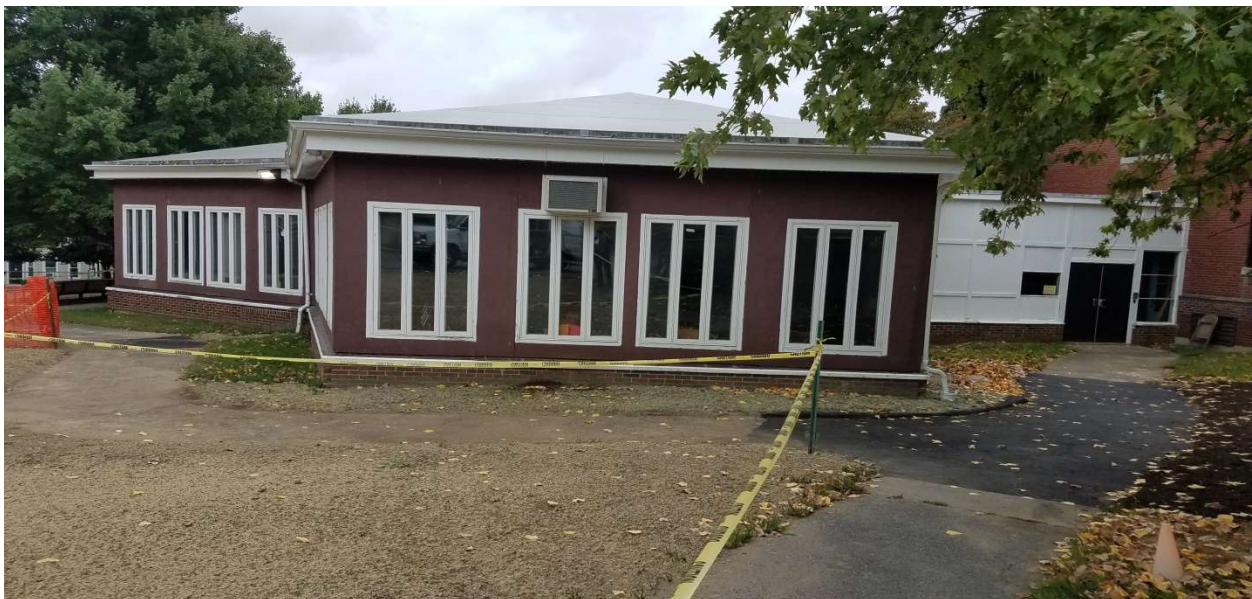
The 1953 addition was not well designed. The spaces are functional and spatially appropriate, but the quality of materials and systems result in a less than optimal learning environment.

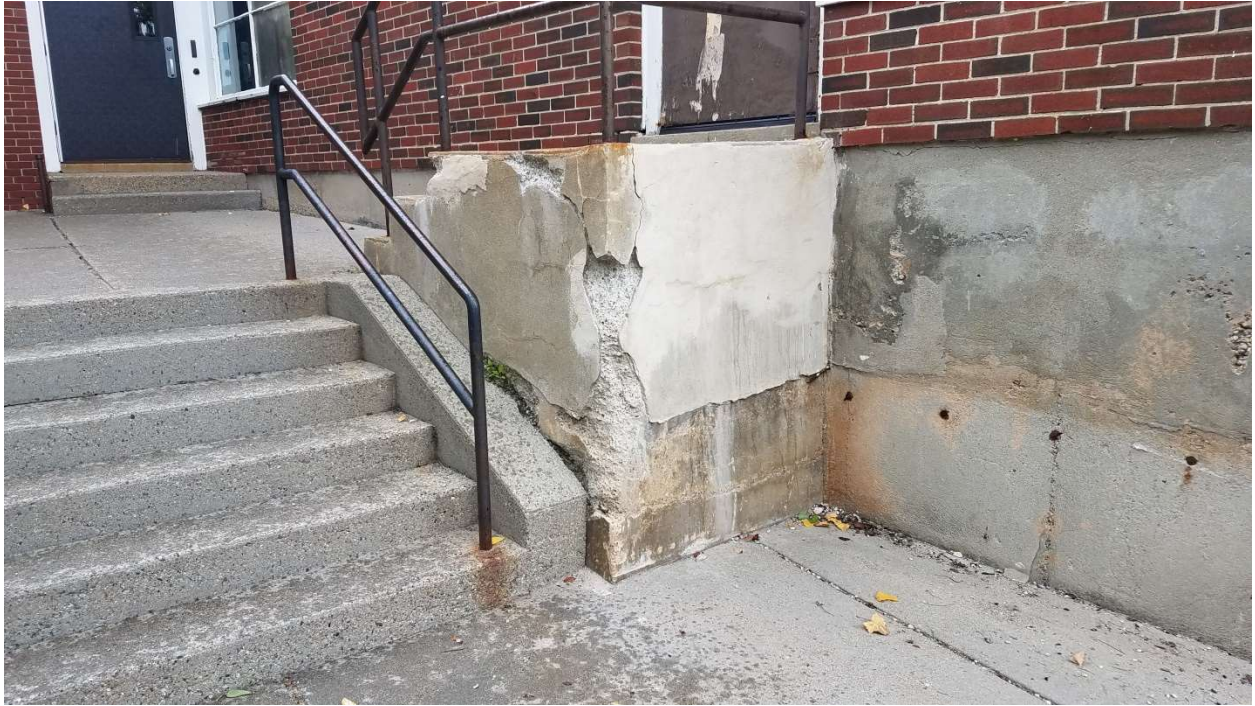
Repairs have been made to this many times before, but clearly more work is needed.

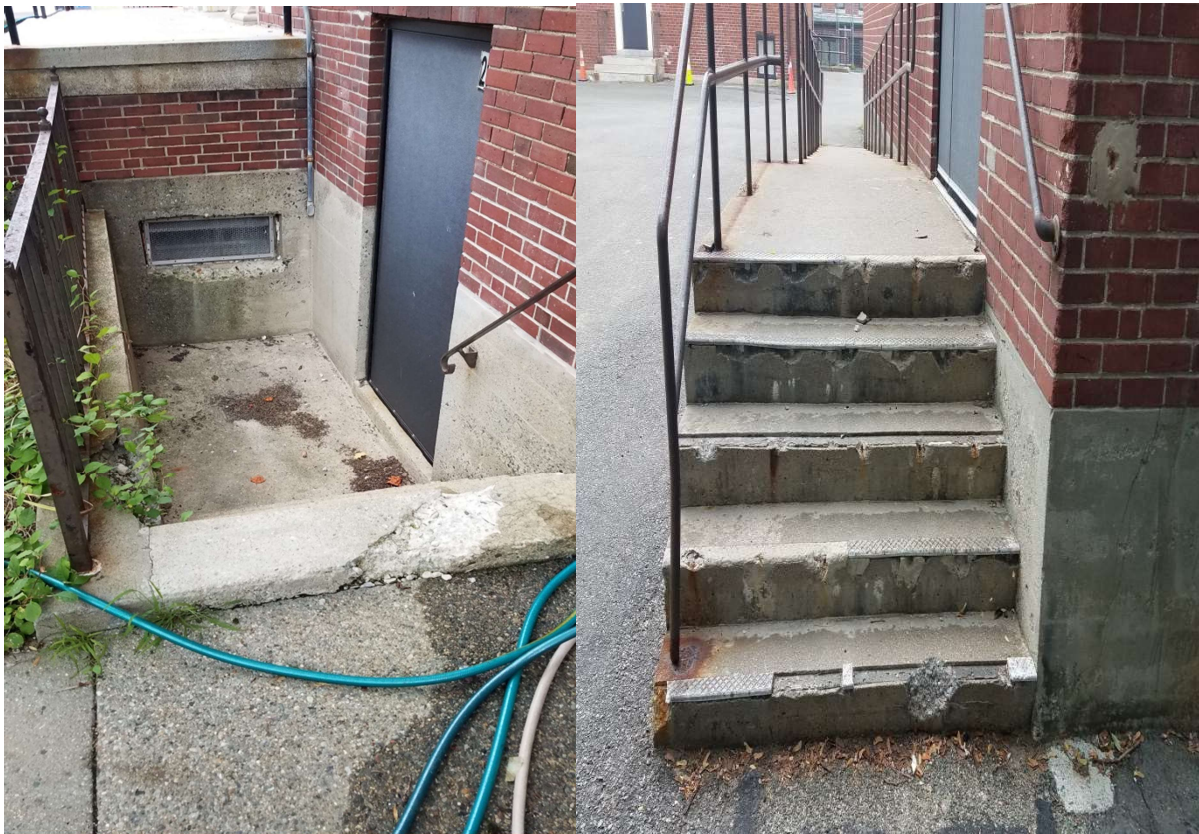
Modest repairs are needed before these become larger replacement projects.

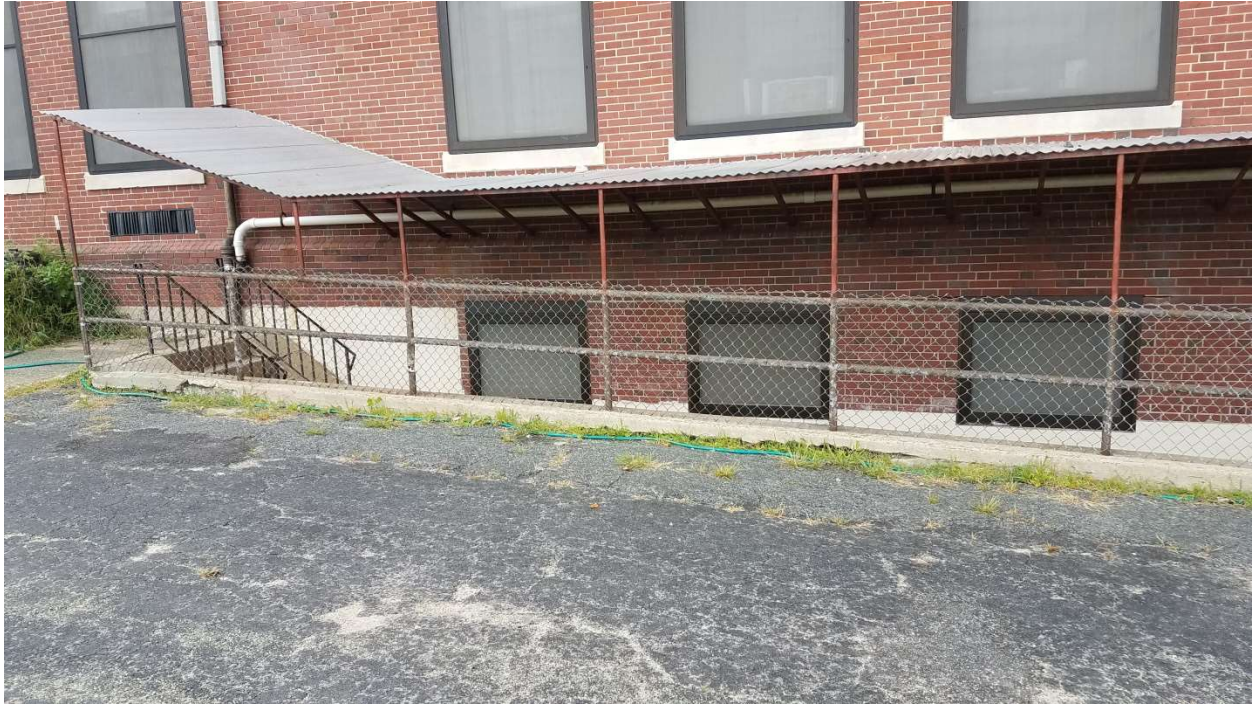
Aside from the gym wing, and 1953 addition, all of the windows were replaced in 1989 as shown here.

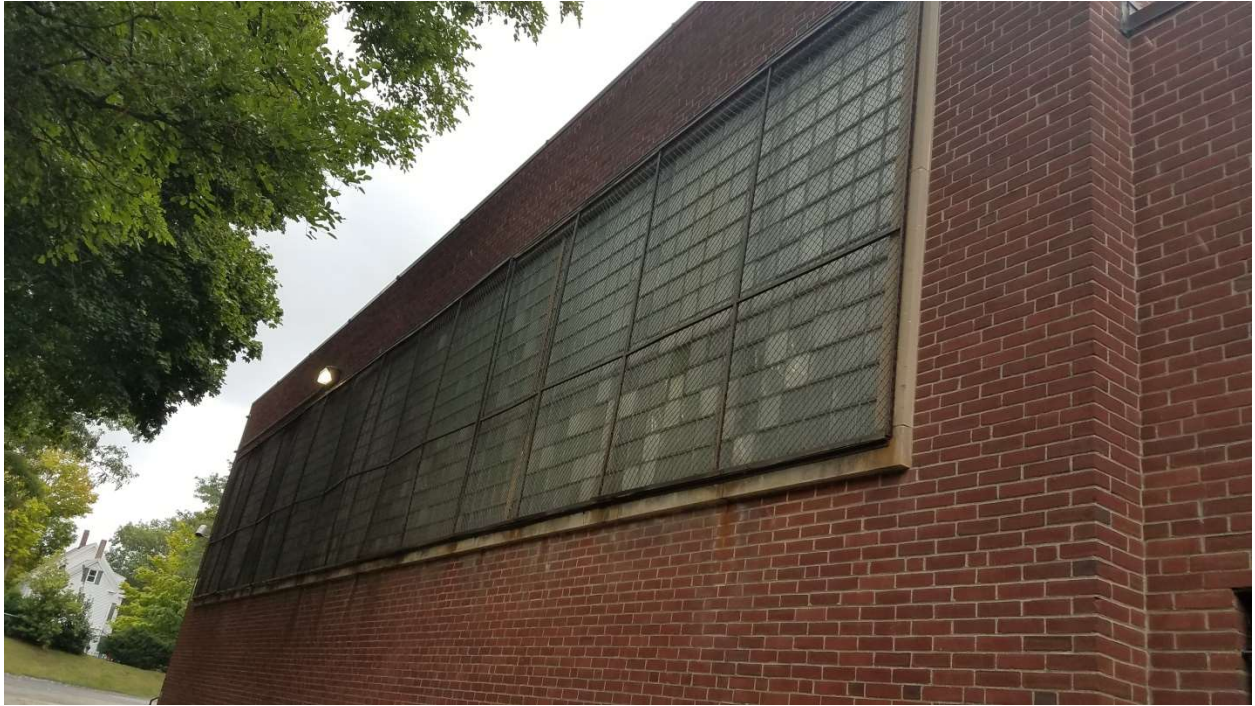
These are the original windows in the 1950 gym.

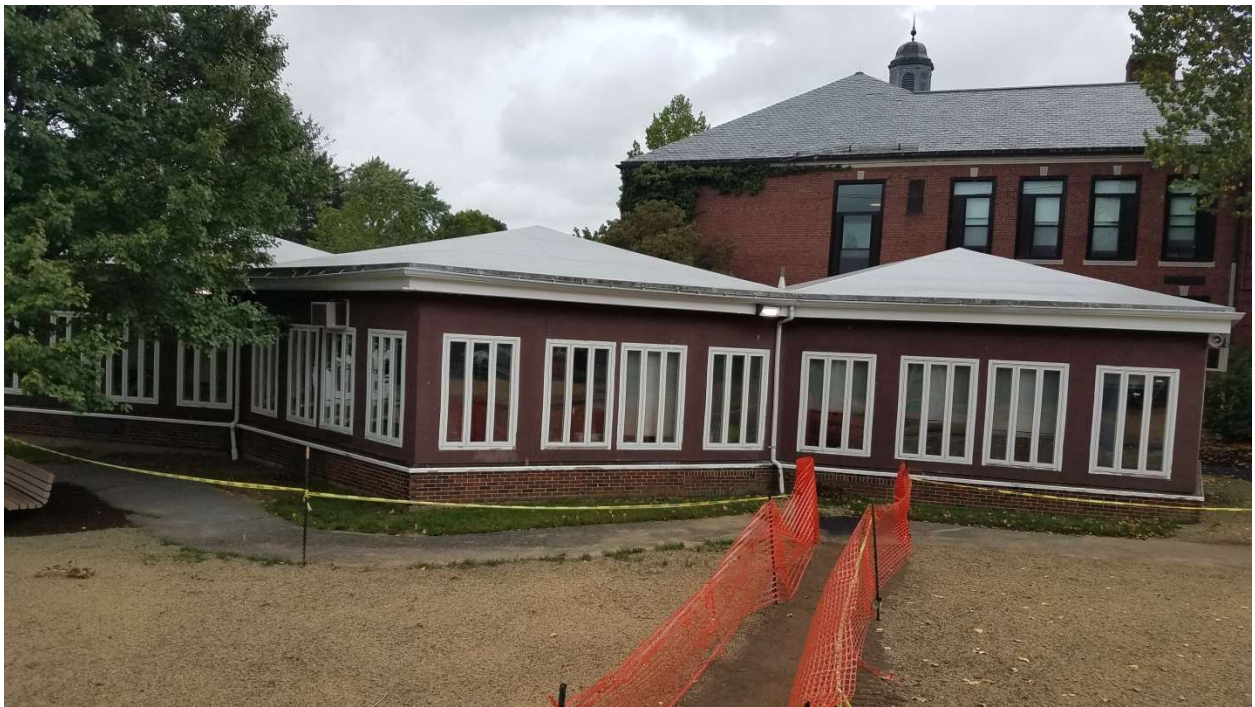
These windows were installed in 2000 in the 1950 addition.

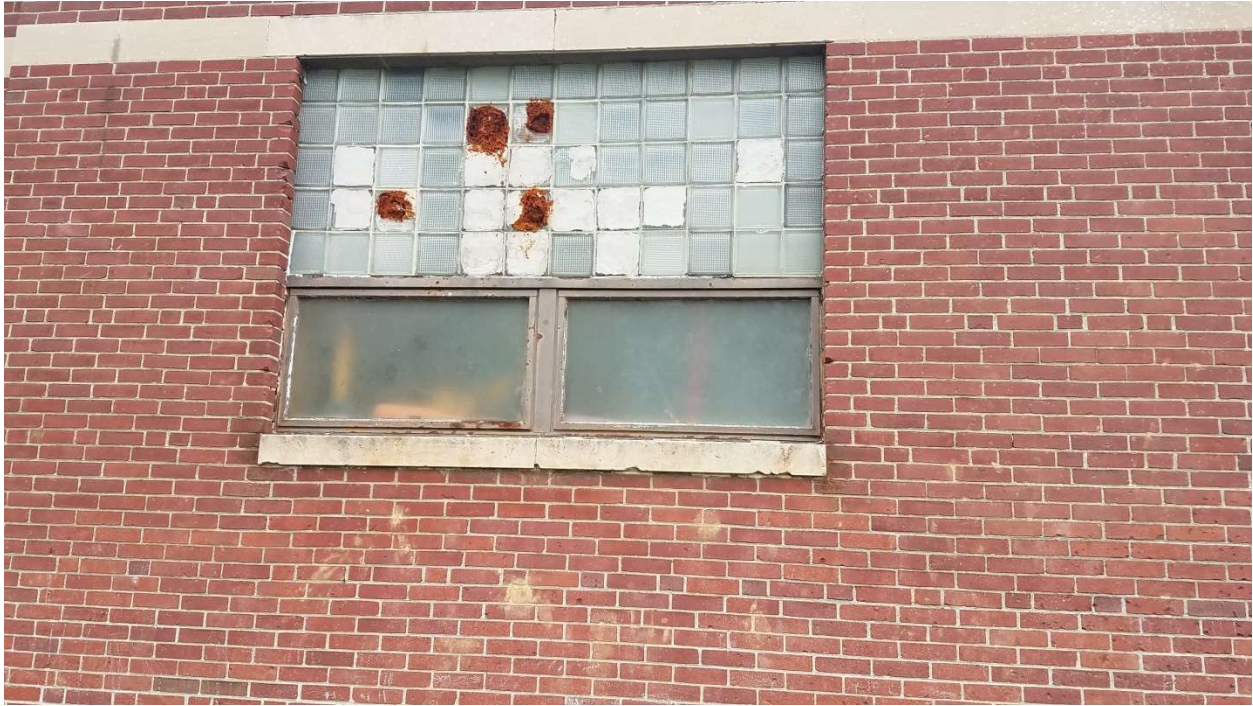
These are the locker room window systems. They were installed in 1950, and need to be replaced.

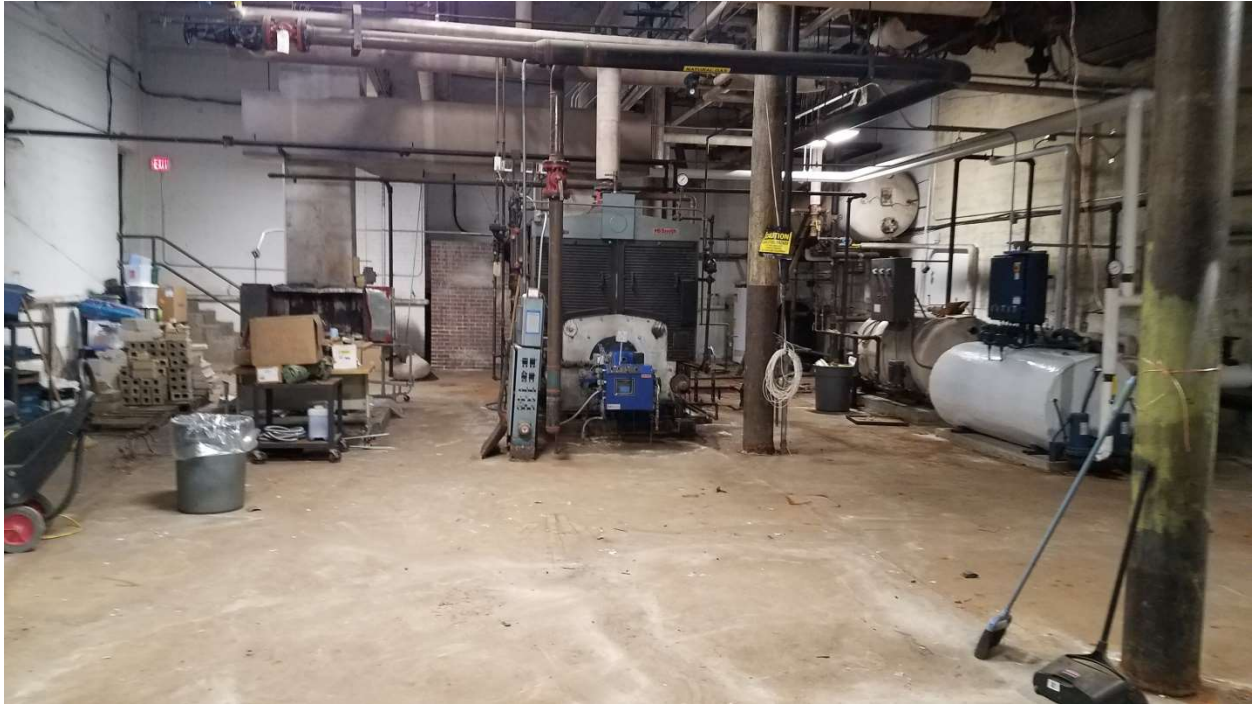
The school has only one boiler. A second boiler should be installed to provide redundancy, and extend equipment life. In 2014, close to \$500,000 was spent on energy improvements in the school, including the new vacuum return system on the right in this picture.

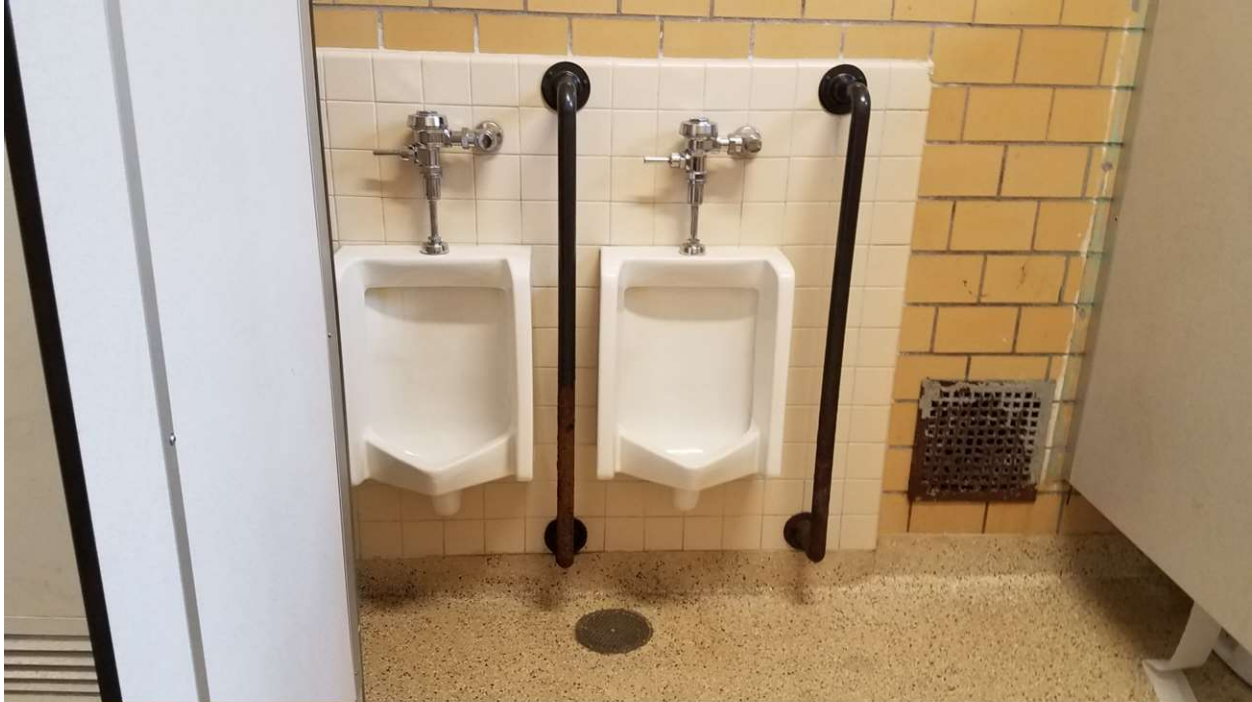
It's not clear what they were trying to accomplish with these grab bars, but clearly there are areas for improvement in some of the bathrooms.

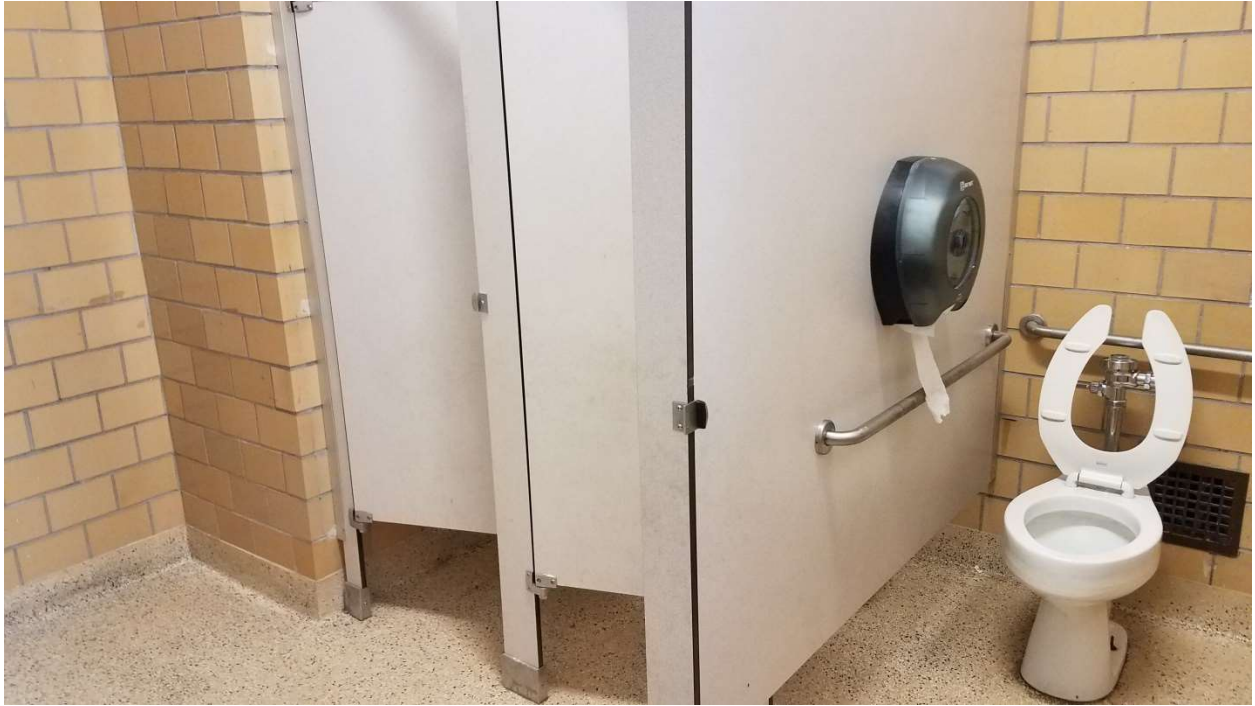
Bathrooms throughout the school are mostly accessible.

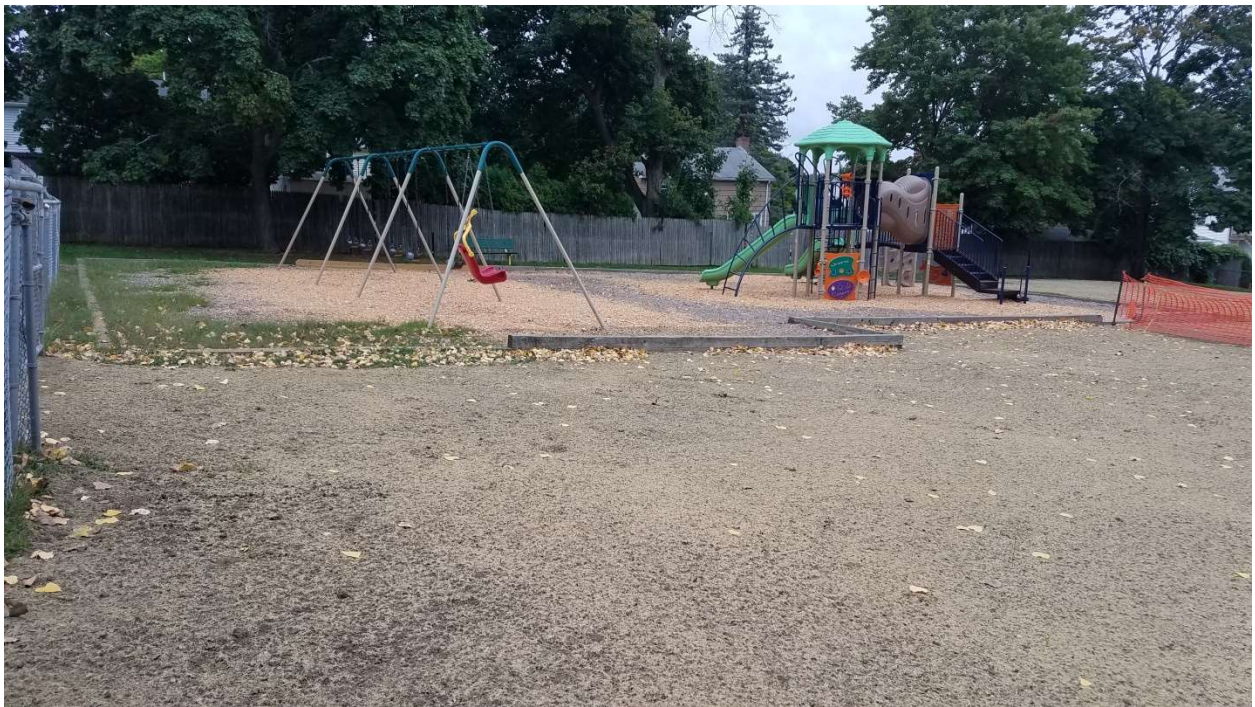
The playgrounds are somewhat accessible, but lack sufficient accessible features.

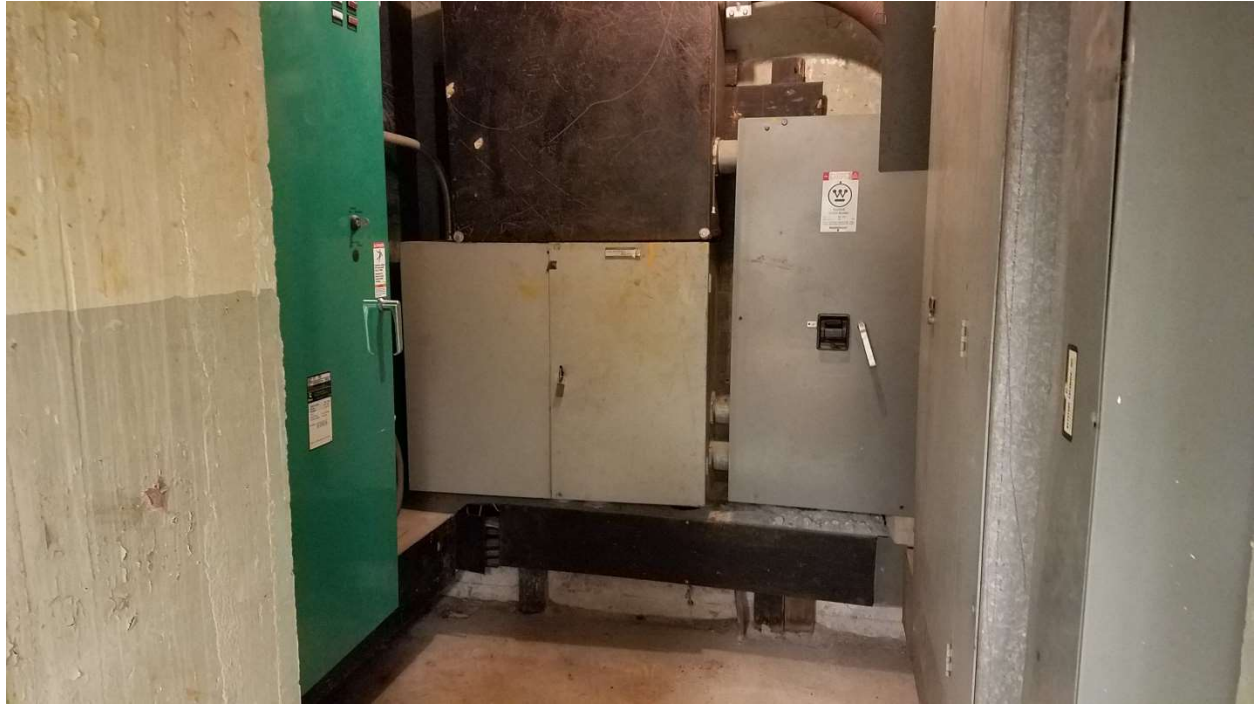
This space is extremely small and does not meet current electrical code requirements.

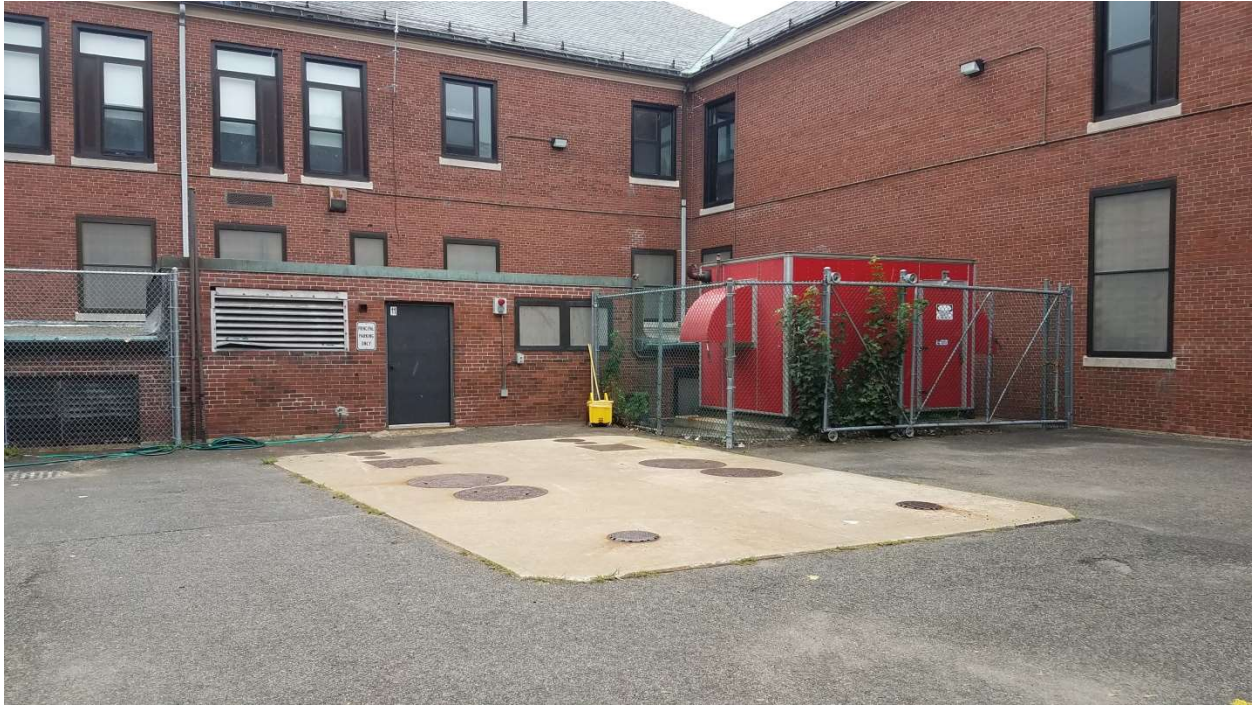
This generator is beyond its useful life, and no longer code compliant. The exhaust stack needs to be well above the building, or the generator needs to be much further away. This is now required to prevent exhaust fumes from entering the building. The oil tanks shown in this picture are no longer used, and need to be removed.

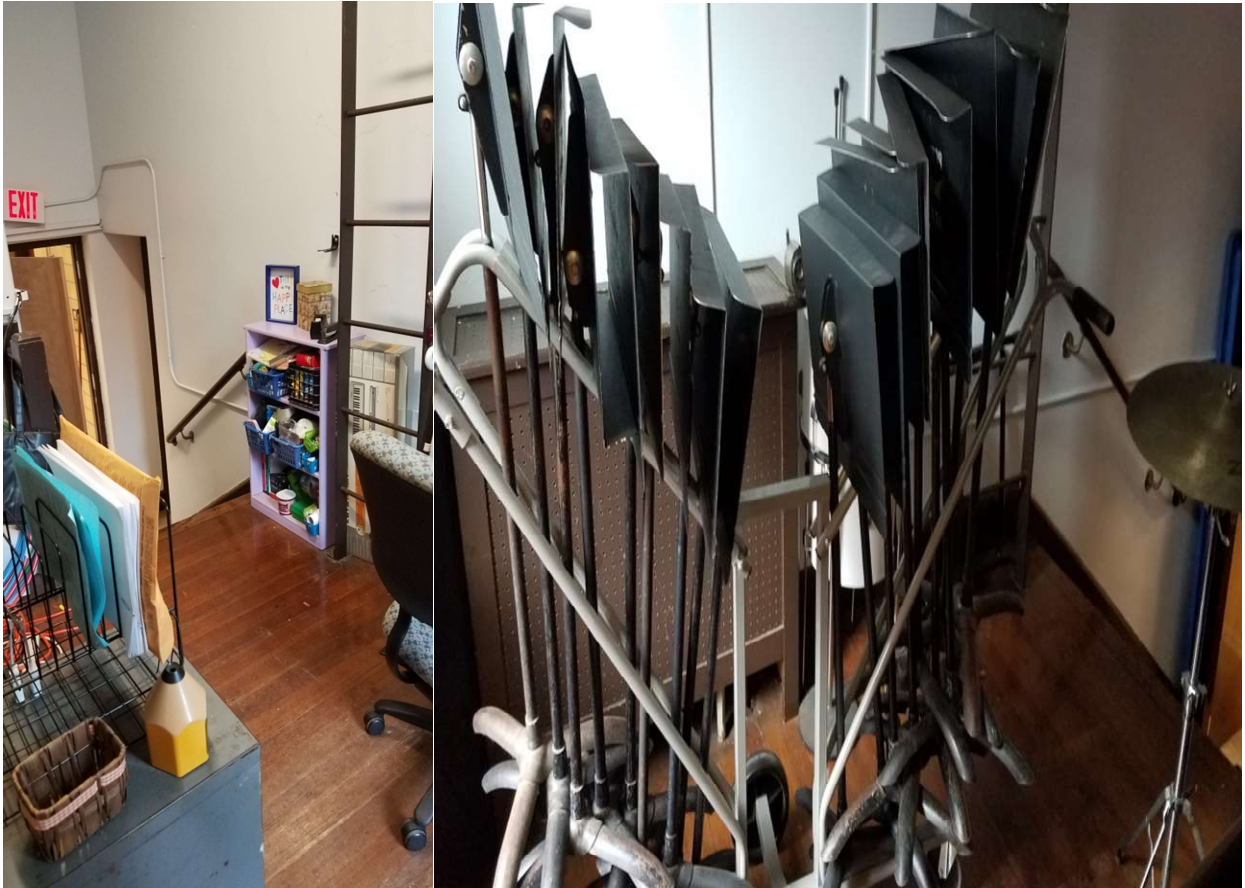
The music program has no teaching space, so the stage acts as the classroom and office. This blocks egress paths, and is not allowed. Overall, this program requires a space three times that which is currently being provided.

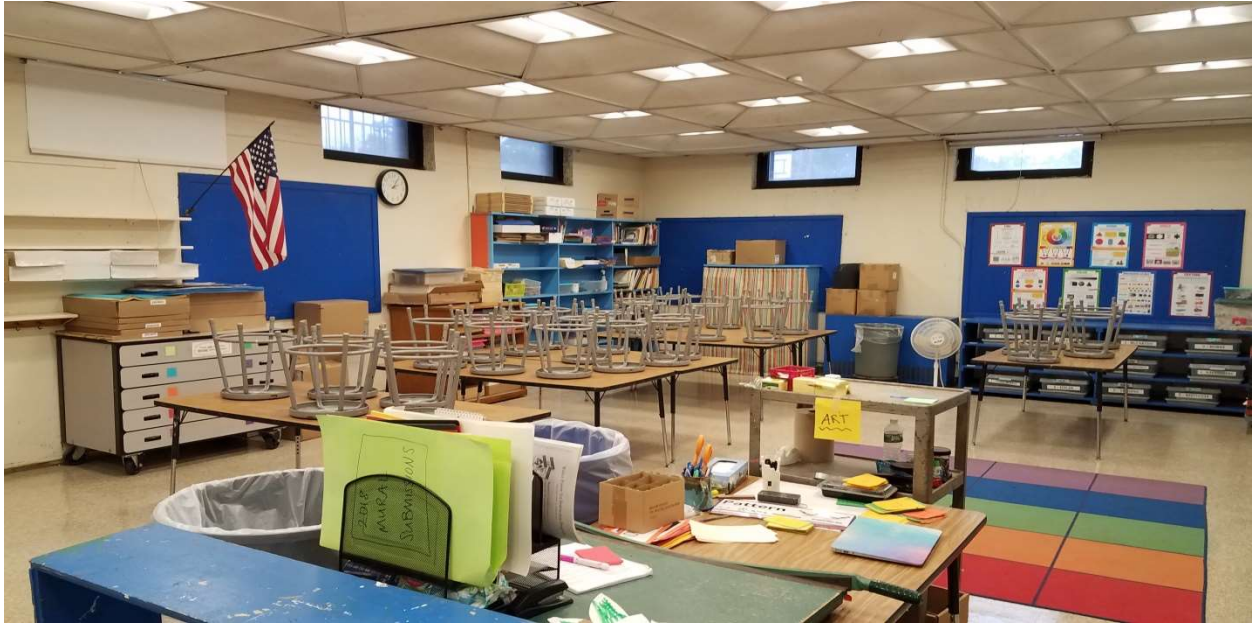
The Art Room is appropriately sized, but is below grade so the natural light levels are not ideal. Window opening could be redesigned to increase daylight.

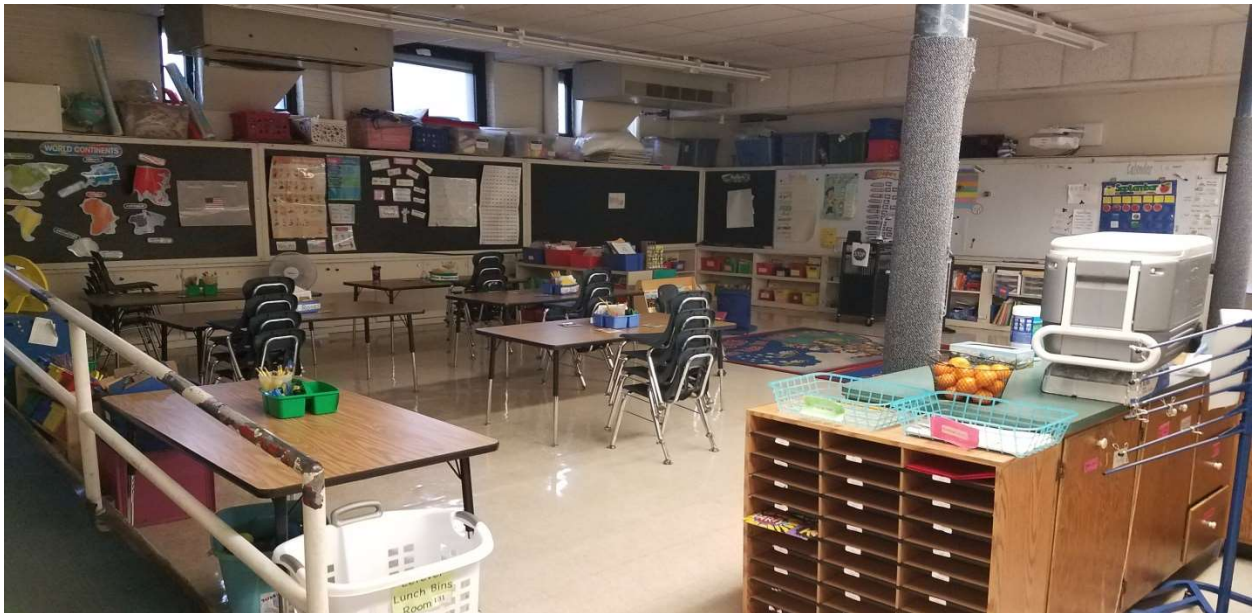
This is currently a 2nd grade classroom, but was designed as the bicycle storage room in 1938. It was previously used for after care, and music, but enrollment pressure required it's conversion to a traditional classroom. The space is below grade, and abuts a partially excavated crawl space with aging steam lines. Humidity levels have caused historic air quality challenges in this space. Investments have been made to improve this area, but a new hvac system with dehumidification and/or air conditioning would greatly improve the conditions in this classroom. Window opening could be redesigned to increase daylight. The other challenge with this space is that it is separated from the rest of the classrooms, which presents programmatic inefficiencies, and there are no accessible bathrooms on this floor.

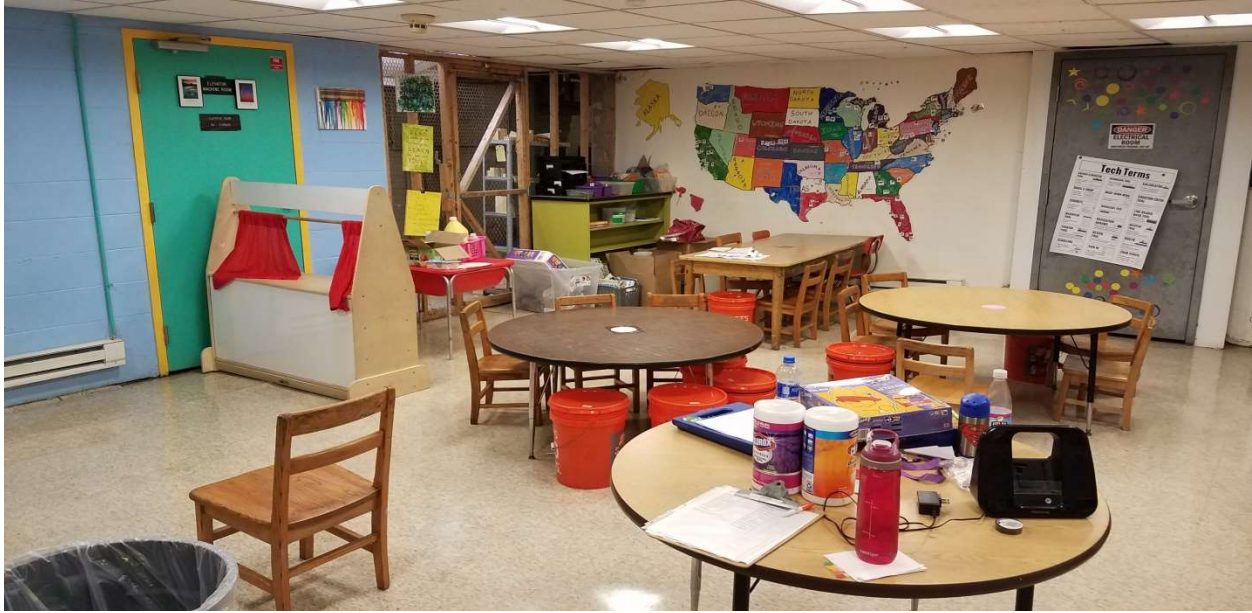
The afterschool program is located in a 500 square foot room in the basement, outside of the elevator machine room and main electric room, and has no access to bathrooms on this floor. This space has no windows, and limited air exchange.

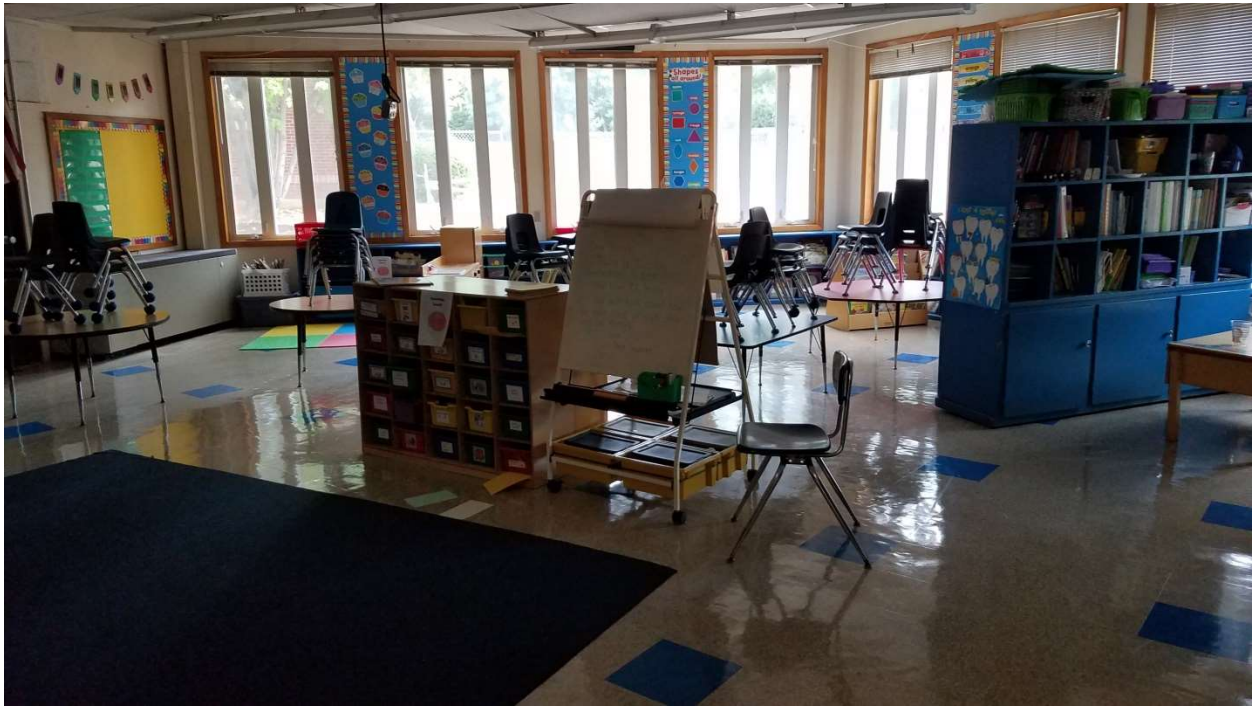
The 1953 addition created 4 of these kindergarten classrooms. They are about 2 feet smaller in each direction than they ideally would be, but the bigger issue is the chronic heating issues. The heating systems can maintain comfortable temperatures, but struggle to recover temperatures during drop-off in the winter when the exterior door in the lobby is open for 20 minutes. This issue could be resolved with heat curtains, interior vestibules, supplemental heat in the classrooms, or operational changes to only allow the main entrance to be used for drop-off.

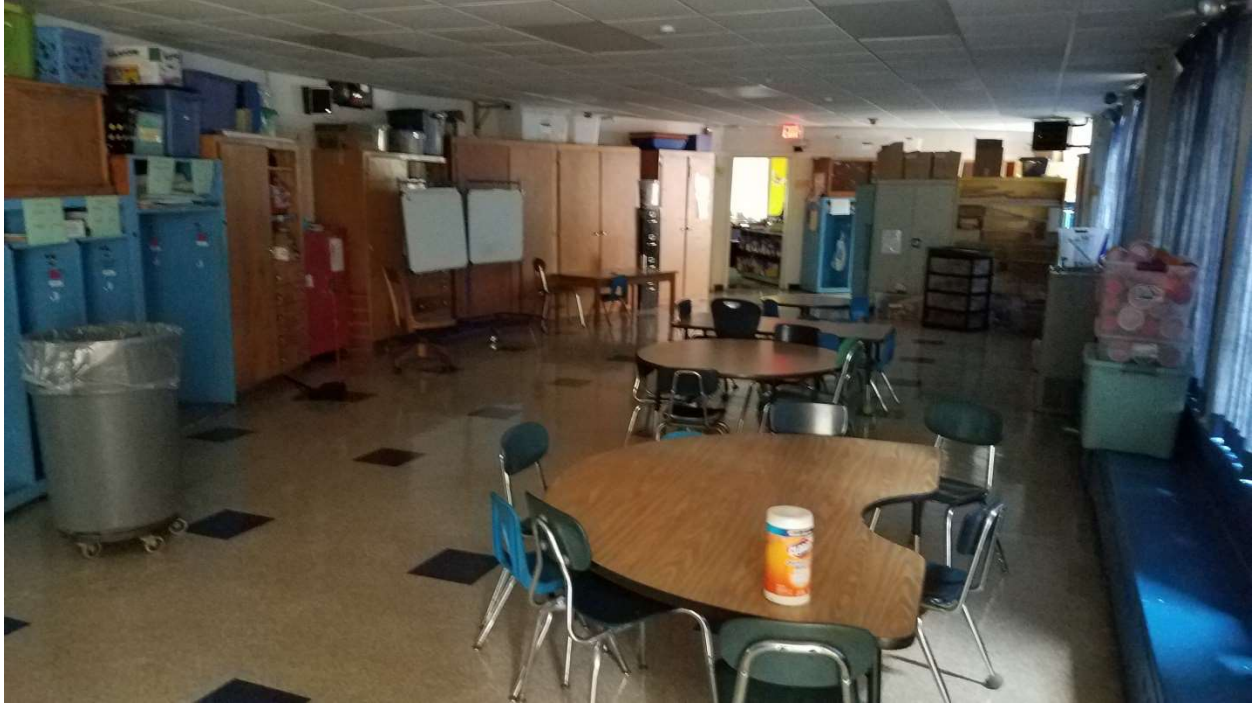
This is the lobby in the 1953 addition. As you can see, the classrooms being slightly undersized, has led to storage in the lobby.

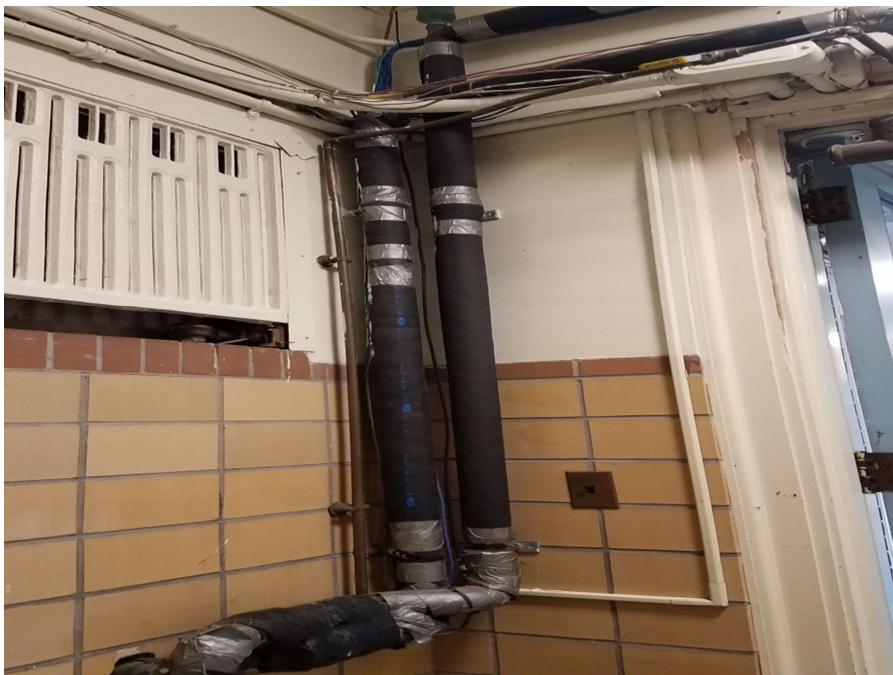
The “retrofits” over the years have not always been done in a way to protect the aesthetic nature of the school. This does not create a warm, welcoming, professional appearance.
