Countryside Elementary School Existing Conditions Report

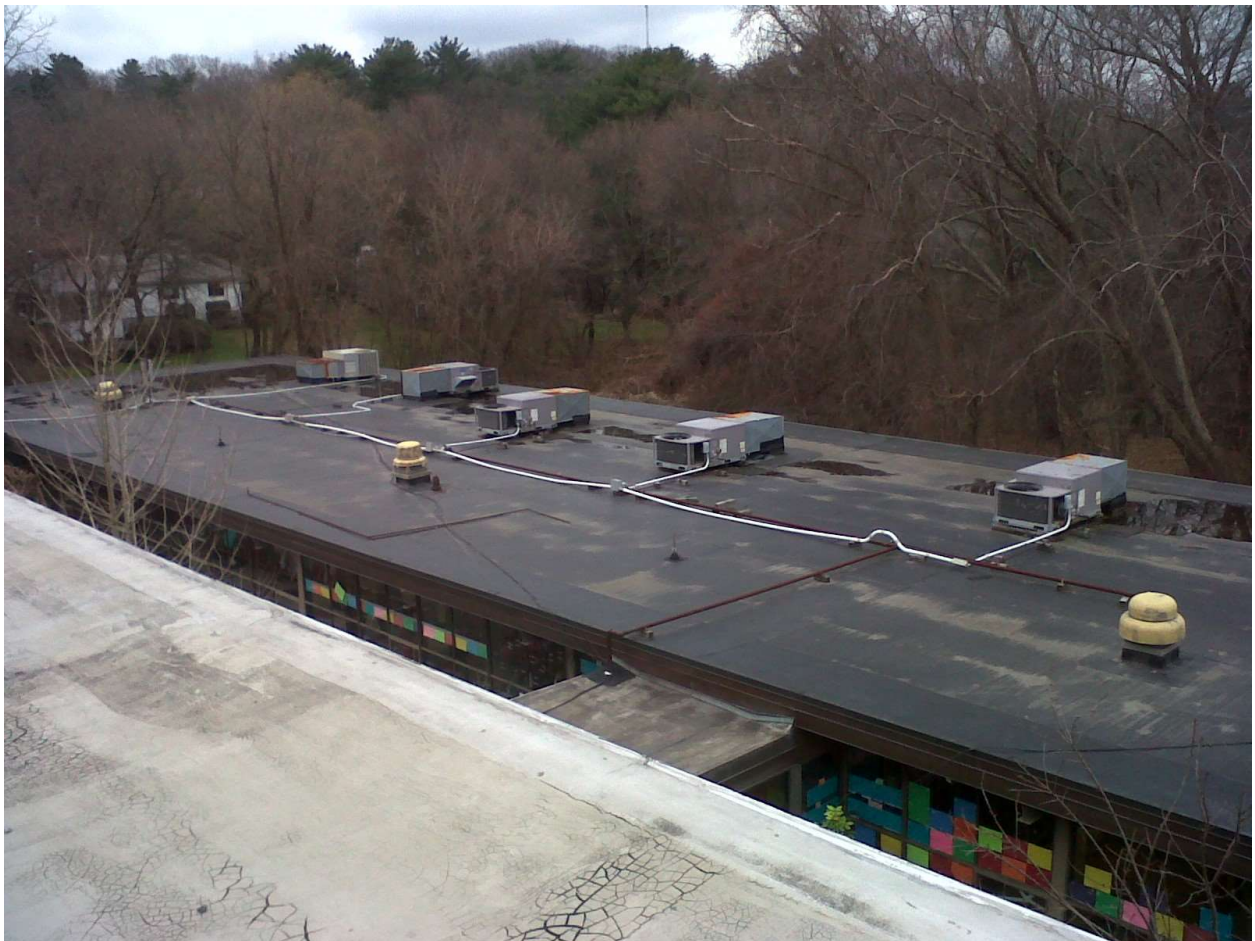
The roof on the 1953 portion of the building was replaced in 2012. The roofs on all of the annexes and modular classrooms are beyond their useful life and need to be replaced.

Notice the standing water and poor overall roof condition.

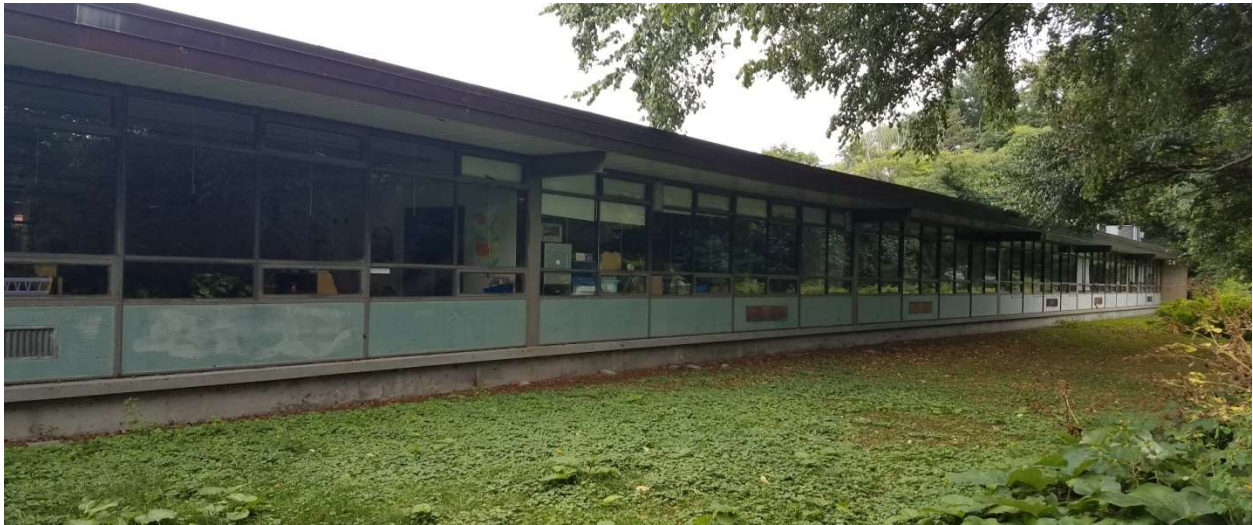
The above picture shows the 1958 single pane hollow metal framed storefront window systems that face the wetlands in the rear of the annexes.

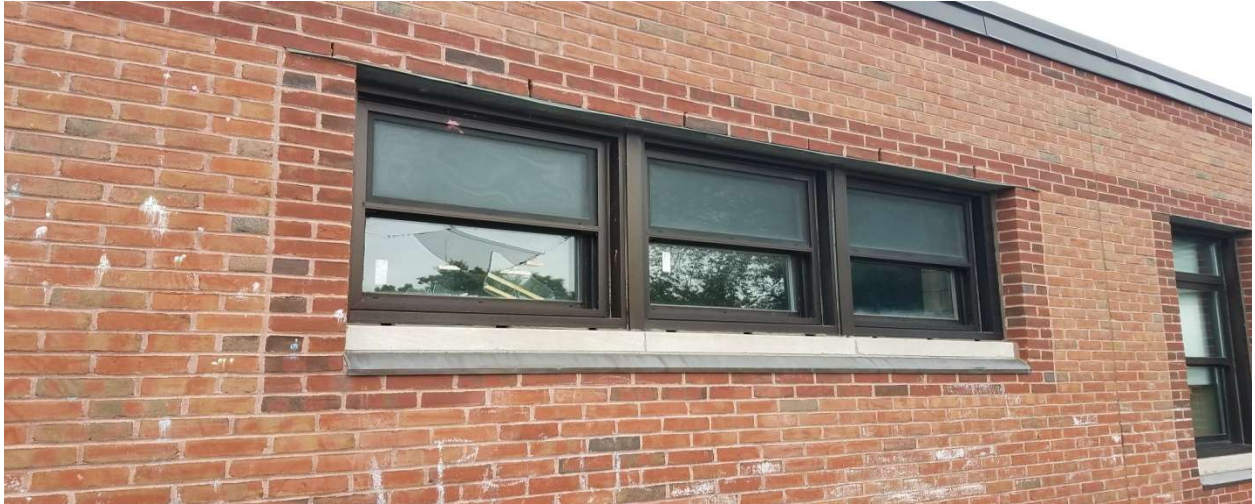
The above shows the double pane metal windows from 1991.

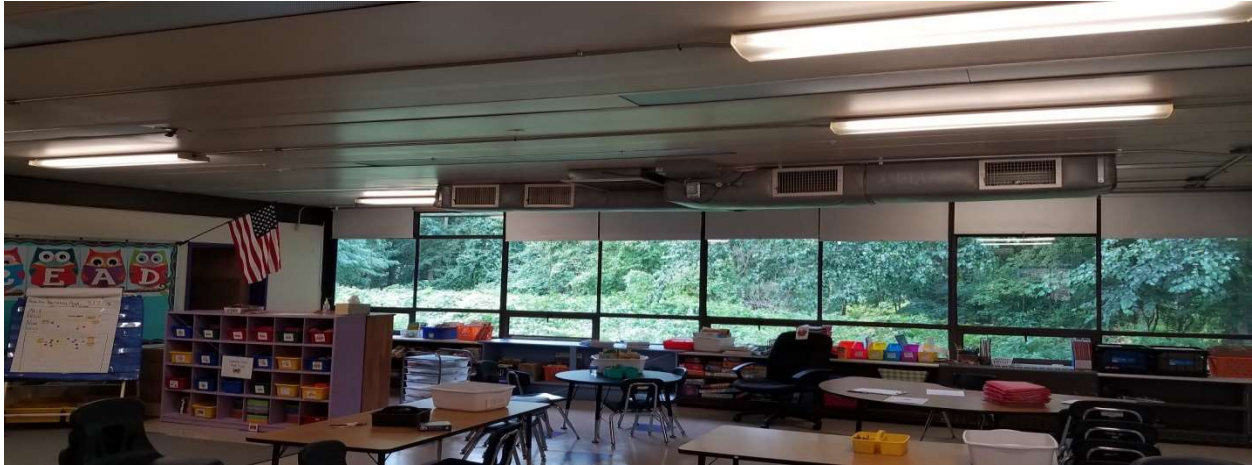
The above picture shows the exposed hvac equipment and ductwork in the annex classrooms. The noise from this does not come close to meeting the acoustical standards for classrooms, and is a distraction to learning.

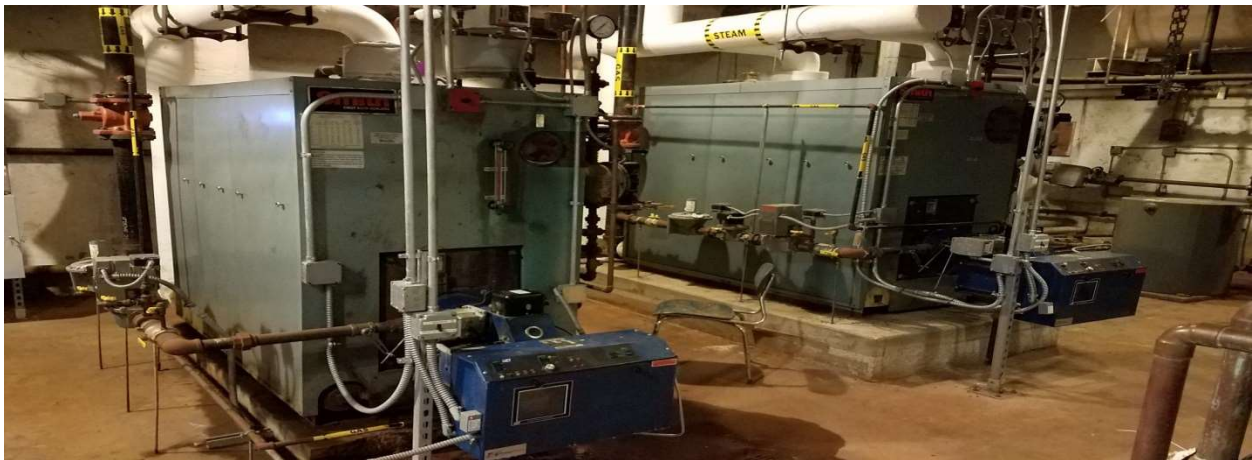
These are the steam boilers that have been replaced countless times over the years. Notice that they are on elevated concrete pads to try and help prevent failure due to chronic flooding.

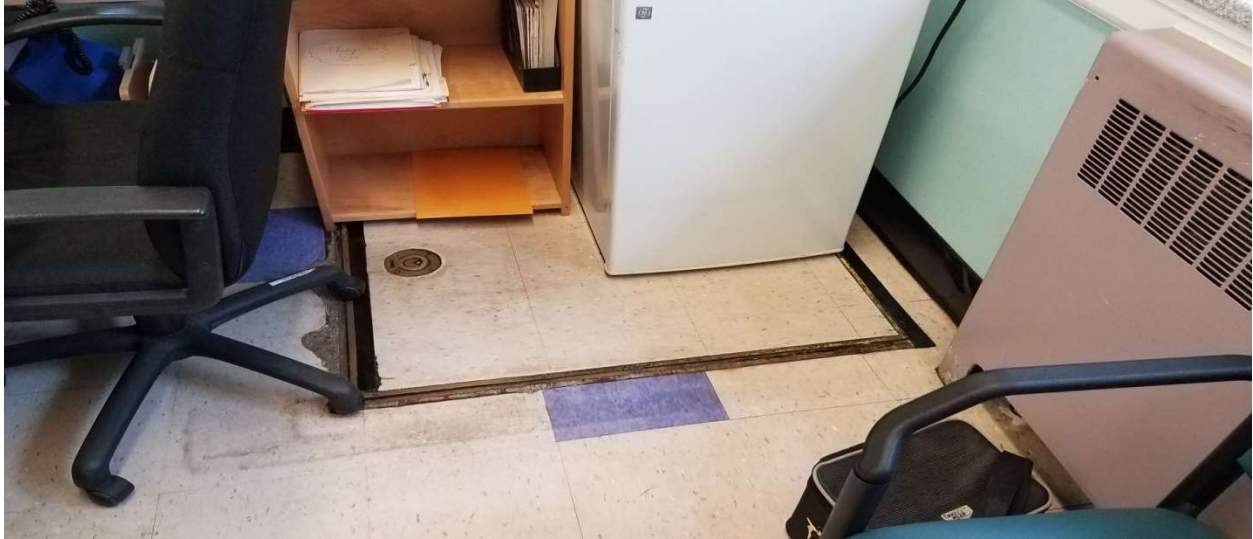
This is the access panel to the crawl space beneath the nurse's office. This is how the sewage ejector pump is accessed. Please note that at the time of this picture, the smell of sewer gas was prevalent.

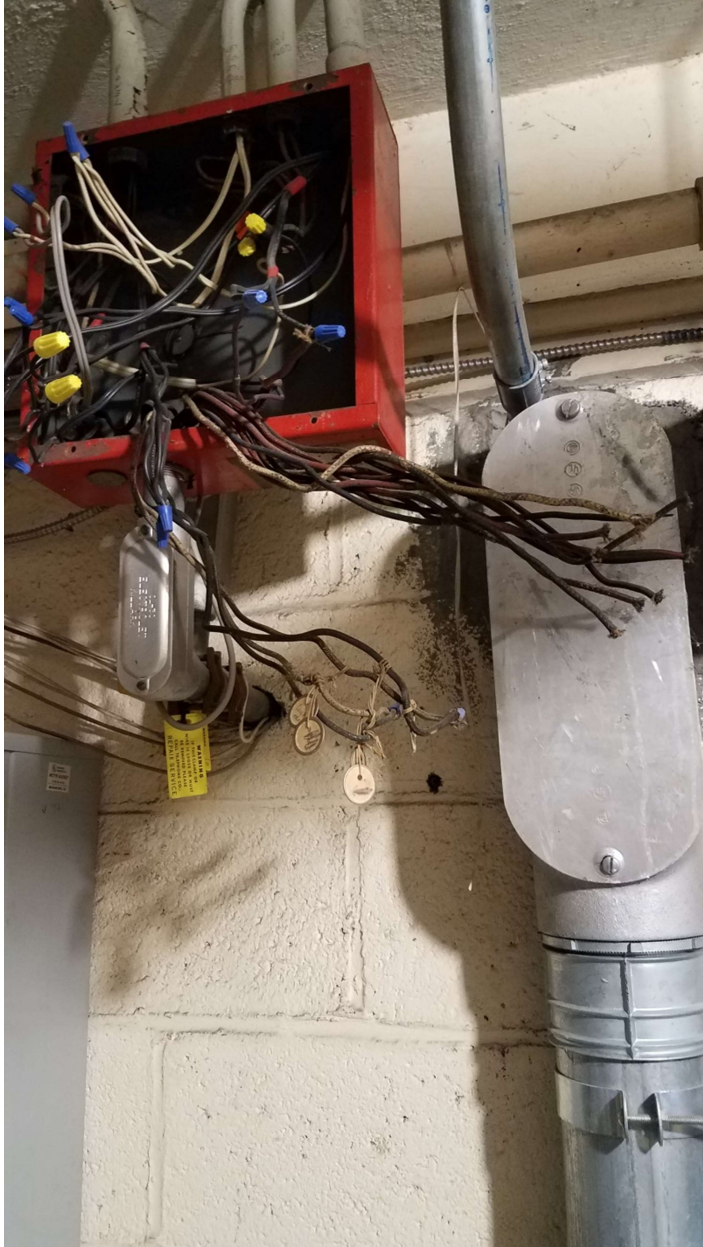
The fire alarm panel was replaced in 2016, but only a small portion of the devices are addressable. Therefore, responses are likely only to the building, and not to a specific area within the building. The fire alarm distribution system is in poor condition and needs to be replaced. The school has no fire suppression systems.

Although some Fire Alarm upgrades have occurred, we have way more work to do.

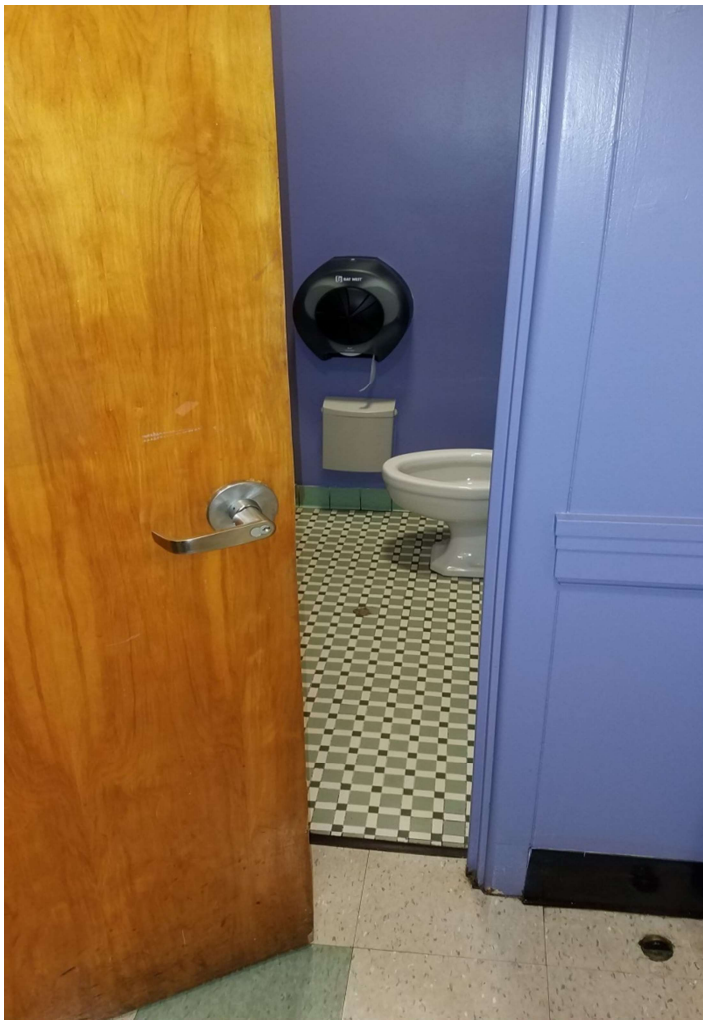
None of the bathrooms in the building are accessible. Some have had minor improvements made to increase accessibility, but some like the one above are not accessible, and create fire egress issues due to layout and door placement.

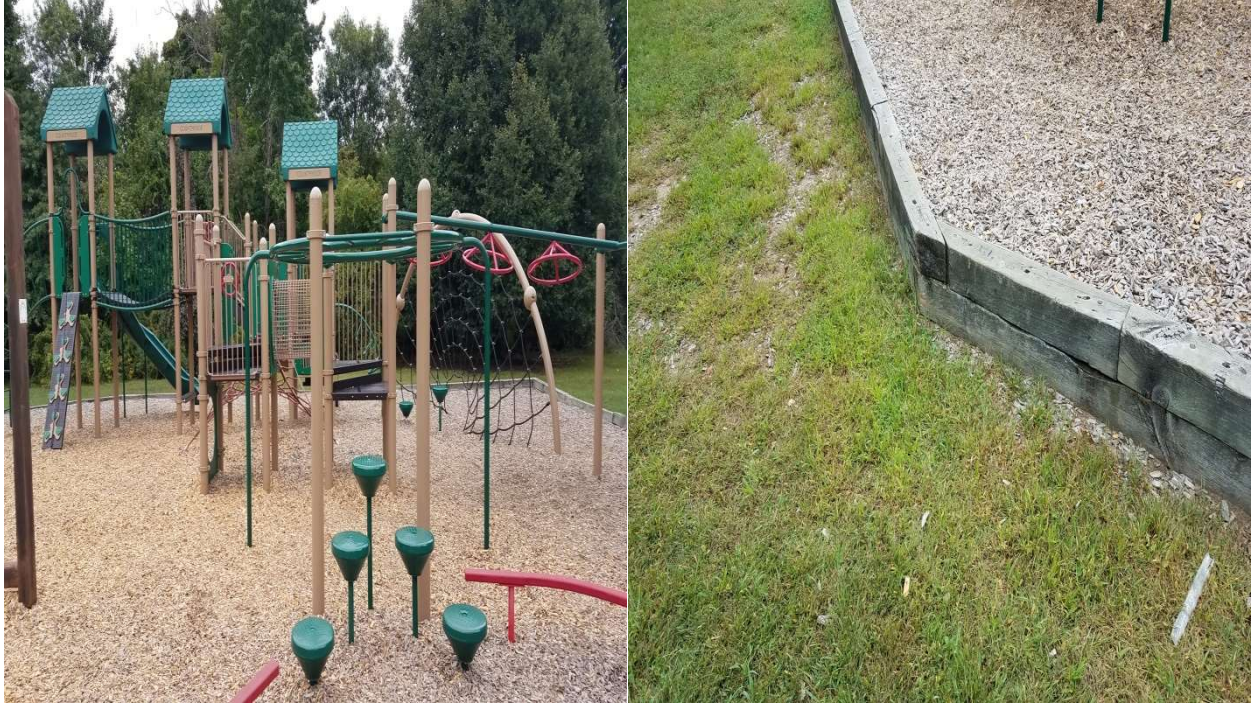
The playground is not accessible.

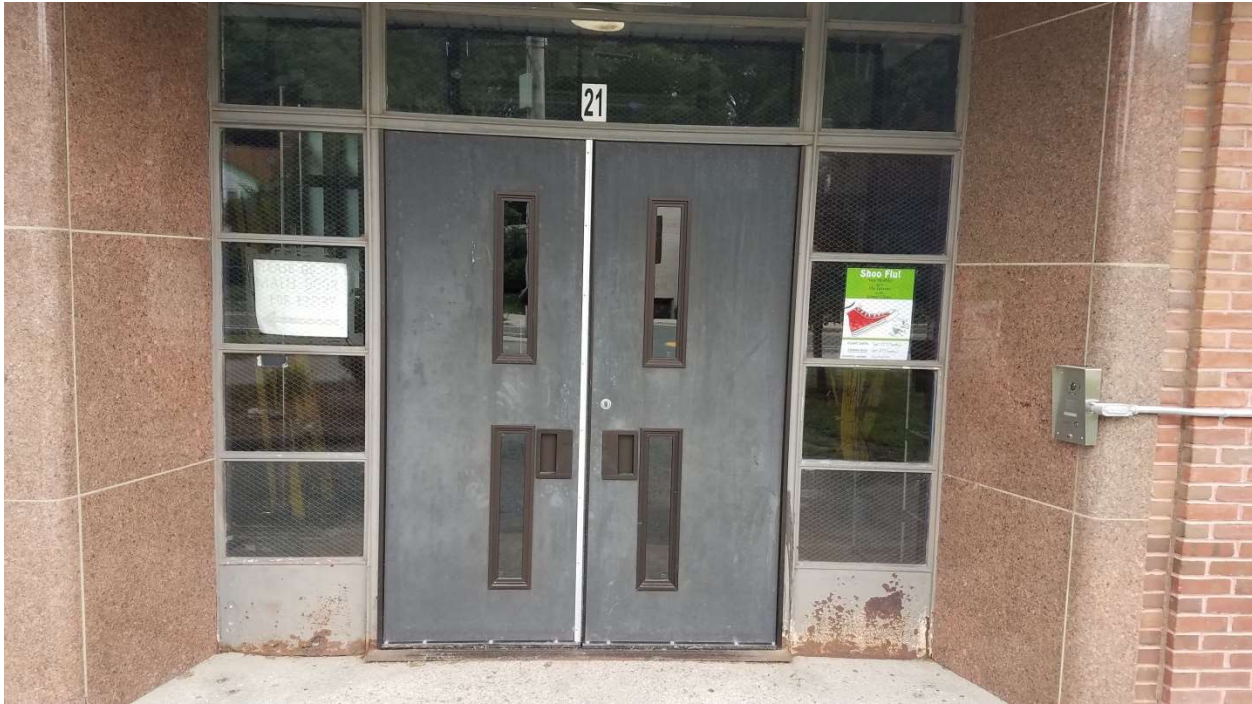
None of the doors are accessible. The main entrance has minimal accessibility.

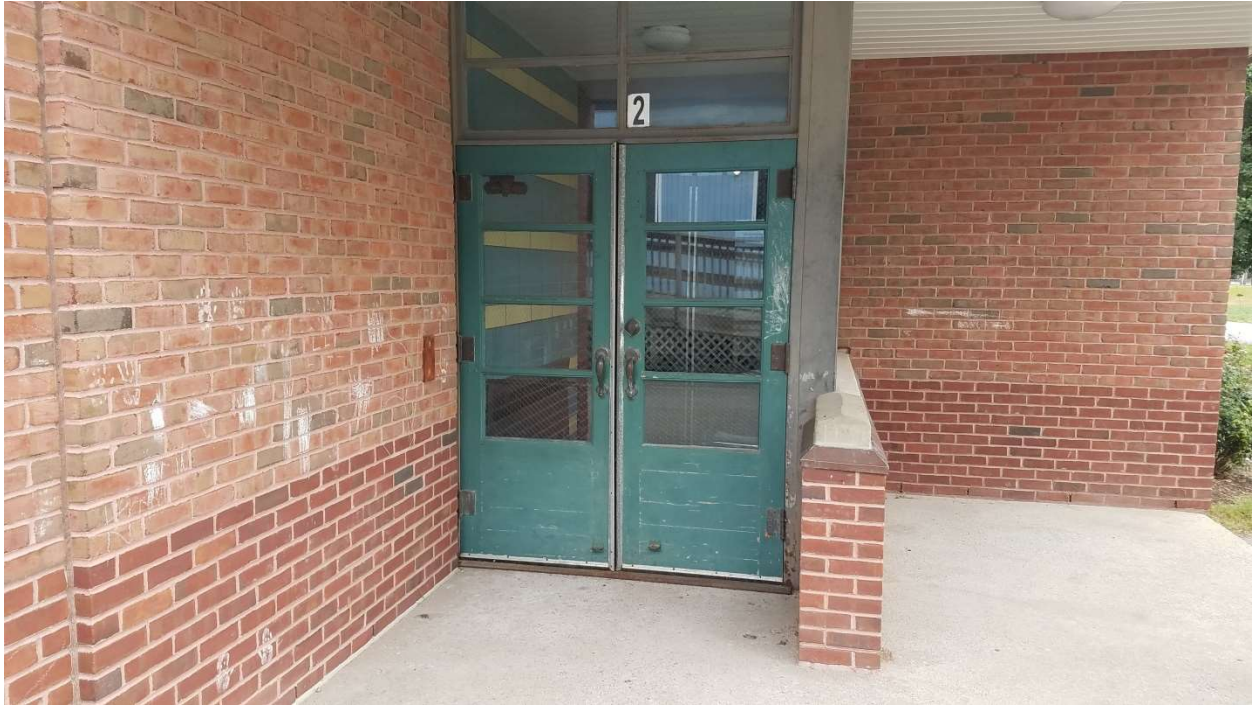
Some doors are not only inaccessible, but original to the building and in very poor condition.

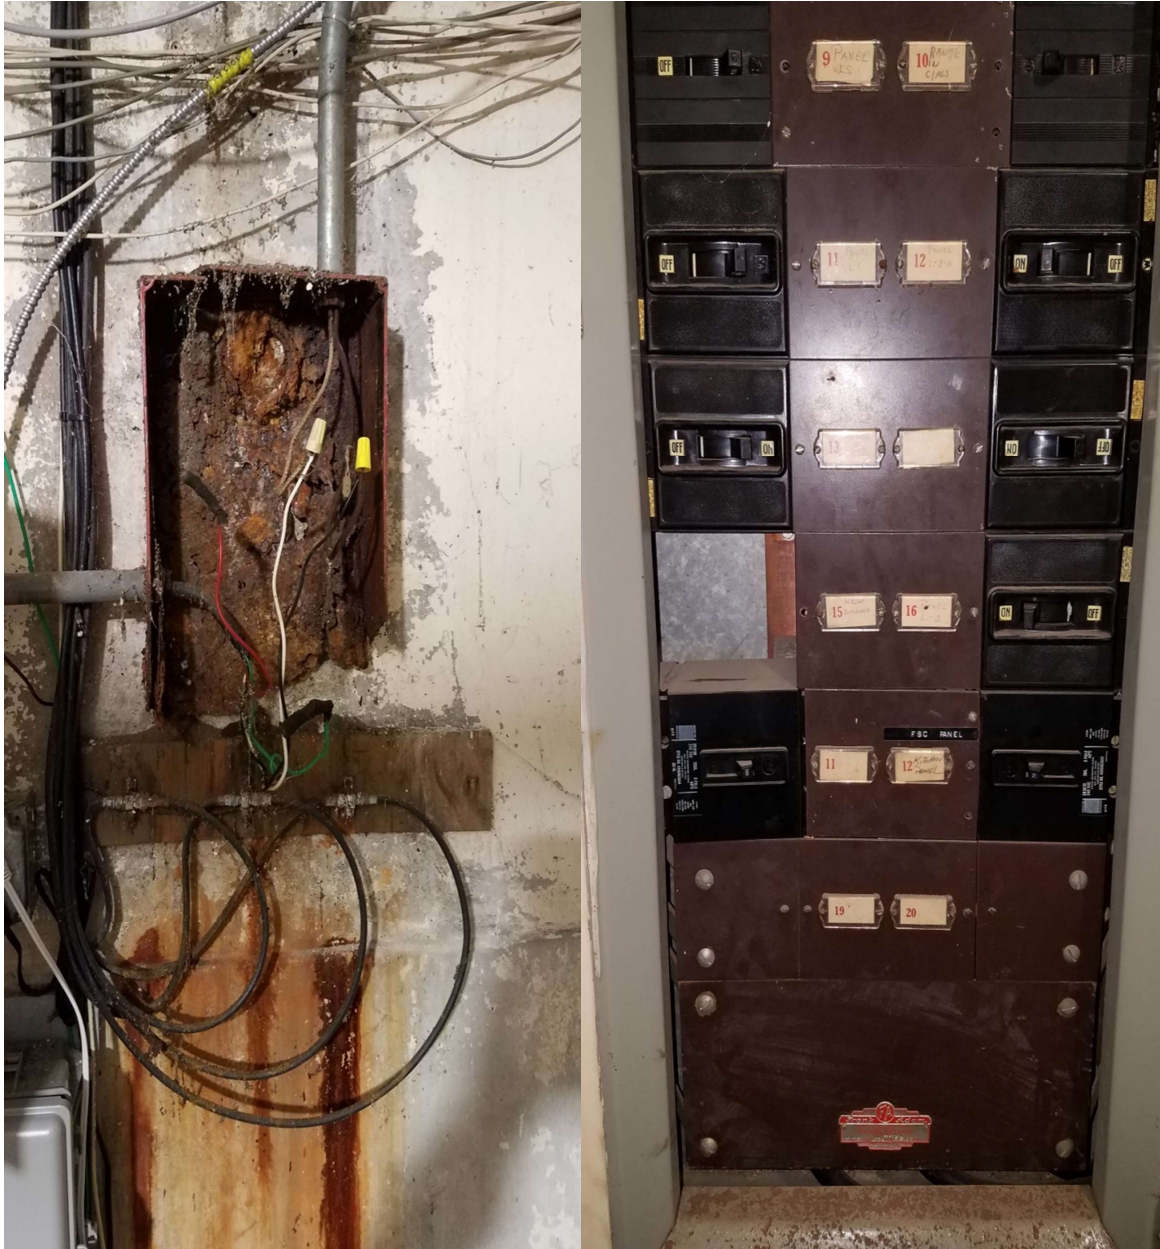
On the left, the chronic flooding has taken its toll. On the right, the main electrical panel for the school. As you can see it is not only original to the building, it is missing components which leaves the copper bus bar on the left exposed creating electrical safety hazards.

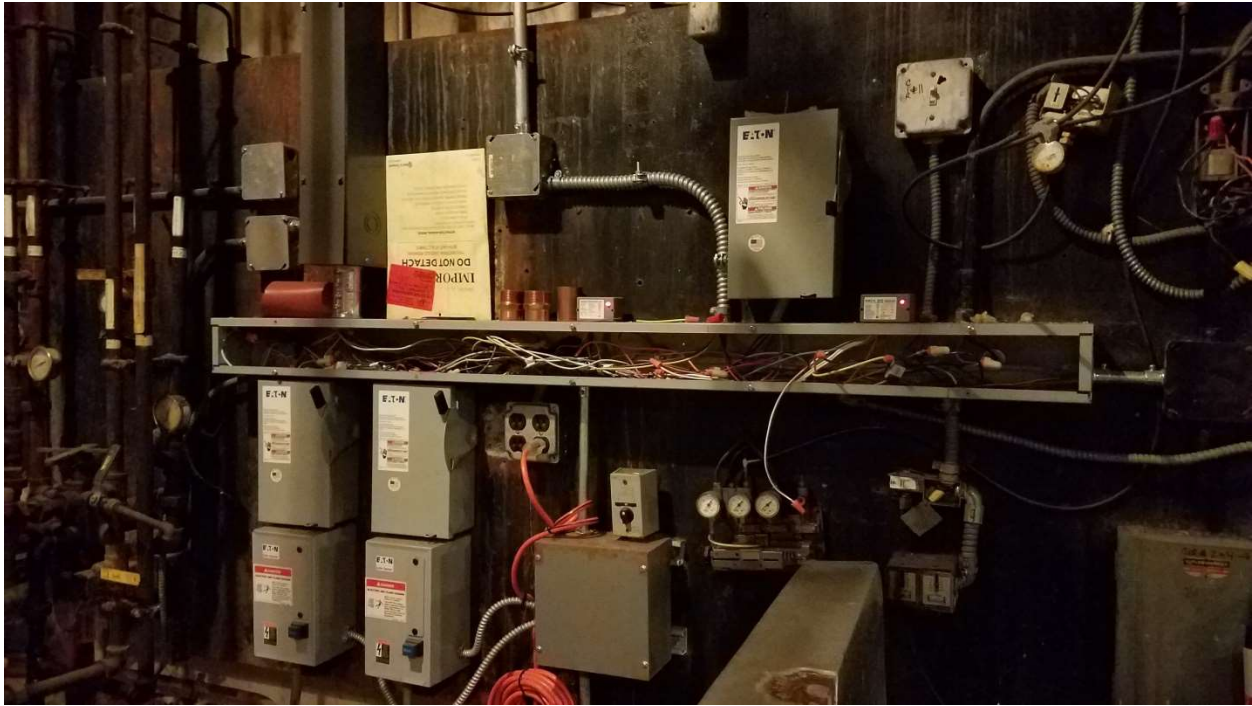
This is a good picture to illustrate that attempts have been made to improve some of the building support systems, but it also shows that there is far more work left to do.

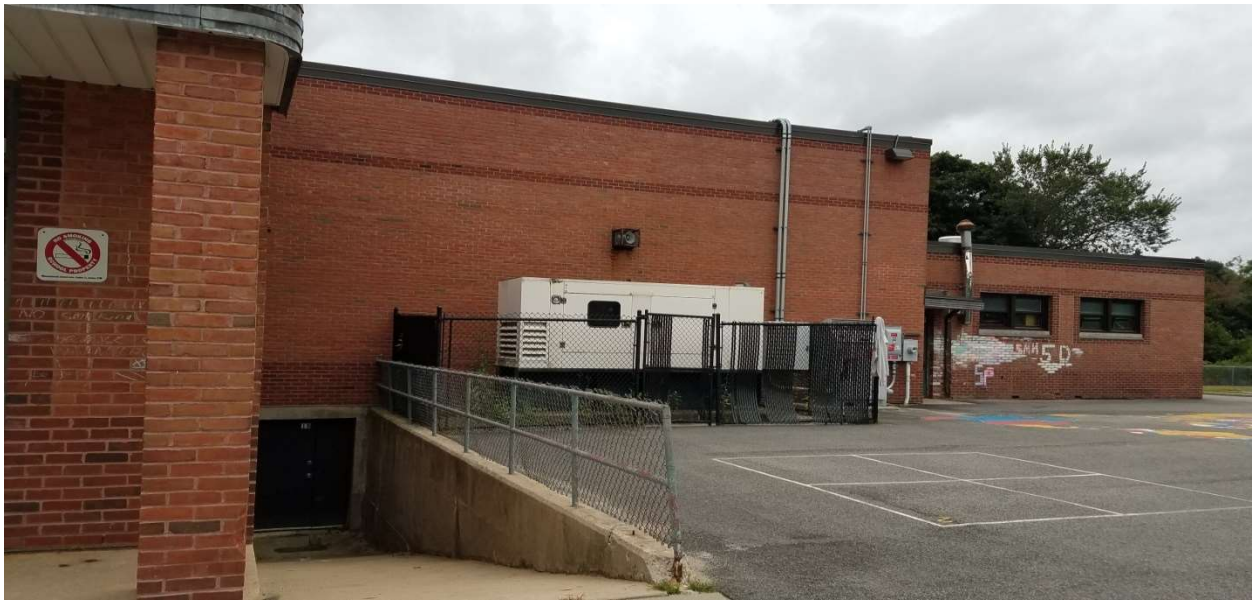
This generator is beyond its useful life, and no longer code compliant. The exhaust stack needs to be well above the building, or the generator needs to be much further away. This is now required to prevent exhaust fumes from entering the building.

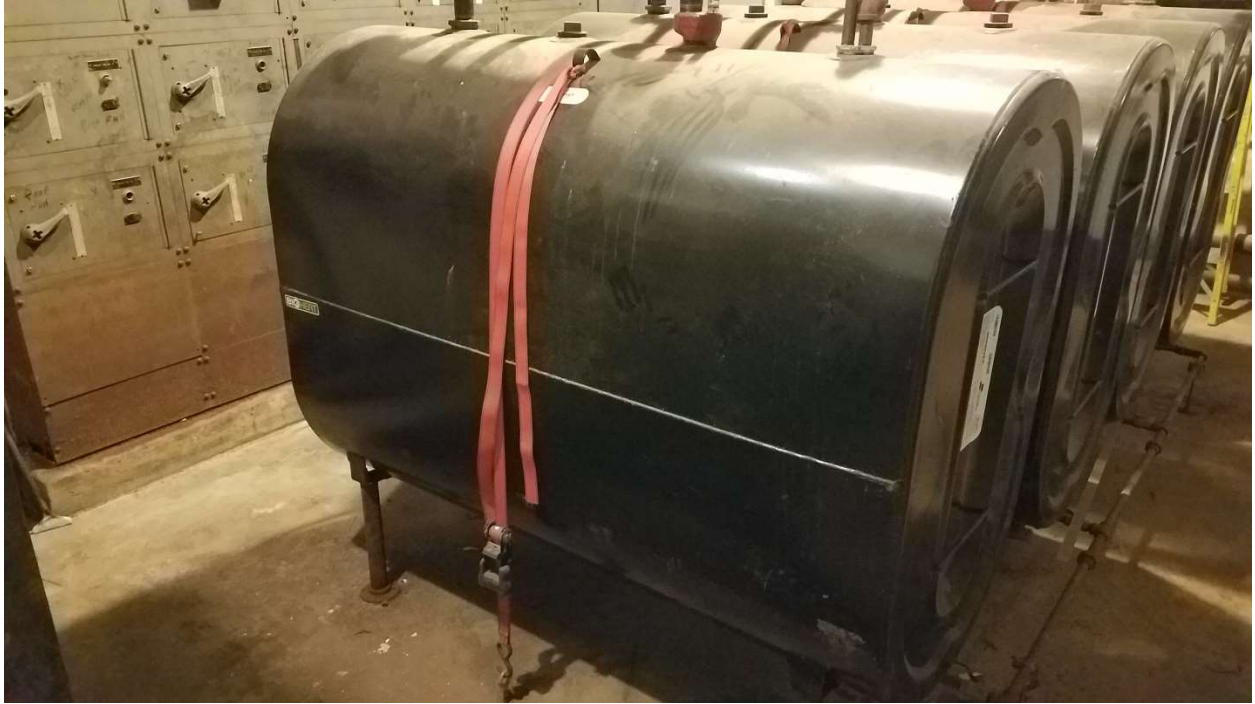
The oil tanks had to be strapped to the boiler room floor to prevent them from breaking free and floating when the area floods.

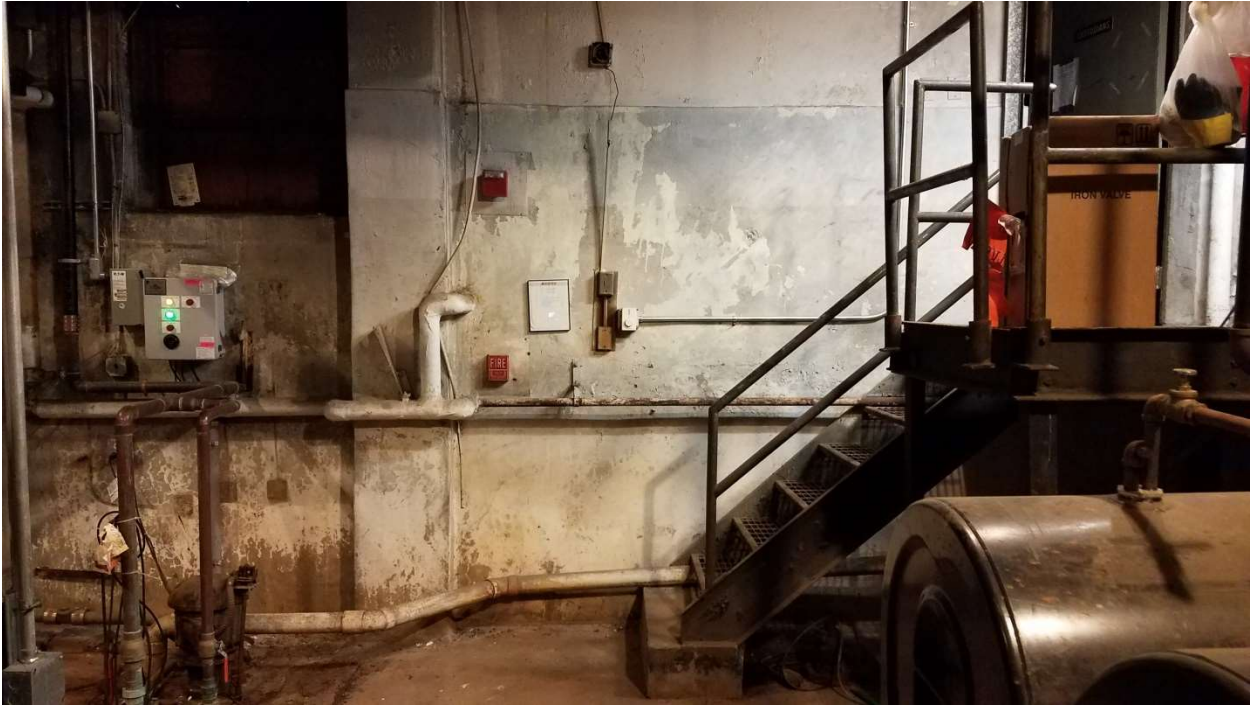
This picture illustrates the chronic flooding. This wall was actually painted fairly recently, but one of the flooding events is memorialized with the flood line about 9 feet up on the wall just below the red box on the wall at the top of the picture.

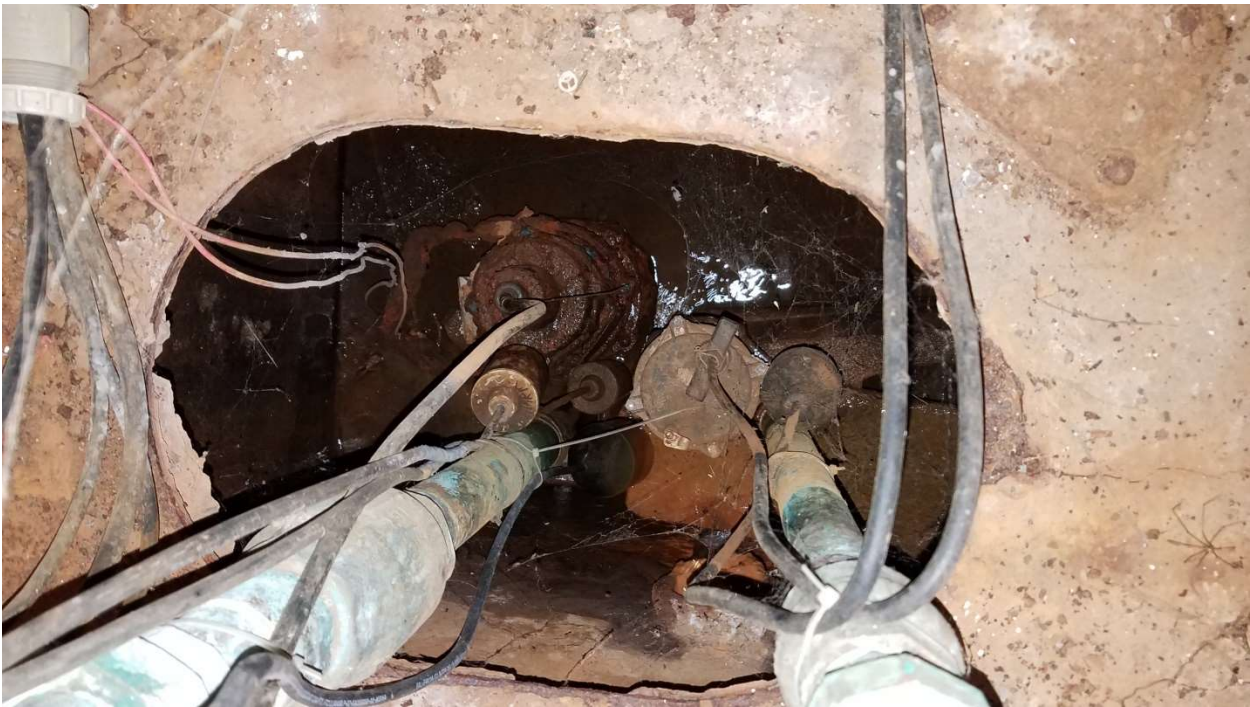
These sump pumps have been replaced countless times. Although the pumps look old in this picture, they were replaced a few years ago. They are constantly wetted, so they rust out pretty quickly.

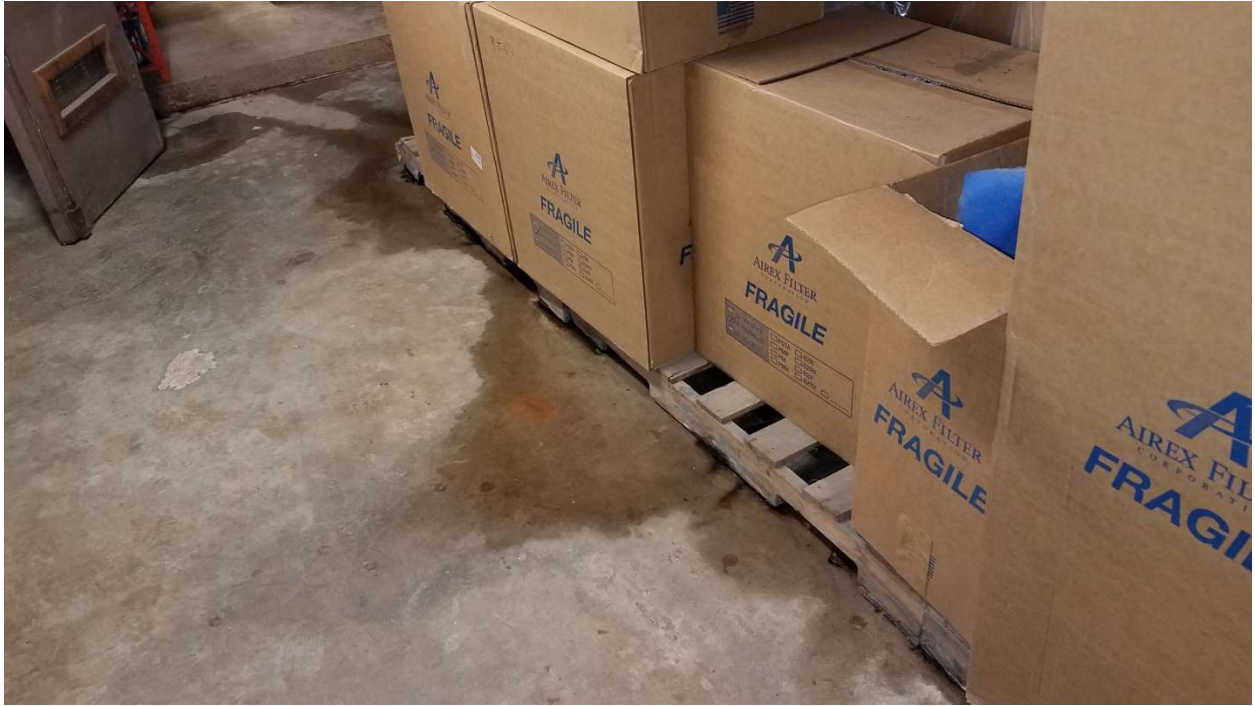
The basement is the only storage area for the entire school. It is chronically wet, and very damp. At the time of this picture, Newton had received little to no rain in the previous few weeks, and it was taken in the driest month of the year.

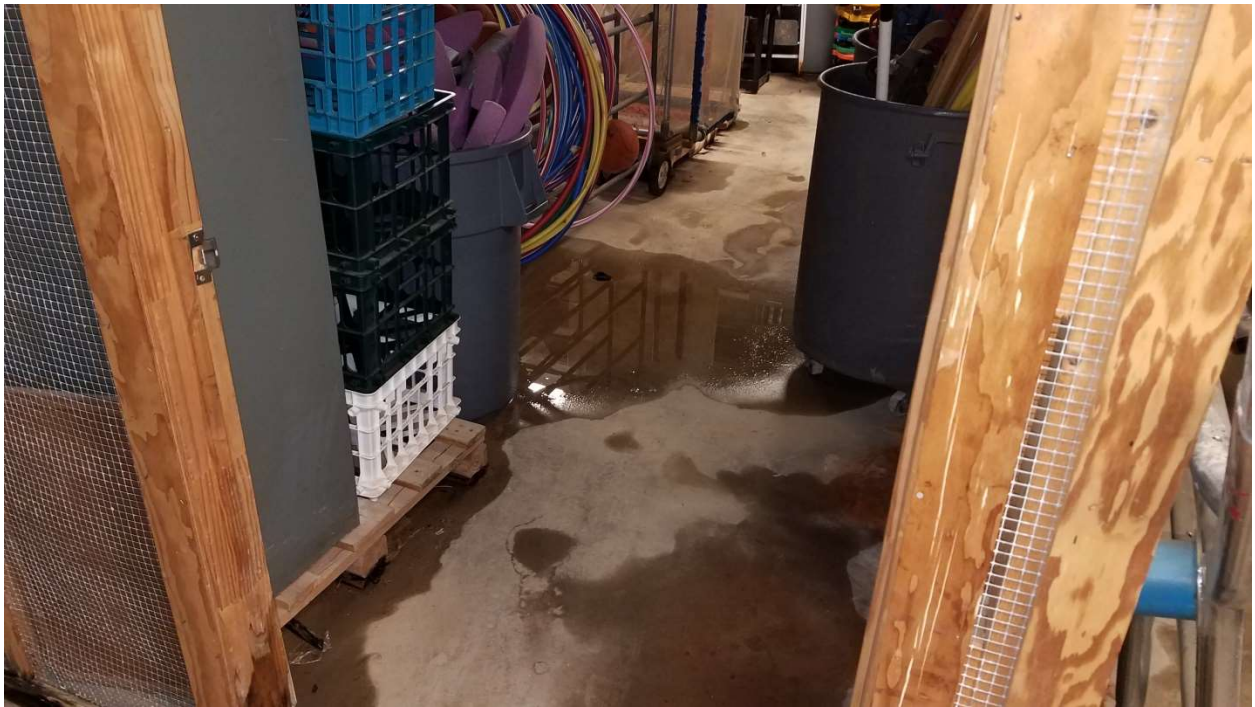
By all records, the basement has never been dry.

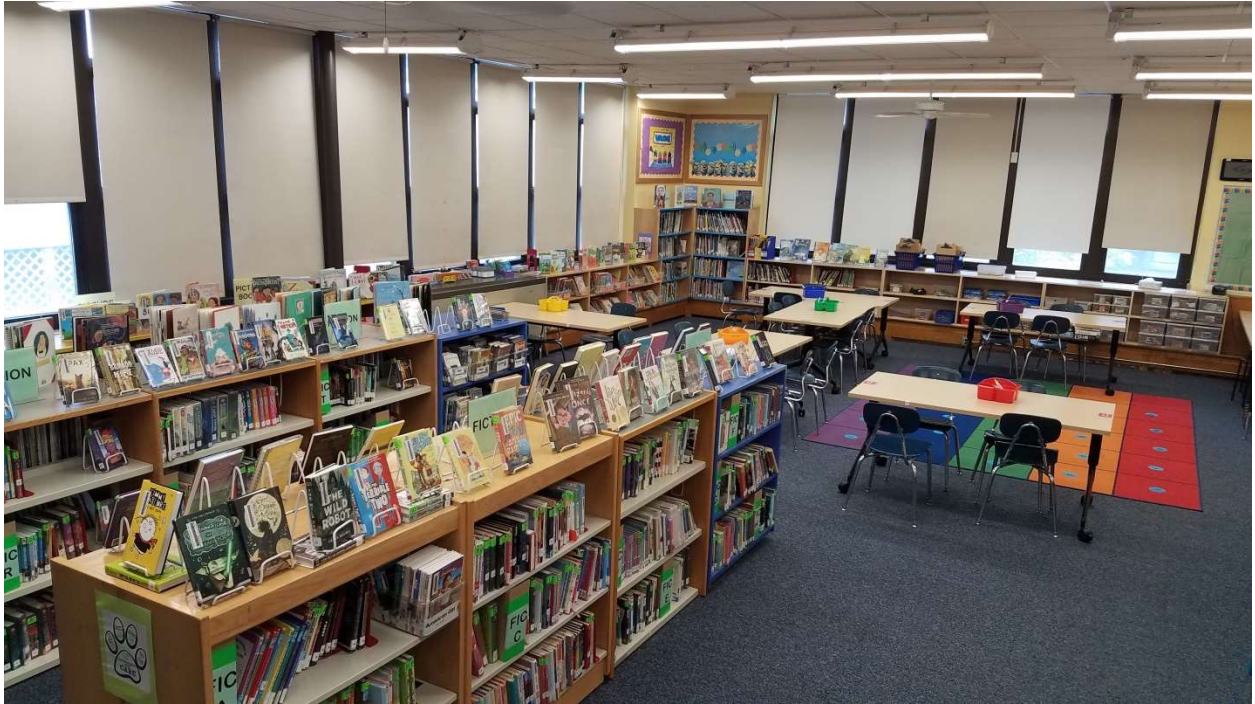
The library is about 30% the size it should be for a school of this size.

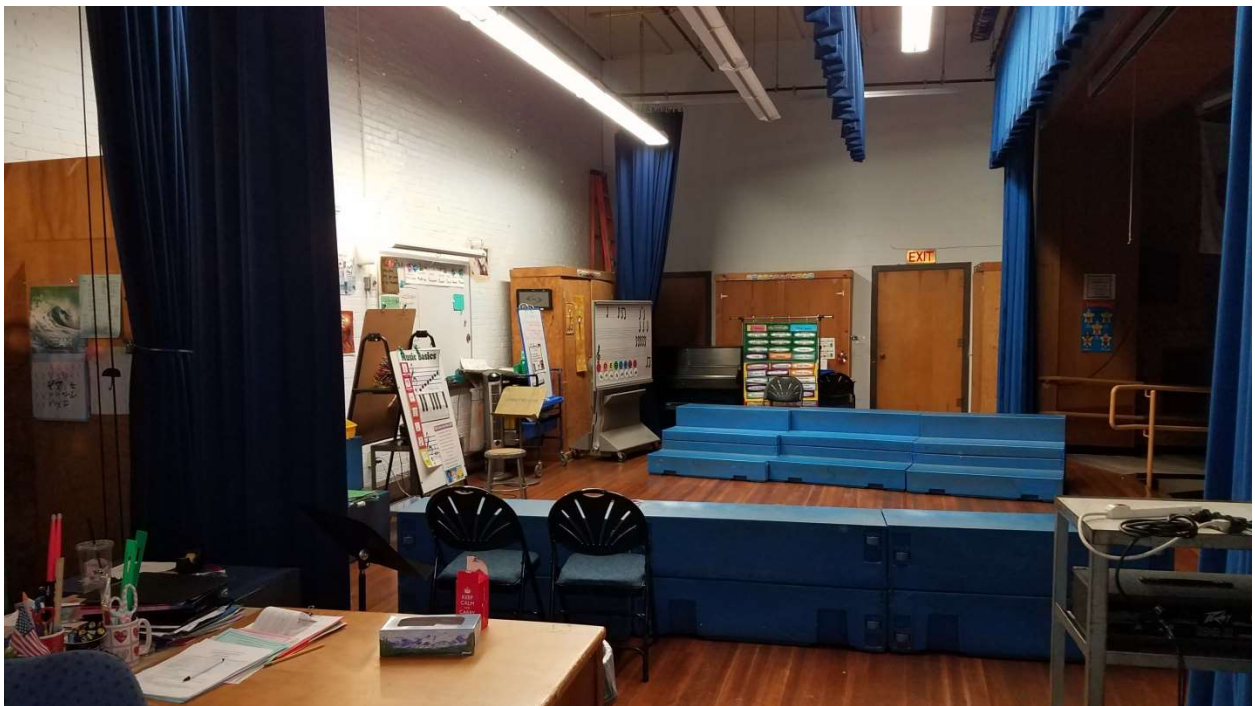
Music is taught on the stage in the cafetorium. This really is not allowed as it blocks egress ways in an area of assembly.

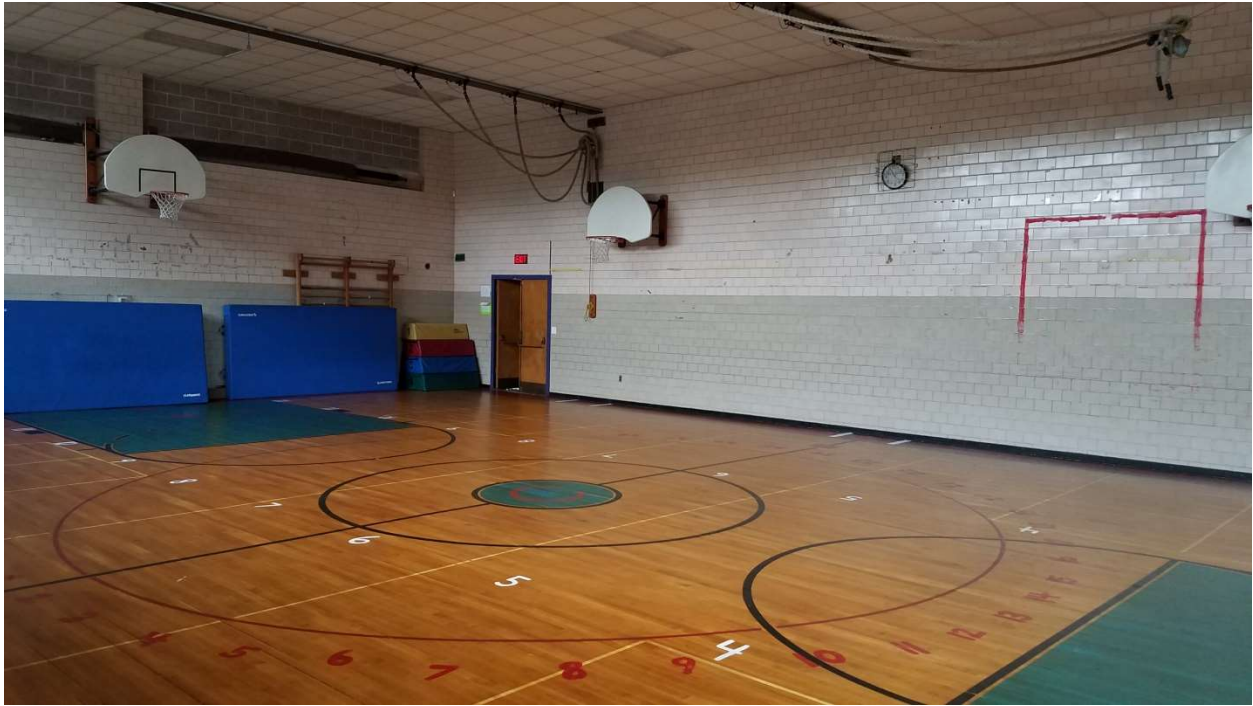
The gym is very small. It should be more than twice this size based on enrollment.

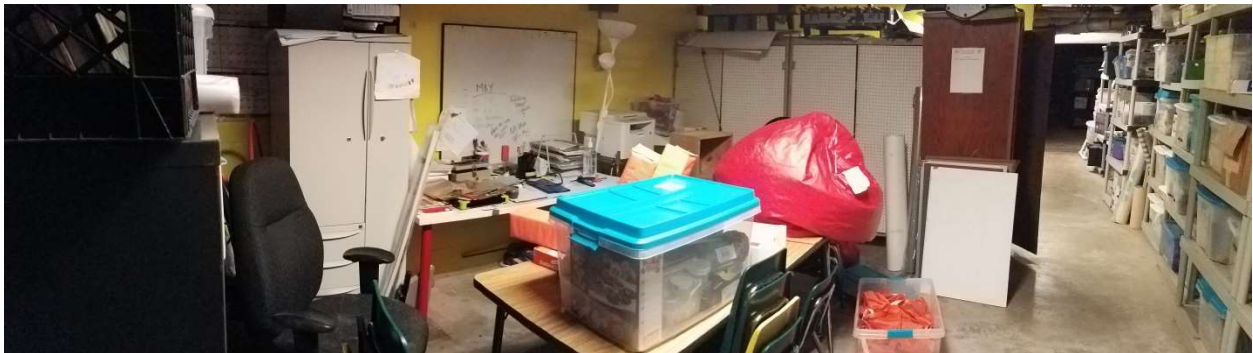
Small group instruction has no space in the school, but it still needs to happen. This is a small instructional space in the basement, next to the old generator vault, with an open crawl space to the sewage ejector pumps on the right.

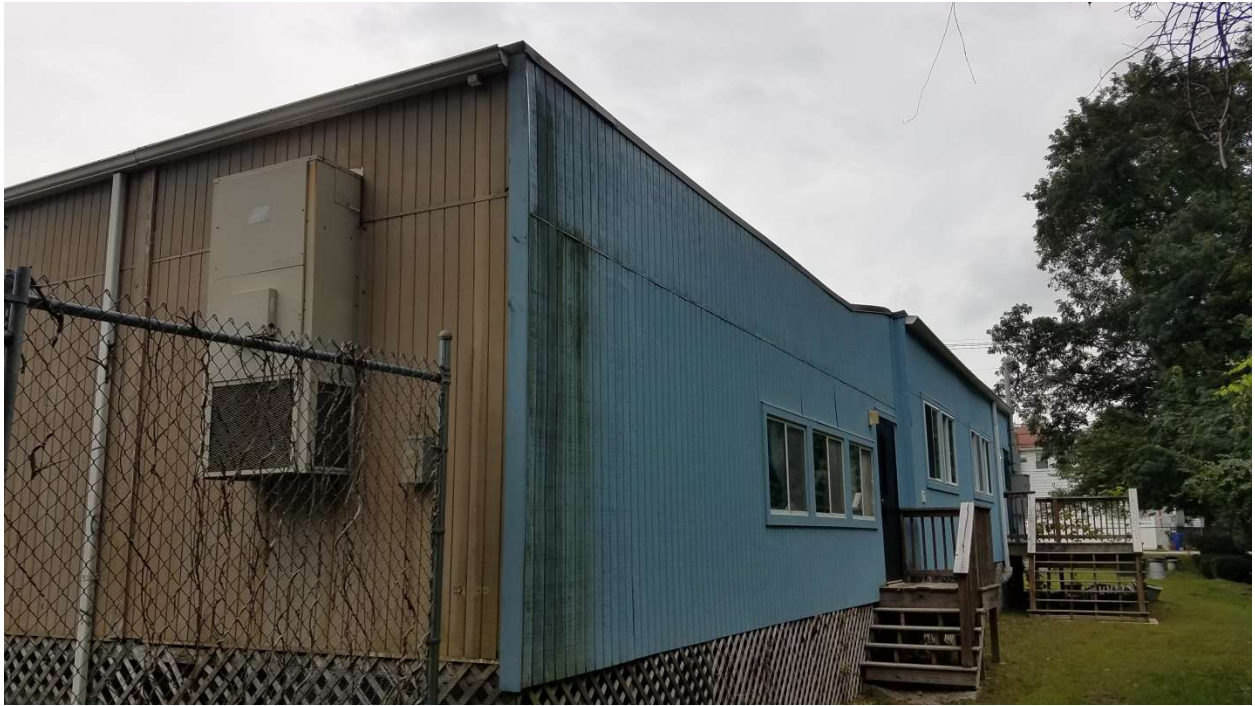
The south side modular classrooms were painted a couple years ago to try and make them a little less unpleasant. The siding is chronically wet and rotting. Notice the HVAC on the left. The air intake for this classroom is right at the rotting wood.

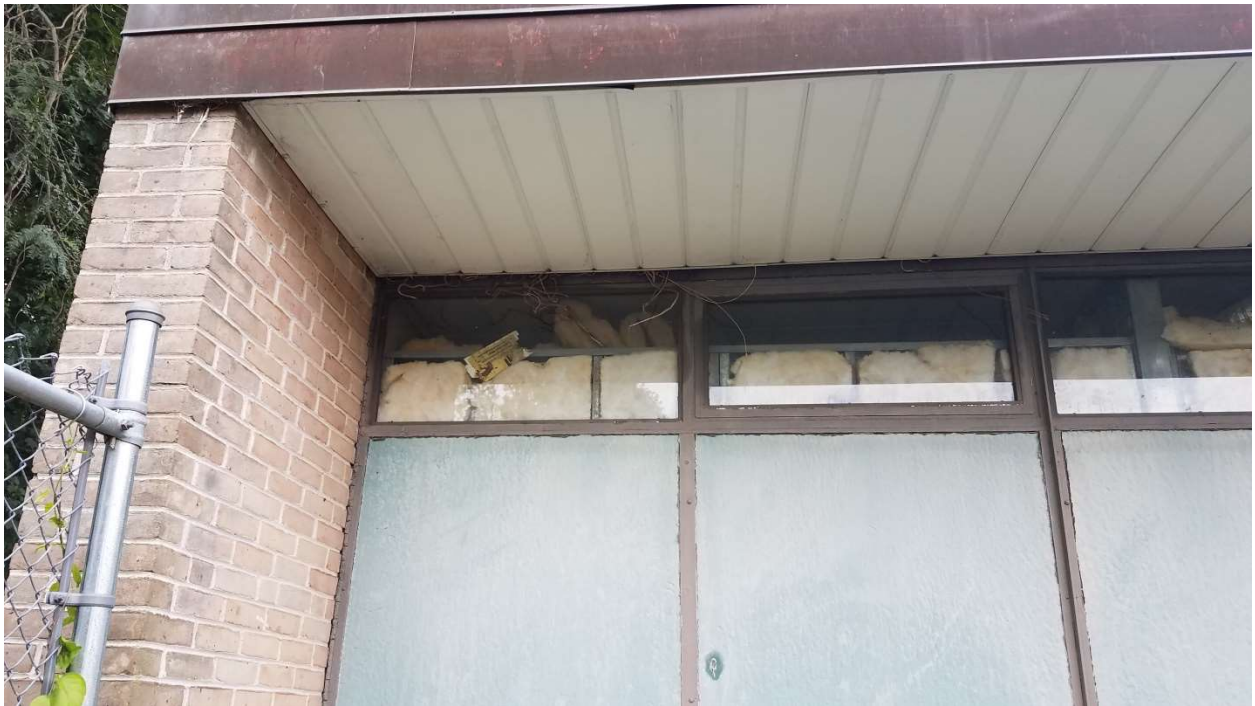
This picture illustrates a number of issues. Vines are growing through the roof and ceilings in the annexes. The interior of the annex at this location was retrofitted with steel studs and fiberglass insulation to try and keep the space from getting too cold in the winter.

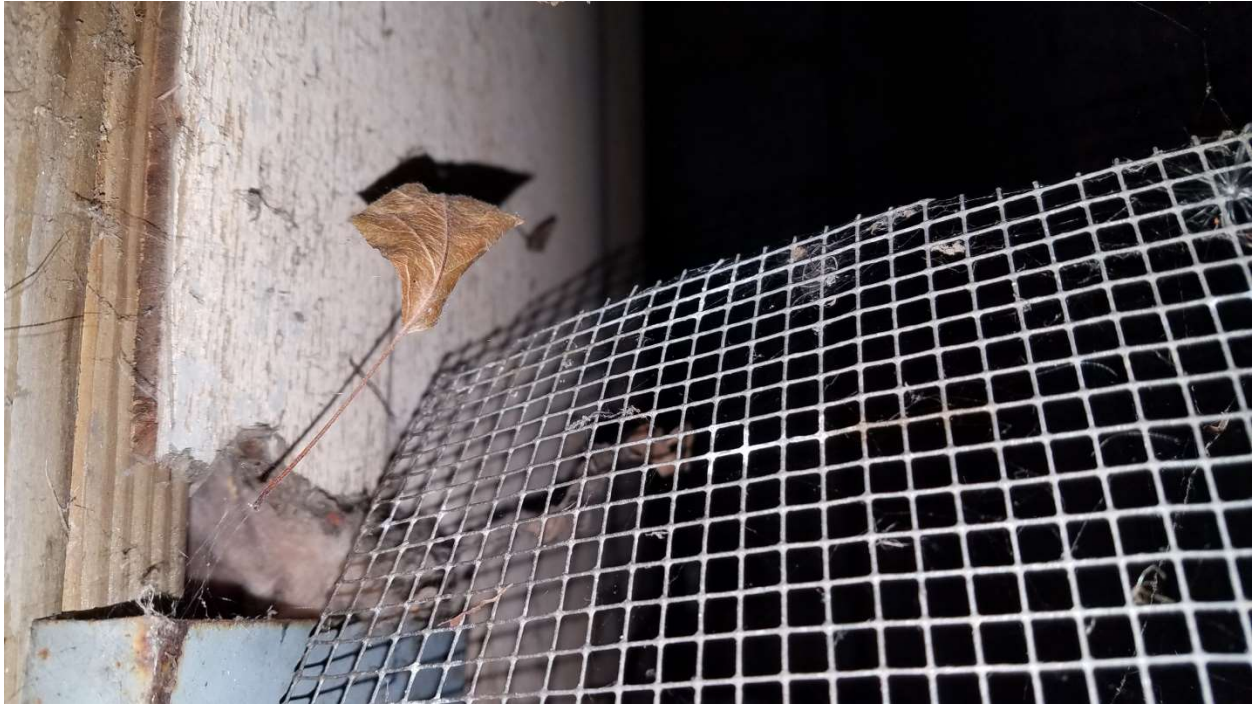
The underside of the modulars has failed, is wet, and constantly houses small animals. A better picture would have been obtained, but a family of skunks was under the modulars at the time this picture was taken. The underside of the modular has been replaced multiple times over the years, but the extreme moisture condition makes this a never-ending battle.
