Countryside Elementary School Existing Conditions Report

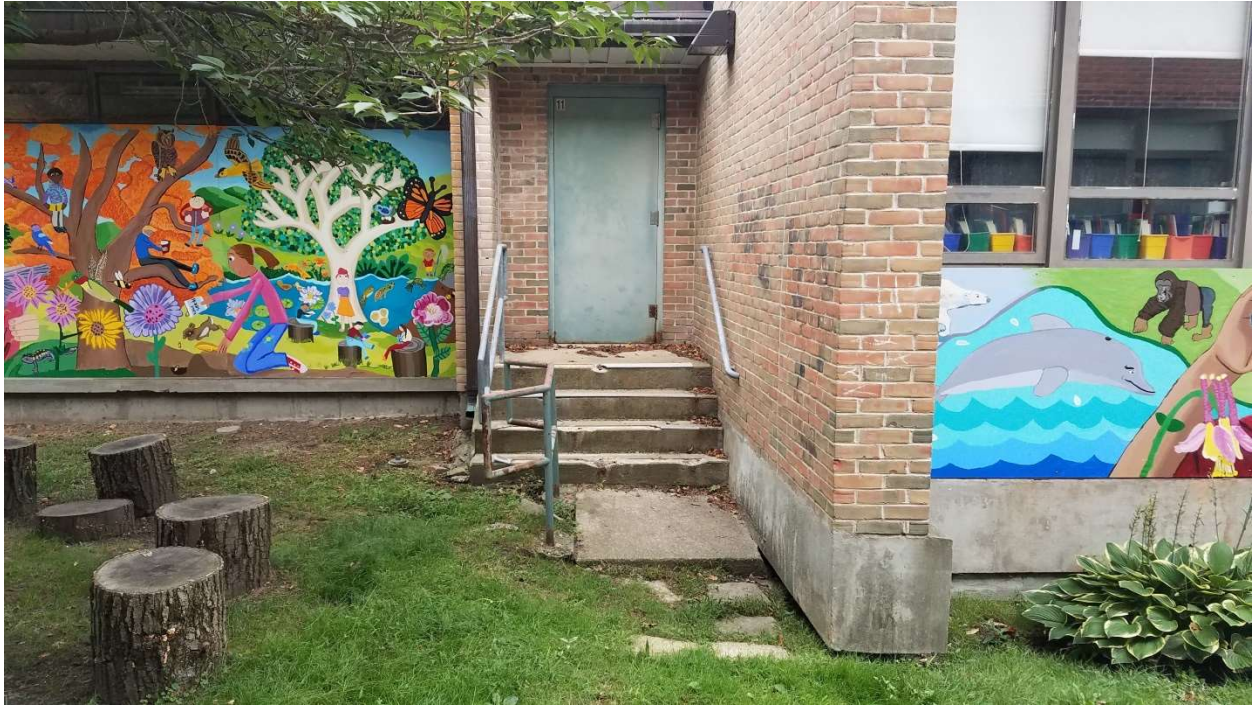
Egresses from the annexes and modulares are failing.

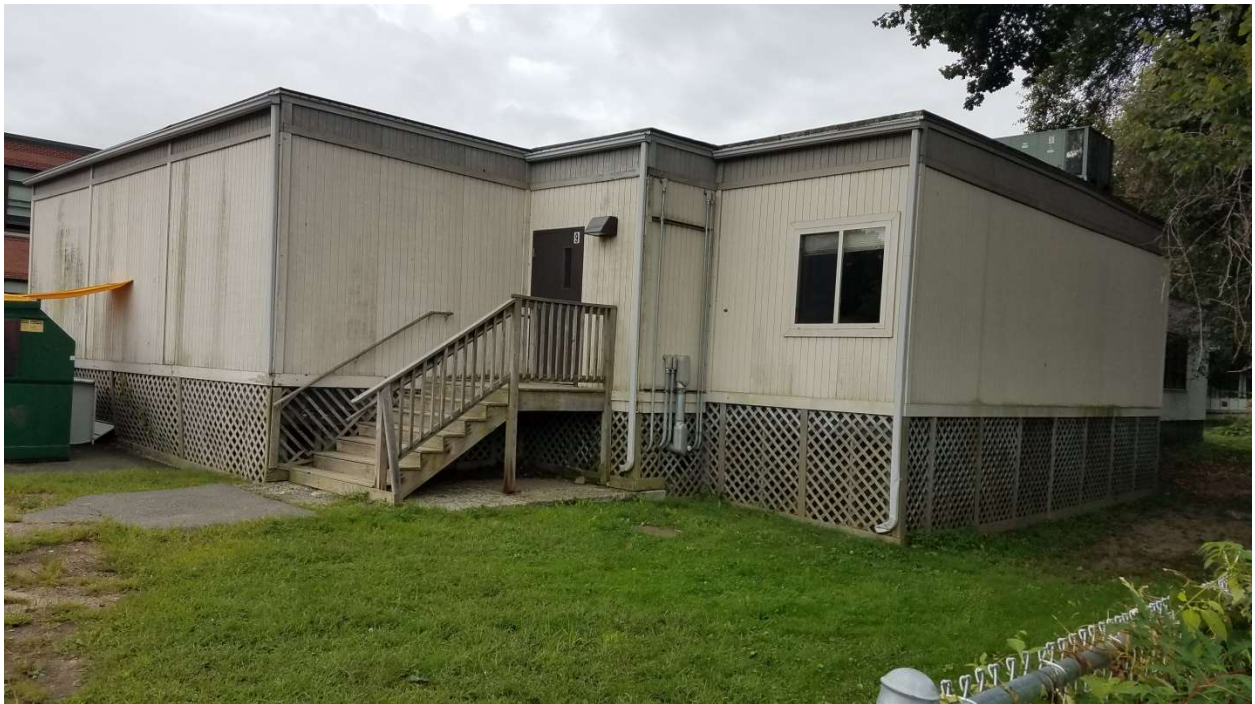
Most of the modulares sit on jacks or cinder blocks. The foundations are then covered with lattice. This means that the floors are exposed to the elements.

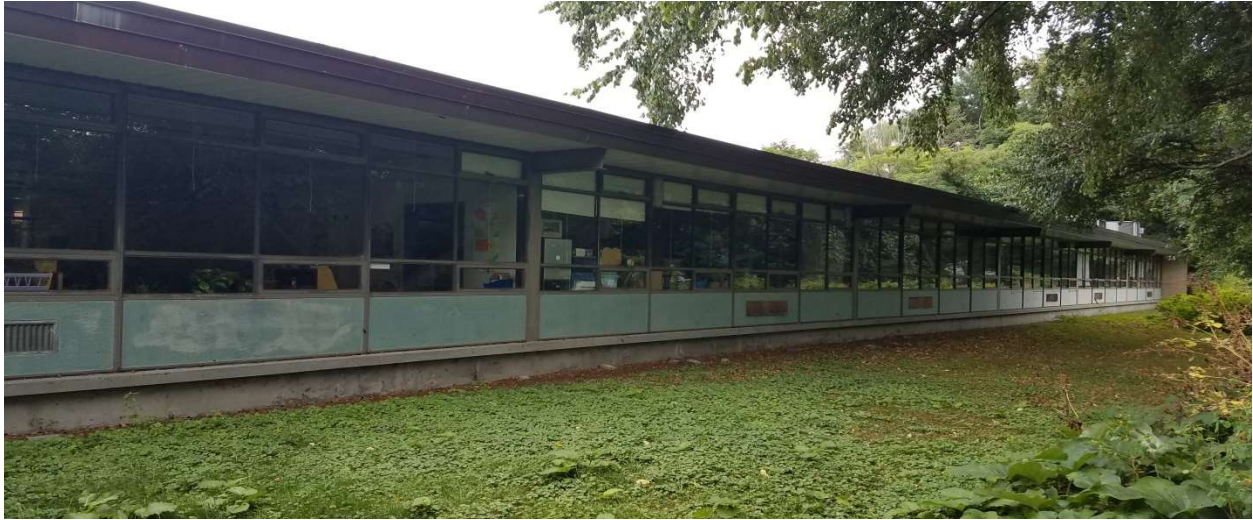
These six classrooms have very limited sunlight. The only windows in them face west, but the proximity to the wetlands, the shade from the trees, and the roof design, means very little sunlight makes its way into the rooms. One of the modular classrooms has one small window in the corner of the classroom which is the only source of daylight for the space.

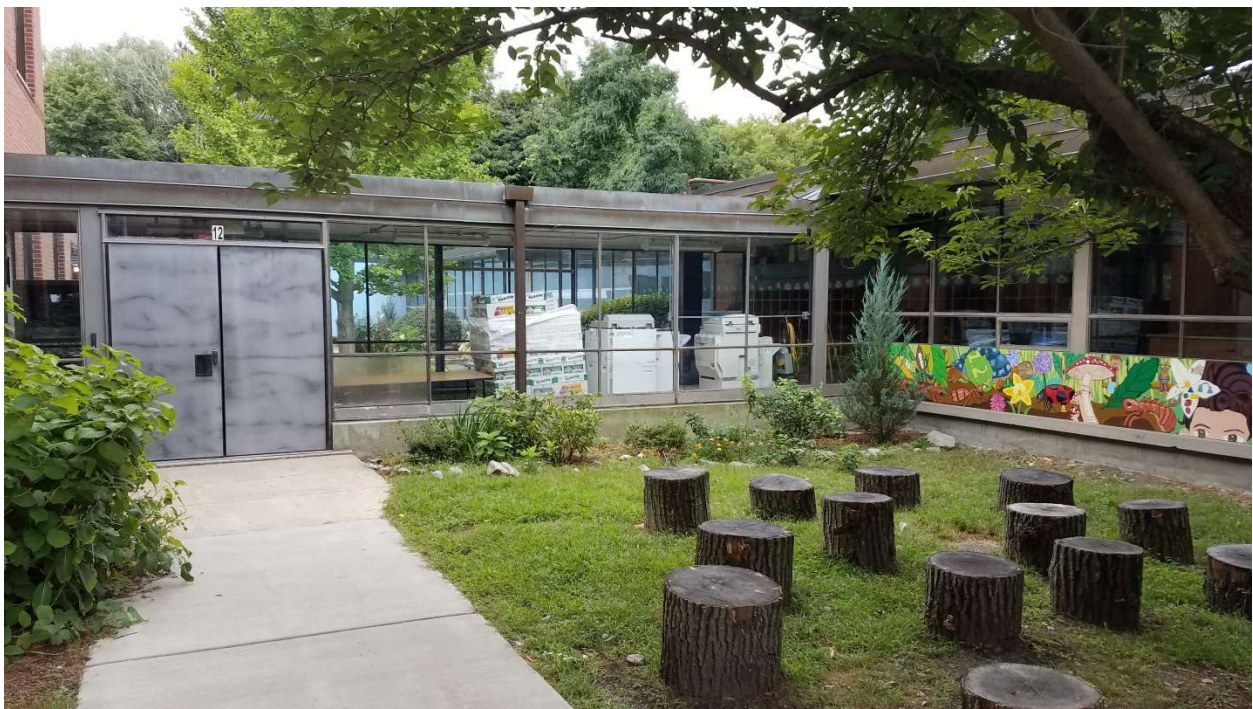
This is the inaccessible connector to the annexes. This picture also shows that the school has no copy room, so one has been created in the hallway. This is not allowed. Furthermore, a pallet of paper has been stored there, as there was nowhere else to put it. This not only blocks the fire egress, it puts a large amount of combustibles in the agree path of 200 plus students.

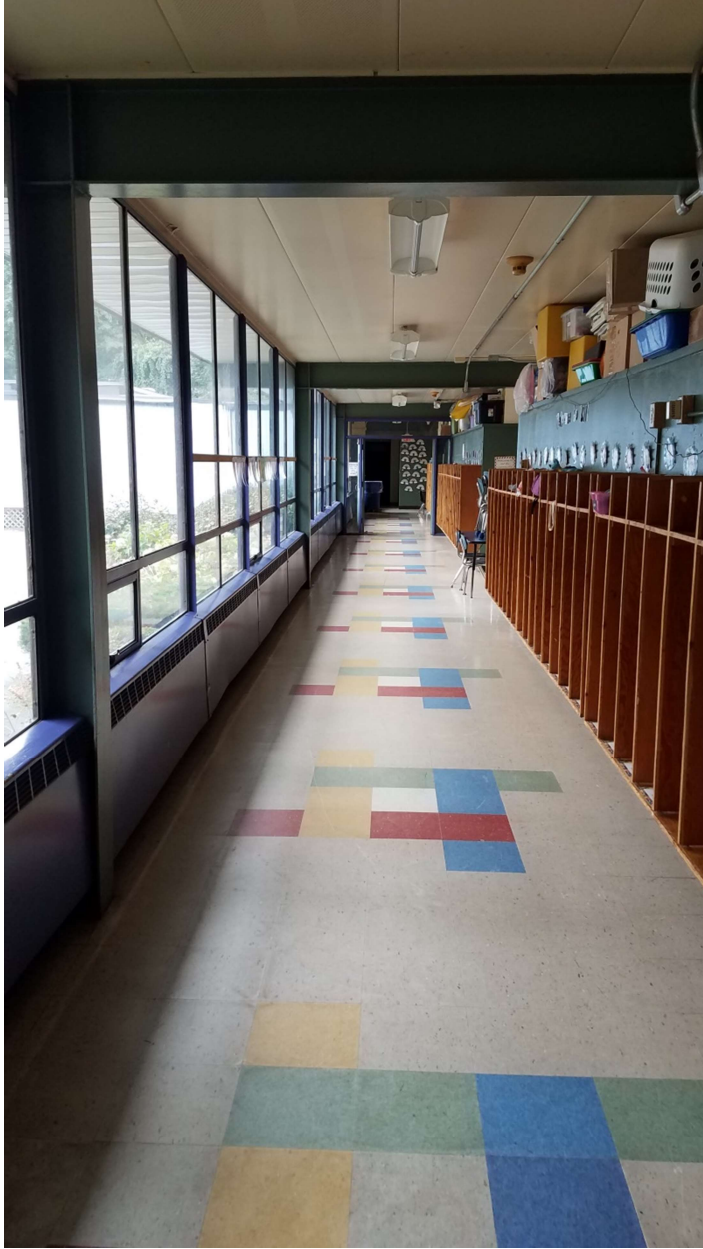
There are single pane windows on the left, cubbies on the right, and only one bathroom with one toilet, for 12 classrooms, 250+ students, and 26 staff. The Annexes and Modular Classrooms make up half of the Countryside School, yet they have essentially no support spaces like bathrooms, offices, small group instruction areas, special education rooms, storage areas, or staff rooms.
