IDDE INVESTIGATION:

- **CHEESECAKE BROOK**
- **CRYSTAL LAKE**
- **EDMANDS BROOK**

TO: Ted Jerdee and Maria Rose, City of Newton Department of Public Works, Utilities Division
CC: Carol Harris and Stephanie Kaiser – Woodard & Curran
Garrett Bergey – SDE
FROM: Zach Henderson and Chelsea Durante
DATE: August 6, 2020
RE: Newton IDDE Investigation Update

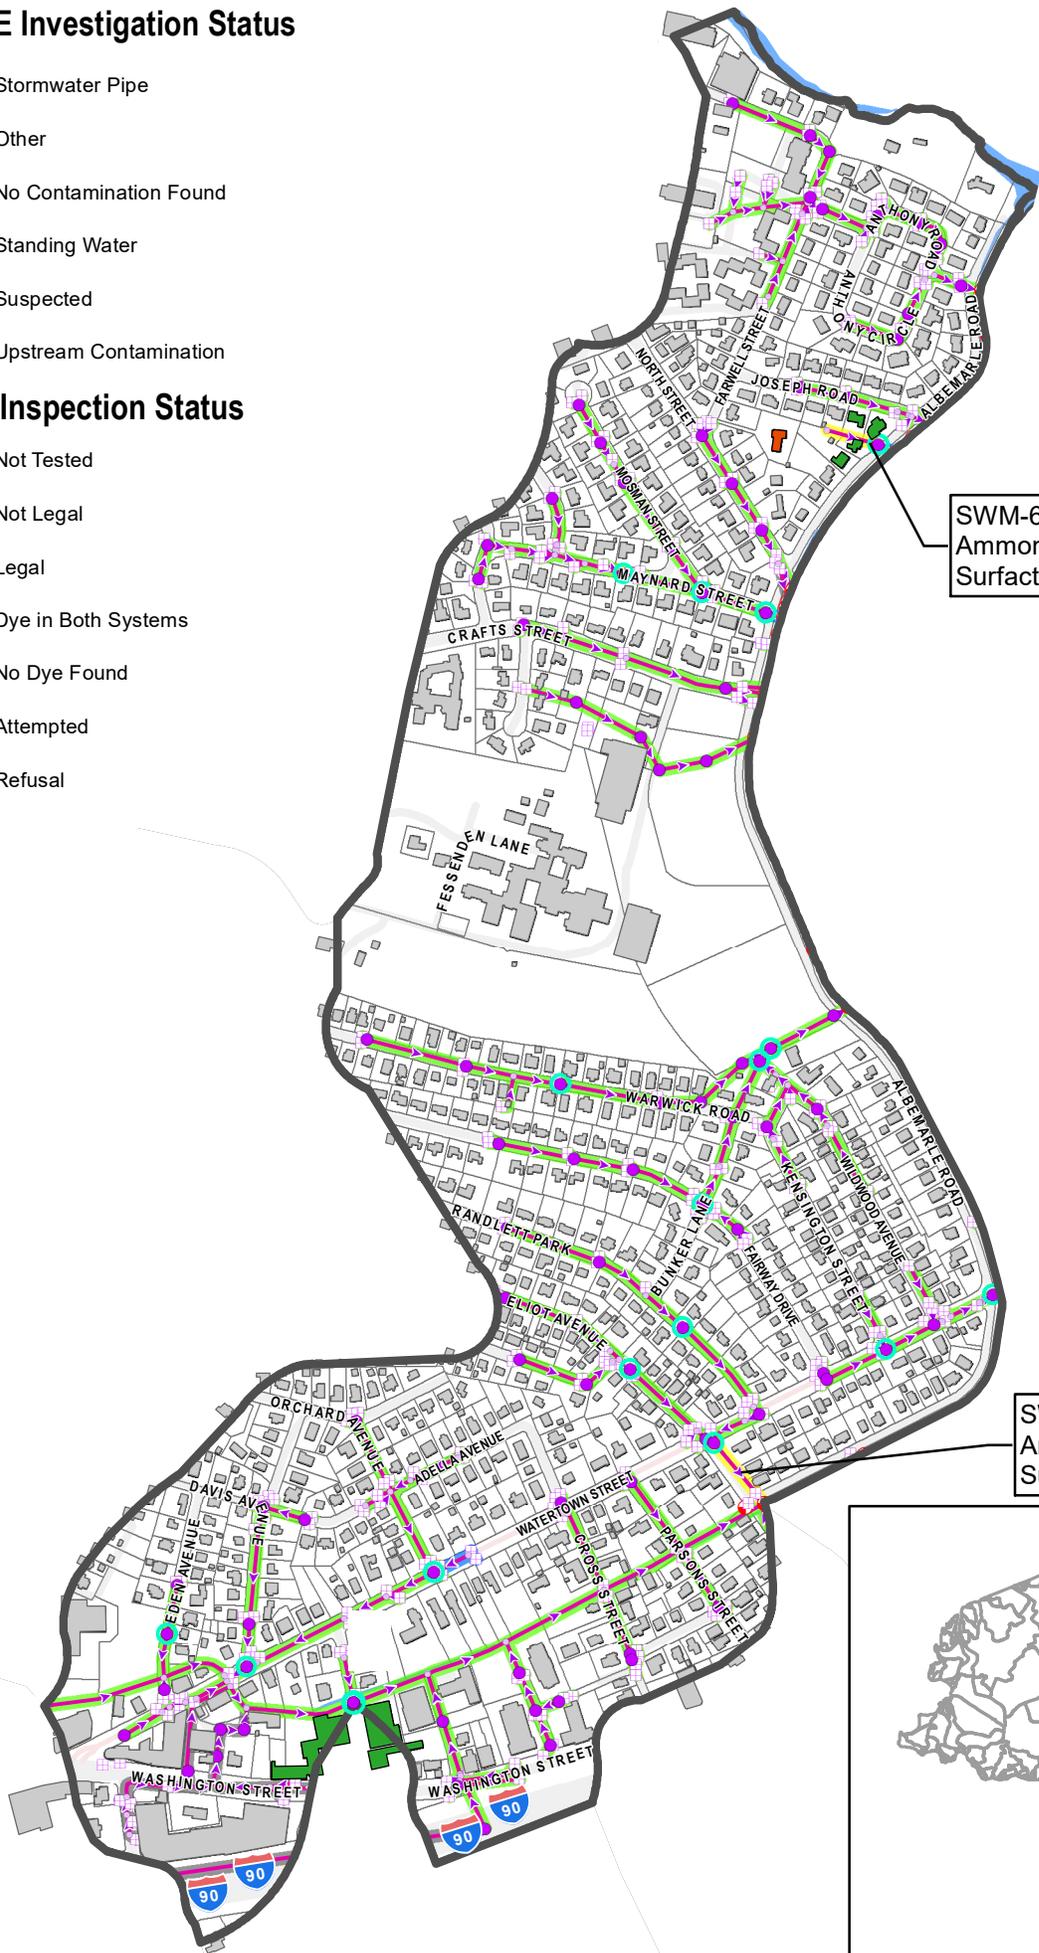
Cheesecake Brook
Sub-Catchment 68-0

This field season, Closed Circuit Television Inspection (CCTV) on stormwater pipe SWM-624 was completed. Inspection observations showed that the pipe was not mapped accurately in the City's GIS. The CCTV inspection showed this pipe is over 180 linear feet. The inspection was abandoned at 183 feet as the pipe was full of water. The upstream manhole was not discovered.

SWM-624
Ammonia: 2
Surfactant: 0

SWM-19806
Ammonia: 0.4
Surfactant: 0.25

Recommendations for further investigations are to identify the upstream structure associated with SWM-624 and conduct further building inspections on Joseph Road (24, 30, 36). Investigations should include inspection of building yards for structures that could potentially provide access to the pipeline.

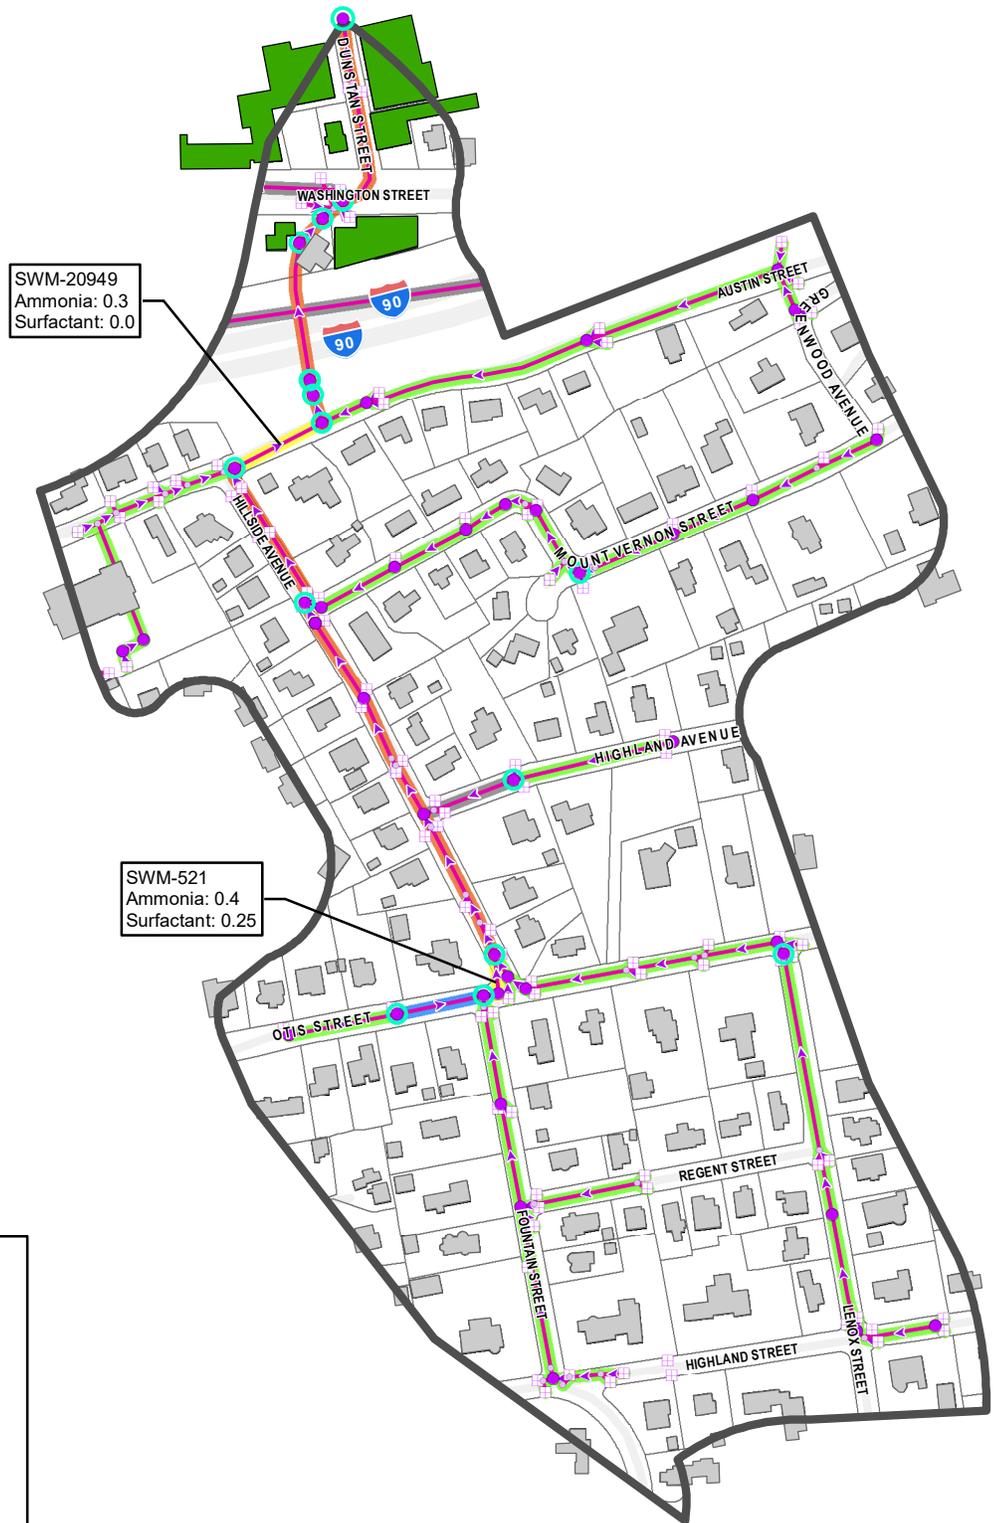
Cheesecake Brook
Sub-Catchment 68-2

This field season, CCTV inspection of both sanitary sewer and stormwater infrastructure was completed. CCTV inspection did not show evidence of sewage infiltration or illicit connections. SDE resampled and found low ammonia levels, about 0.4 mg/L and did not detect surfactants. The sample from 2018 had an ammonia level of 3.0 mg/L and surfactants was not detected.

SWM-20949
Ammonia: 0.3
Surfactant: 0.0

SWM-521
Ammonia: 0.4
Surfactant: 0.25

Since level of ammonia are relatively low, and visual evidence of illicit connections were not evident in CCTV inspections, Woodard & Curran recommends focusing efforts on higher priorities.

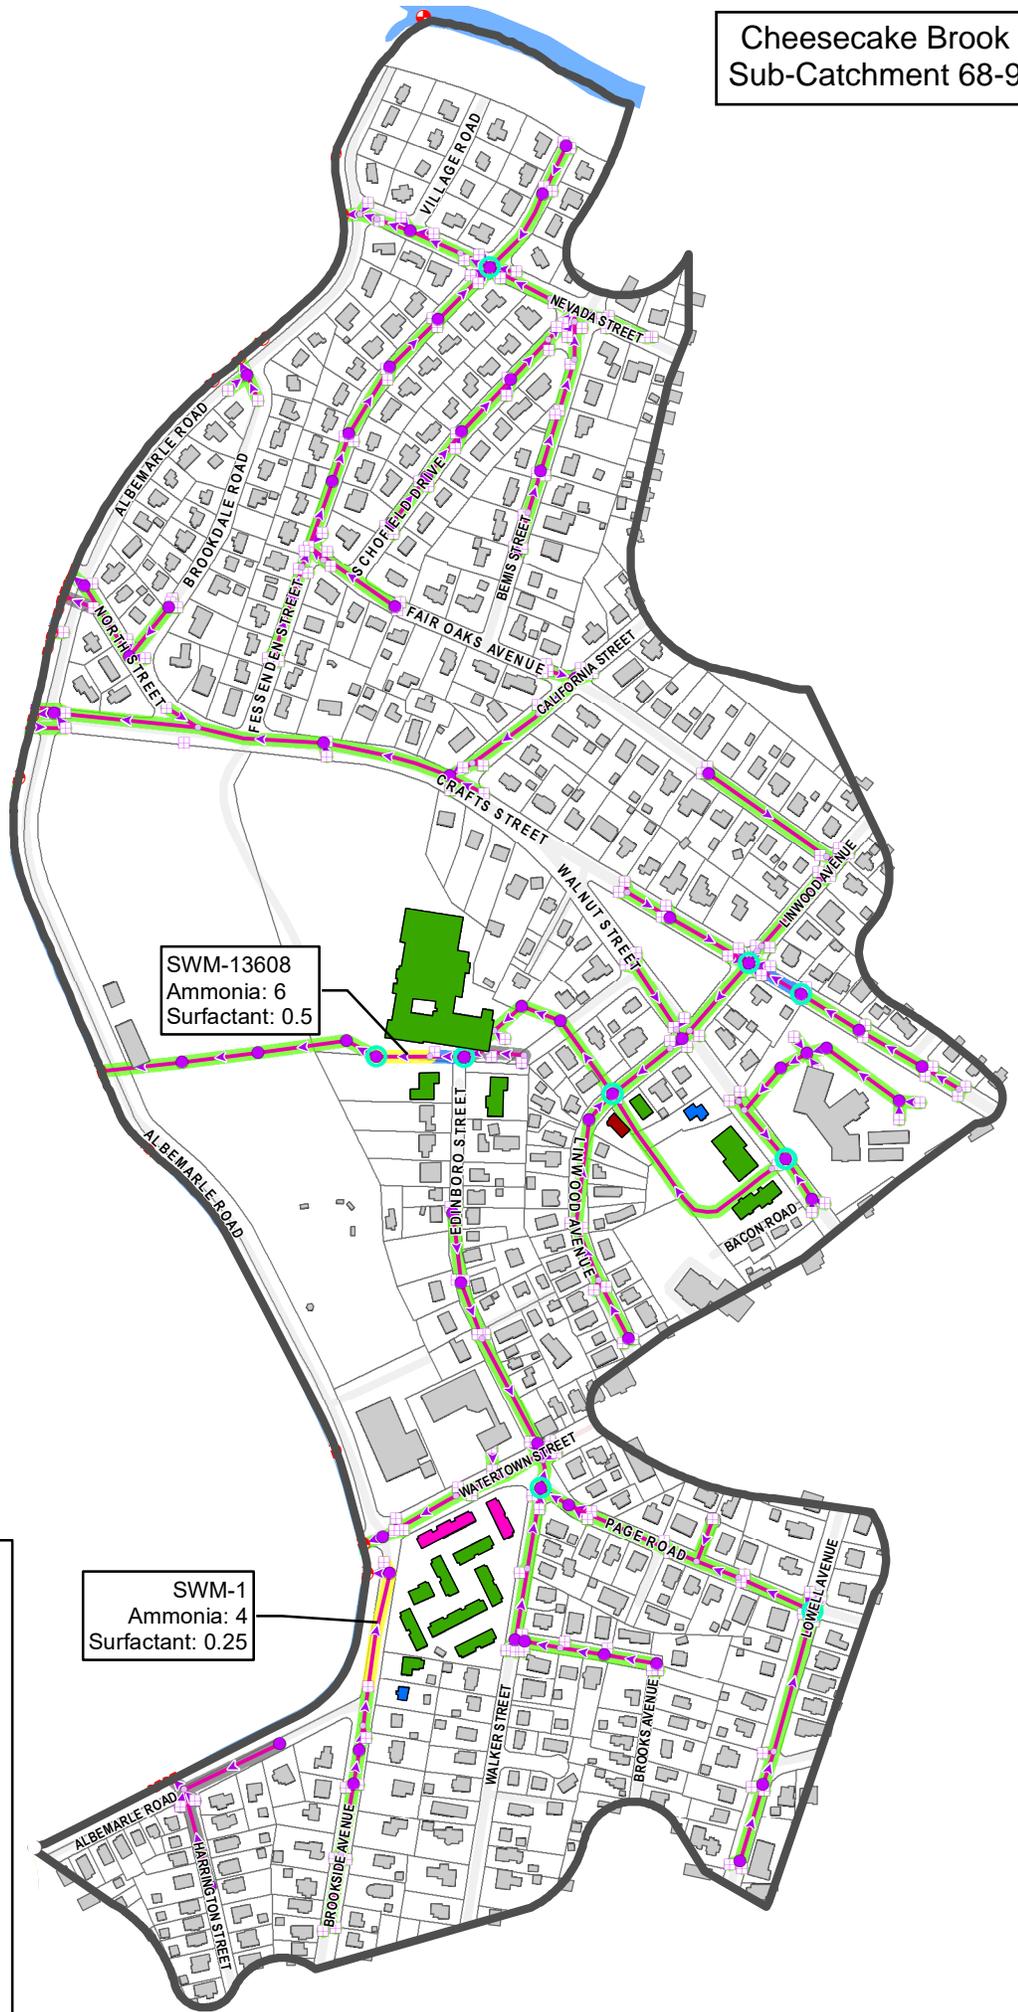
In 2018, manhole sampling resulted in suspected contamination near 21 Minot Place. The suspect pipe is located adjacent to Day Middle School which tested legal during its' 2019 building inspection. CCTV inspection of the storm drain was completed in Spring 2020. CCTV of storm drain showed Infiltration staining at joints throughout pipe. Inspection of the sewer could not be completed due to the adjacent surcharged sewer nearby. Further inspection of sewer can be attempted after the surcharge issue has been resolved.

The source of the contamination on Brookside Avenue is due to an indirect connection at the Newton Housing Authority property. In 2019, dye test inspection showed a defect in the private sewer infrastructure at the Newton Housing Authority. It was not clear whether the sewage is exfiltrating from the private manhole or the piping itself.

CCTV inspection of the outlet pipe was completed in 2020. The inspection was abandoned before reaching the upstream manhole where the defect is located due to an intruding lateral. We recommend the inspection of that pipe be completed, either using a push camera from the upstream manhole or by cutting the intruding lateral in order to complete the CCTV of the pipe segment. It is noted that the intruding lateral was observed to be AC pipe.

SWM-13608
Ammonia: 6
Surfactant: 0.5

SWM-1
Ammonia: 4
Surfactant: 0.25

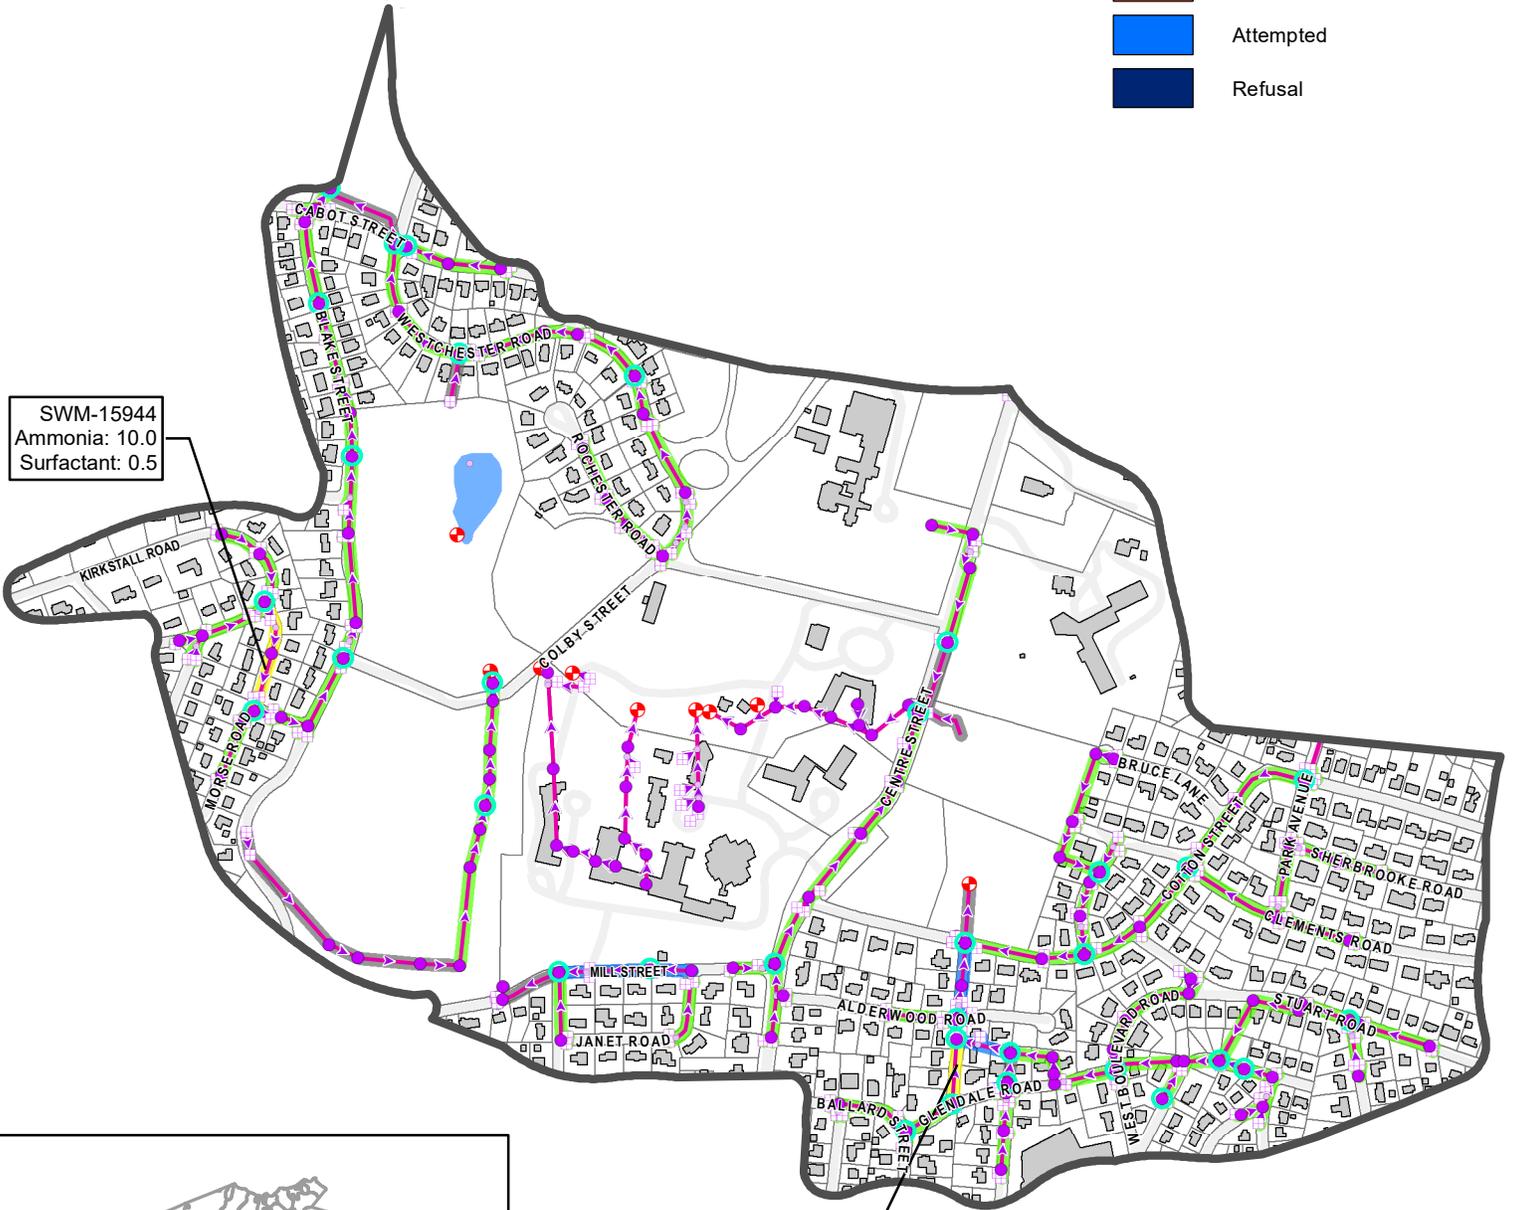
**Edmunds Brook
Sub-Catchment 77-4**

SWM-15944
Ammonia: 10.0
Surfactant: 0.5

SWM-19899
Ammonia: 0.6
Surfactant: 0.25

Based on the pipe results presented in Table 6, building inspections are recommended as a next step. Buildings recommended for inspection and dye test are presented in Table 7, below. The buildings are prioritized based on illicit potential and ease of inspection. High priority buildings are labeled with an asterisk.

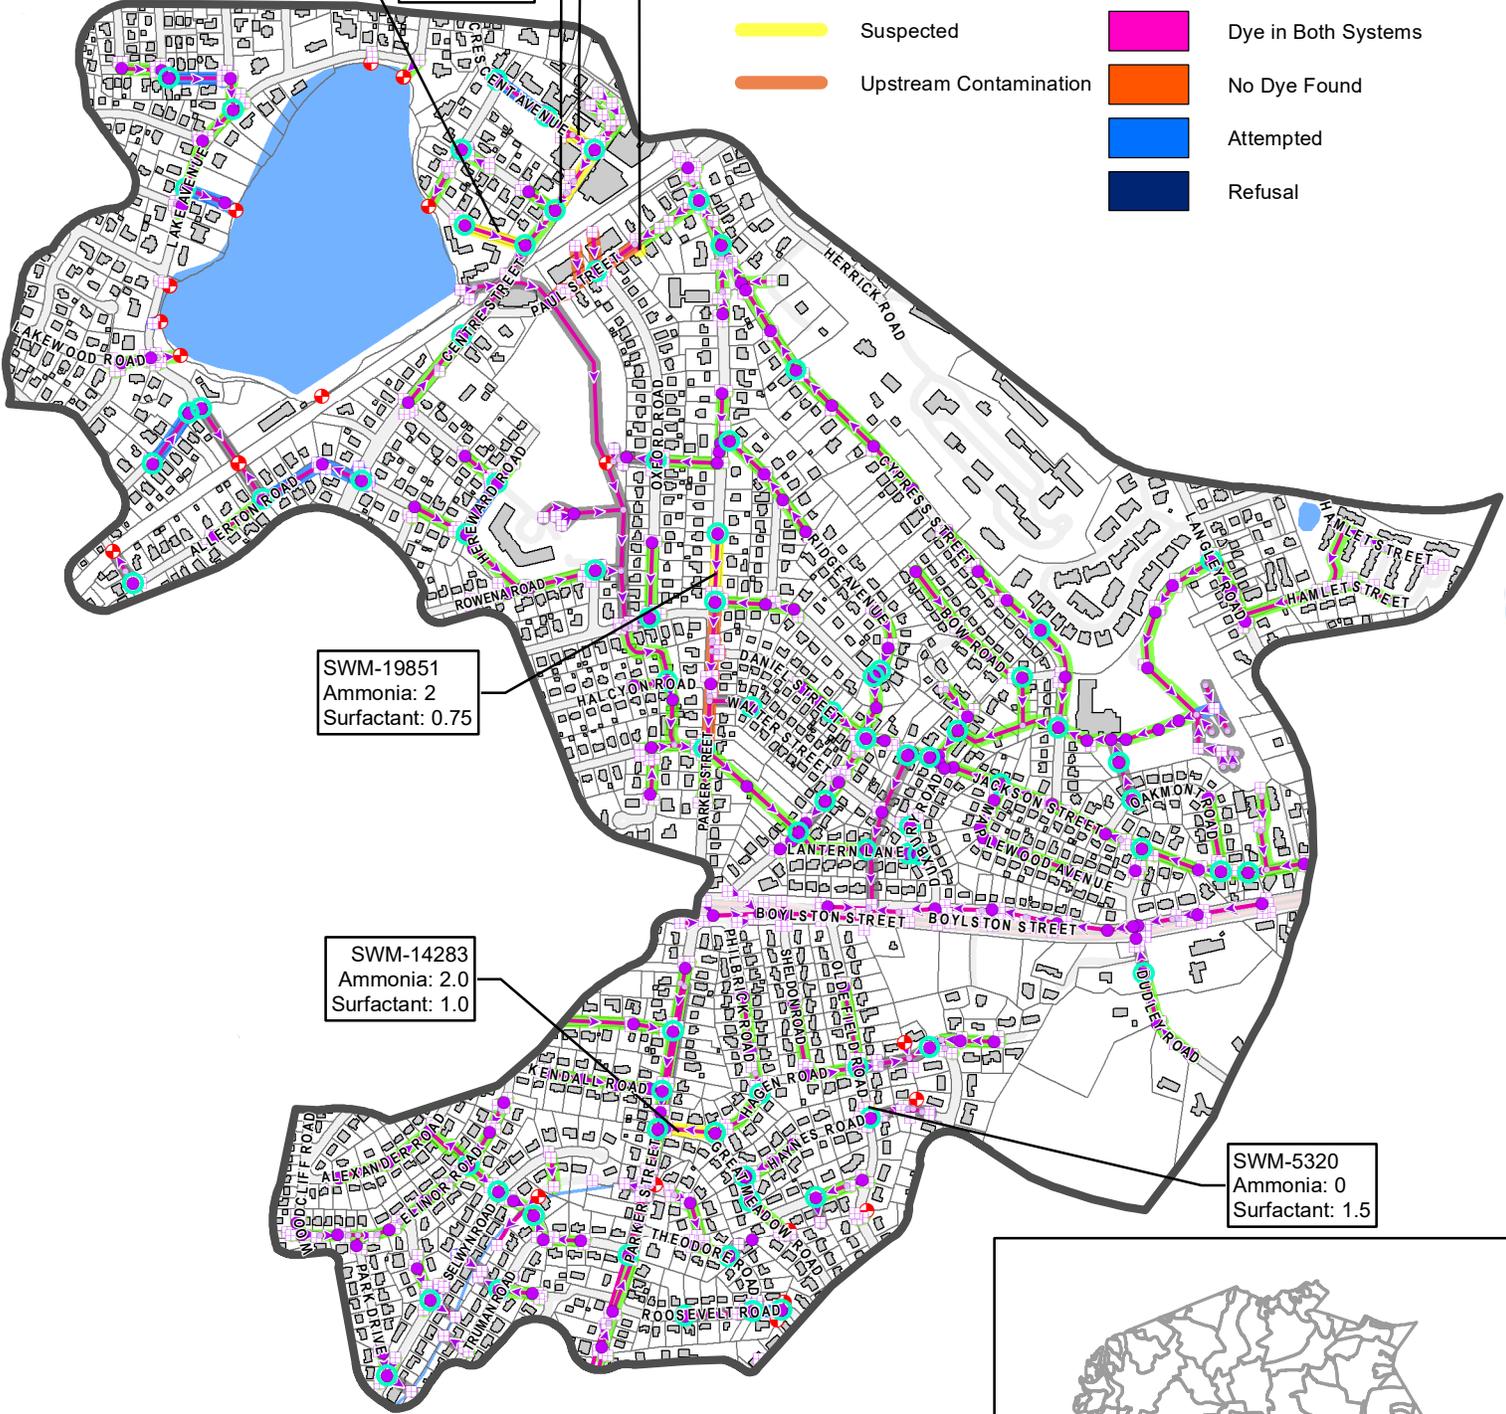
**Crystal Lake
Sub-Catchment 11-5**

SWM-22447
Ammonia: 10
Surfactant: 3.0

Based on the pipe results presented in Table 3, building inspections are recommended as a next step. Buildings recommended for inspection and dye test are presented in Table 4, below. The buildings are prioritized based on illicit potential and ease of inspection. High priority buildings are labeled with an asterisk.
