# IDDE INVESTIGATION:

## • LAUNDRY BROOK

DATE: May 14, 2021

RE: Newton IDDE Investigation Update

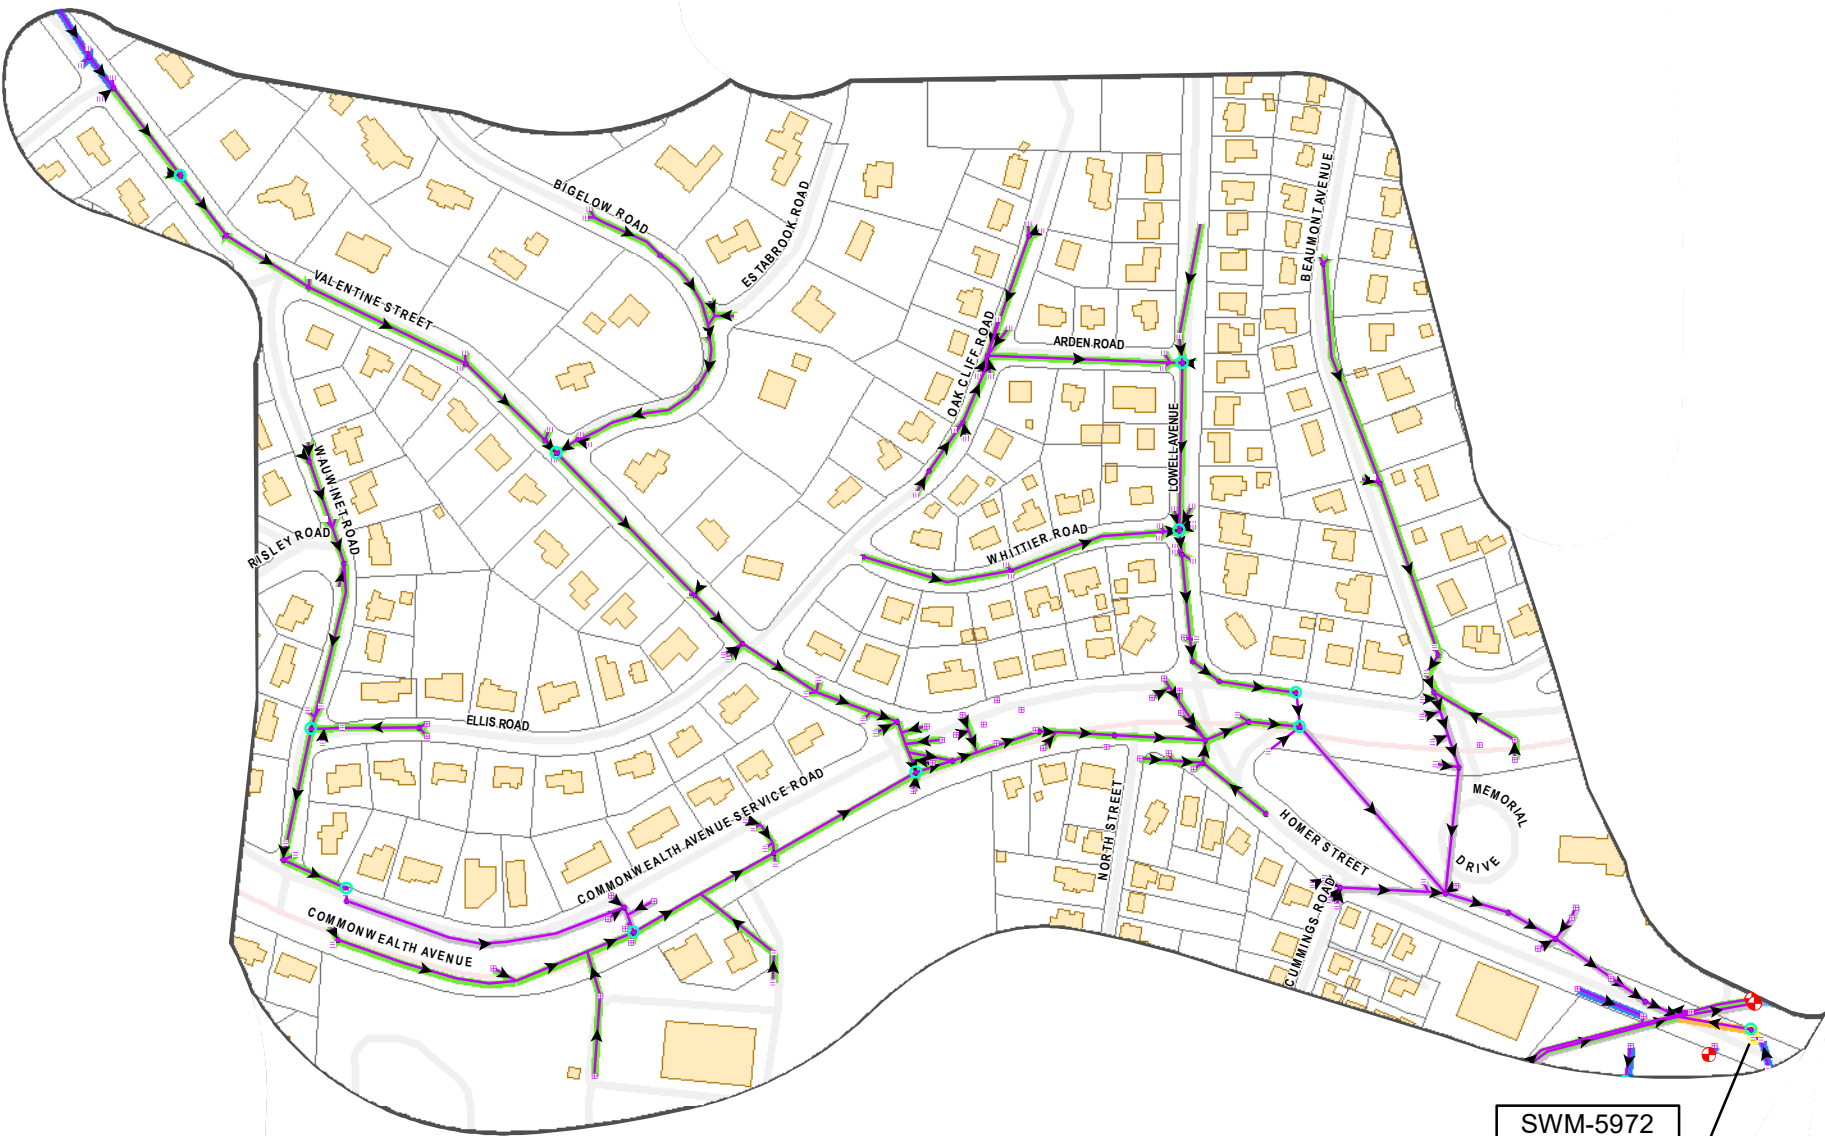
Sub-Catchment 77-6

- Sub-catchment 77-5: SDE could not find access to some storm drains on Langdon Street and Laudholm Road.
- Sub-catchment 77-6: SDE could not find access to much of the drainage on Homer Street as well as the drainage mapped at City Hall.

SWM-5972  
Ammonia: 0.4  
Surfactants:0.5

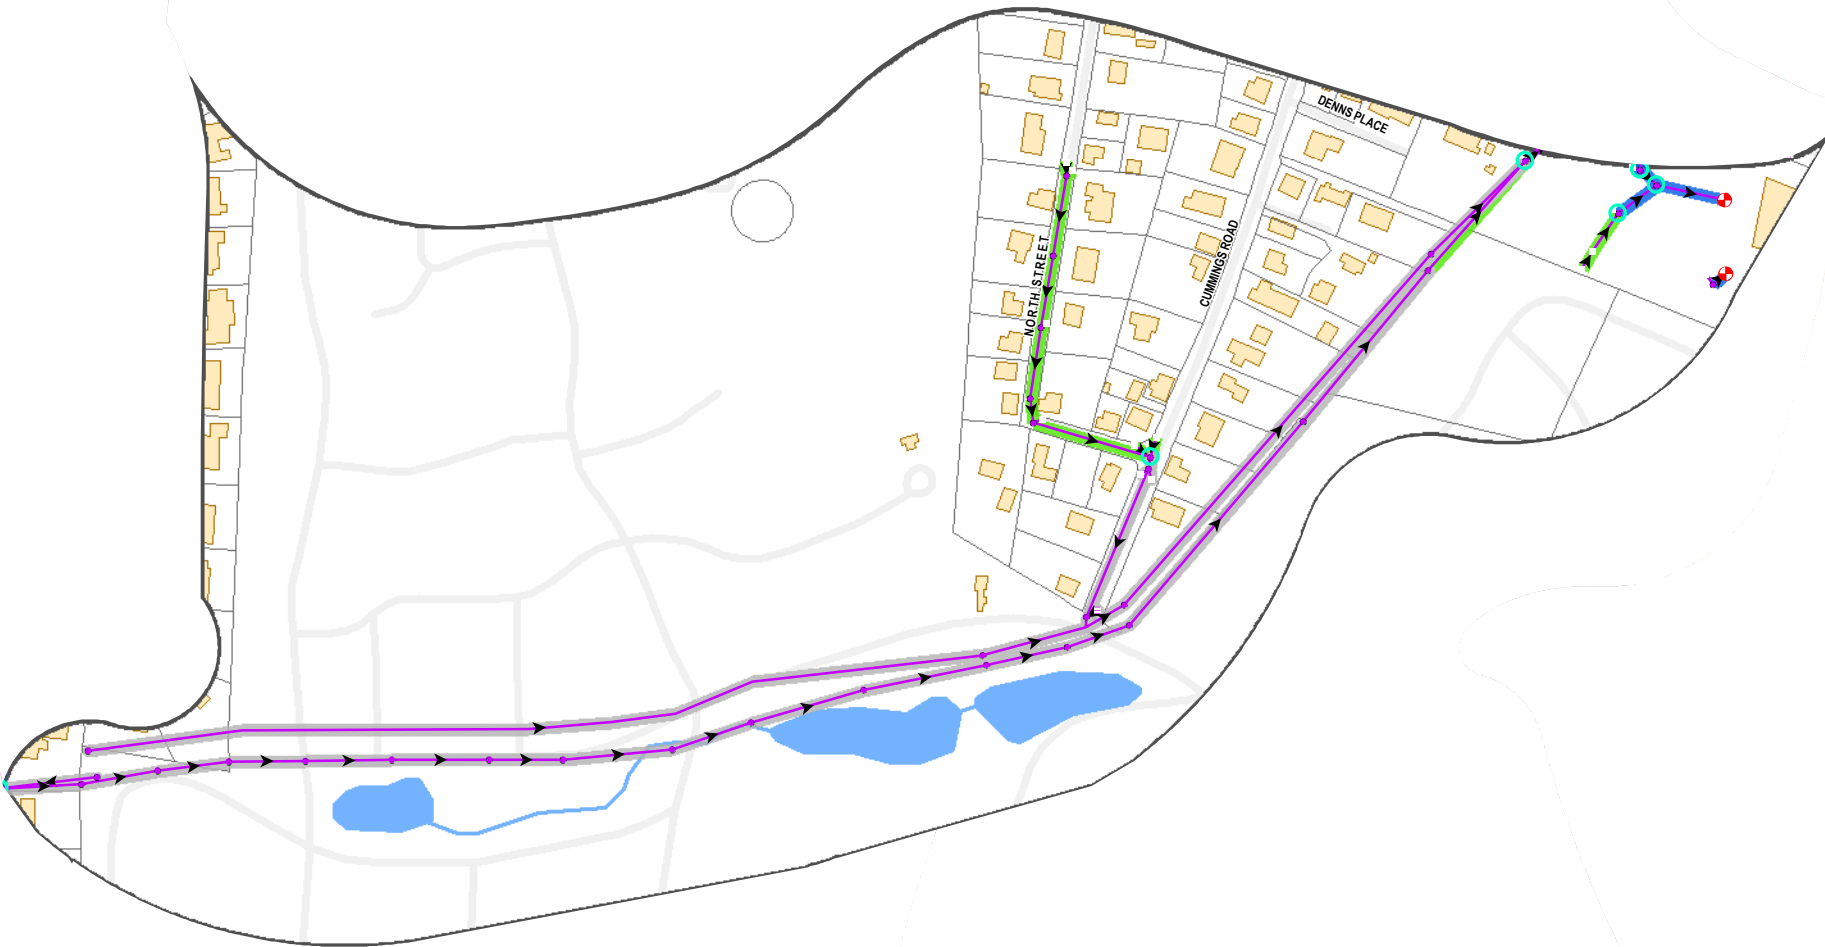
Sub-catchment 77-7

- Sub-catchment 77-7: 80% of the storm drain pipes in this sub-catchment are located in Newton Cemetery & Arboretum. Based on the City's GIS, there are parallel storm drains that run through this area. However, the City's record drawings show one drain and one sewer pipe. The drain is documented as a 4-foot by 5-foot box culvert. SDE could not locate access points to this pipe.

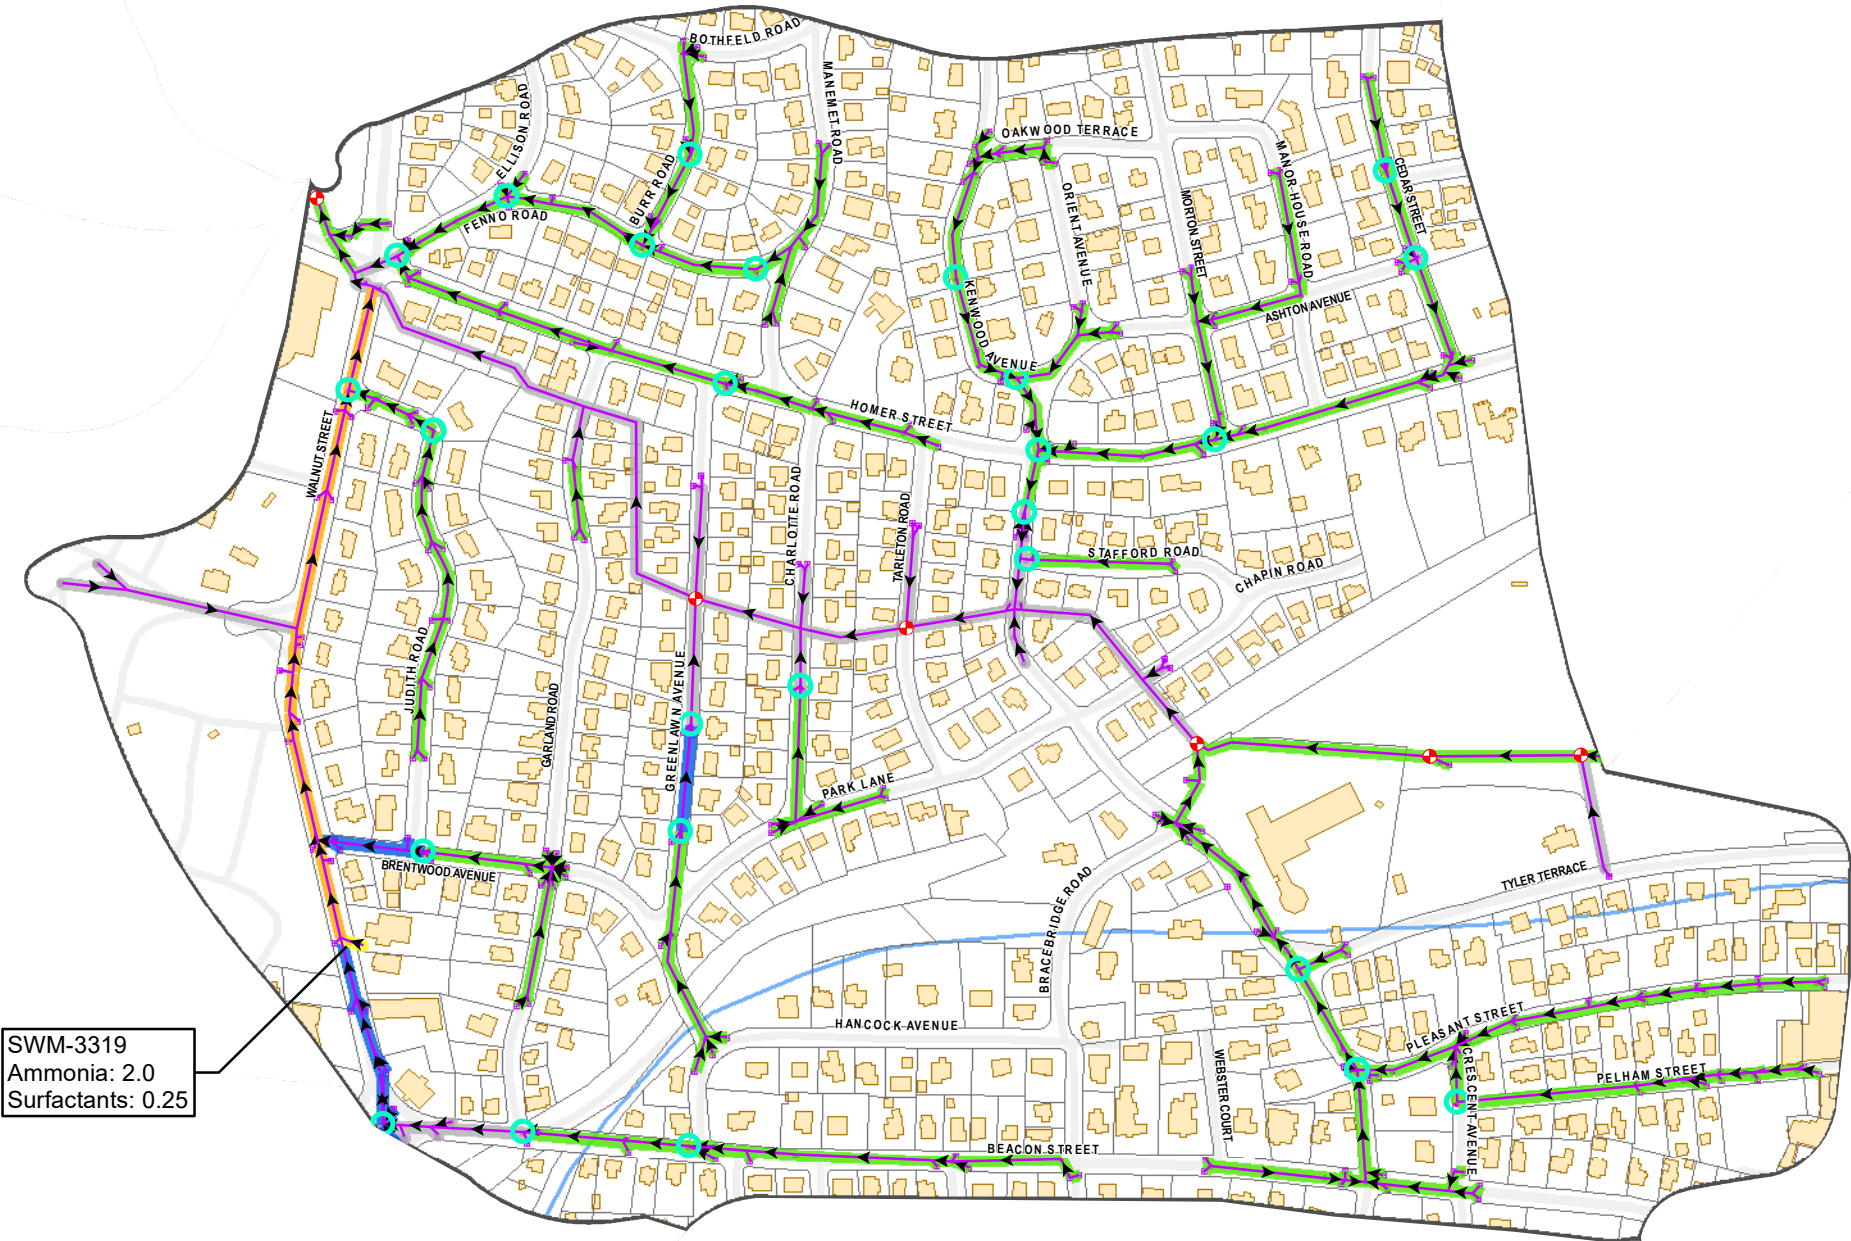
Sub-catchment 77-9

- Sub-catchment 77-9: The 5-foot by 10-foot Hammond Brook culvert runs cross-country from the Mason Rice Elementary School to Walnut Street. SDE could not locate access points to this pipe.

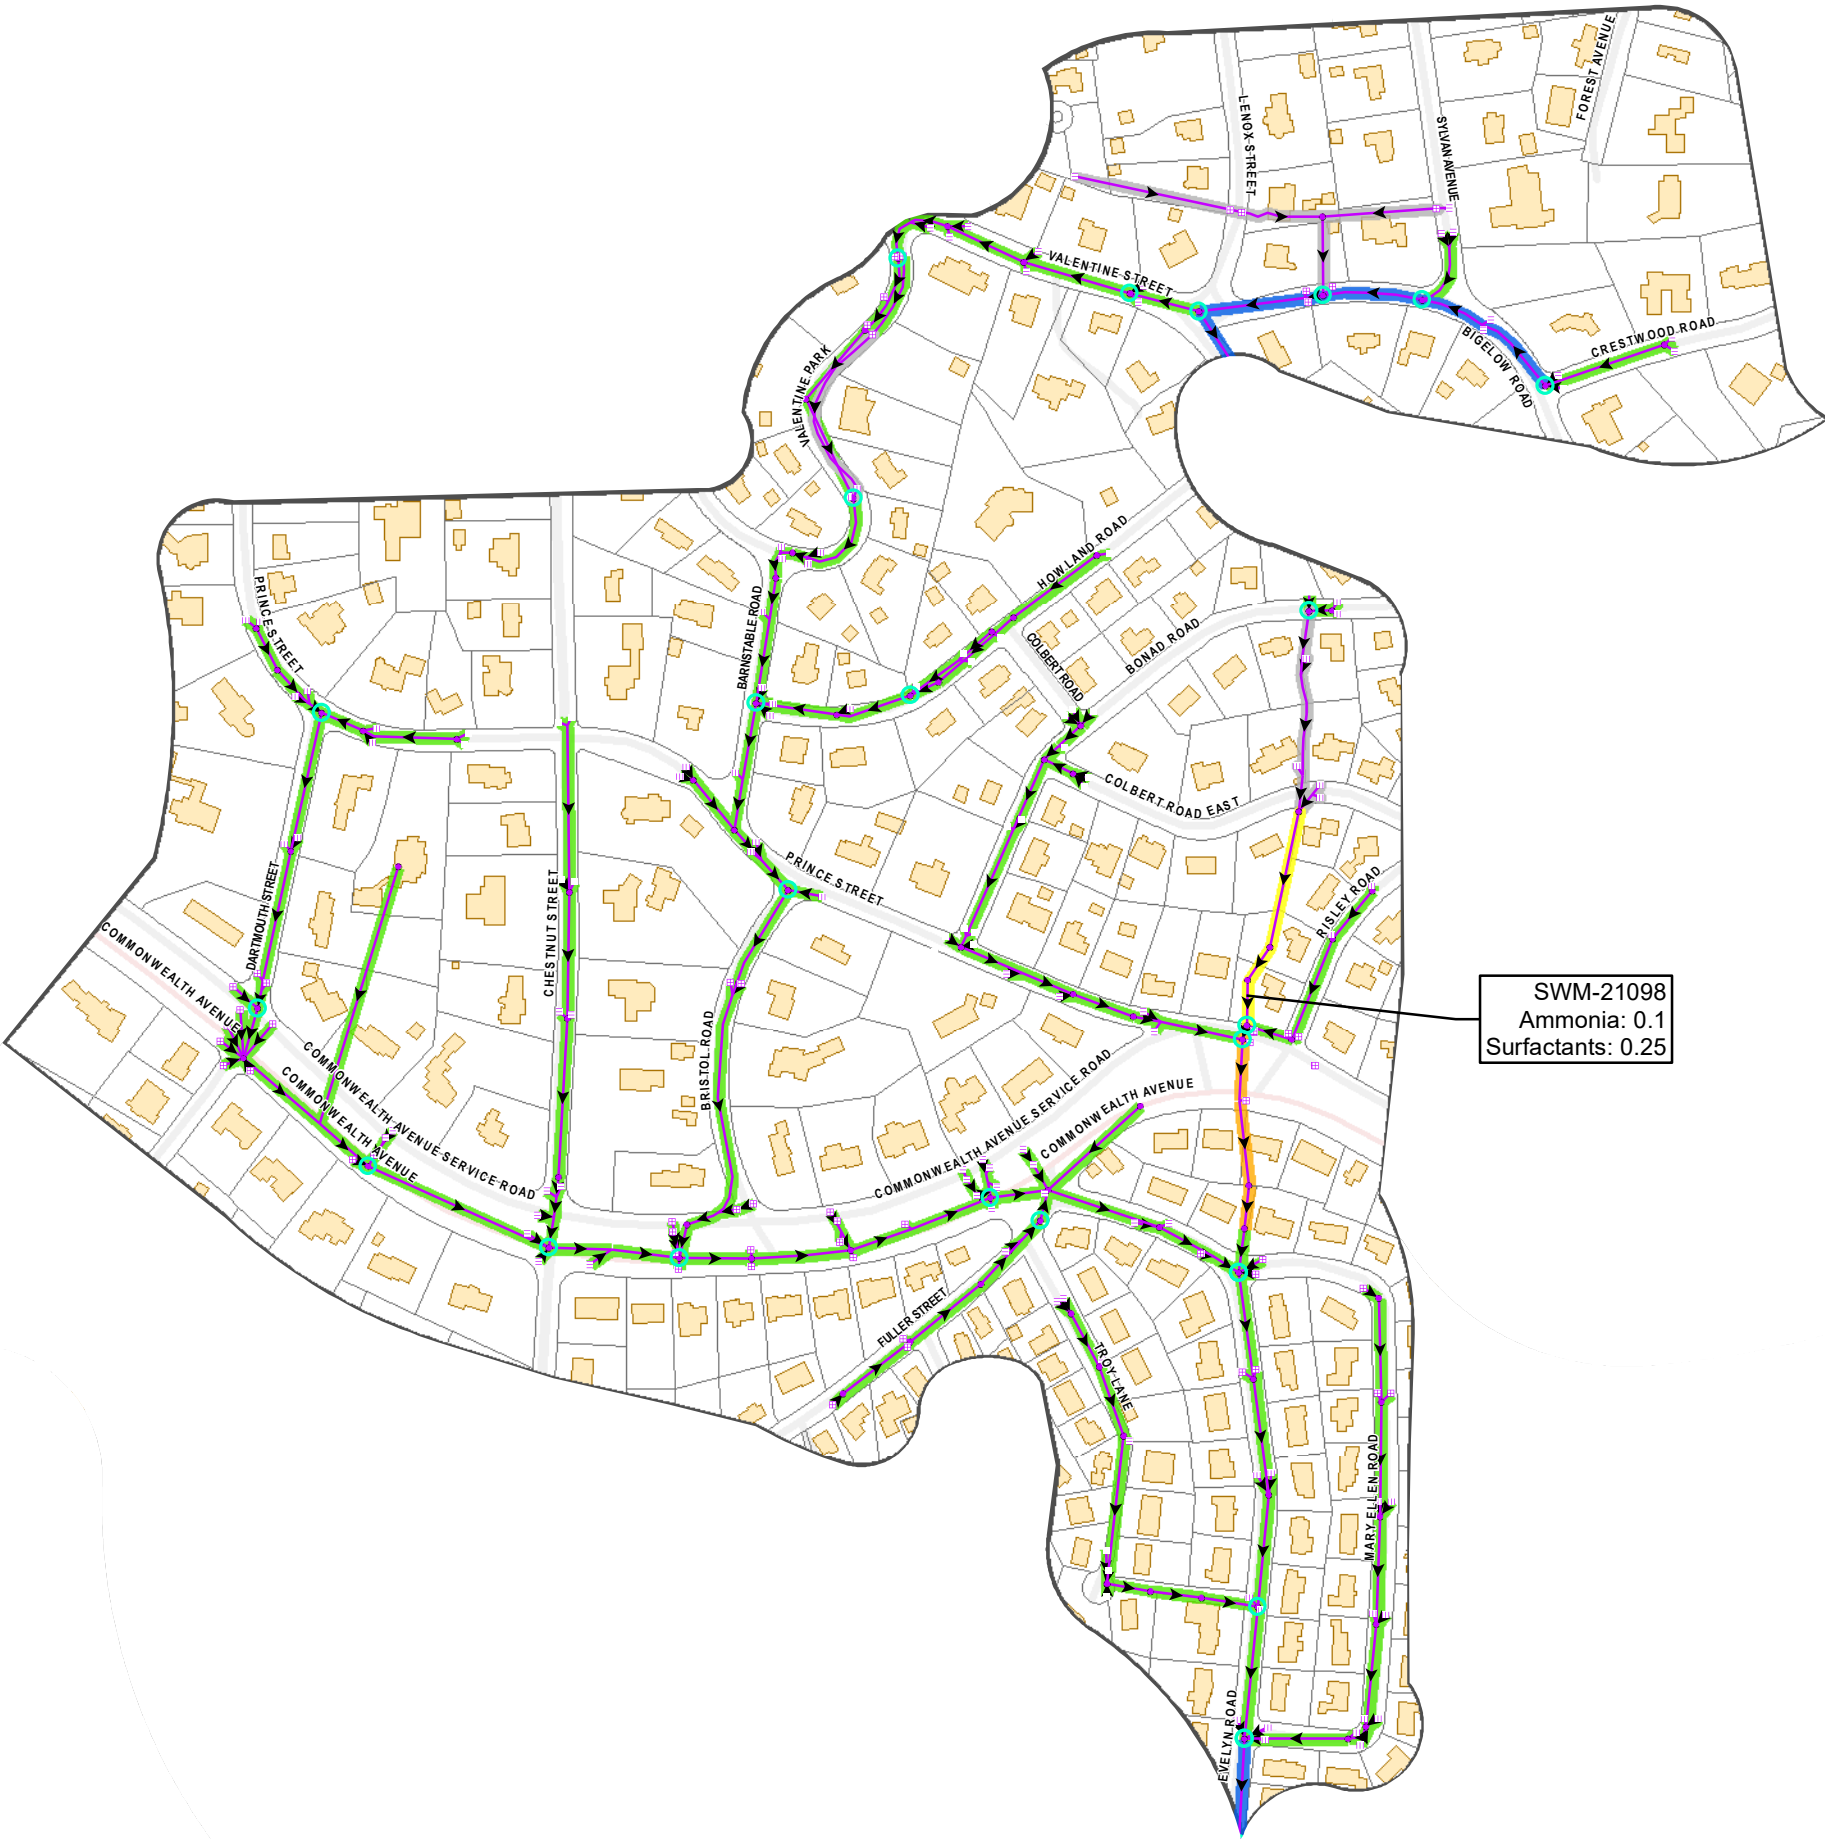
Sub-catchment 77-10

SWM-21098  
Ammonia: 0.1  
Surfactants: 0.25

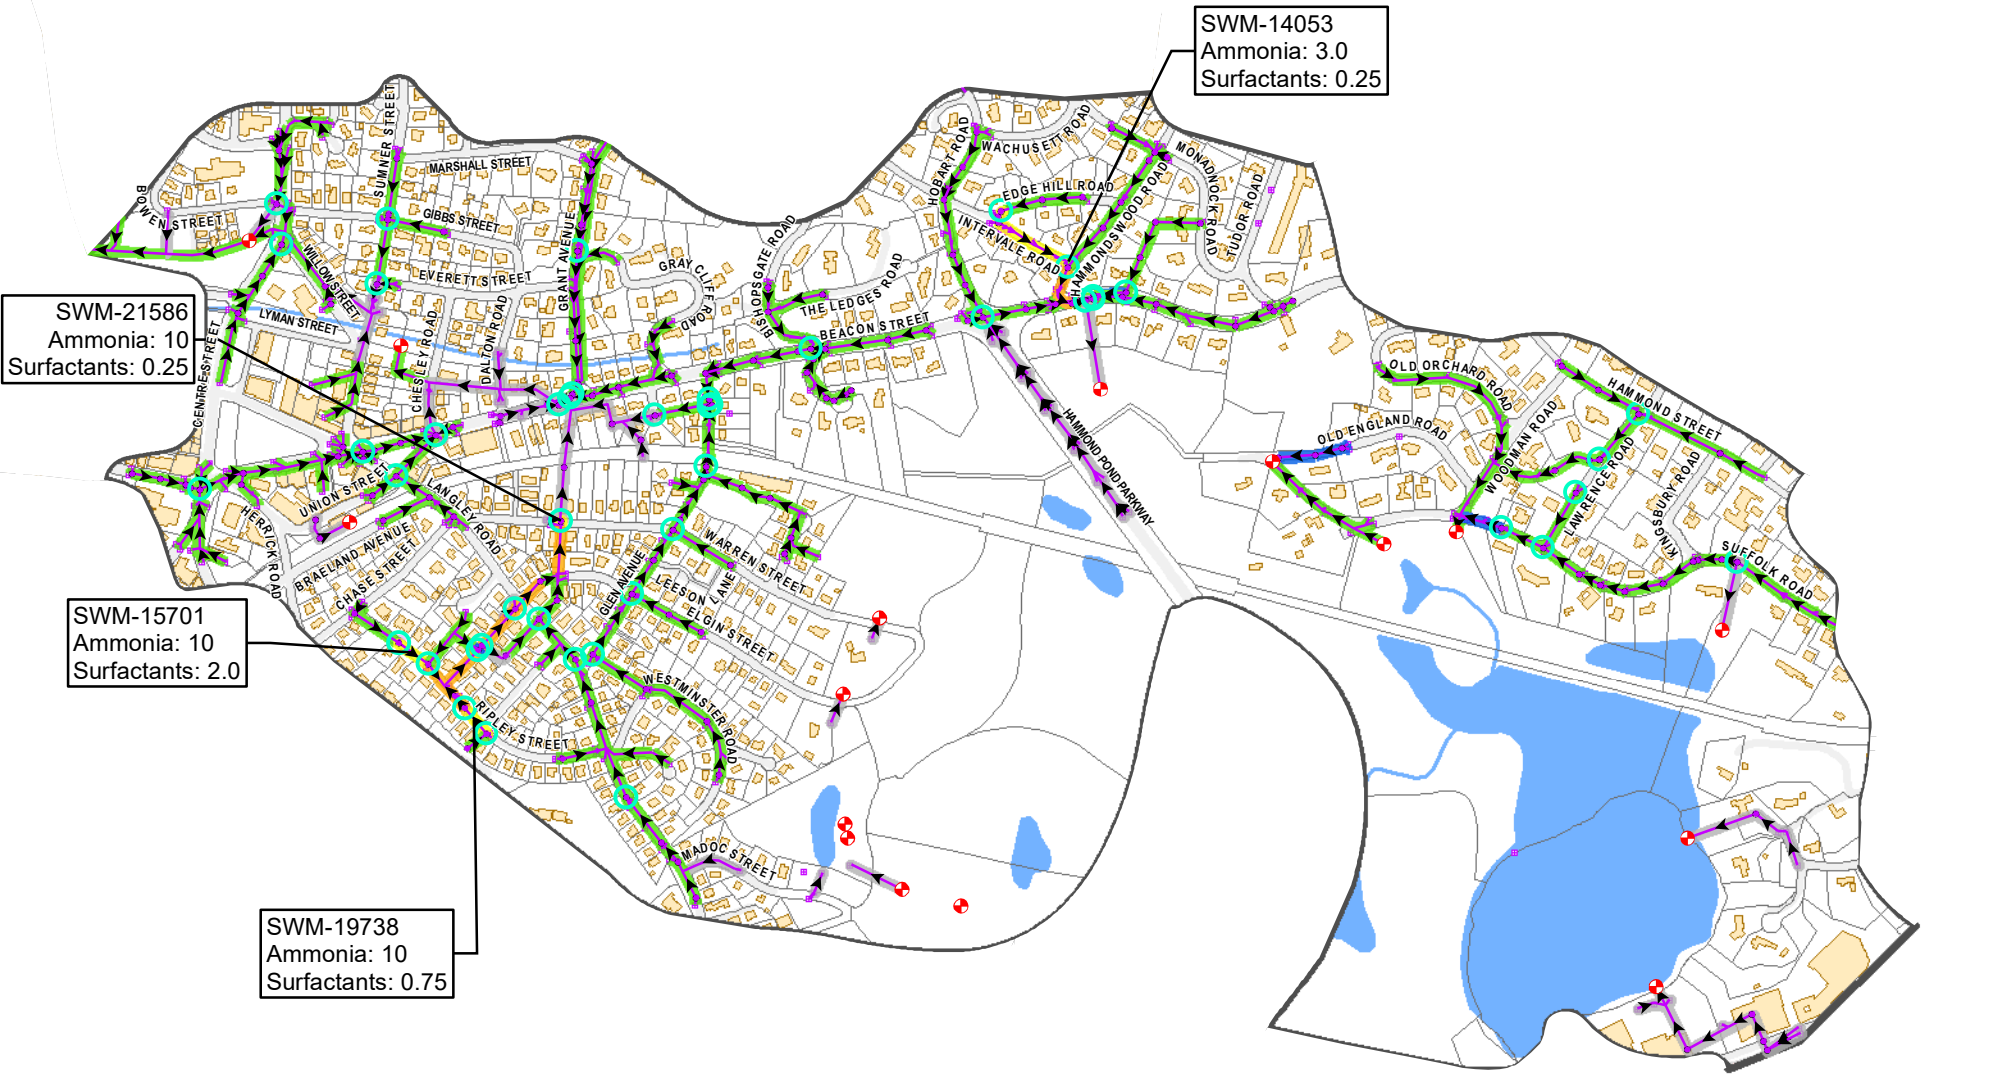
Sub-catchment 77-13

77-11	SWM-837	Cross Country off Beacon Street	0	0.5	
77-11	SWM-14614	Beethoven Avenue	0	0.5	
77-11	SWM-18569	Beethoven Avenue	0	0.25	
77-13	SWM-15701	Ripley Street	10	2	
77-13	SWM-19738	Ripley Street	10	0.75	Musty Odor
77-13	SWM-21586	Warren Street	10	0.25	
77-13	SWM-14053	Intersection of Intervale Road and Hammondswood Road	3	0.25	Sewage Odor

- Sub-catchment 77-12: SDE could not locate portions of the storm drain located on Commonwealth Avenue.
- Sub-catchment 77-13: SDE could not access various storm drain pipes throughout the sub-catchment. There are also potential mapping inaccuracies in this area. These mapping discrepancies are noted in the section below.

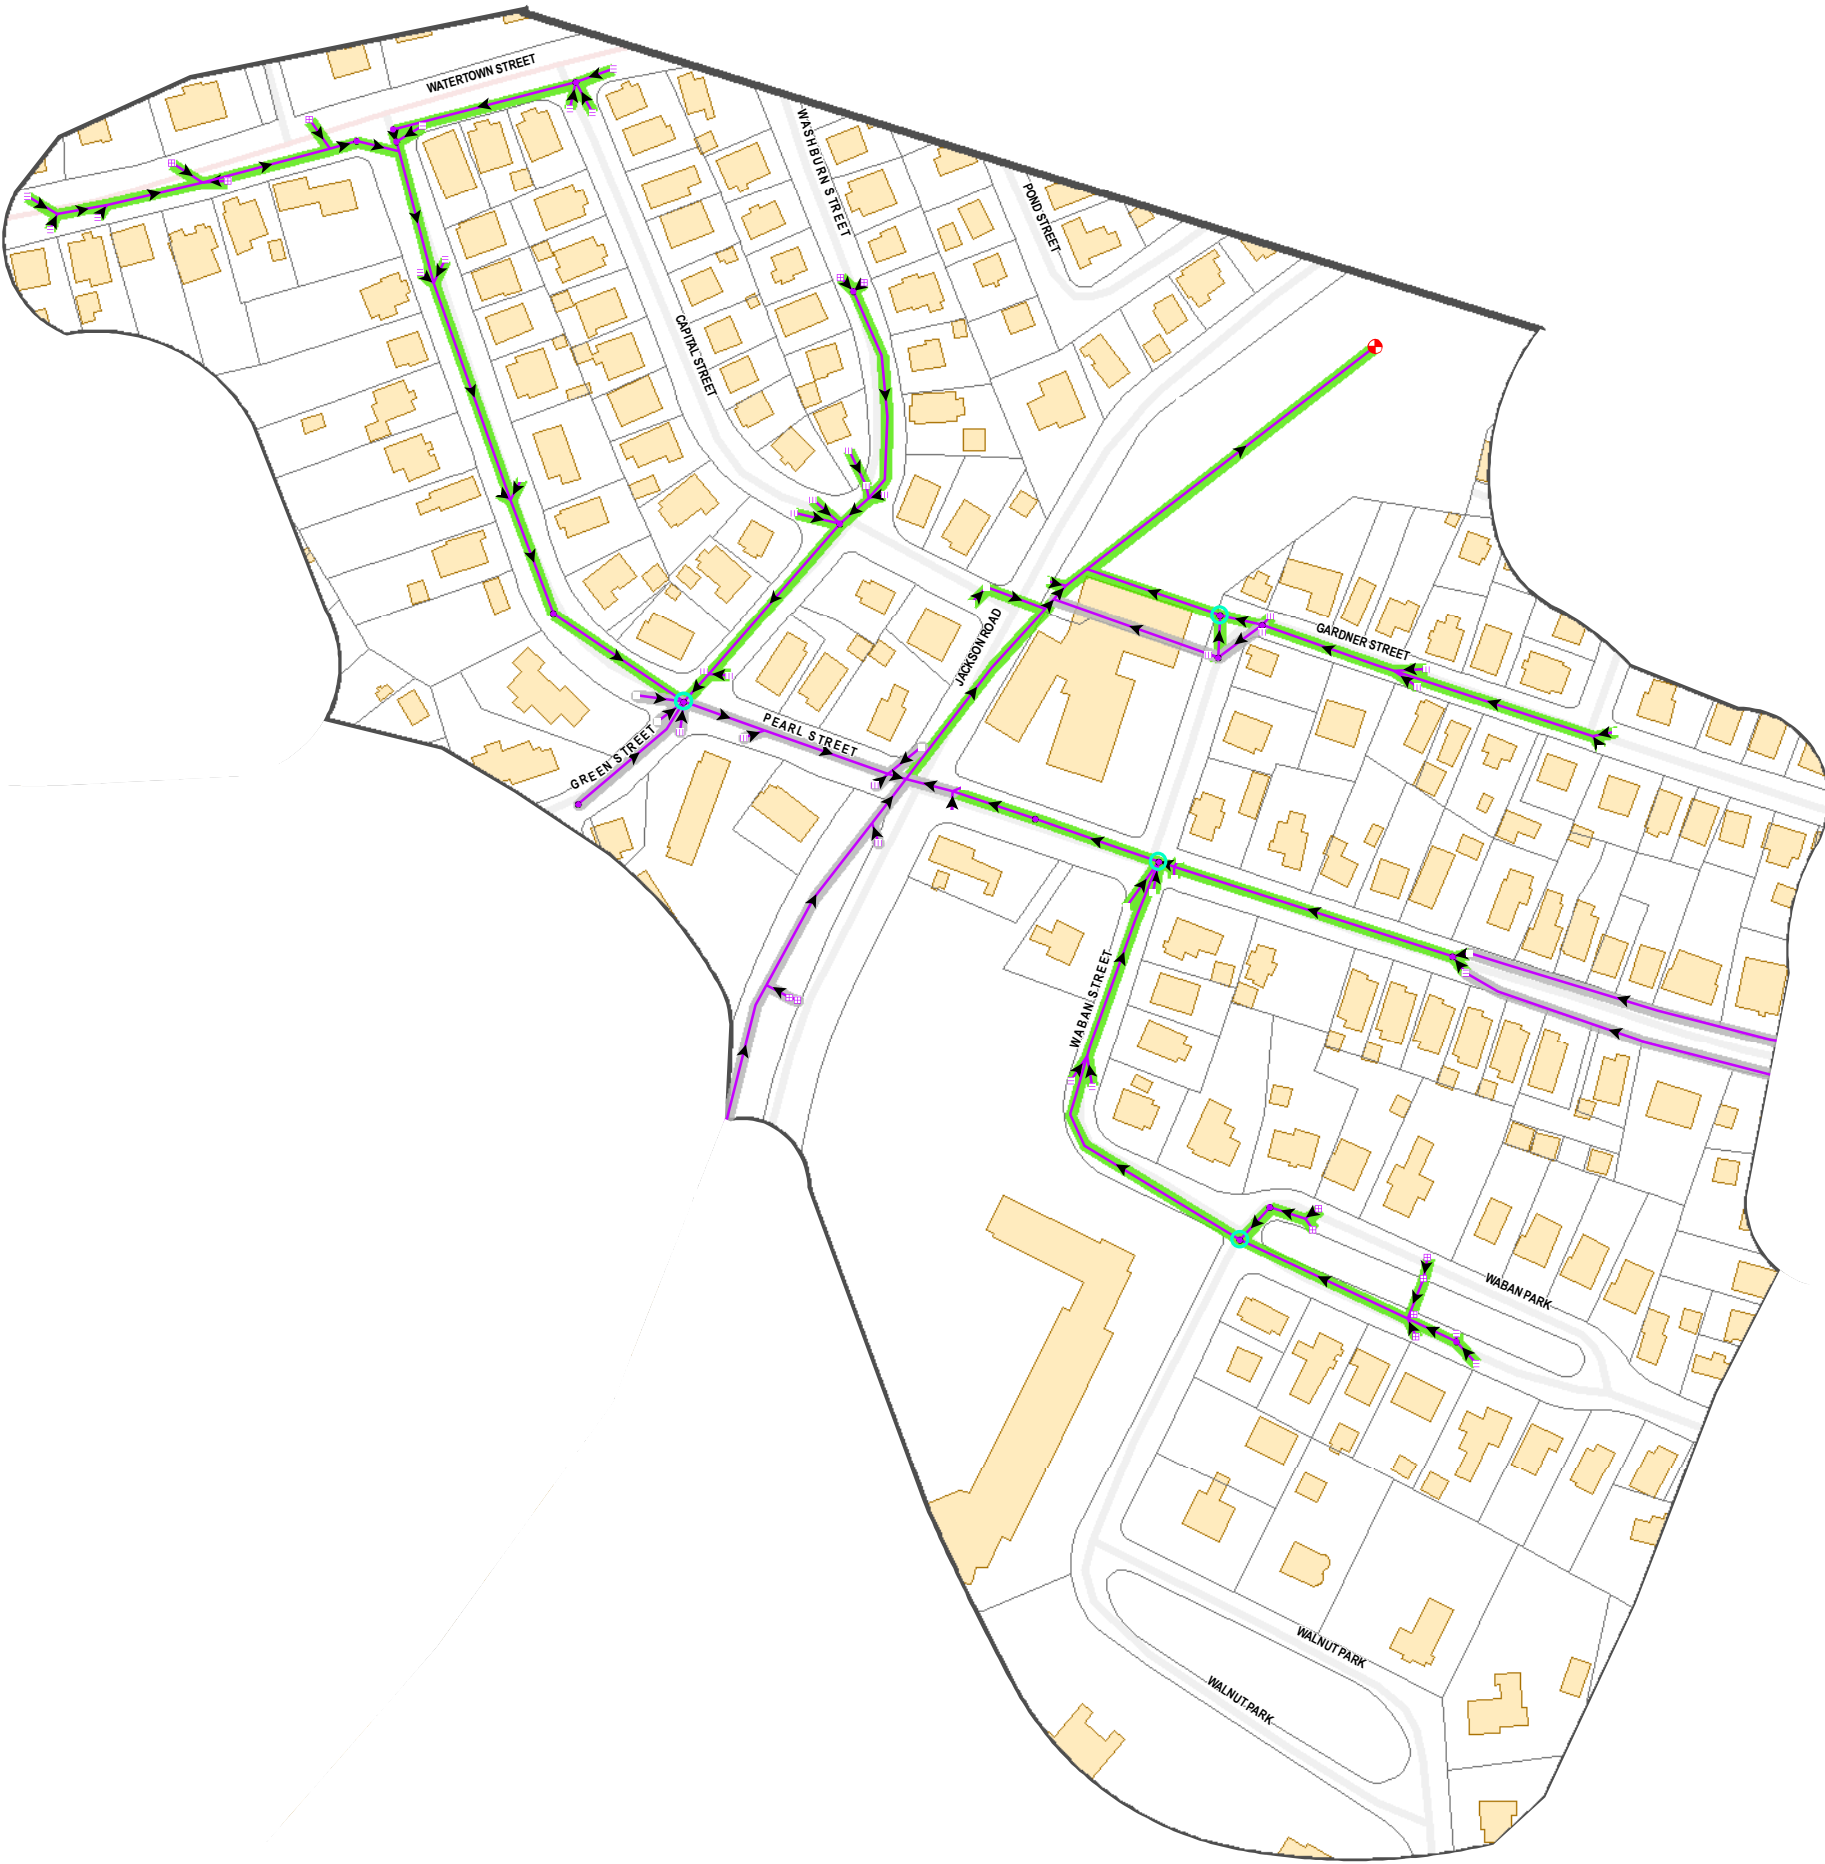
Sub-catchment 77-14

- Sub-catchment 77-14: SDE could not access various storm drains throughout the sub-catchment. There are also potential mapping inaccuracies in this area. These mapping discrepancies are noted in the section below.
