The Church of the Open Word

11 Highland Ave., Newton MA 02460

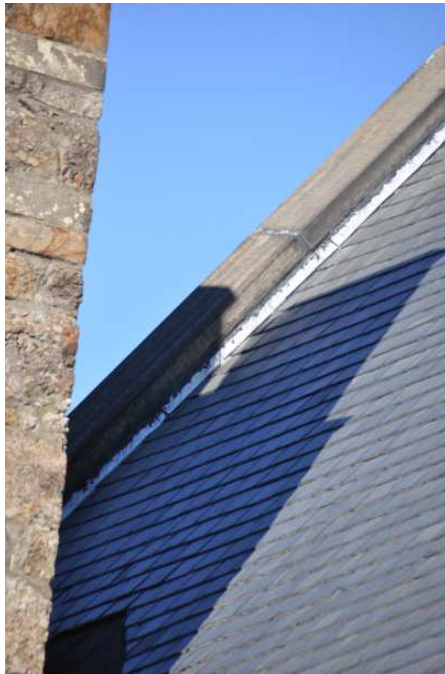
Photo 1: Flashing at Parapet

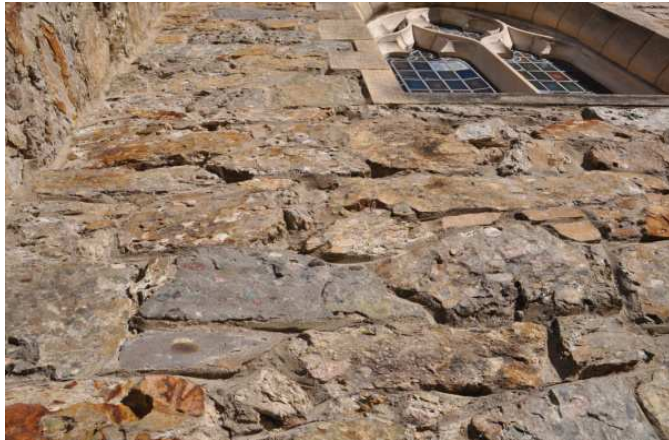
Photo 3: Mortar Deterioration on Church

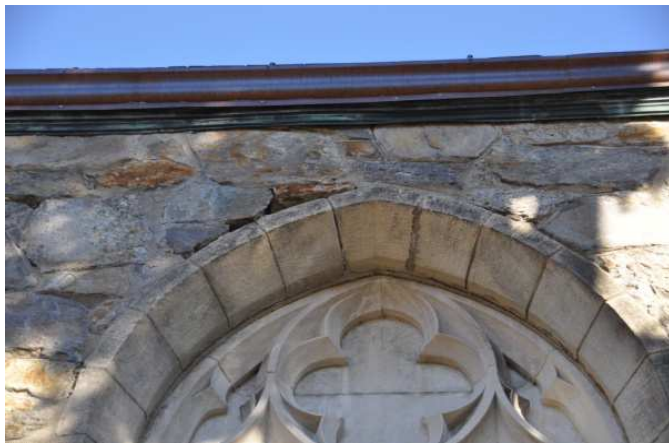
Photo 4: Mortar Deterioration at Blank Window

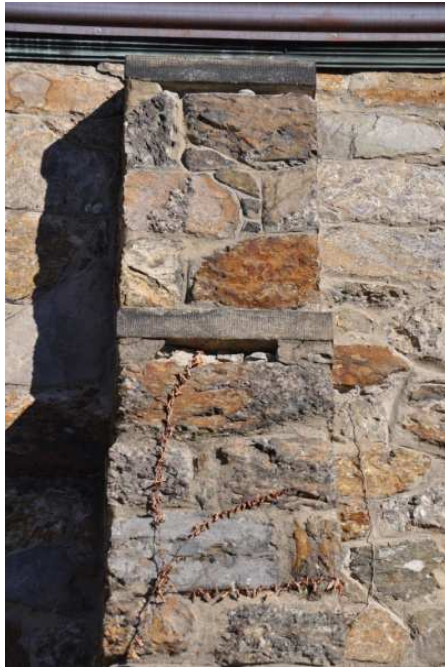
Photo 5: Mortar Deterioration at
Coping Stone

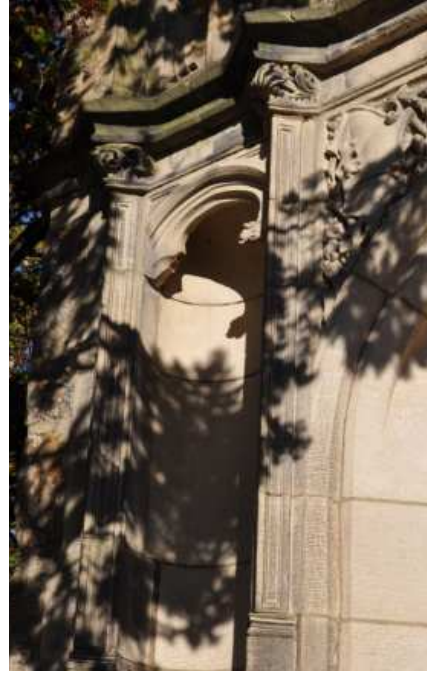
Photo 6: Missing Stone at niche

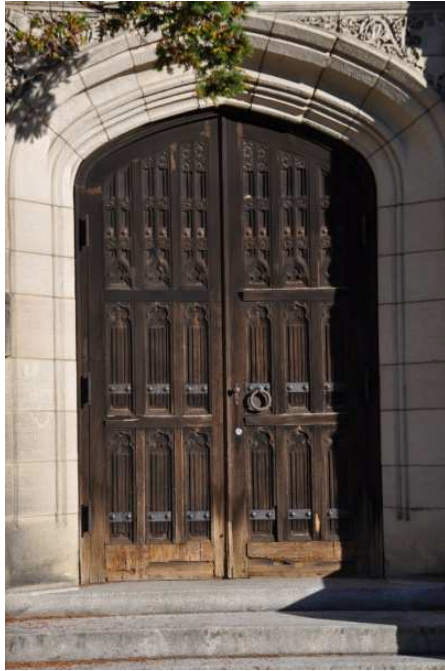
Photo 7: Entrance at Tower

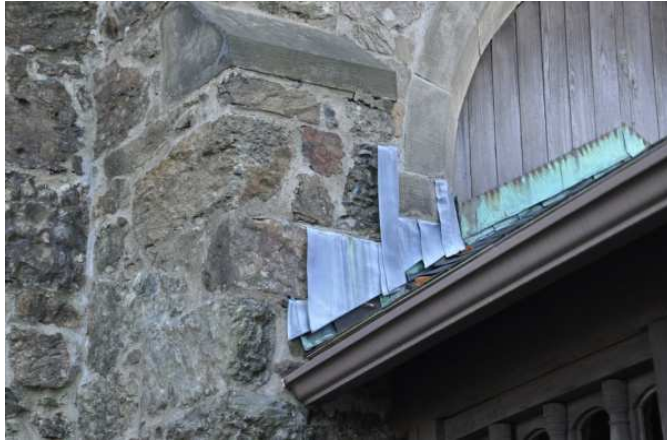
Photo 9: Flashing at Porte-cochere

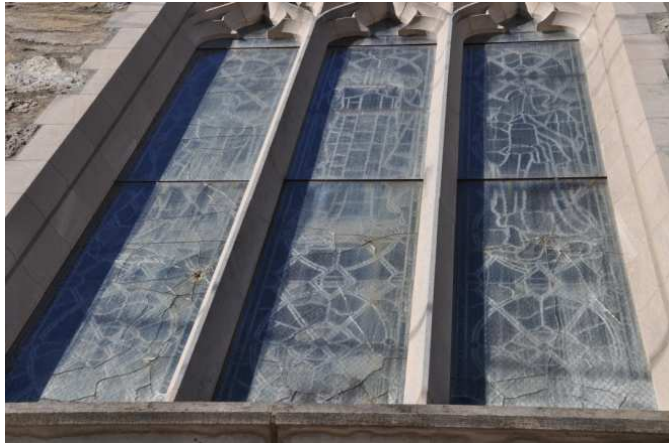
Photo 11: Protective Glazing at Altar Window

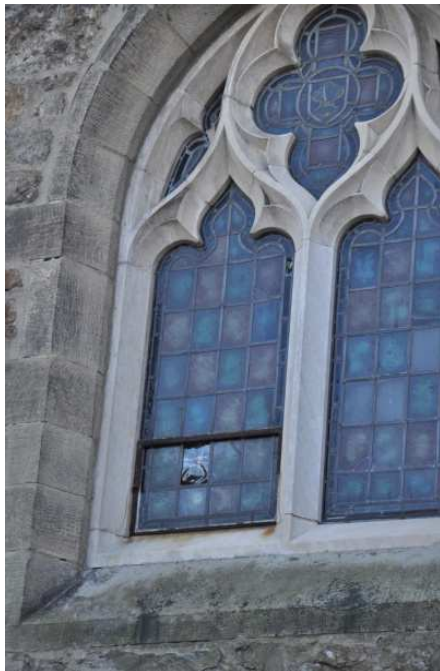
Photo 12: Broken Pane in Nave Window

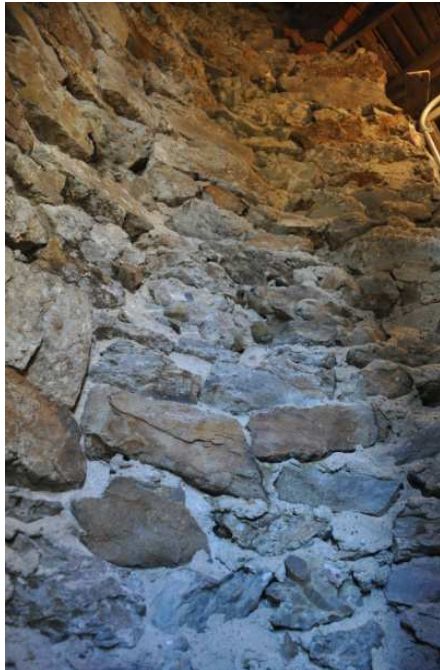
Photo 13: Mortar Deterioration inside tower

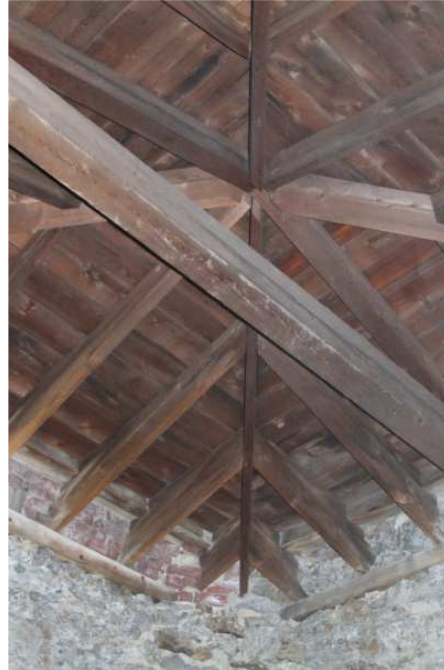
Photo 14: Wood ceiling structure in tower

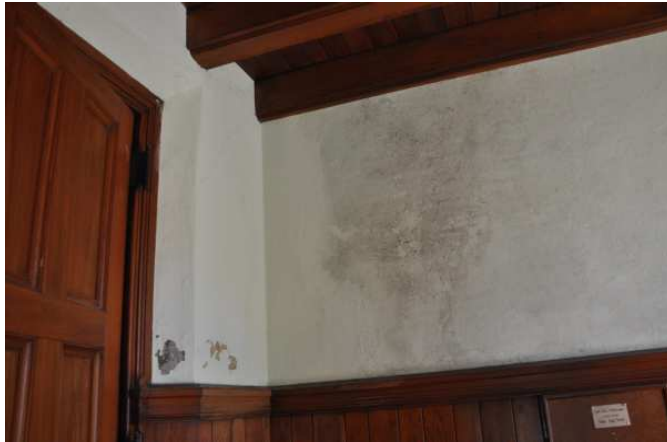
Photo 15: Wall in Vestibule

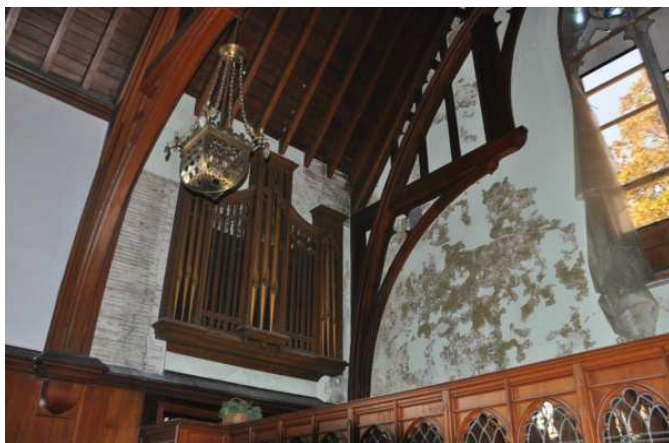
Photo 17: Wall in Nave

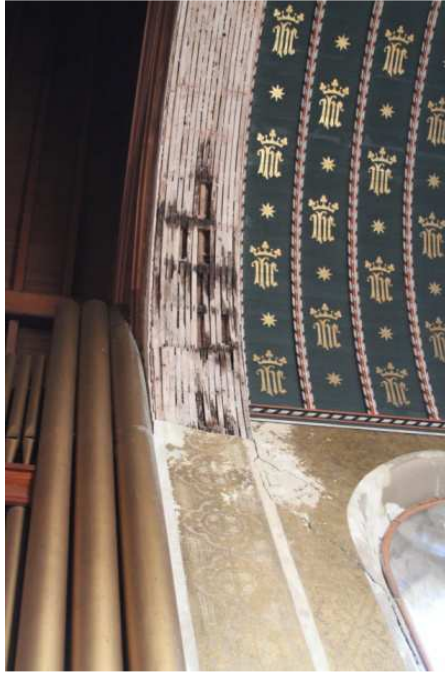
Photo 19: Arch in Chancel

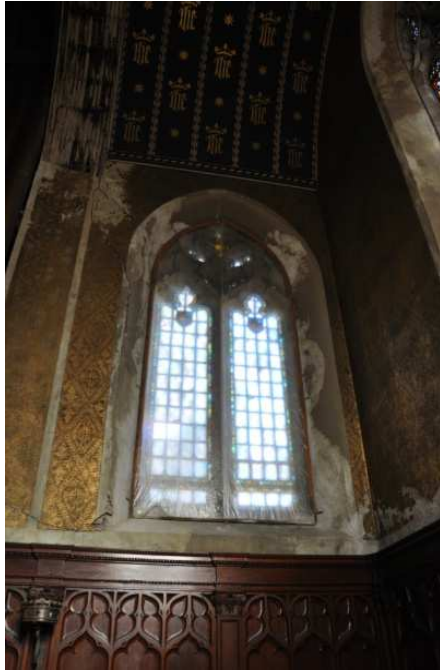
Photo 21: Window in Chancel

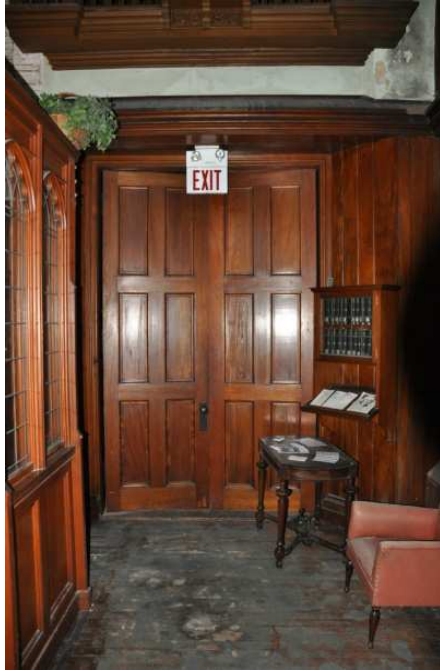
Photo 23: Door into Vestibule

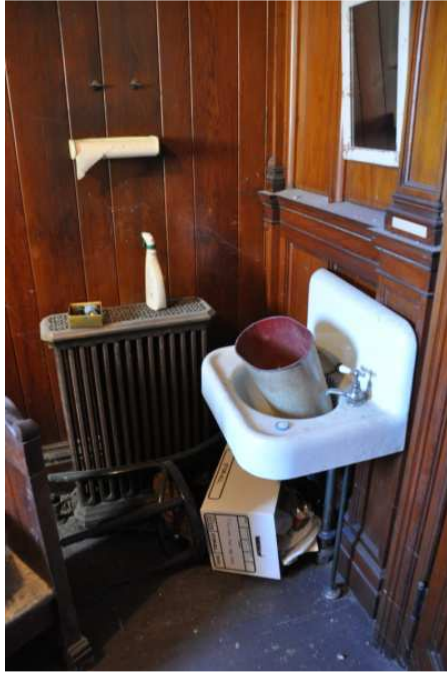
Recommendations: Repair the damaged wainscoting. Repair the plaster on the ceiling. Refinish hardwood flooring and other woodwork.

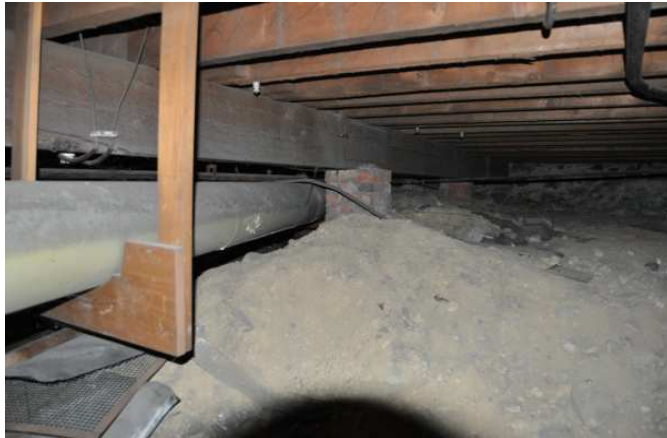
Recommendations: Test for asbestos, remediate if necessary.

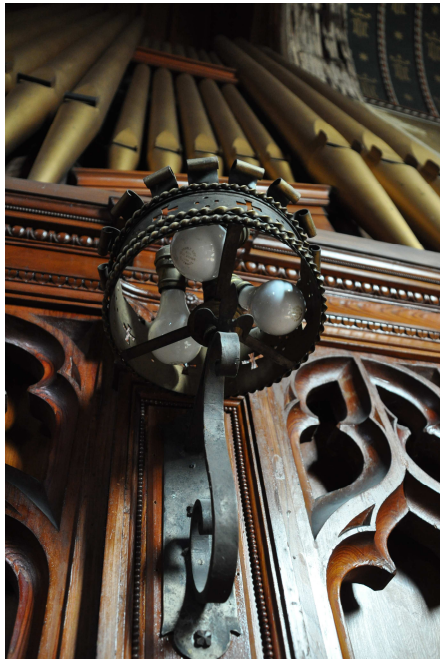
Photo 29: Light in Chancel
