October 3, 2022

Suitability for Tree Preservation at 21 Court St, Newton, MA

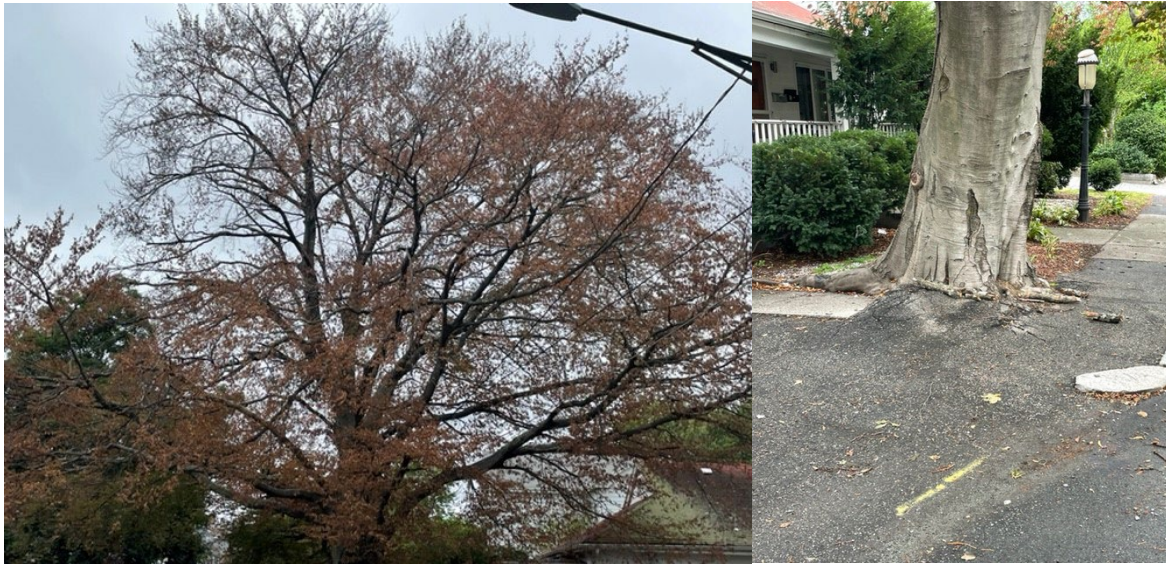
The tree is a European beech which is 45 inches in diameter. The tree is growing against the driveway of 21 Court St and the sidewalk along Court St. The canopy of the beech tree is very thin with most of the foliage having already dropped early in the season. The remaining foliage is undersized for this species of tree. Approximately half the canopy is dead, with the largest dead portion of stem being 18" +/- . It is uncertain if the remaining canopy will leaf out next season.

Due to the restricted root zone of the tree, soil therapies to slow decline will not be effective. Additionally, Beech Leaf Disease, a new invasive pest to beech trees, is in the area and expected to affect this tree in the near future. Beech leaf disease is shown to quickly cause mortality in trees in poor condition such as this tree.

Image of assessed beech tree taken on September 27, 2022.

I conclude that this tree is of very low suitability for preservation and should be removed as soon as possible to eliminate the potential for branch failures.
