PRESERVATION GUIDELINES
FOR MUNICIPALLY OWNED
HISTORIC BURIAL GROUNDS AND CEMETERIES

EAST PARISH BURIAL GROUND

NEWTON, 1660

**EAST PARISH BURIAL GROUND
PRESERVATION PLAN
NEWTON, MASSACHUSETTS**

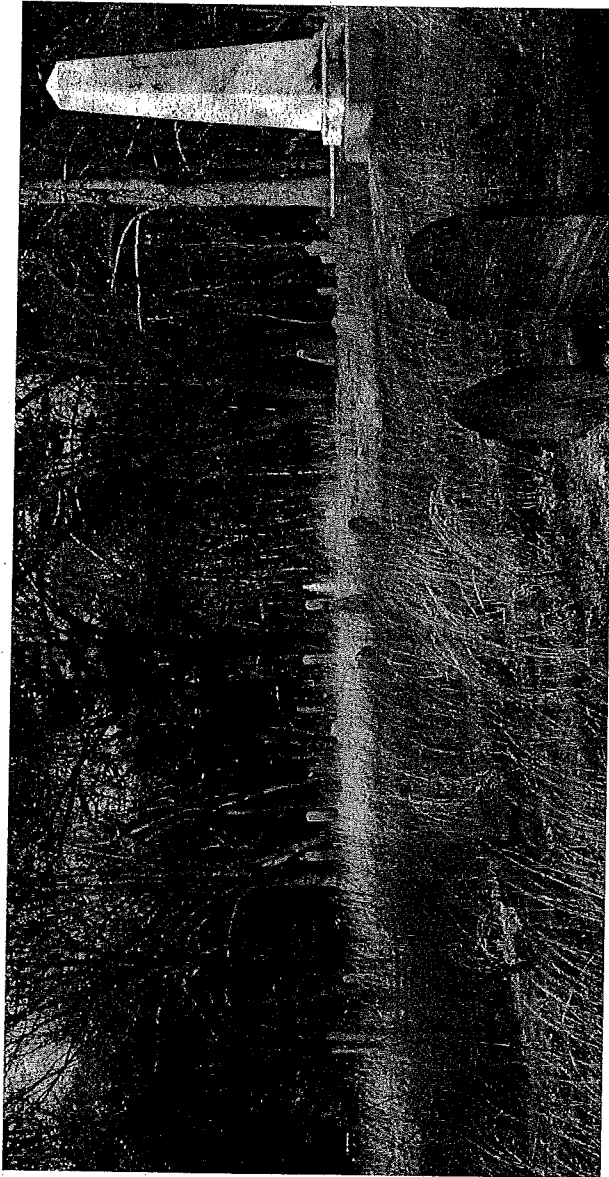
First Settlers Monument

A white marble obelisk honoring the First Settlers of Newton and marking the presumed site of the first Meeting House, which stood there from 1660 to 1697, has been placed at the high point of the site. While the structure appears in good condition, the marble is eroding from acid rain.

Clean and protective coat the marble.

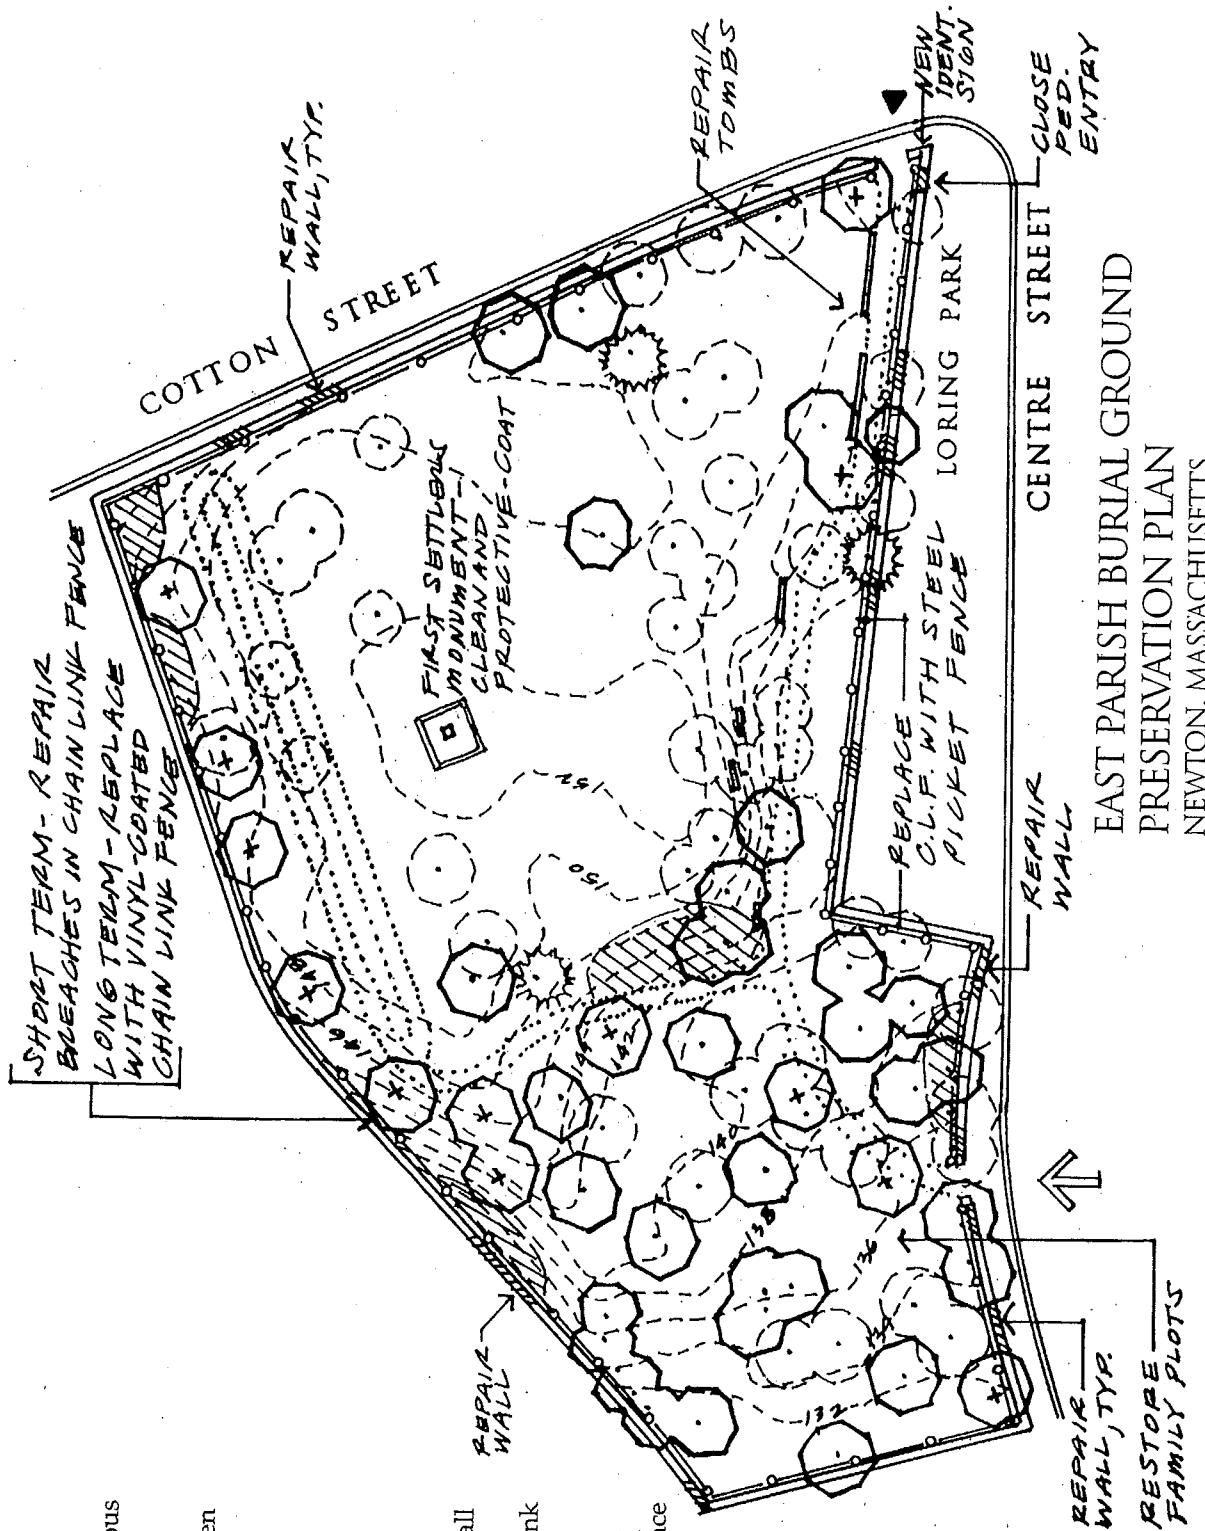
Vehicular / Pedestrian Entrance

Pedestrian access is available from Centre Street at the southwest corner of the site with one step up on a stone wall and through a 4' wide opening in the fence which is interrupted by three concrete filled steel bollards. Space between the bollards is narrow and the entrance is not universally accessible.

Vehicular access for maintenance is available from both Centre and Cotton Streets. Each gate opening is 12' wide with an inward swinging gate.

Remove the current steel bollard entry and develop a new 5' wide pedestrian access with an appropriate lockable gate from Cotton Street where the vehicular gate is now located. Slopes in this area will allow universal accessibility with a modest amount of excavation at the Cotton Street end which should be done under the supervision of an archaeologist.

Maintain the locked vehicular access for maintenance purposes at the current width at the Centre Street entrance. Convert the Cotton Street entrance to a pedestrian entrance as described above.
