**NEWTON PUBLIC BUILDINGS SURVEY  
PHASE II – ANALYSIS OF HISTORICAL SIGNIFICANCE**

**Building Analysis**

**Lincoln-Eliot Elementary School**

Address: 191 Pearl Street  
Year of Construction: 1939

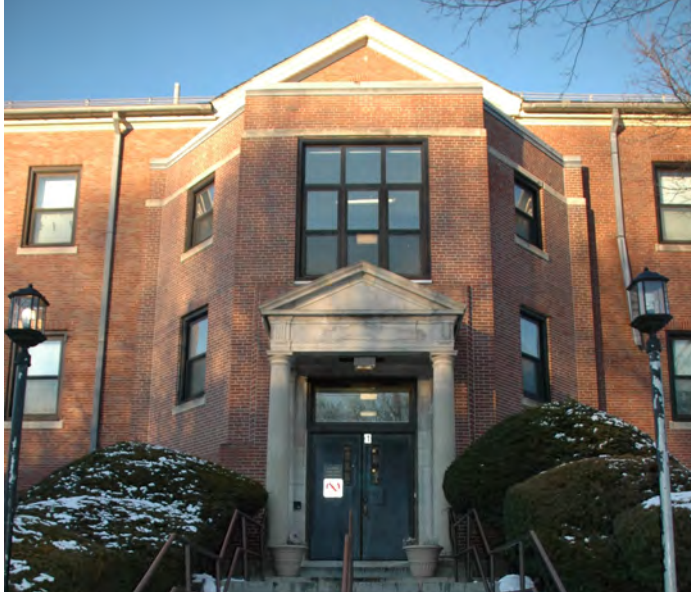
Figure 1 (top left): The current main entry is demarcated by a limestone pedimented portico at the southern, narrow end of the historic building, at the top of a large set of exterior stairs.

- Repair all broken leaders and replace all missing leader components. Reattach leaders where loose from the building.
- Severe water staining and efflorescence at south and east entry porticos. Inspect roof, and repair as required. Repoint all joints in the masonry and install weather caps at skyward-facing joints. Repair the areas of water damage at the stucco portico ceilings.

- Repair or replace the severely cracked concrete stair landings at the south entrance including replacement of failing previous repairs. Repair cracks in granite thresholds and repoint granite stairs.

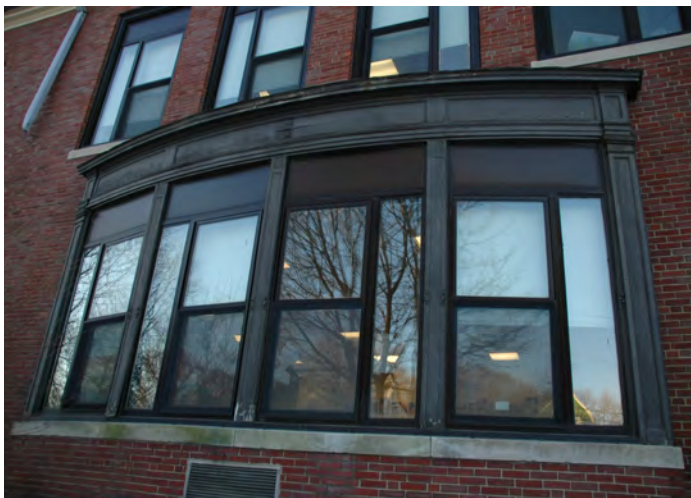
Figure 2 (middle left): The overall rhythm of single window openings with soldier course brick over steel lintels and limestone sills is interrupted by the shallow bow window at the east elevation.

- Confirm metals used in roof and drainage elements. Replace gutters and leaders if necessary to prevent galvanic corrosion.
- Survey condition of all steel window and door lintels. Replace severely rusted lintels. Reset and repoint displaced bricks to match existing adjacent brickwork where rust jacking has occurred and where removed to replace lintels. Repaint all lintels.

- Paint all wood elements, particularly the area of peeling paint at the south gable. Repair wood elements as necessary.
- Replace missing wood elements at bow window. Reattach all loose elements.

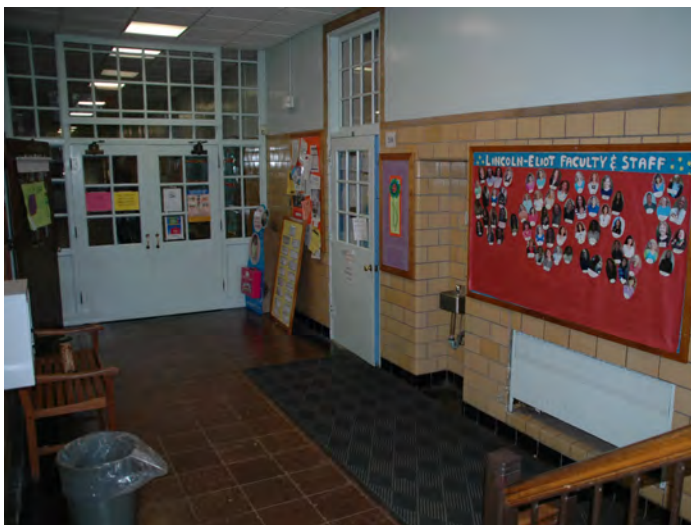
Figure 3 (bottom left): Many character-defining features visible in this view. Note the glazed partition wall separating the main corridor from the stair hall; the classroom door with transom; the built-in recesses for water fountains and radiators; the glazed ceramic tile and brick at the walls.

- Repair transom above principal's office door and replace missing muntins to bring the transom back to its original appearance.
- Repaint metal stair elements.
- Clean paint smears from the glass at the glazed corridor walls.
- The dropped ceiling at second floor is obscuring the classroom door transoms. The dropped ceilings at the first and second floors obscure the top of the glazed corridor wall. Review the necessity of the dropped ceilings. Remove if not needed

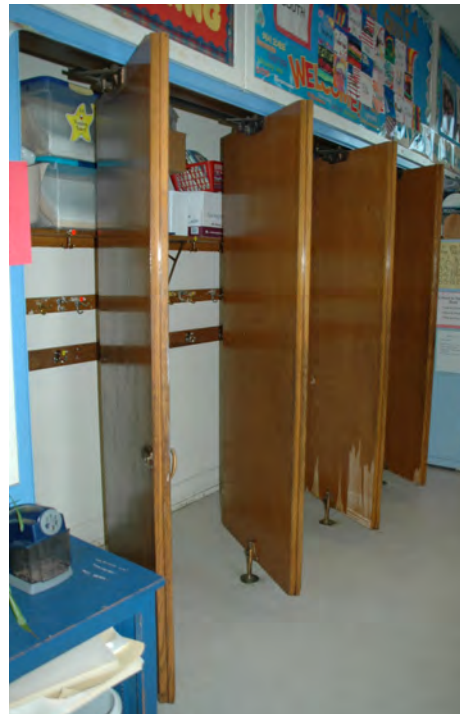
Figure 4 (below): Original set of pivot doors at a wide, shallow coat closet, typical in each classroom. The doors have been removed from many classrooms, but are in storage in the basement.

- Repair damaged plywood veneer at classroom doors and pivot doors. Finish to match existing adjacent door veneer.
