**NEWTON PUBLIC BUILDINGS SURVEY
PHASE II – ANALYSIS OF HISTORICAL SIGNIFICANCE**

Oak Hill Middle School

Address: 130 Wheeler Road
Year of Construction: 1936

PART I - Analysis of Historical Significance

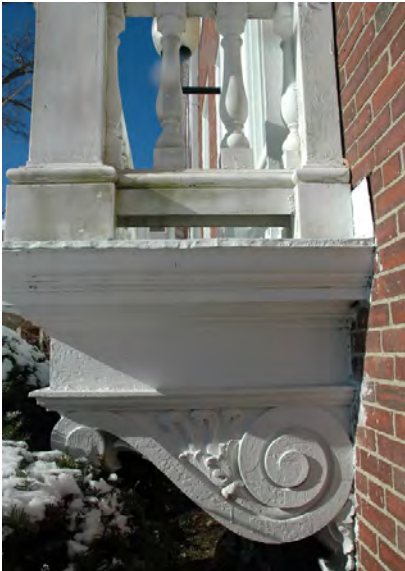
Figure 3: Decorative wood bracket below projecting balcony at south elevation.

- Perform wood repairs at projecting balcony at center of south elevation, main building and the roof balustrades at the library connector and library bay window. Repairs include:

- Complete removal of existing paint from wood surfaces. This will also remove the biological growth present at the balustrades.
 - Installation of new wood dutchmen with profiles matching the existing wood elements at areas of severe deterioration. Replacement of wood elements in-kind at areas of deterioration that are not repairable.

- Consolidation at areas of less severely deteriorated wood.
 - Repainting wood surfaces.
 - Installation of painted metal caps at some of the more vulnerable areas of wood to prevent further deterioration.

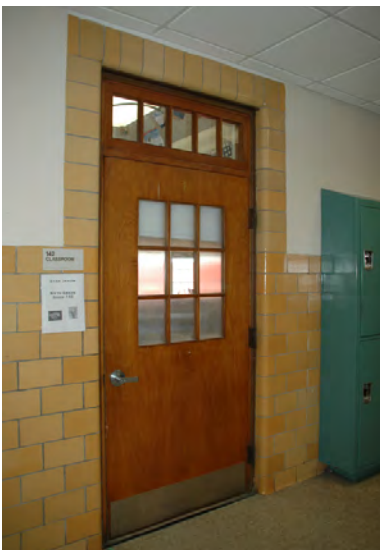
Figure 5: Tile wainscot and door surround in corridor.

- Patch or replace in kind damaged and broken tiles at the corridor and stairway wainscot.
- The brown/finish coats of plaster around the door to the exterior porch in the Art Classroom are delaminating. Repair the exterior surround to prevent water entry and repair plaster.
- Consolidate and hide loose-hanging wiring at classroom ceilings.
- Concrete patch repairs at spalled areas of foundation.
