**NEWTON PUBLIC BUILDINGS SURVEY
PHASE II – ANALYSIS OF HISTORICAL SIGNIFICANCE**

Building Analysis

Underwood Elementary School

Address: 19-21 Eldredge Street

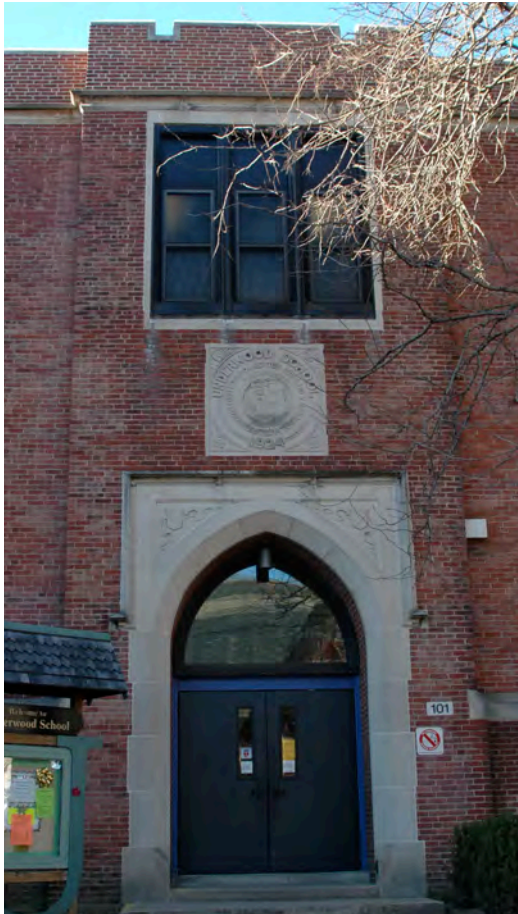
Figure 2: the front entrance on the east elevation (shown), is mirrored with slightly less elaborate secondary entrances to the west and north. Note the crenelated parapet, the cast stone school seal, the elaborate cast stone door surround, and the large windows

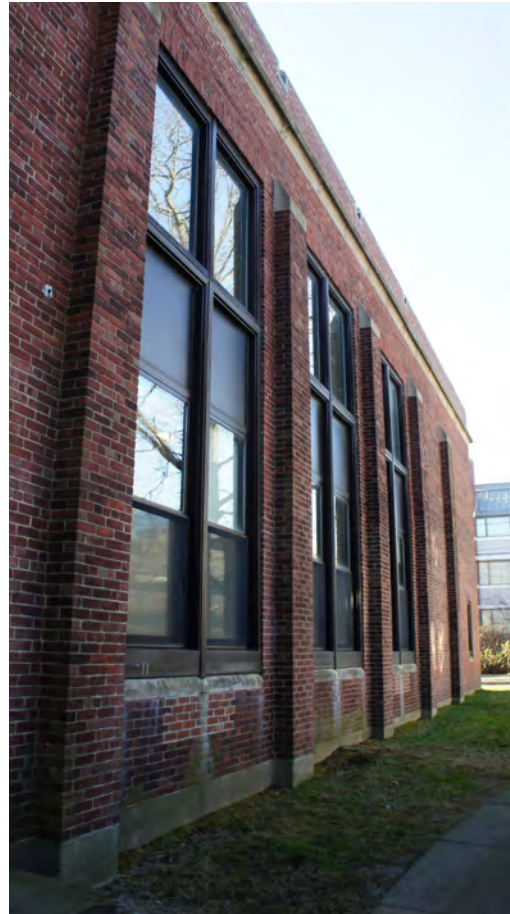
Figure 3: the gymnasium wing is characterized by the tall windows between buttresses; the three cast stone arched doorways on the west façade (not shown) and the round arched arcade to the south, seen below.

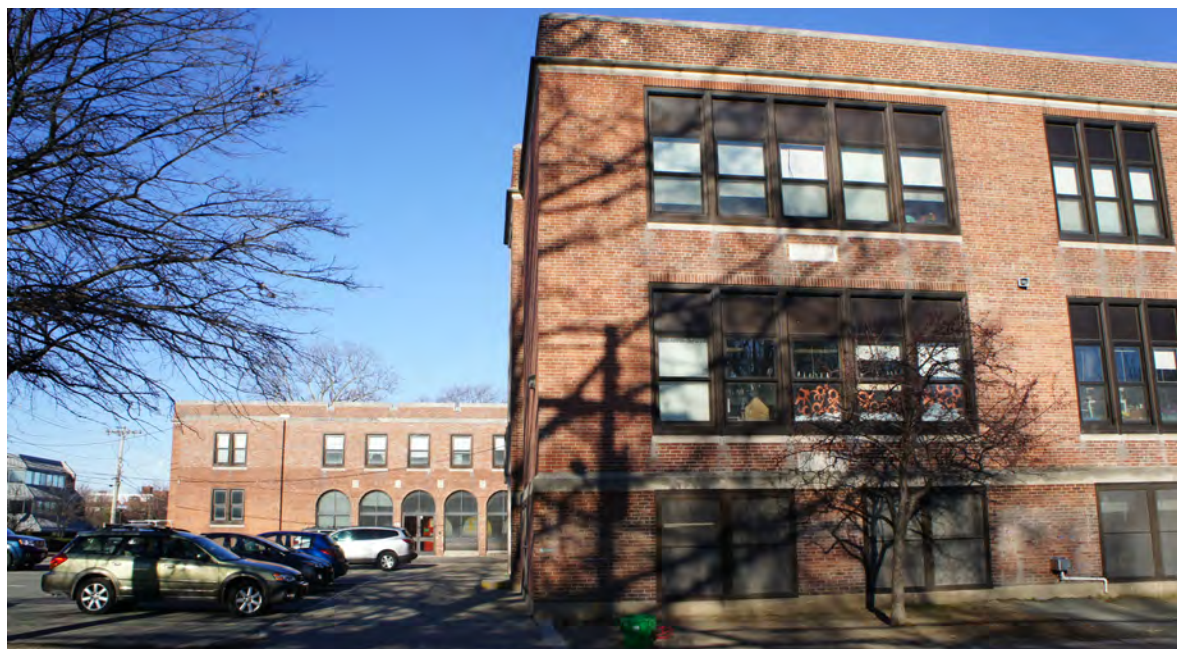
Figure 4: the general rhythm of the building facades is characterized by the large banks of windows seen here in the foreground. The replacement windows drastically affected the character of the building; compare with the historic photo in Figure 1.

- Conduct thorough survey of window condition, including sash, frame, lintel and hardware. Initial exterior inspection indicates failing sealant at the lintels and water infiltration into the vertical mullions, but the windows are otherwise generally in good condition. Evaluate in conjunction with daylighting, ventilation and energy efficiency strategies (beyond the scope of this survey), to prioritize timing of replacement. At the time of next replacement, replace with operable windows matching in appearance to the original windows.
