October 3, 2023

BEC 21-112

Re: Closeout Package for Asbestos Abatement Activities
for Coleman House 1 Façade Repairs
677 Winchester Street
Newton, Massachusetts

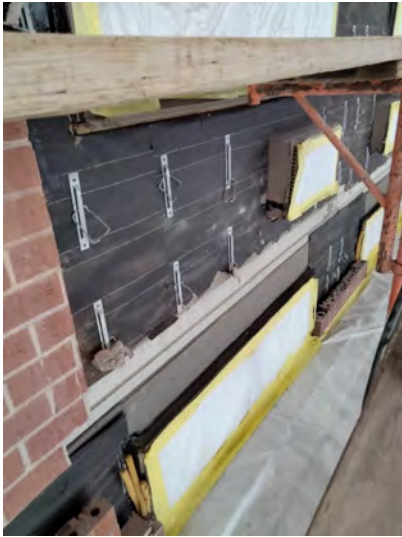
Clearance Photos

CLEARANCE SECTION			
Visual clearance passed?	Yes	Remaining ACM	N/A
Encapsulate applied?	N/A	Air Sampling Clearance Passed?	Yes
Date of Final Clearance	11-17-21	Time of Final Clearance	01:00 PM

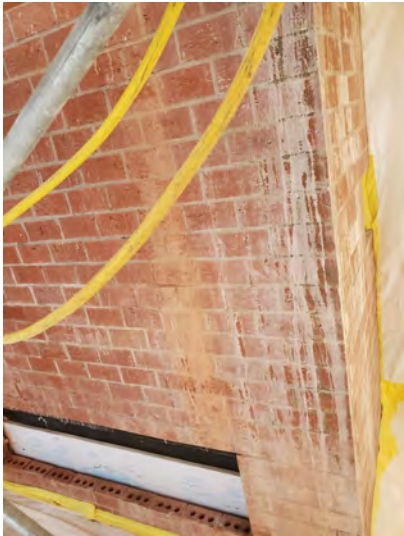
Clearance Photos

CLEARANCE SECTION

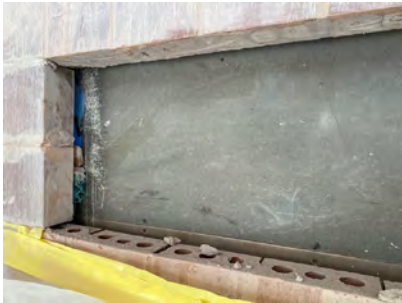
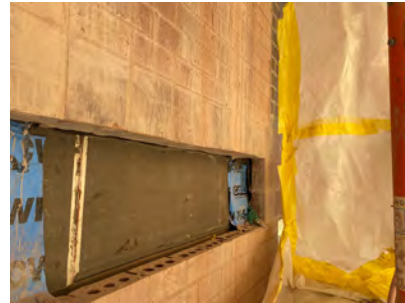
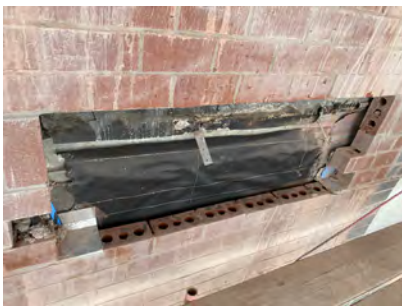
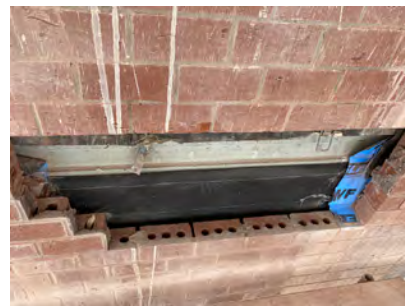
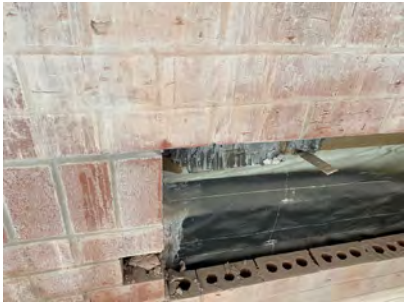
Clearance Photos

CLEARANCE SECTION			
Visual clearance passed?	Yes	Remaining ACM	N/A
Encapsulate applied?	No	Air Sampling Clearance Passed?	Yes
Date of Final Clearance	12-06-21	Time of Final Clearance	03:33 PM

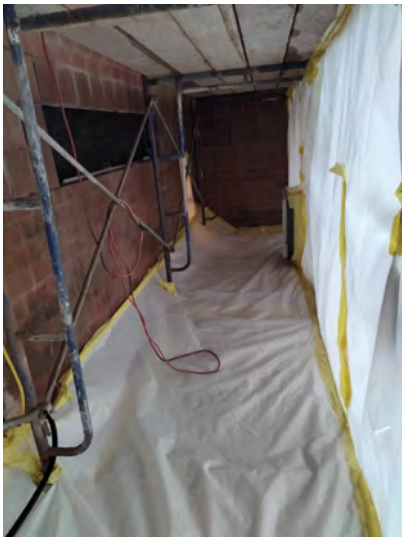
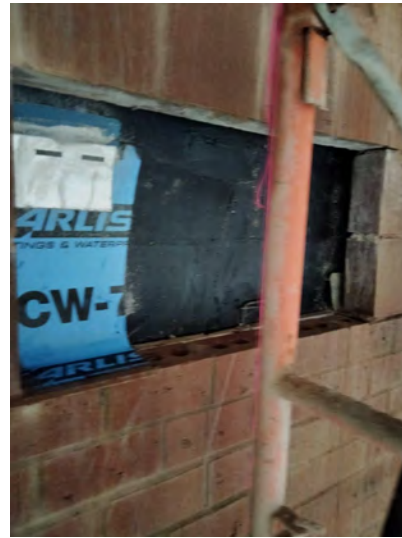
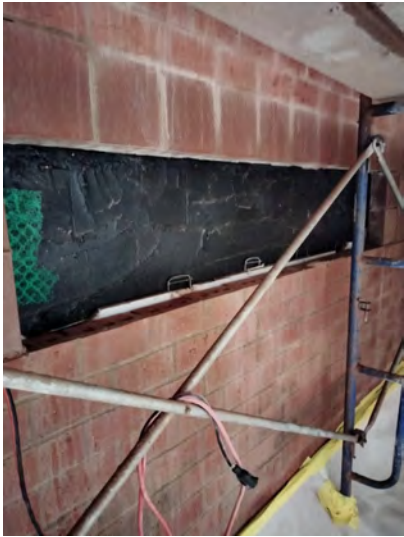
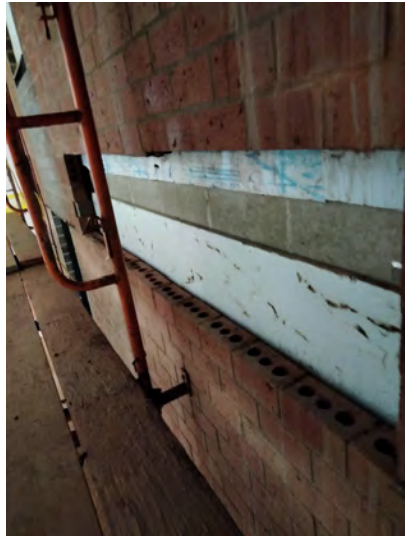
Clearance Photos

CLEARANCE SECTION			
Visual clearance passed?	Yes	Remaining ACM	None
Encapsulate applied?	No	Air Sampling Clearance Passed?	Yes
Date of Final Clearance	12-16-21	Time of Final Clearance	02:00 PM

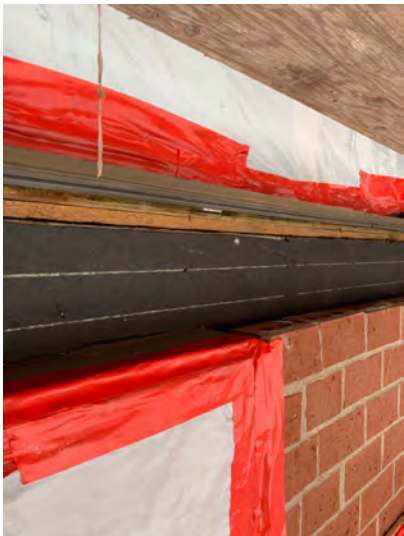
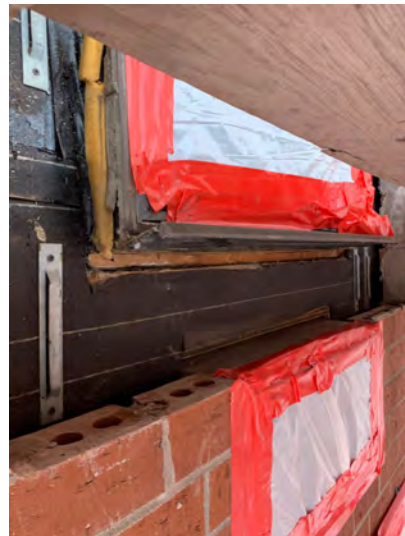
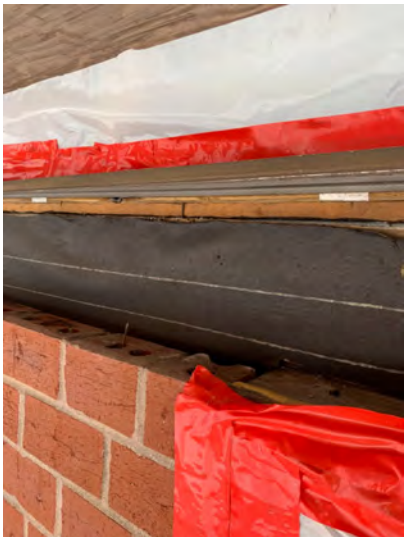
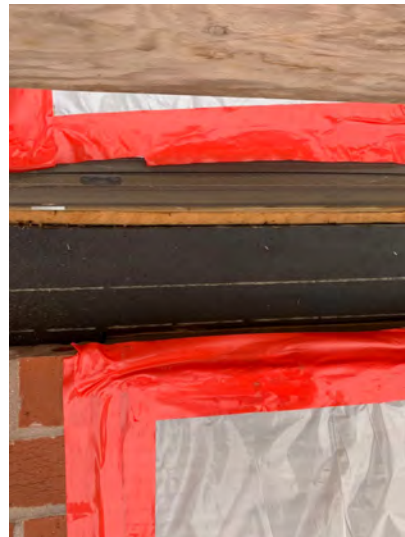
Clearance Photos

CLEARANCE SECTION
