**City of Newton**  
**MS4 Annual Report PY6**  
**July 1, 2023 – June 30, 2024**

MS4 General Permit Year 6  
Performance Evaluation

PROJECT: Newton, MA Phosphorus Control Plan

SUBJECT: MS4 General Permit Year 6 Performance Evaluation

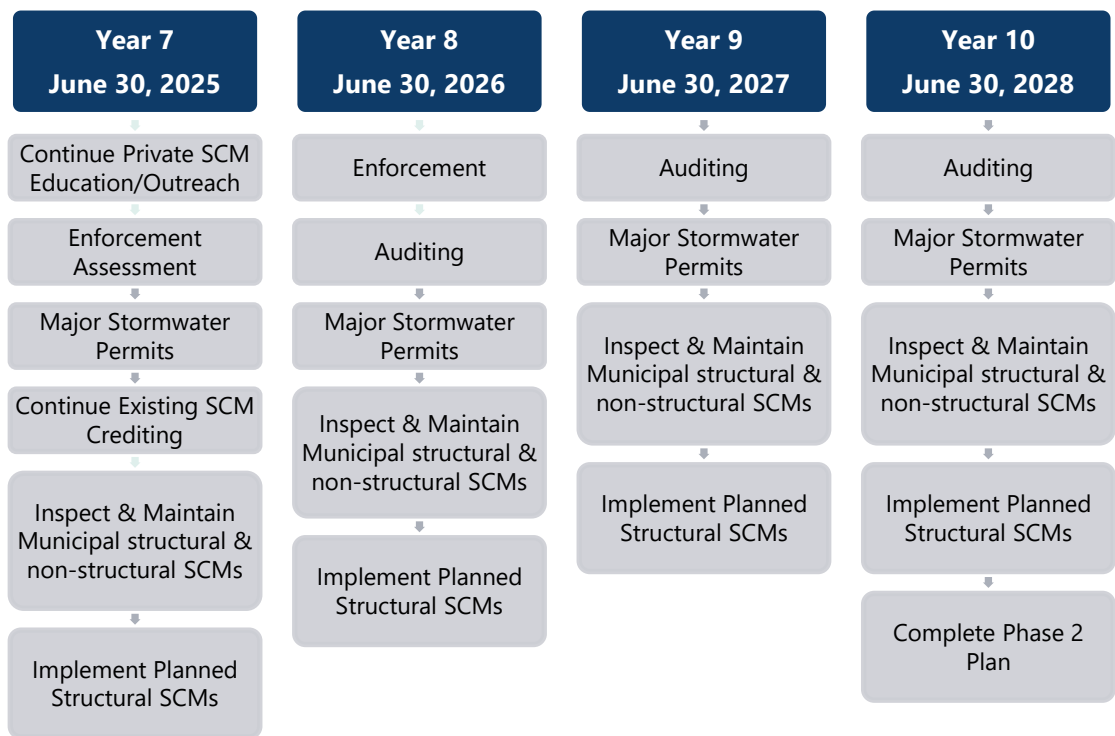
**Figure 7-4: Phase 1 Implementation Schedule Elements**

The primary elements of the implementation schedule are included in the updated Figure 7-4 below.

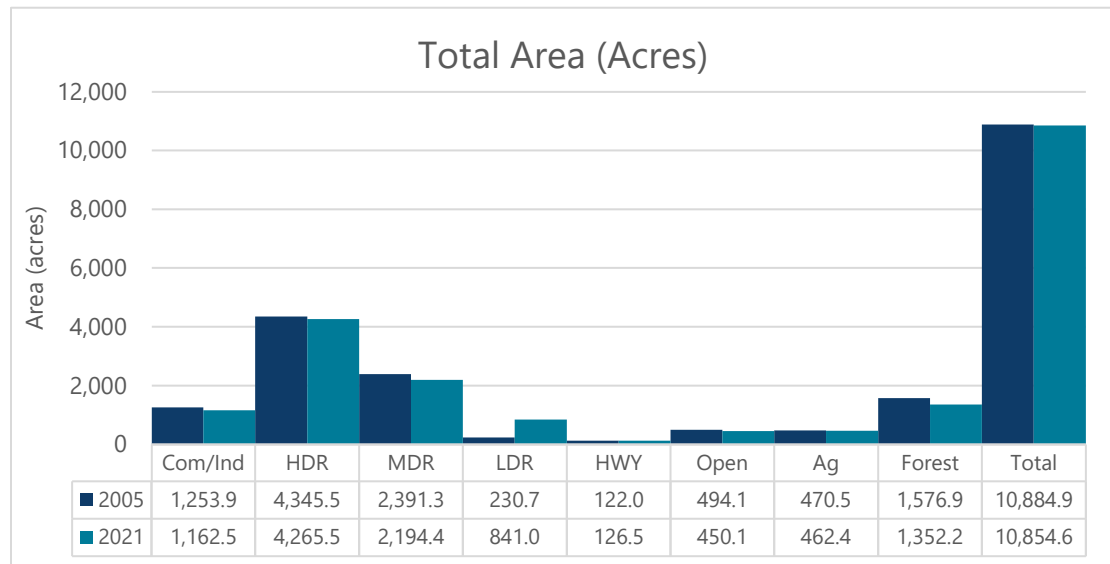
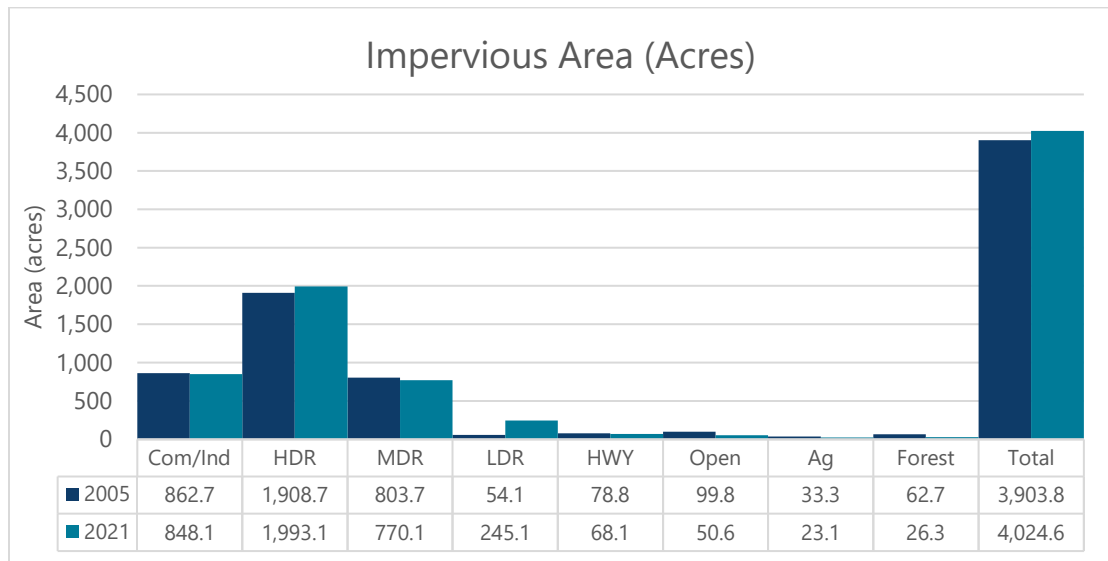
Newton’s total PCP area and impervious area, organized by land use, is presented in the following charts.
