Potential Corridor Improvements Board Three
Cheesecake Brook Greenway Project

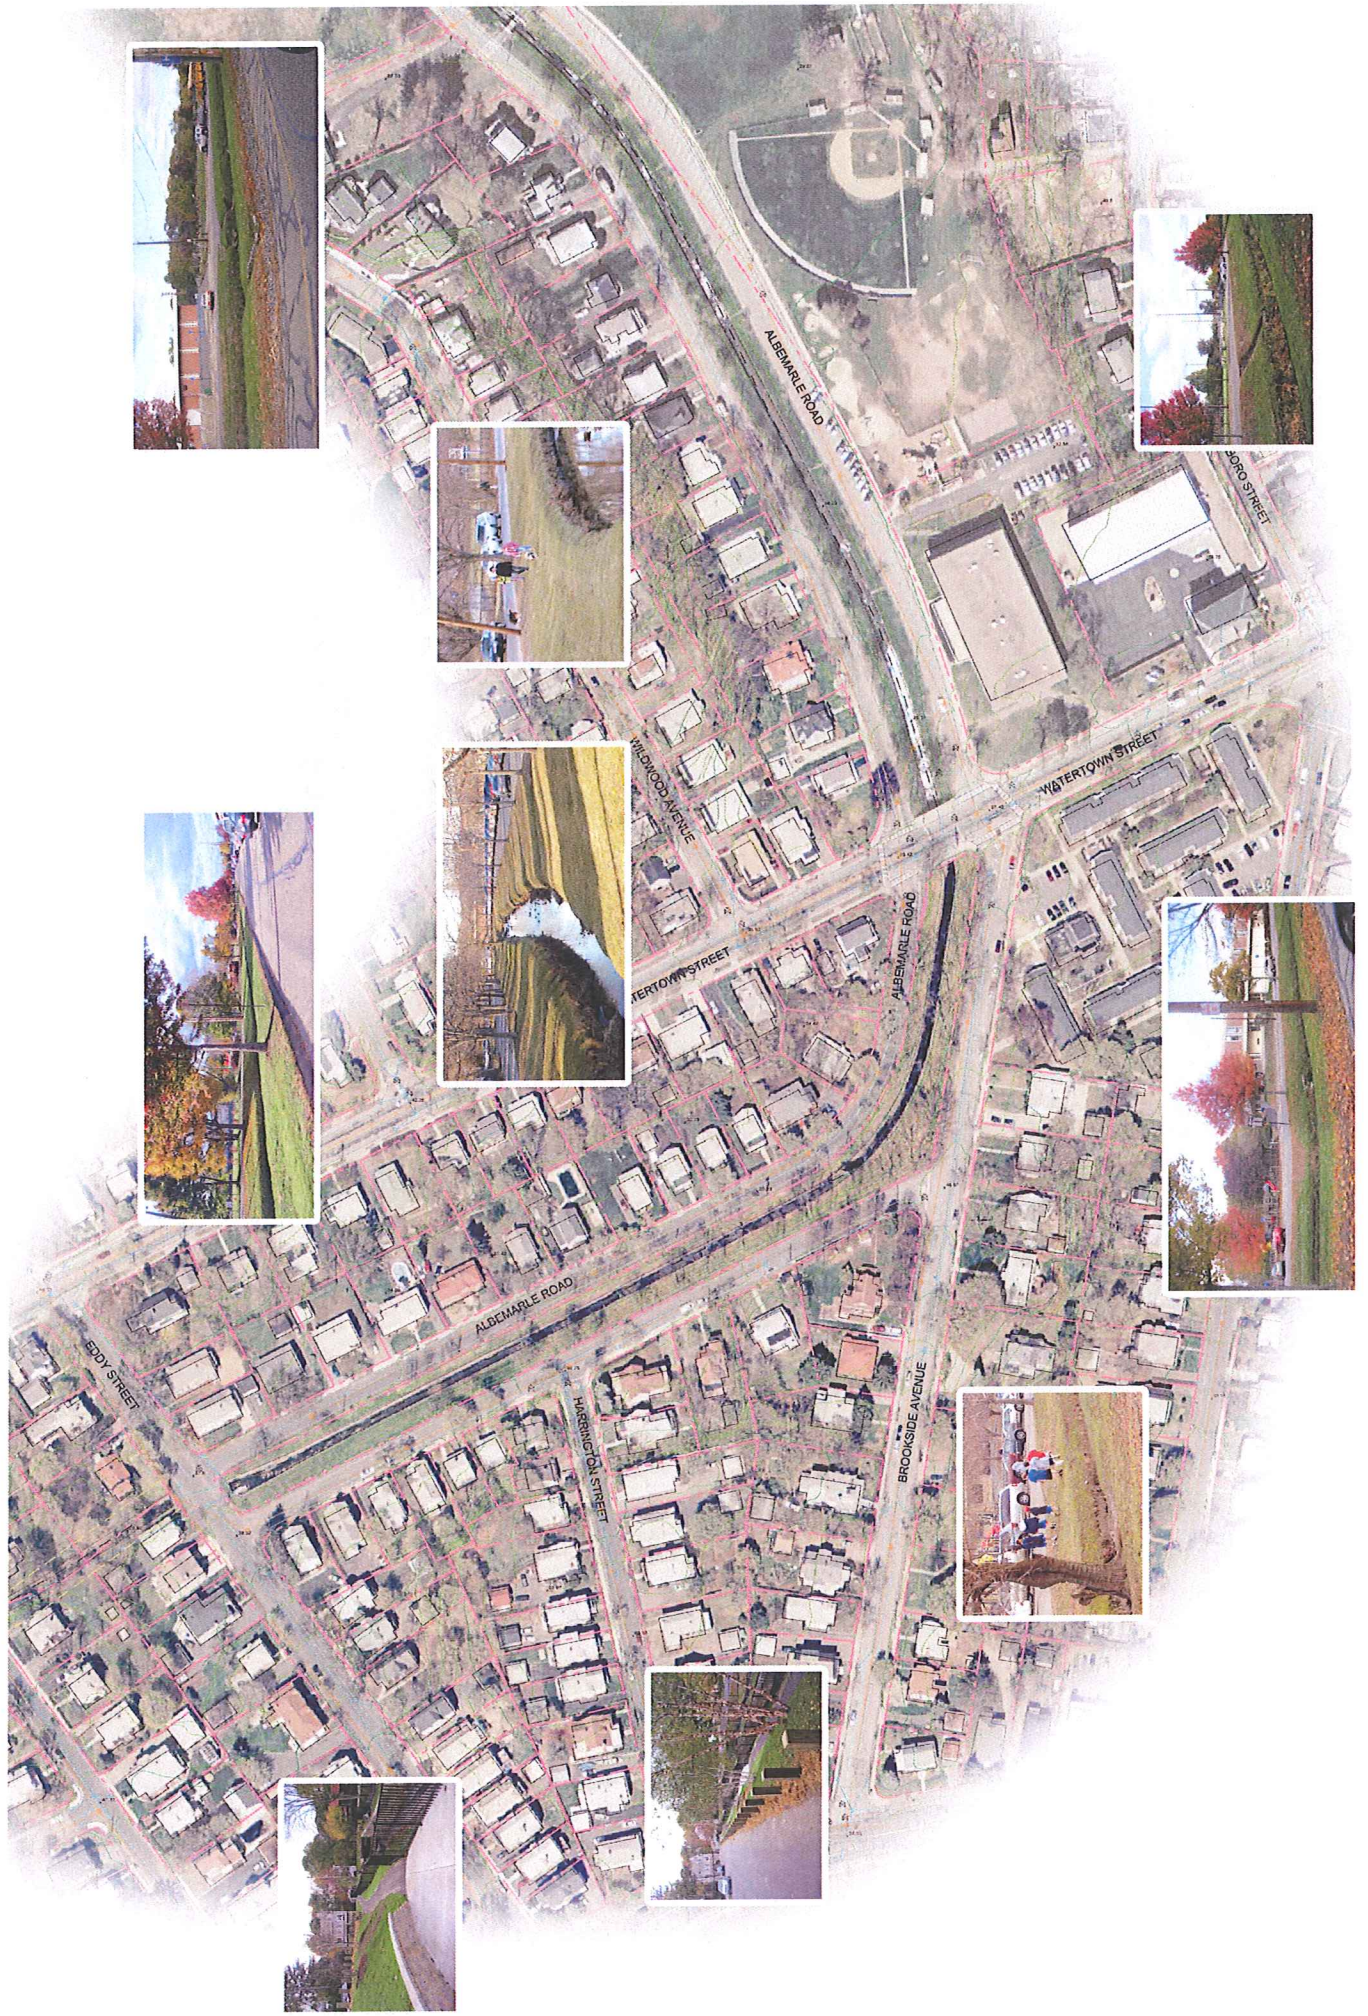
ASPHALT & CONCRETE CURBING VARIES FROM POOR TO FAIR CONDITION ALONG THE CORRIDOR

ROADWAY PAVEMENT IS IN POOR CONDITION

CONCRETE & ASPHALT DRAINAGE SWALES SEND STORMWATER DIRECTLY INTO THE BROOK WITHOUT BENEFIT OF TSS REMOVAL OR BIRPS FROM NORTH STREET TO THE CHARLES RIVER STORMWATER SHEET FLOWS ACROSS THE GRASS INTO THE BROOK

ERODED LAWN AREAS ADJACENT TO THE BROOK CAUSE THE DEPOSITING OF SILT IN THE BROOK

BROOK WALLS ARE UNDERMINED OR DAMAGED IN CERTAIN LOCATIONS

REGIONS OF SEDIMENT, DEBRIS AND VEGETATION BUILD UP CREATING STREAM BLOCKAGE

THE EXISTING CHEESECAKE BROOK PEDESTRIAN CROSSINGS ARE NOT ADA/AB COMPLIANT

THE LOCATION OF THE CROSSING CREATES A CONFLICT BETWEEN PEDESTRIAN, BUS AND VEHICULAR TRAFFIC

THE CENTRAL ACCESS TO THE PARK LACKS A SENSE OF ENTRY OR APPROACH

THERE IS NO FORMAL PEDESTRIAN ACCESS ALONG THE BROOK

CROSSWALKS AND ADA RAMP ARE LACKING IN KEY LOCATIONS ALONG THE CORRIDOR

CROSS STREETS ARE DIFFICULT FOR PEDESTRIANS AND CYCLISTS TO TRAVERSE

CROSSWALKS ARE EXTREMELY LONG IN CERTAIN LOCATIONS

VEHICLES OBSERVED ALONG THE CORRIDOR APPEAR TO BE TRAVELING IN EXCESS OF POSTED SPEED LIMITS.

THE CORRIDOR IS LACKING PEDESTRIAN LINKAGES AT KEY LOCATIONS

THE CORRIDOR LACKS SITE FURNISHINGS (BENCHES, SIGNAGE, APPROPRIATE FENCING AND THE LIKE)

DCR TRAILHEAD IS NON-DESCRIPT, THERE IS VEHICULAR AND CYCLIST CONFLICT AT THE CHARLES RIVER END OF ALBEMARLE ROAD

EXISTING BROOK OVERPASSES DO NOT ALLOW FOR CRITTER TRAVEL ALONG THE EDGE OF THE BROOK

WALLS ARE DAMAGED FROM TREE GROWTH AND OTHER VEGETATION

EXISTING HEALTHY TREES ALONG THE CORRIDOR PROVIDE SHADE AND VISUAL INTEREST.

THERE ARE A FEW DEAD OR DYING TREES

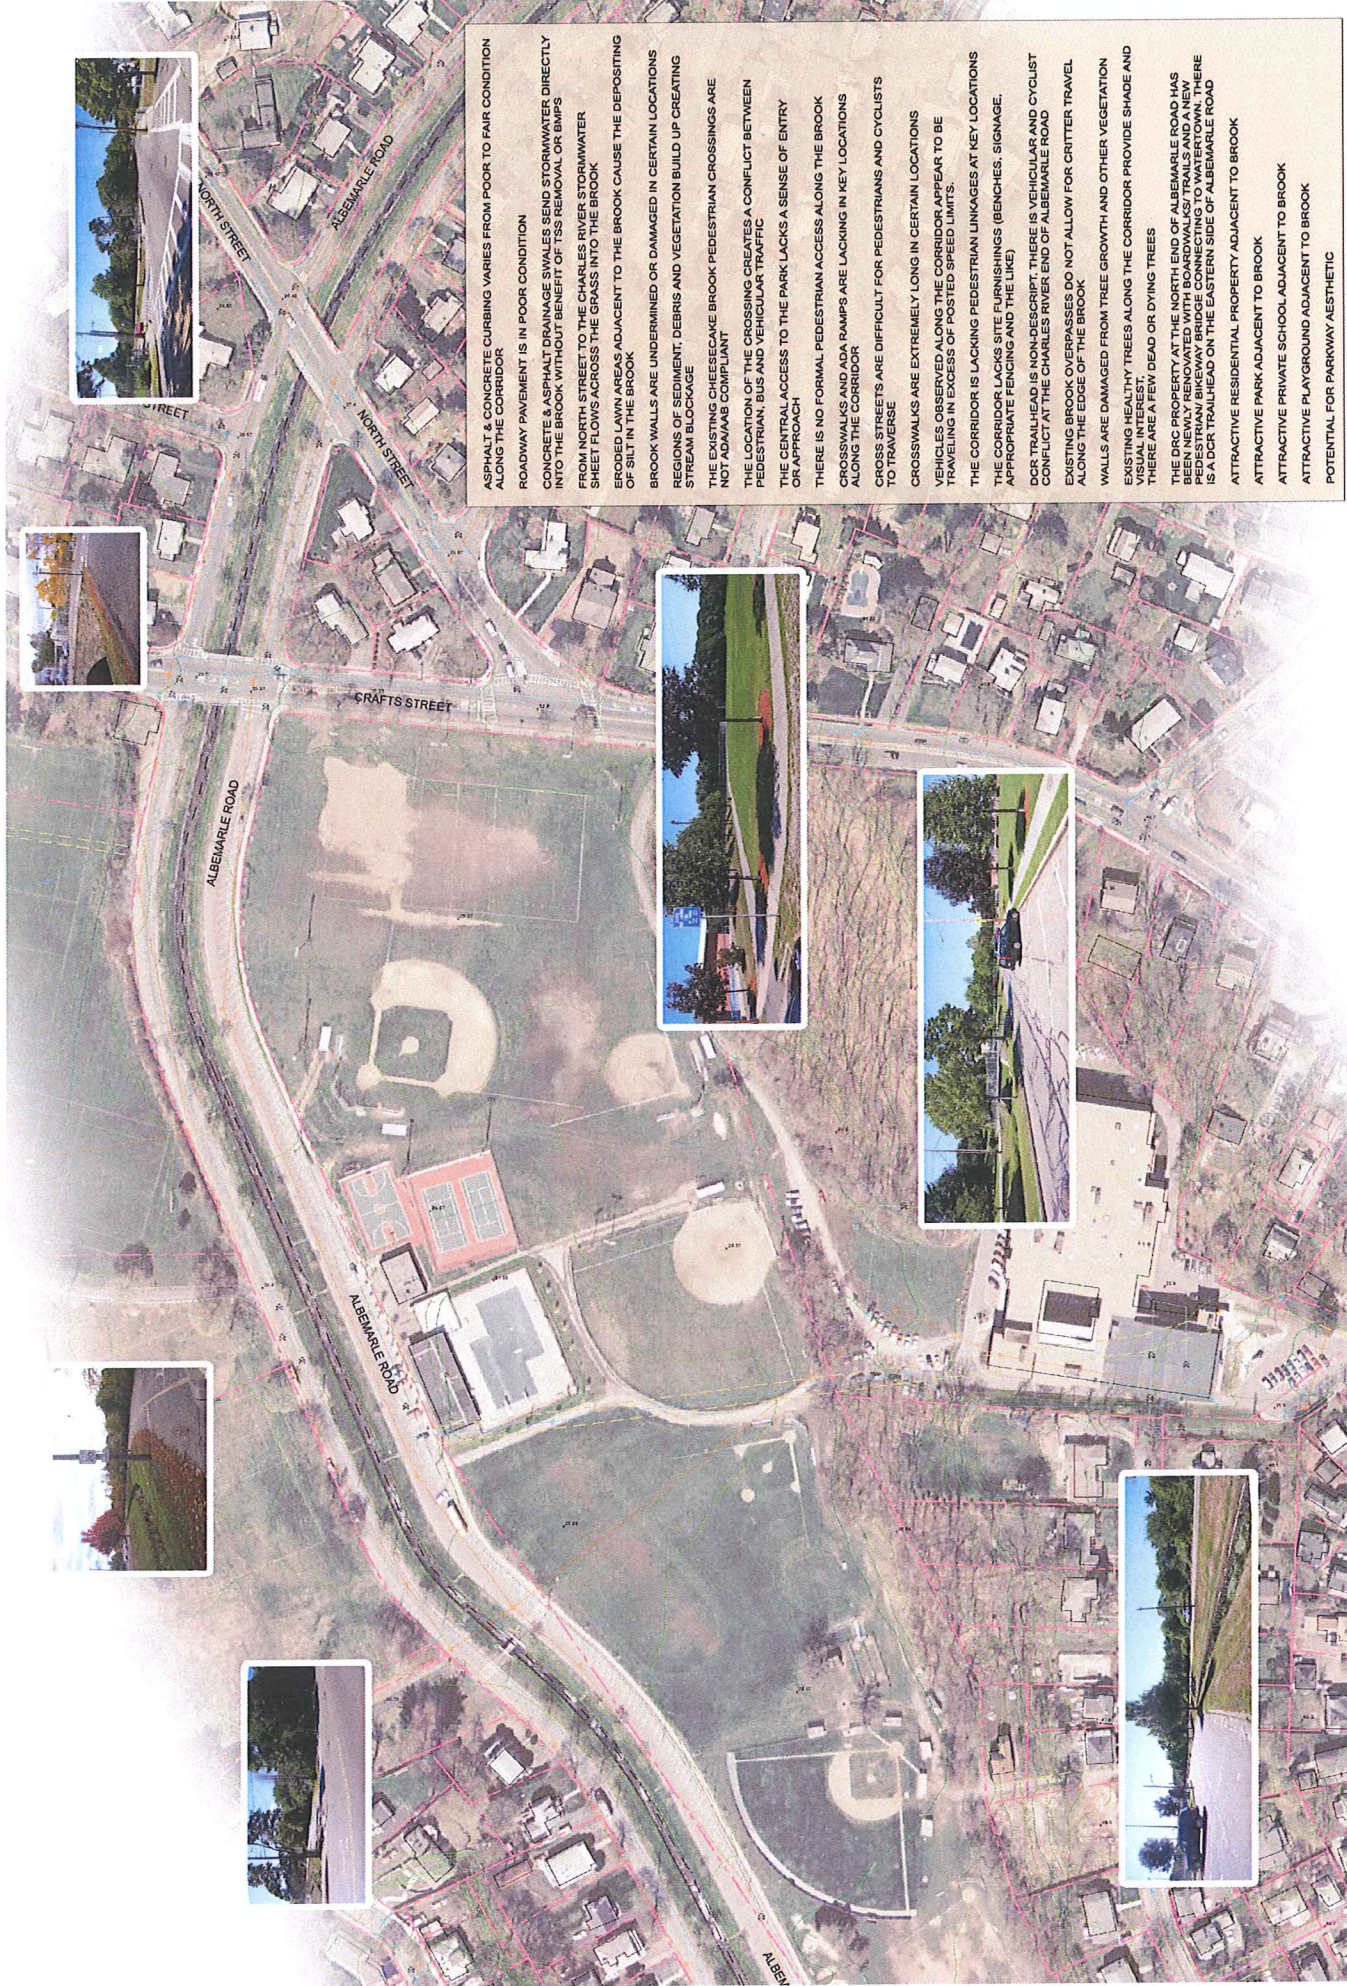
THE DCR PROPERTY AT THE NORTH END OF ALBEMARLE ROAD HAS BEEN NEWLY RENOVATED WITH BOARDWALKS/ TRAILS AND A NEW TRAILHEAD. THE TRAILHEAD AND BOARDWALKS ARE ADJACENT TO A DCR TRAILHEAD ON THE EASTERN SIDE OF ALBEMARLE ROAD

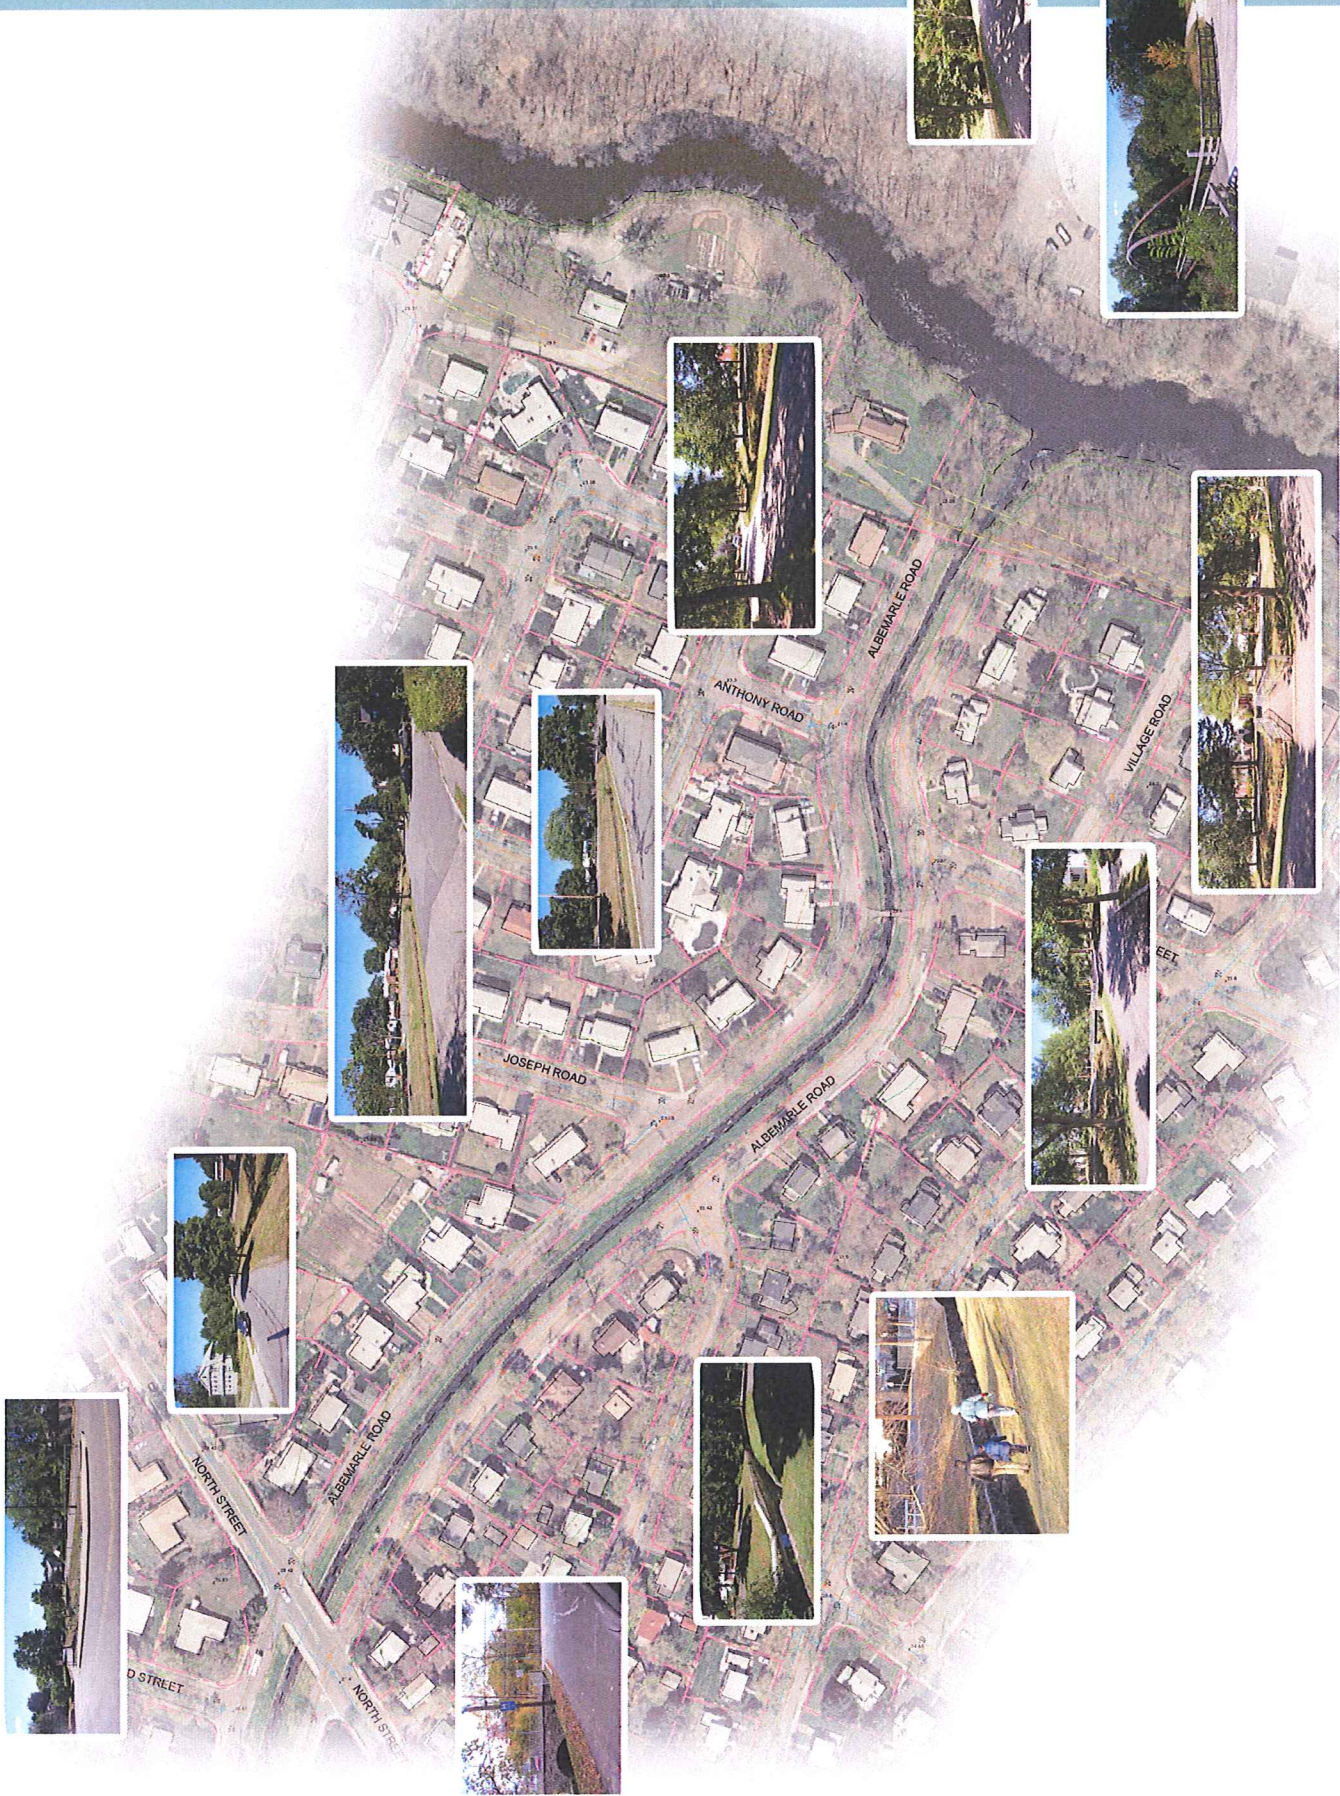
RAIN GARDENS AND STORMWATER MANAGEMENT

The rain garden captures stormwater and filters it directly into the ground, as well as provide aesthetic value. When large storm events overwhelm the rain garden, the water flows into the underground pipe. When the rain retention ponds are overwhelmed, the overflow will be sent about two feet into the brook, and prevent inundation.

- The rain garden provides the following benefits:
- Enhance landscape beauty and attract wildlife
 - Helps conserve hazardous waterway funds
 - Reduces runoff leaving property and entering the brook
 - Reduces potential water pollution to nearby Charles River
 - Replenishes valuable groundwater resources
