Moving Historic Buildings

John Obed Curtis

U.S. Department of the Interior
Heritage Conservation and Recreation Service
Technical Preservation Services Division
Washington, D.C. 1979

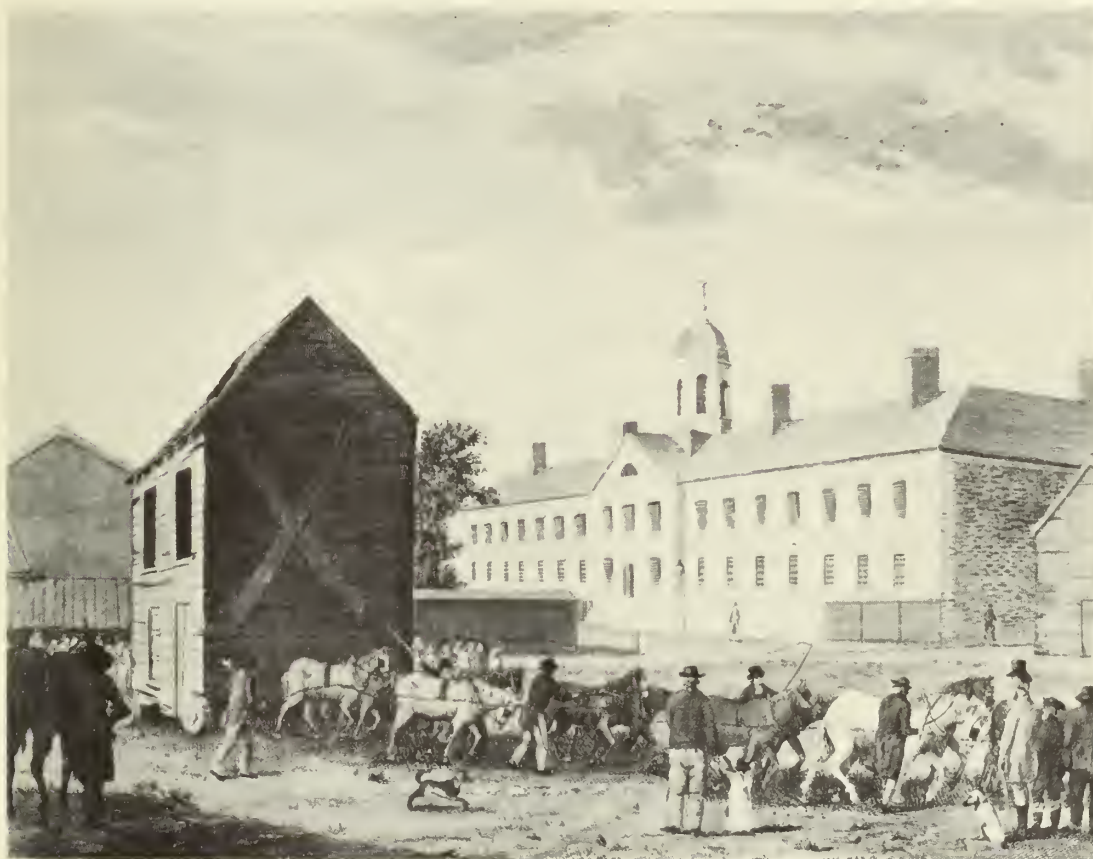
Figure 1. Moving a building in Philadelphia in 1799

One of the earliest illustrations to be found of house moving in America is this 1799 engraving by William Birch and Son, which illustrates a small frame building being moved by teams of horses.

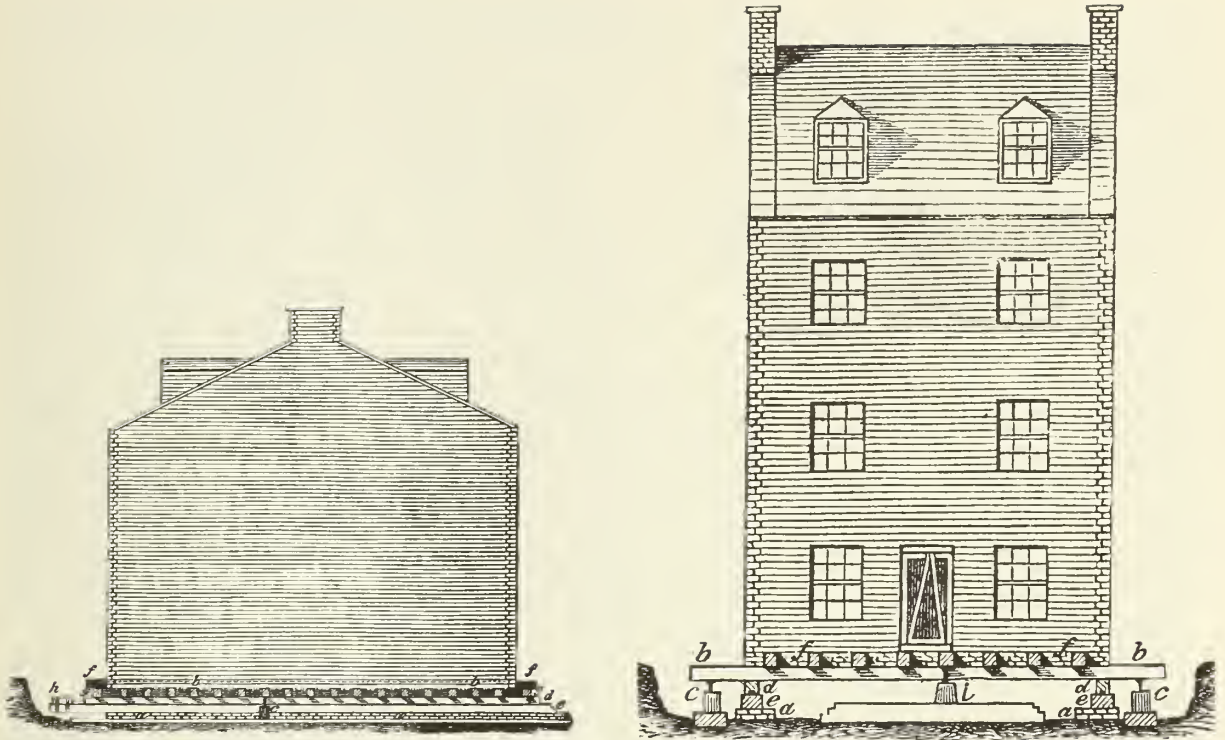
Figures 2–3: Moving a brick house in New York in the 1830s

When David Stevenson, a civil engineer from Scotland, published his "Sketch of the Civil Engineering of North America" in 1838 (an account of his three-month-long travels through the United States and Canada), his fascination with the phenomenon of house moving led him to include an entire chapter on this subject in his book.

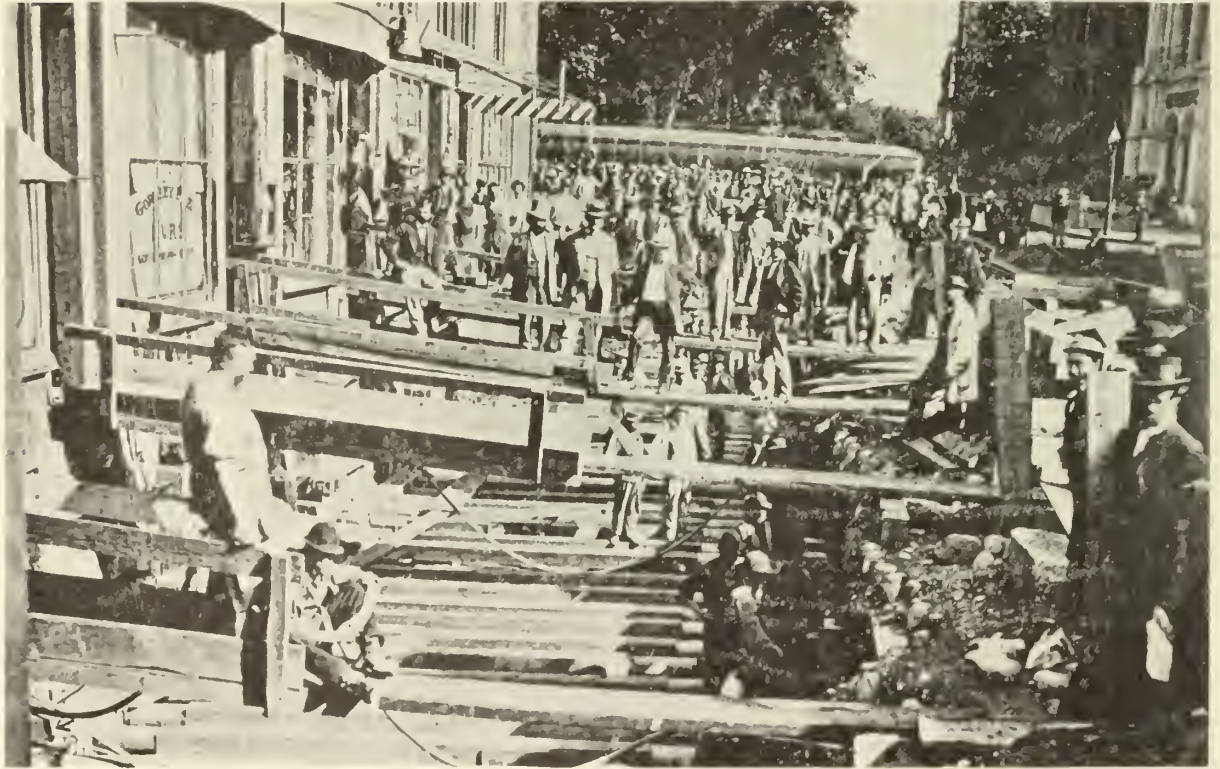
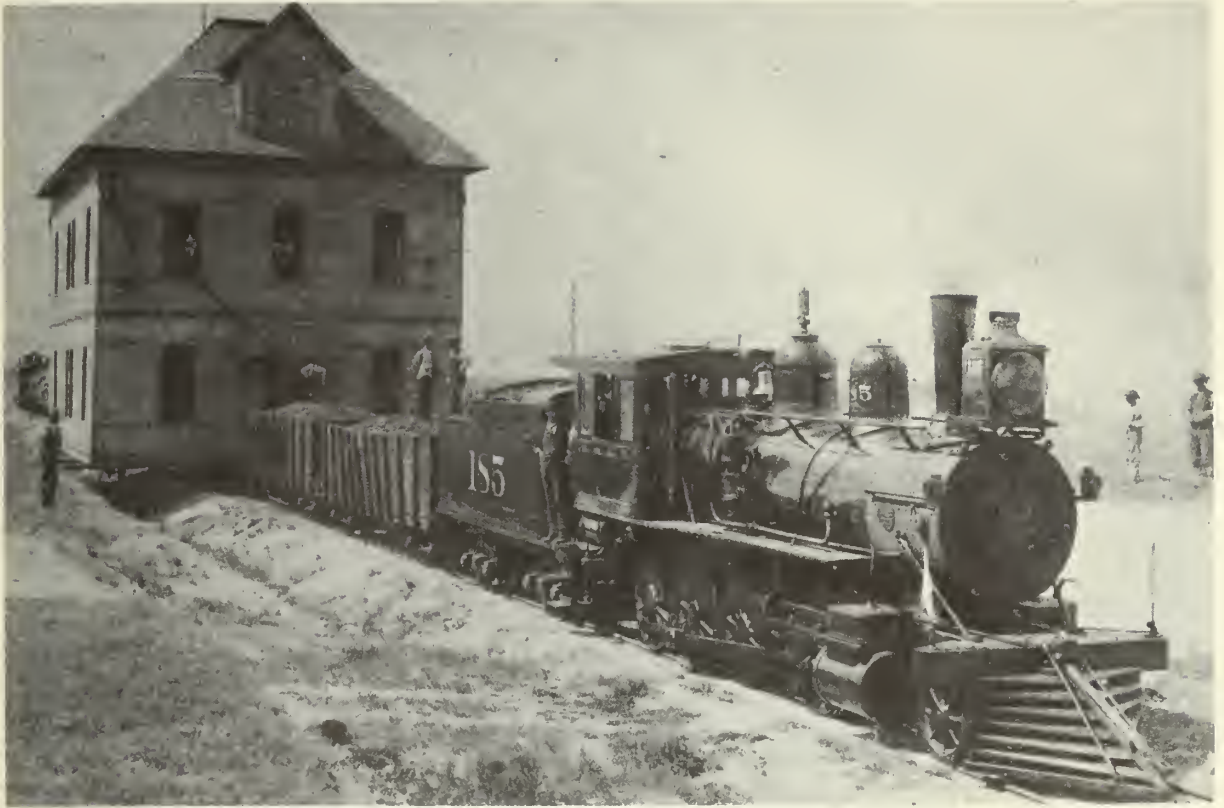
Figure 4: Hotel Pelham, Boston

Probably the earliest instance of the relocation of a large masonry structure took place in Boston in 1869, when the seven-story Hotel Pelham was moved back to permit the widening of Boylston Street. Constructed of freestone and brick, the building covered 5,800 square feet and its weight was estimated at 5,000 tons. According to a contemporary report in the *Journal of the Franklin Institute*, there was some question about the feasibility of such a move, but experts were consulted who declared it possible, as well as less expensive than the alternative of cutting off a portion of the front to allow for the widened street. The building was moved a total of 13 feet 10 inches at a rate of about 1 inch every 5 minutes. Through an elaborate system, incorporating a combination of 904 rollers and 72 screws, the structure was pushed along iron rails. The complete removal process took approximately 3 months, during which time the first floor businesses, and several of the apartment tenants remained in residence, with plumbing and gas services kept in continuous operation through the use of flexible tubes. [Photograph: Courtesy of the Boston Public Library Print Department]

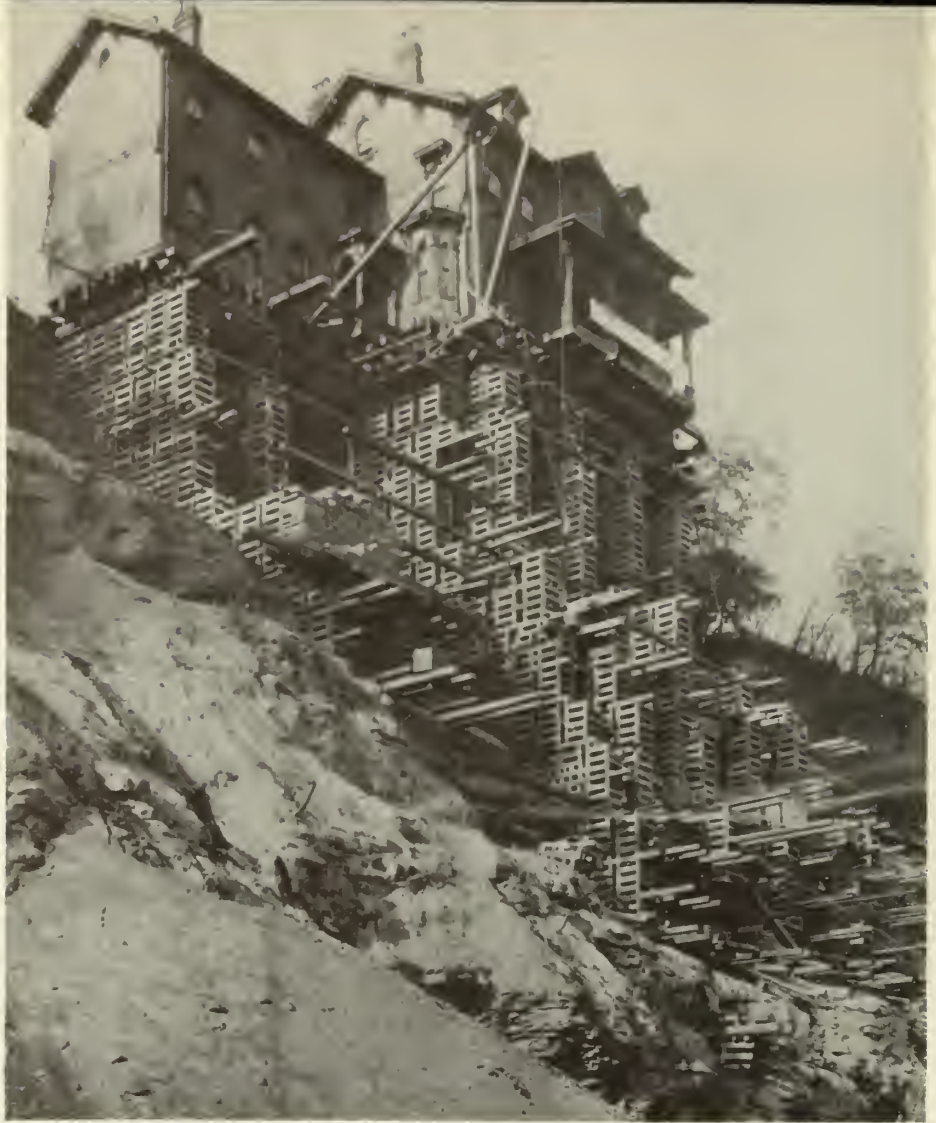
Figure 6: Captain Samuel Brown's Mansion, Brown's Station, Pennsylvania

The building was then raised a small amount at a time using hand jacks, so that eight walls of timber cribwork could be built up beneath it. This cribwork was strengthened by 8-inch by 8-inch waling pieces, and it was sway-braced by $\frac{1}{2}$ inch chains with turnbuckles. When the building had been raised 30 feet, it was pulled onto the first bench using two winches located at the top of the cliff. Each winch was driven by two horses, using 2-inch line with four-part blocks. This operation was repeated four more times until the house had been placed on its new site, 200 feet back from its former site and 160 feet above it. The move required over 20,000 wooden beams and timbers, which had to be transported to the site in twenty railroad cars. Because the \$40,000 cost of moving the Brown mansion considerably exceeded that of its original construction, it is believed that the move was undertaken primarily out of a desire to preserve a family inheritance. After such great effort, it is sad to relate that the structure was totally destroyed by fire 10 years later, in 1913. [Photograph: Courtesy of the Carnegie Library of Pittsburgh]

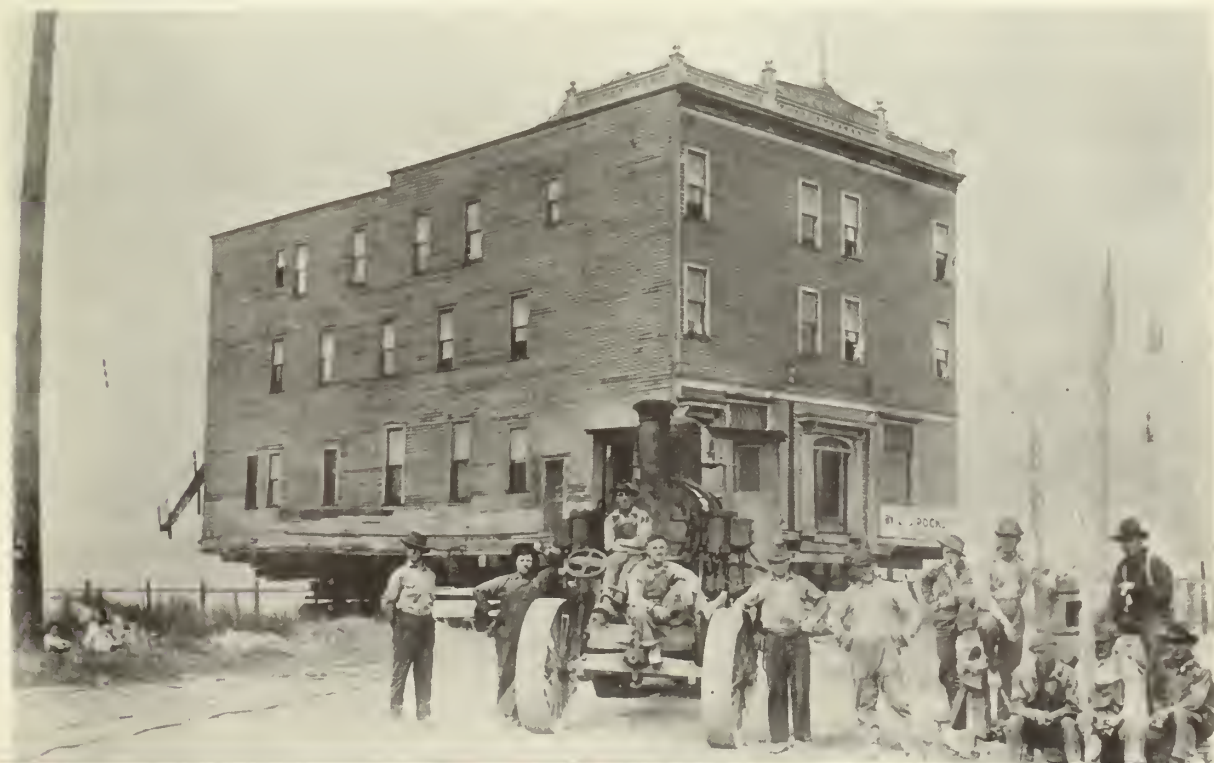
Figures 7–8: Hibbing, Minnesota

Discovery of a large vein of iron ore beneath approximately one-third of the town of Hibbing in 1919, led to possibly the most extensive building relocation project undertaken in the United States at that time. The structures within the sixteen-block area covering this vein of iron ore were gradually moved over a period of about three years to a new area on the outskirts of town. The immense scale of the project involved a great deal of manual labor and required considerable skill, as well as the use of numerous types of moving equipment: primarily steam locomotive tractors with traction belts and jacks, horse teams and wagons, and heavy trucks and logs.

These two photographs suggest the variety of buildings moved during this relocation project—including houses, a hotel, a church, the city market, clubs and many other commercial and private structures. Some buildings were constructed of brick and others of wood. The size of this project prefigured a similar project undertaken half a century later in Most, Czechoslovakia, in order to reach a rich vein of coal lying below the surface of the village. (See figures 12–17 for an illustrated description of that relocation project.)

In some unusual instances it may be necessary to contract with two building moving firms if one does not have sufficient equipment for the job. Sometimes it is possible for a contractor to rent additional equipment. Screw and hydraulic jacks, cribbing and bridging timbers, wheeled dollies, cranes, tractors, and trailers are the primary tools of the building moving contractor. During recent years even helicopters (figure 18), ships, and barges (figure 19) have been utilized in building relocation, while steam engines, train cars (see figures 5, 7, 8) and teams of oxen were commonly employed for such projects in earlier times.

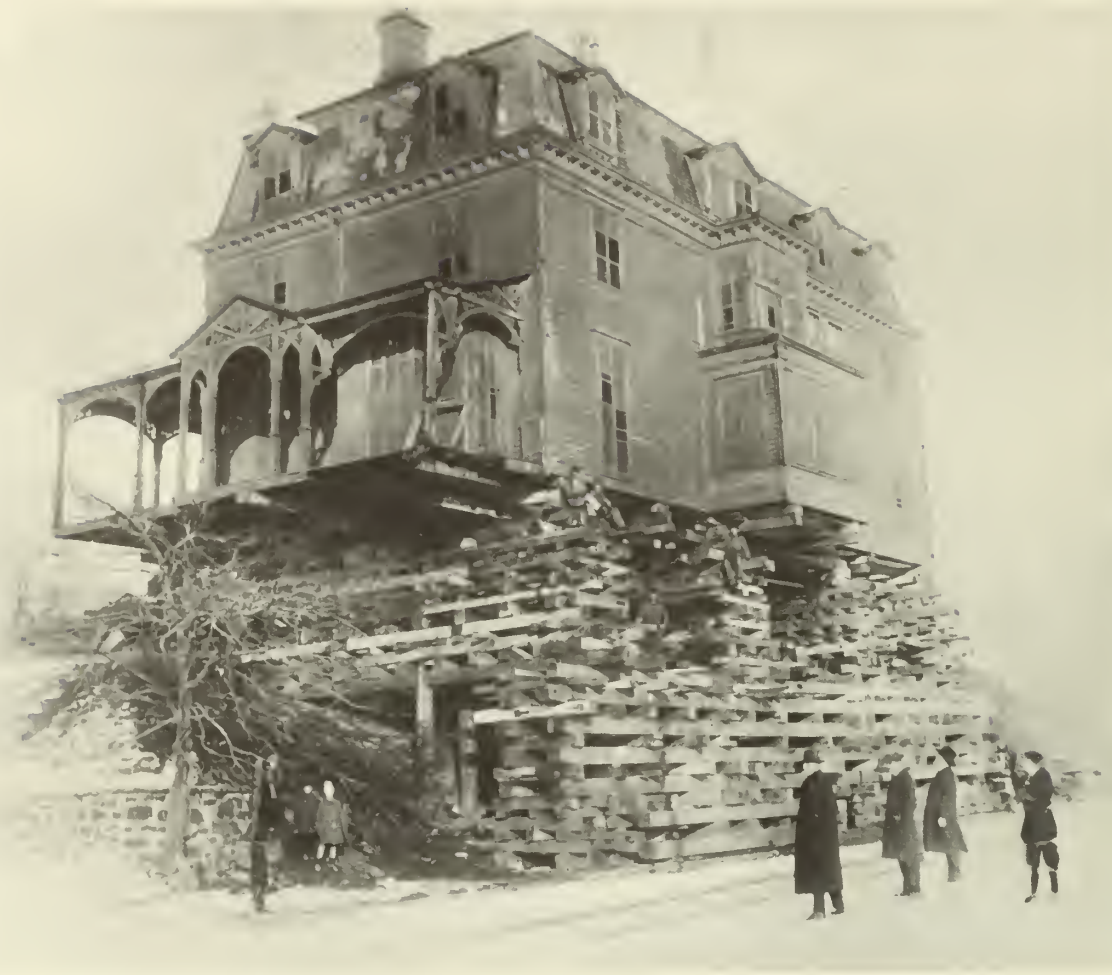
Figure 9: Perry Mansion, Bay Ridge, New York

In 1923 when the Perry Estate, the last remaining large tract in the Bay Ridge section of Brooklyn overlooking New York Bay, was to be broken up into smaller parcels of land, the 60-year old Perry Mansion was moved from its original and somewhat elevated location to another slightly lower site on the opposite side of a busy street. To further complicate the move, the roadway had to be kept open for traffic. The house was first jacked up and placed on cribbing, which was then extended to the edge of the roadway, and the house was moved on rollers to the end of the cribbing 28 feet above the street. Because the opposite bank was lower, enough of the cribbing under the house was removed to bring the house down to a height equal to that of the other bank. Cribbing was then built out from the other side, leaving a space large enough to allow the passage of cars. This opening was bridged with long heavy timbers, and the house was pulled across, where it was resituated 200 feet from its original location.

This view shows the Perry Mansion on its cribbing at the edge of the hill, prior to erection of the bridging across the street. This photograph was featured in the March 1, 1923 "Brooklyn Daily Eagle" [Photograph: Courtesy of the Brooklyn Public Library, Brooklyn Collection]

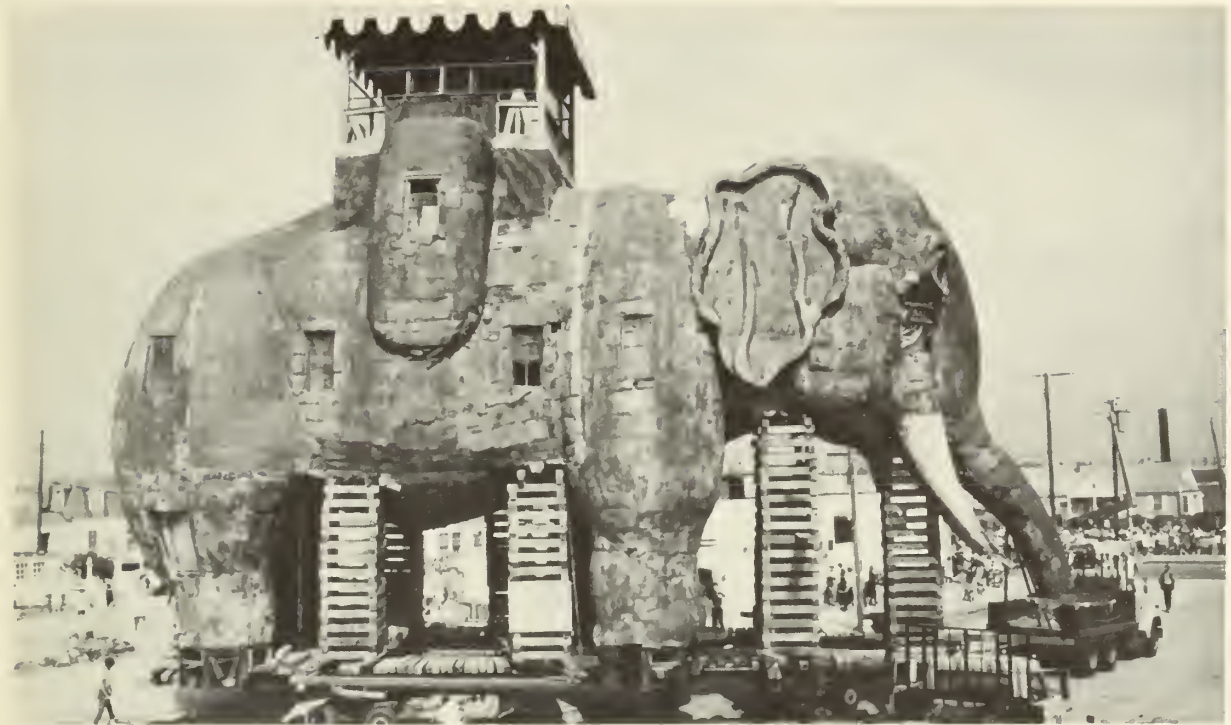
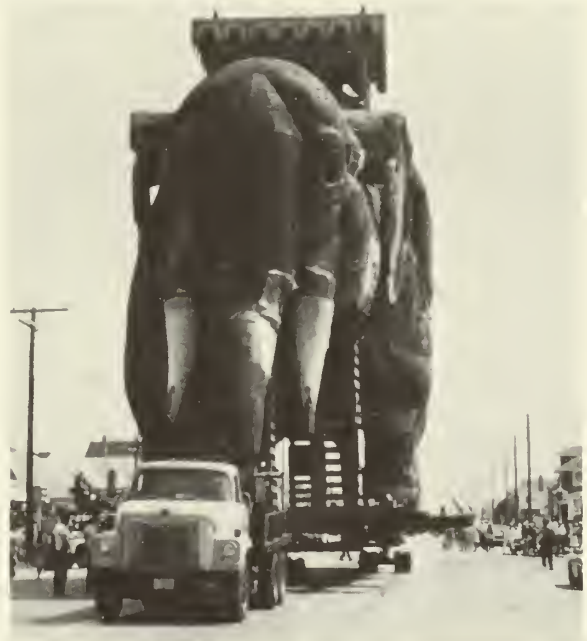
Figures 10–11: “Lucy,” The Margate Elephant

In order to carry out the move, “Lucy” was raised from her location by hydraulic jacks and wooden cribbing; she was placed on a heavy steel framework carriage and supported by three separate sets of wheels. Resting on this carriage, “Lucy” was towed to her new site and lowered onto her new foundation. The foundation consisted of five concrete pads for the four legs and trunk, each 10 feet square by 3 feet deep, which were set on 26 foot long wooden pilings driven into the sand.

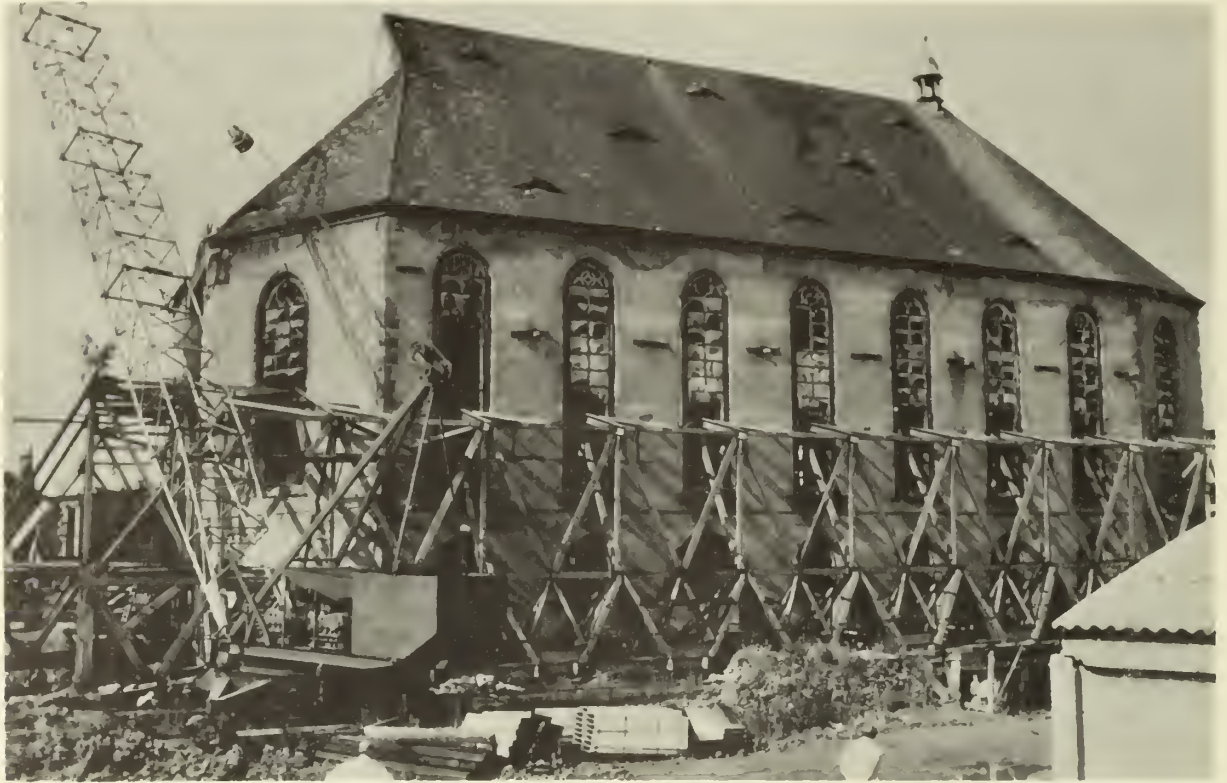
Figure 12: The first step in the moving process was to remove the later addition of a tower (not seen here). Then a steel girdle was constructed, approximately 197 feet long by 97 feet wide by 103 feet high, to encircle the structure. [Photograph from a slide by Jack E. Boucher, 1975]

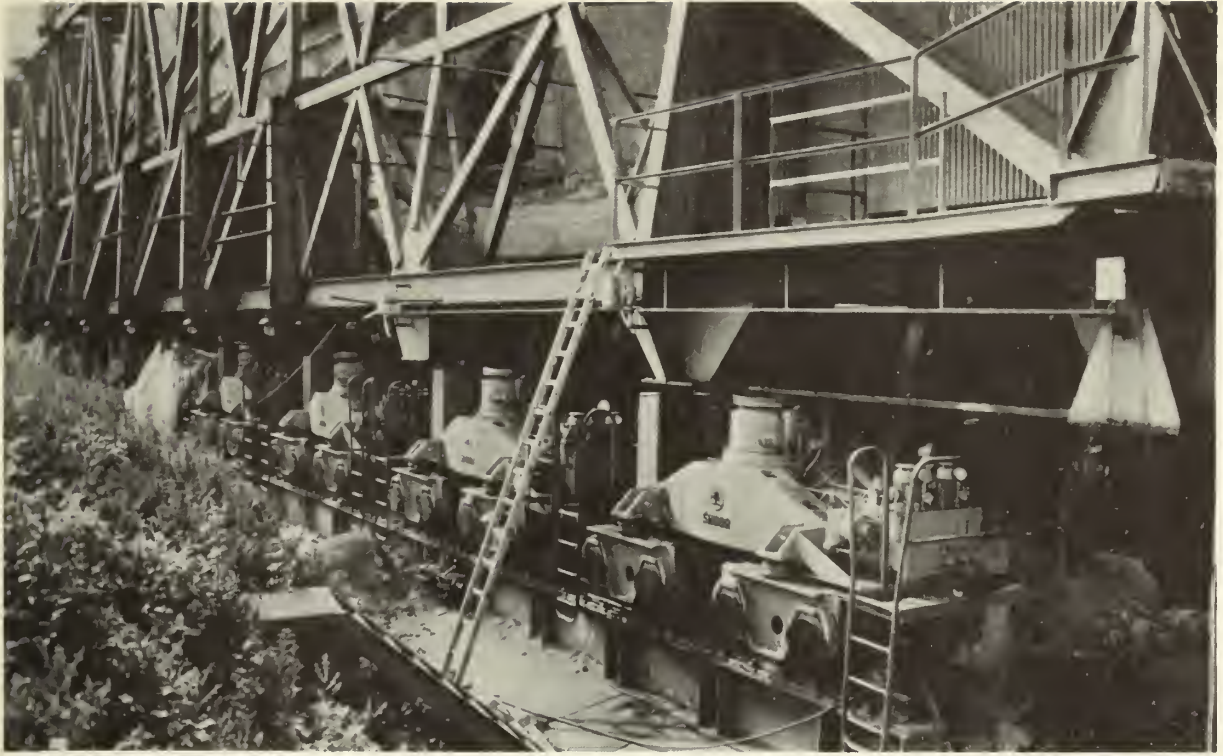
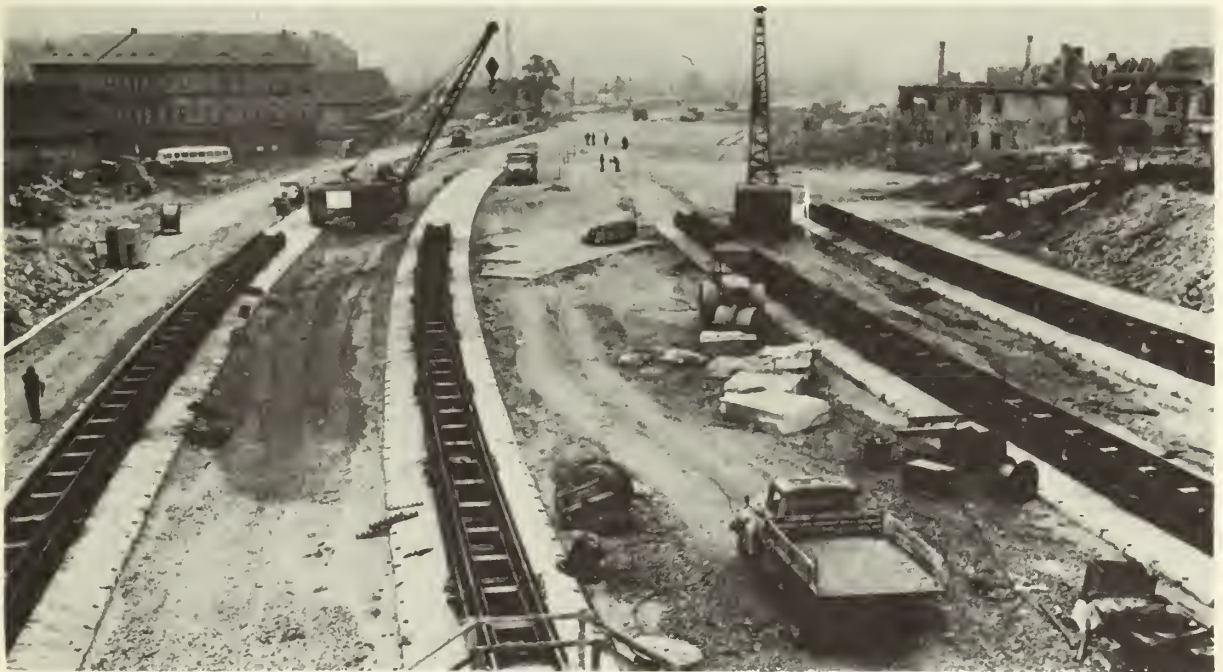
Figures 13–14: The weight of the church and its steel supportive superstructure, together totaling 10,560 tons, was raised to allow the emplacement of more than 50 trolleys (figure 13) which carried the church over four sets of train tracks to its new site (figure 14). [Figure 13 from a slide by Jack E. Boucher, 1975. Figure 14 photograph by W. Preiss, Dresden, 1975, courtesy of Jack E. Boucher]

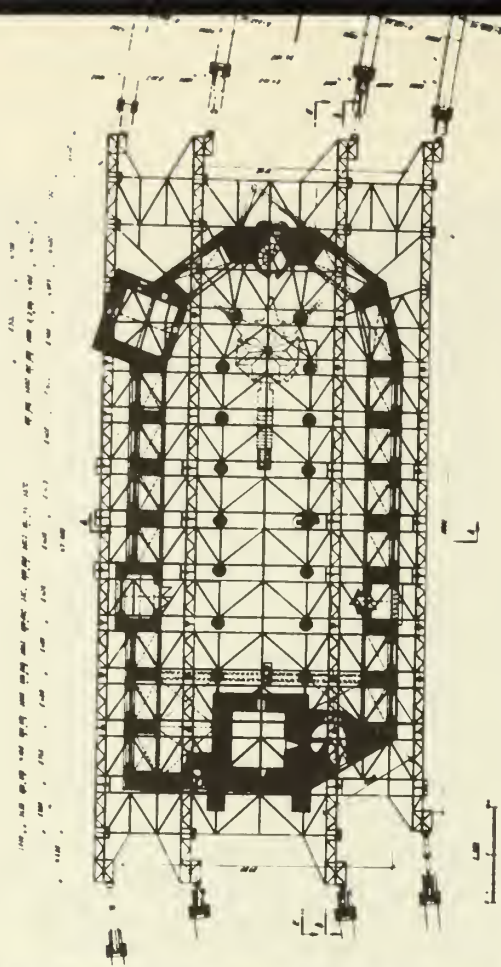
Figure 15: This diagram illustrates the detailed system of exterior and interior bracing used to support the church, and the route it was to follow during the move. [Photograph: by W. Preiss, Dresden, 1975, Courtesy of Jack E. Boucher]

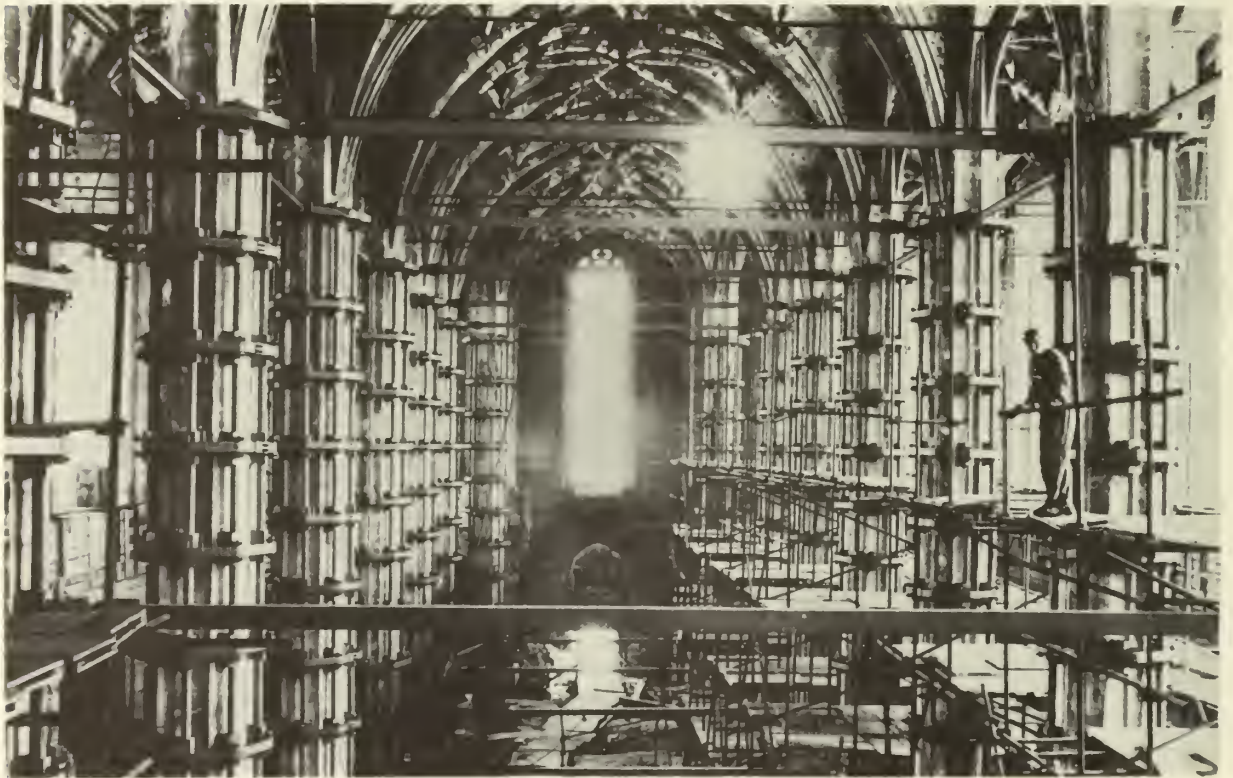
The steel supports encasing the piers were then connected longitudinally by steel beams which were in turn supported by the addition of vertical steel beams between every two piers. This same bracing system was further reinforced by a similar arrangement of tie beams extending across the width of the church. Such thorough supportive measures were necessary to ensure that the interior angles of the church remained constant during the move. Even though the church was moved very slowly (approximately 1 inch per minute), a specially designed hydroelectric stabilization system was developed using two Hewlett-Packard 9821 calculators which continuously monitored any possible shifting in the church structure. This system was linked to sensors attached to the trolleys, and any change in the alignment of the structure, as minute as $\frac{1}{25}$ of an inch, was equalized with the assistance of the computers. [Photograph: W. Preiss, Dresden, 1973, courtesy of Jack E. Boucher]

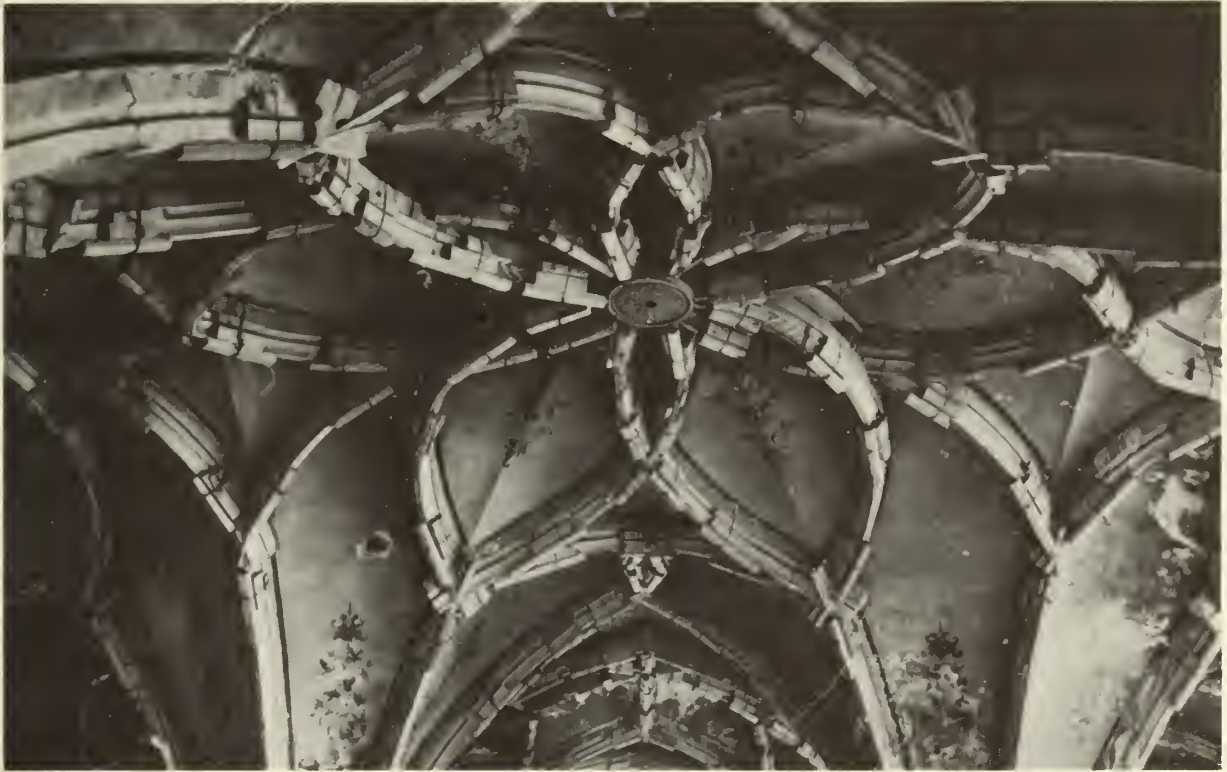
Figure 17: This photograph further illustrates the elaborate measures taken to stabilize the structure. The groins of the intricately detailed lierne vaulting were braced to cushion them from possible shocks during moving, and to make certain that this area of the church was tied into the monitoring system. [Photograph from a slide by Jack E. Boucher, 1975]

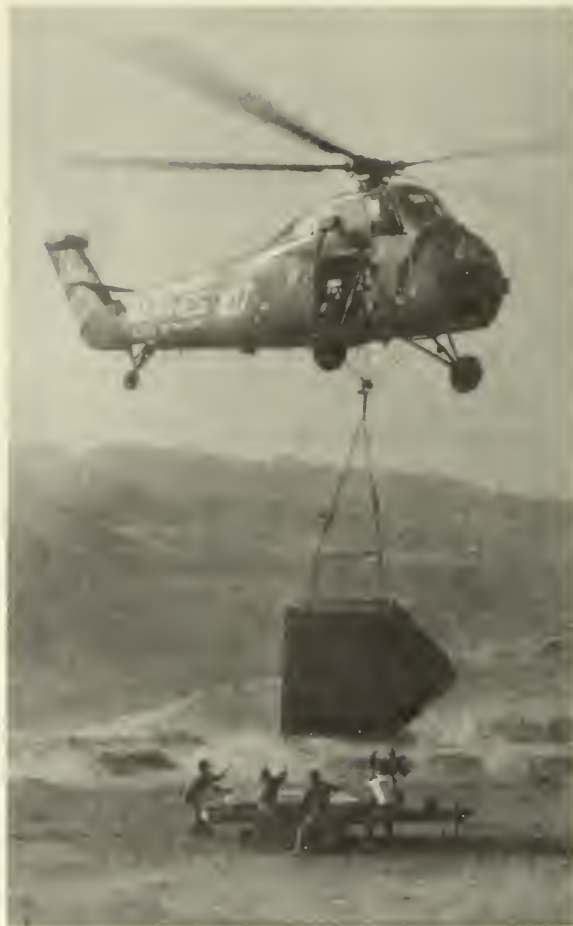
Figure 18: Moving by helicopter

Illustrated here is a less traditional method of moving a small building. When Mystic Seaport decided to acquire this little "Halfway House" in 1968, it was apparent that its location on sand dunes, halfway between two life-saving stations on Cape Cod, made it quite inaccessible and almost impossible to remove using conventional land or sea vehicles. With the help of the U.S. Marine Corps, the Halfway House was airlifted onto a flat-bed trailer which had been placed in a nearby visitor parking lot. The process was complicated by the blowing sand raised by the rotating helicopter blades, and by the unexpected weight of the Halfway House which caused a loss of engine power, endangering the helicopter and operator. Only after the excess fuel was drained from the helicopter could the building be lifted safely and removed to the trailer, on which it was transported to its new location at Mystic Seaport. [Photograph: Courtesy of Mystic Seaport, Inc.]

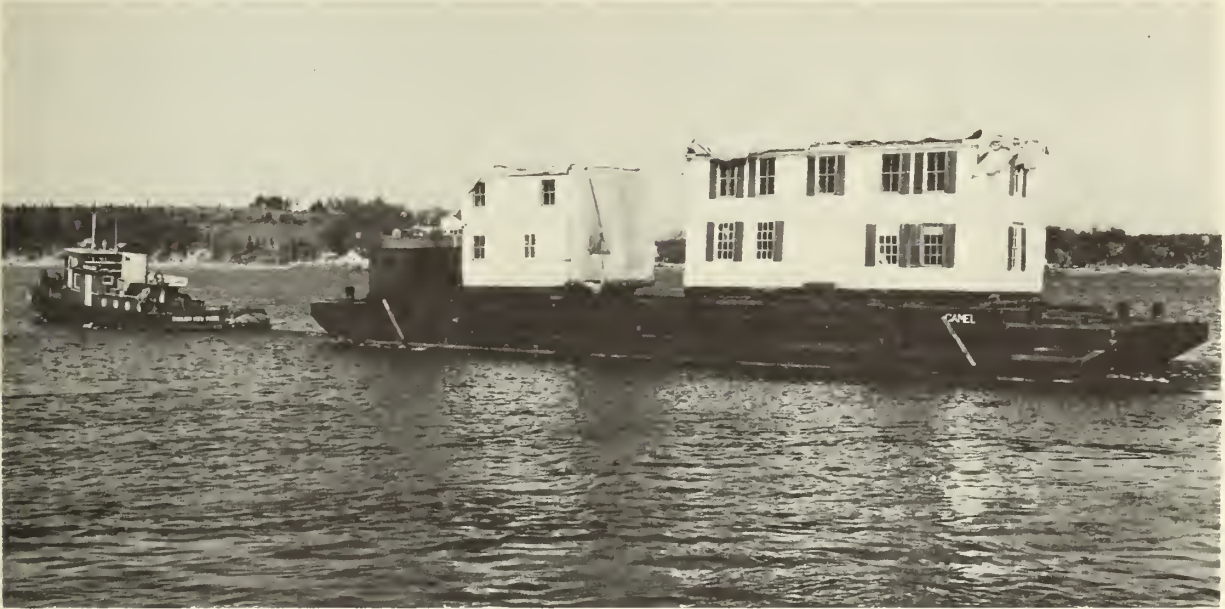
Figure 19: Moving by barge

In order to move the house, the main section, built in the second quarter of the 18th century, was separated from the kitchen addition in the rear. (Interestingly enough, the kitchen section was built in the 1690s and had been moved and attached to the main house in the 18th century.) The roofs of both sections were removed, and their openings covered as protection against the elements. Both were placed on a barge and shipped to Mystic Seaport, where the sections were reassembled and set on a new foundation and the house restored to its 18th-century appearance. [Photograph: Courtesy of Mystic Seaport, Inc.]

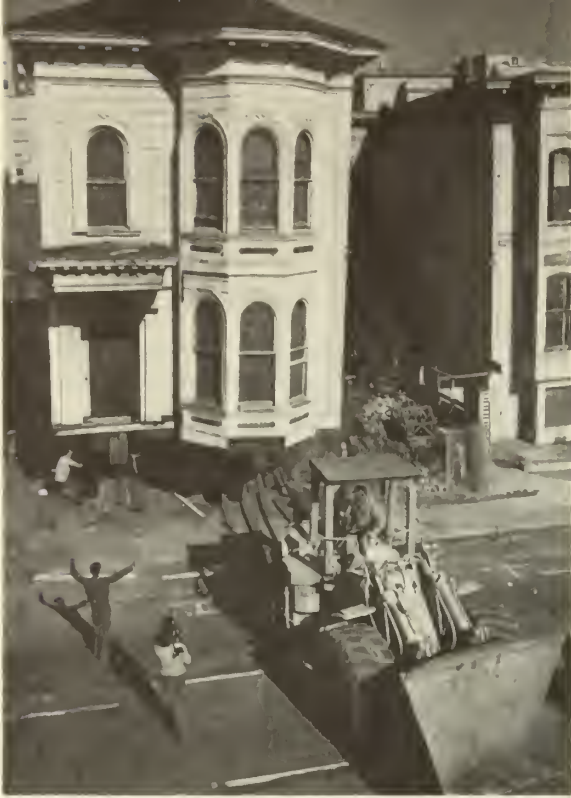
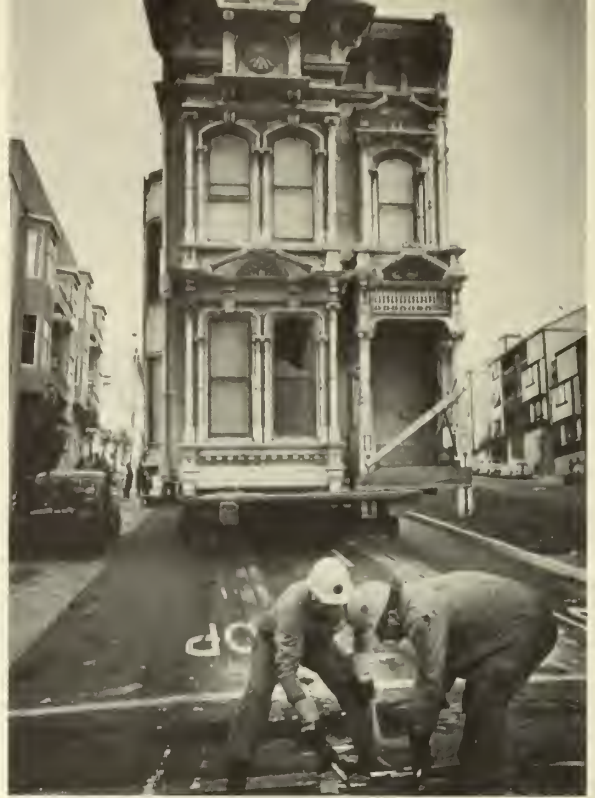
Figure 20: House moving in San Francisco

On three successive weekends in November 1974, twelve late 19th-century frame houses in San Francisco, such as the ones pictured here, were moved intact from their original locations within a "fire zone" to the Western Addition, a section of the city in which wood frame structures are permitted. These structures had been put up for public sale in 1972 by the San Francisco Redevelopment Agency (SFRA) as part of an ongoing effort to decrease the threat of fire by removing all frame buildings from this area of the city. The houses were purchased by the Foundation for San Francisco's Architectural Heritage, which in turn found buyers for the buildings. The new owners were required to demonstrate the ability to pay for the costs of purchasing the relocation site, installing a new foundation and utility hookups, and restoring the houses, but the move was carried out by the SFRA. Because all of the houses had been designated city landmarks and/or were listed in the National Register (through the efforts of the SFRA staff), the SFRA was eligible to receive Federal funds to help defray the costs of the move. [Photographs: Jeremiah O. Bragstad for the San Francisco Redevelopment Agency]

The relocation of a building as a single and intact unit is generally the most desirable method (figure 20). Not only are the labor costs of dismantling and reassembling avoided, but more importantly, the original fabric is preserved (figure 21). No matter how skilled the artisans who disassemble the building, the loss factor increases with the scope of the dismantling process.

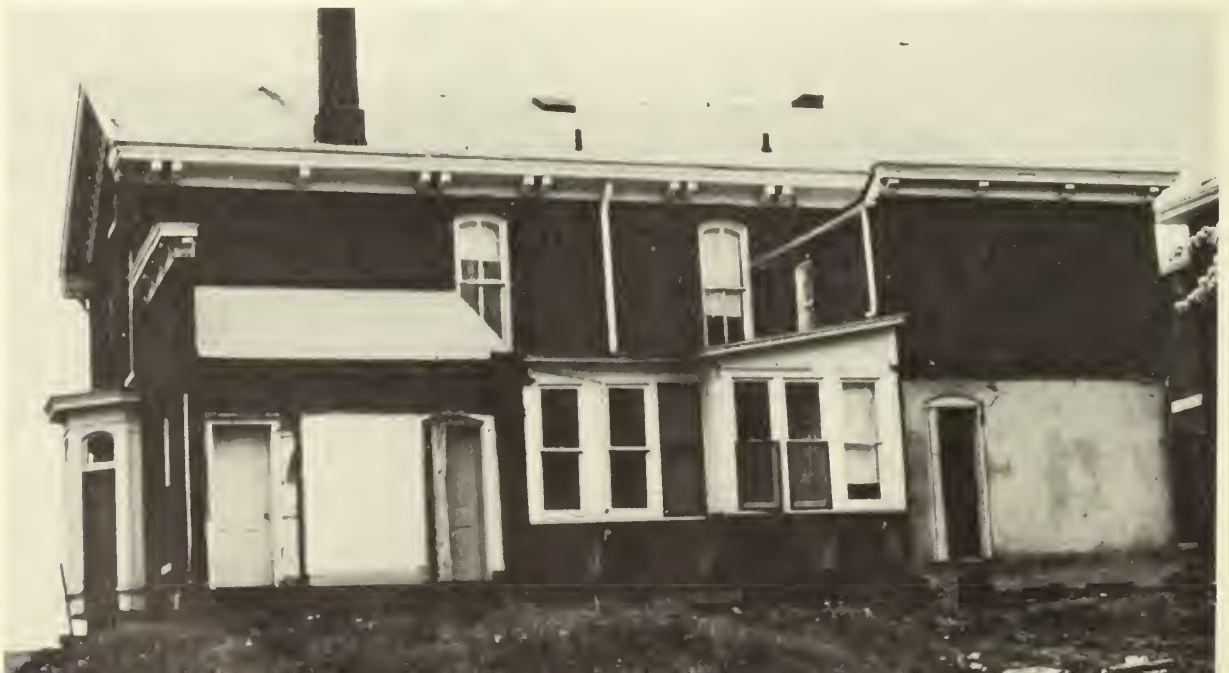
Figure 21: Alexander Clark House, Muscatine, Iowa

In planning the relocation of a structure that has been enlarged several times over the years, it is often assumed that the additions (especially if they are of masonry), will have to be removed from the main section of the building and moved separately. One can see from this photograph of the Alexander Clark House that it was successfully moved with its several "appendages" still attached, thus avoiding the problem of rejoining them to the main building after the relocation. [Photograph: Courtesy of Elizabeth Leach]

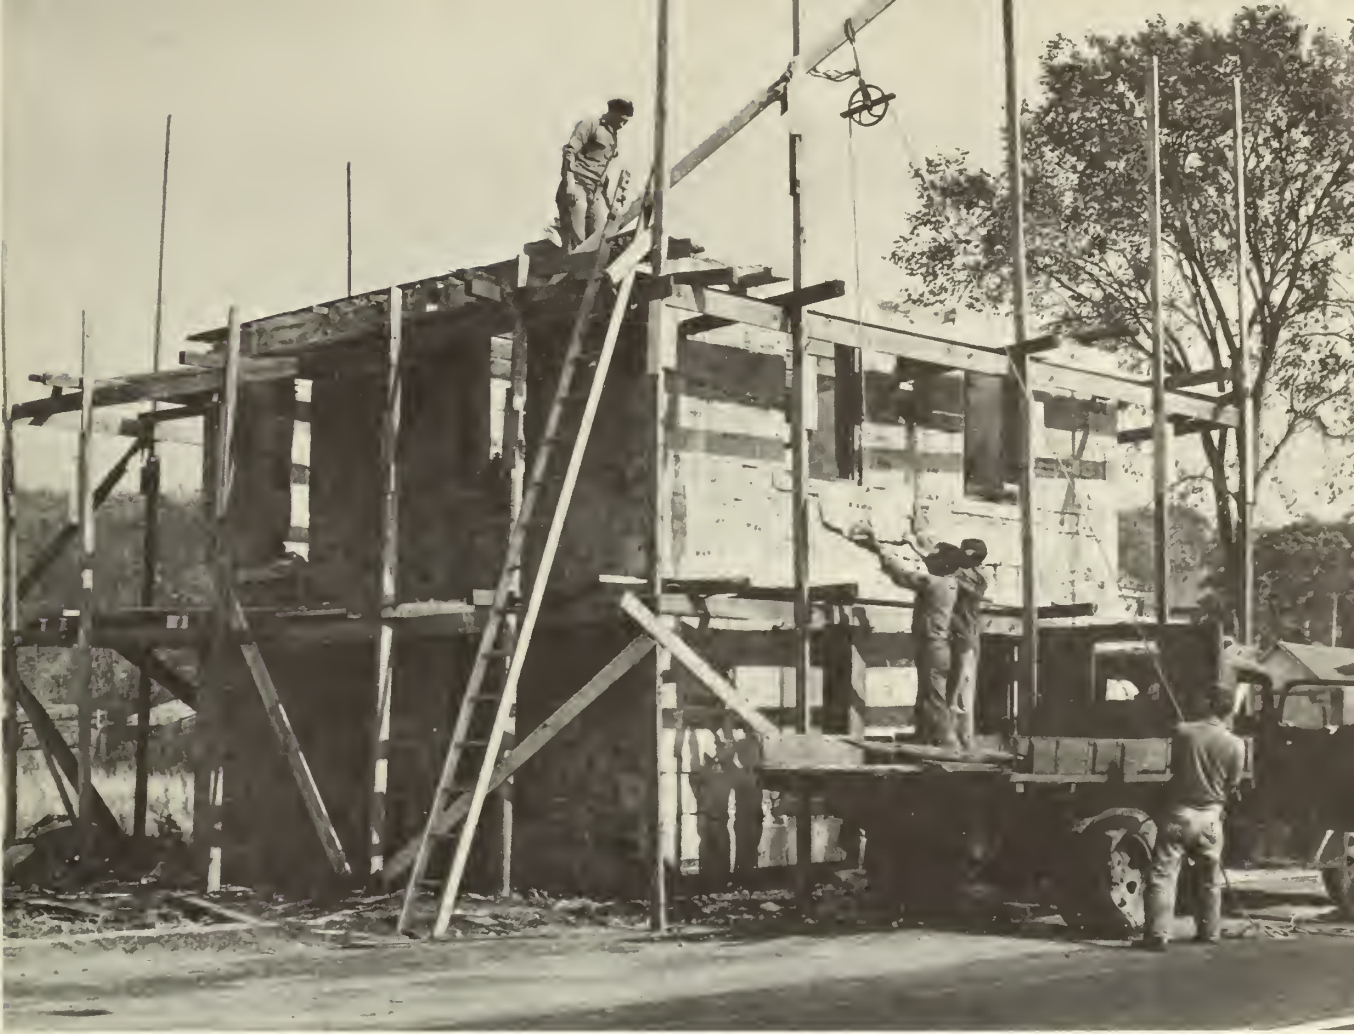
Figure 22: Disassembly of a stone masonry building in Mystic, Connecticut

The 1833 Mystic Bank, a stylistic mixture of Federal and Greek Revival, was acquired by Mystic Seaport, Inc. in 1947, following almost 70 years of disuse. In order to move the structure, each of the building stones was carefully marked according to orientation and numerical arrangement. Then the building was disassembled stone by stone, and reassembled on the grounds of Mystic Seaport where it remains the second oldest bank building in Connecticut. [Photograph: Courtesy of Mystic Seaport, Inc.]

Breakage and consequent loss of masonry units varies, depending upon the potential friability of the masonry units themselves and the nature of the mortar (figure 22). Most mortars used after the third quarter of the 19th century contain some portion of Portland cement. These mortars, because of their strength and bonding capabilities, are very difficult to remove from most stones, such as sandstone, marble, and from brick. Even with minimal attrition, the texture and coloration of the original masonry wall is extremely difficult to reproduce faithfully. Aside from the actual physical loss of original fabric, which cannot be avoided during the complete dismantling of a structure, there is the very unfortunate loss of the originality that is part of an undisturbed building.

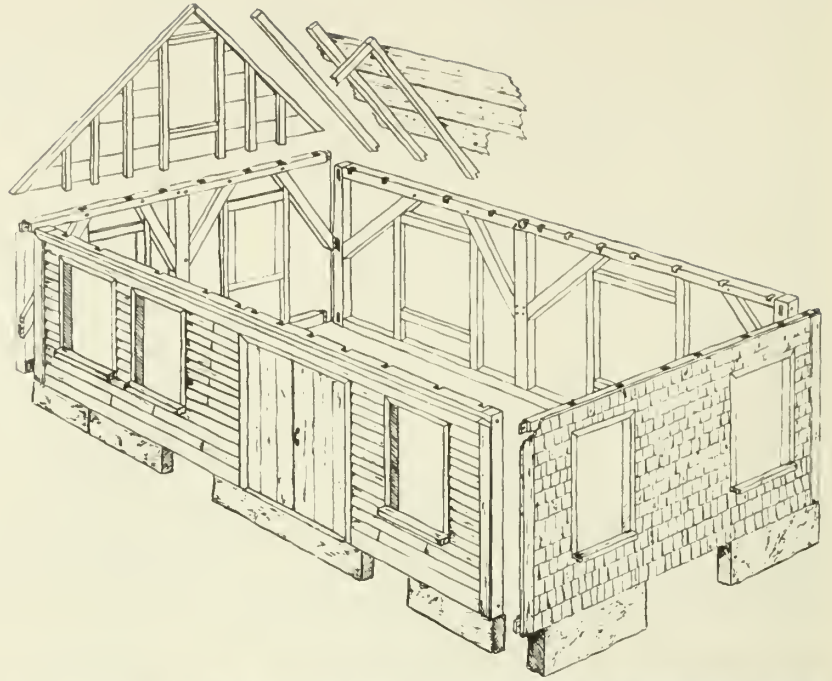
Figure 23: A schematic drawing of the circa 1830 Hapgood Carding Mill in South Waterford, Maine, details a method of partial disassembly. Roof components must be marked and disassembled in their entirety prior to separating the remainder of the structure into six major elements. [Sketch by John O. Curtis, Old Sturbridge Village]
