Moving Historic Buildings

John Obed Curtis

U.S. Department of the Interior
Heritage Conservation and Recreation Service
Technical Preservation Services Division
Washington, D.C. 1979

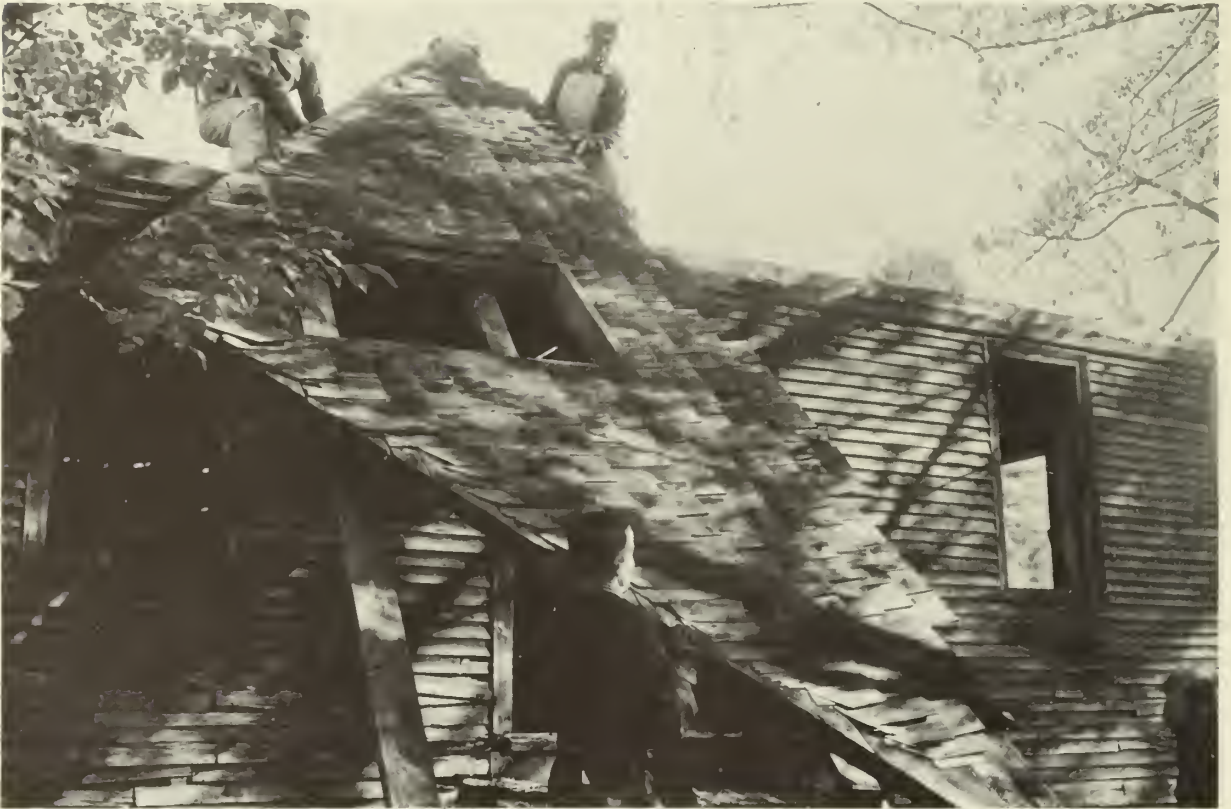
Figure 24: The entire gable end of the Hapgood Carding Mill is handled as a unit in a partial disassembly. [Photograph: John O. Curtis, Old Sturbridge Village]

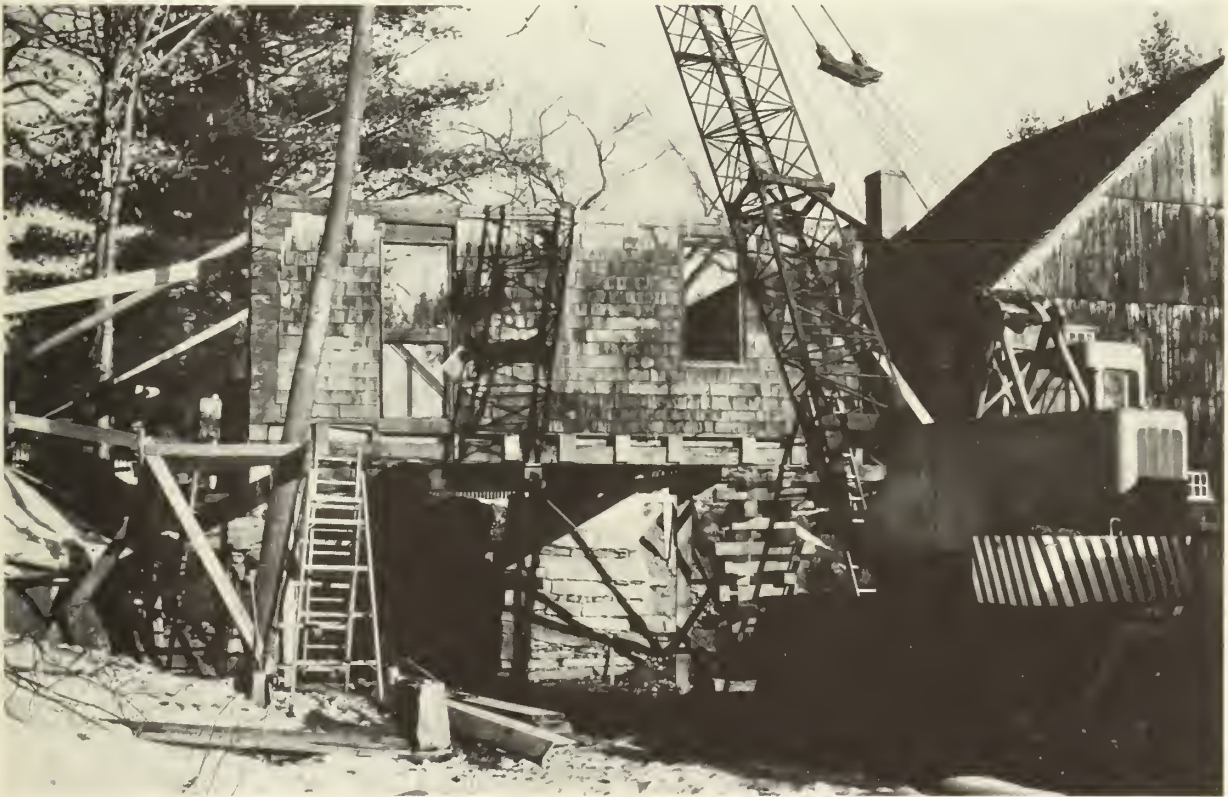
Figure 25: Using a crane to reassemble a wall unit

Using a crane, the entire end wall of the Hapgood Carding Mill is hoisted into position atop a reconstructed foundation (at left) and timber cribbing (at right). Partial disassembly of a frame building expedites reconstruction and conserves original fabric. [Photograph: James C. Ward, Old Sturbridge Village]

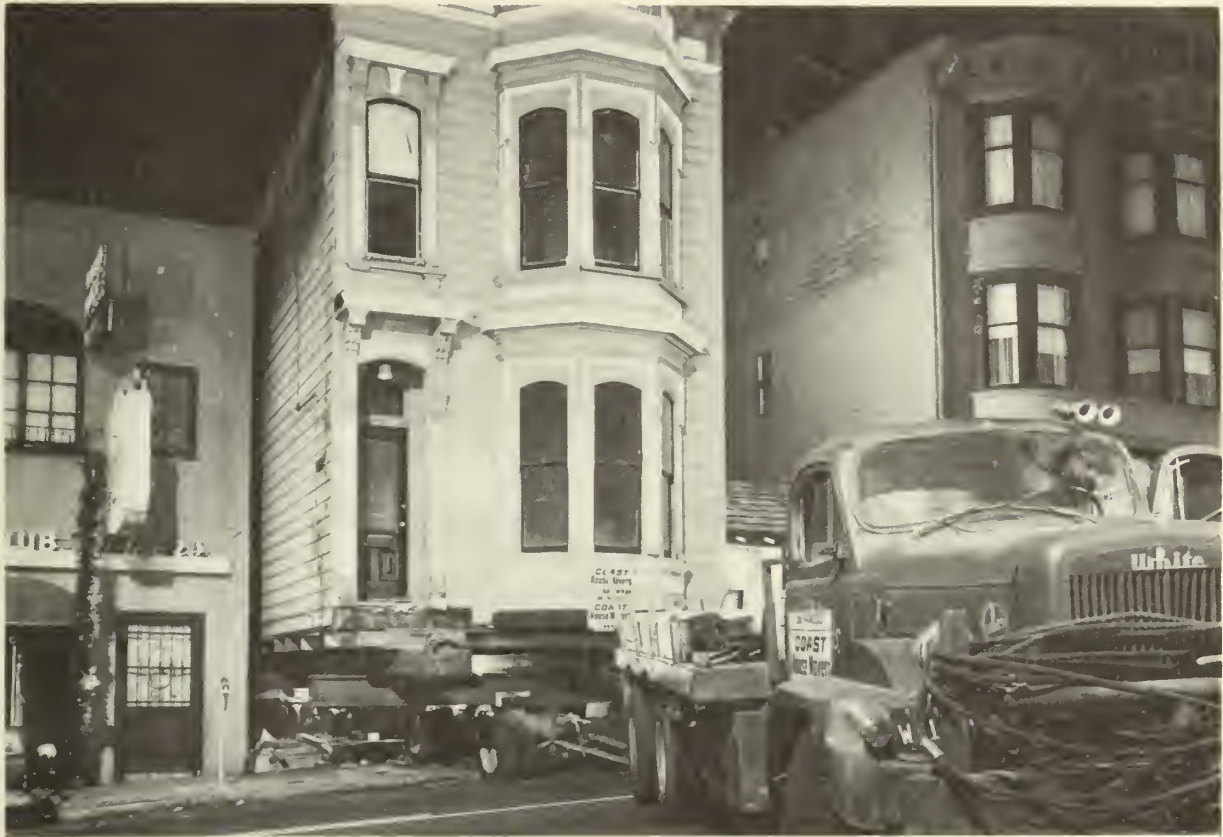
Figure 26: Housemoving in tight spaces

This view of another of the twelve Victorian houses relocated by the San Francisco Redevelopment Agency (see figure 20) clearly illustrates two difficulties attendant on moving buildings in built-up urban areas. Space in which to maneuver heavy equipment and the building itself may be severely limited, making the move more difficult, but no less attainable. Secondly, the move itself may have to take place at night, in order to avoid massive traffic tie-ups and rush-hour delays. [Photograph: Jeremiah O. Bragstad for the San Francisco Redevelopment Agency]

traffic-control duty during the actual move. If the duration of the move is likely to take several days, traveling at an average speed of 3 to 4 miles per hour, then provision must be made for surveillance or police protection while the structure is parked during the intervening nights. In planning the travel route for a move of several days duration, parking sites should be carefully selected and permission for their use secured in advance. In some areas, especially in cities, building moving must be done at night rather than during daylight hours; thus, provision must be made for daytime parking accommodations (see figure 26).

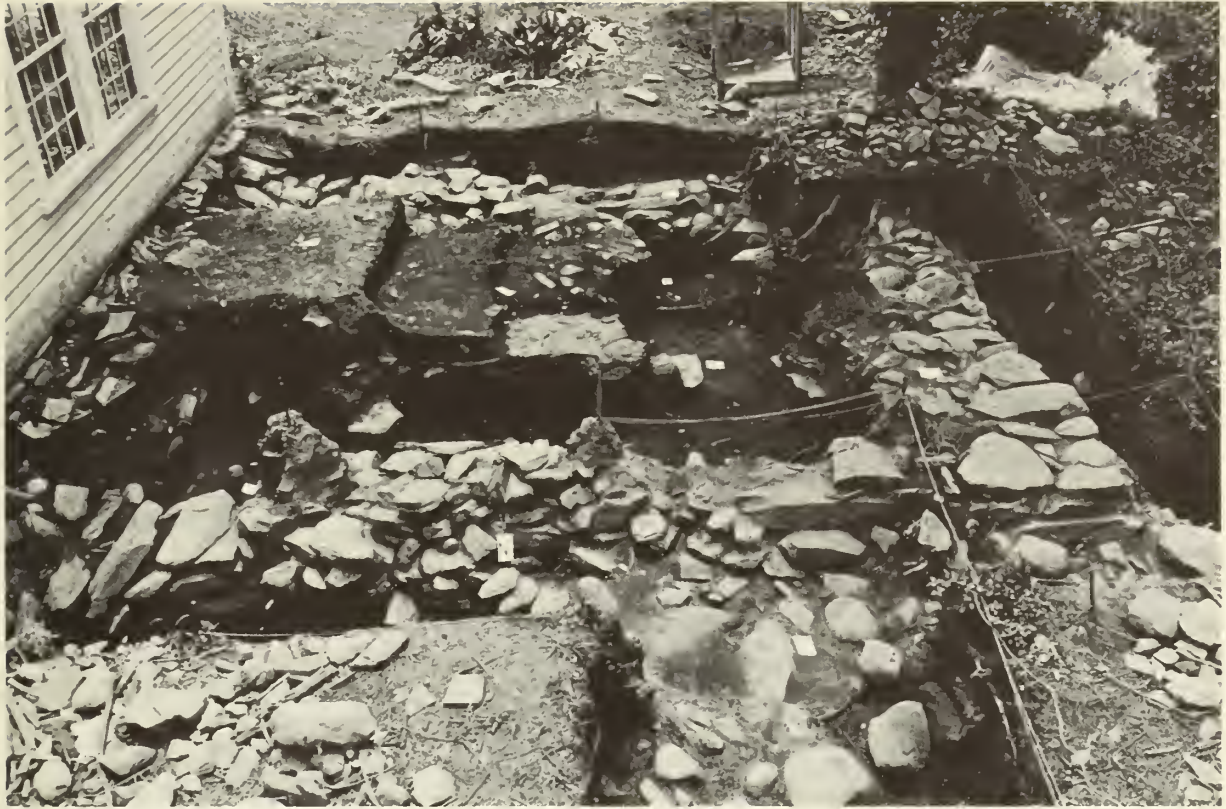
Figure 27: Excavation of a historic site

Site archeology may bring to light significant and vital information about a structure's previous configuration, as in this instance where the earliest part of the building survived only into the opening years of the present century. Through excavation, the dimensions of the ground plan were accurately ascertained and subsequently provided the basis, along with old photographs, for an accurate reconstruction of the missing elements. [Photograph: John O. Curtis, Old Sturbridge Village]

Once a chronology of owners is established, the researcher can turn to other documentary sources for additional clues to structural changes or the physical evolution of the building (figure 27). If extant, tax records, assessors' records, and insurance records may be valuable in that they usually contain somewhat more detailed descriptions of the structure. References to square footage of ground plan, number of stories, type of construction, number of windows, number of chimneys or fireplaces, and outbuildings are often contained in these records. If authentic furnishing of the building is contemplated, then a search of probate inventories should be conducted in the county probate records office to see if the pertinent estates were inventoried at the time of death of the owner(s). Such room by room inventories are not only of great assistance in developing furnishings schedules, but also they may provide clues to former decorative treatment of particular spaces through brief descriptions. In the case of those former owners who did not die intestate, registered wills may provide the same types of information.

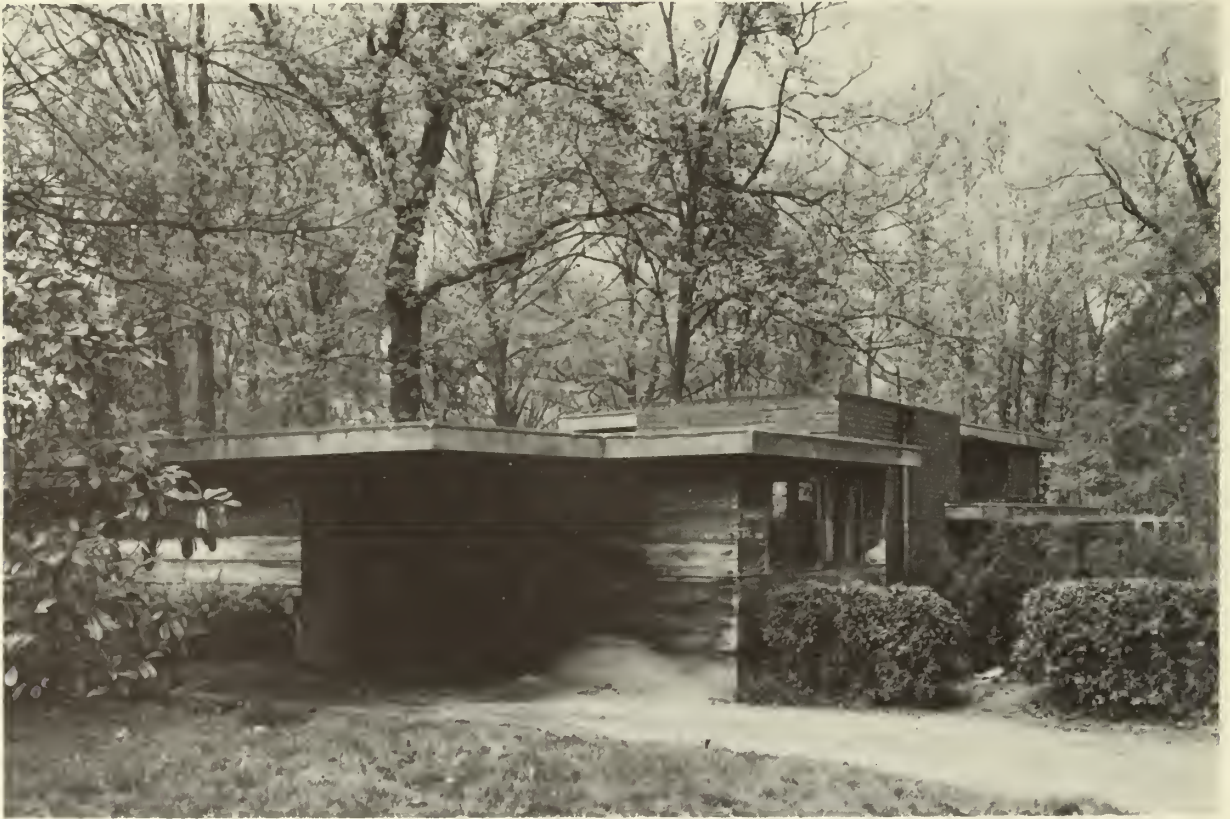
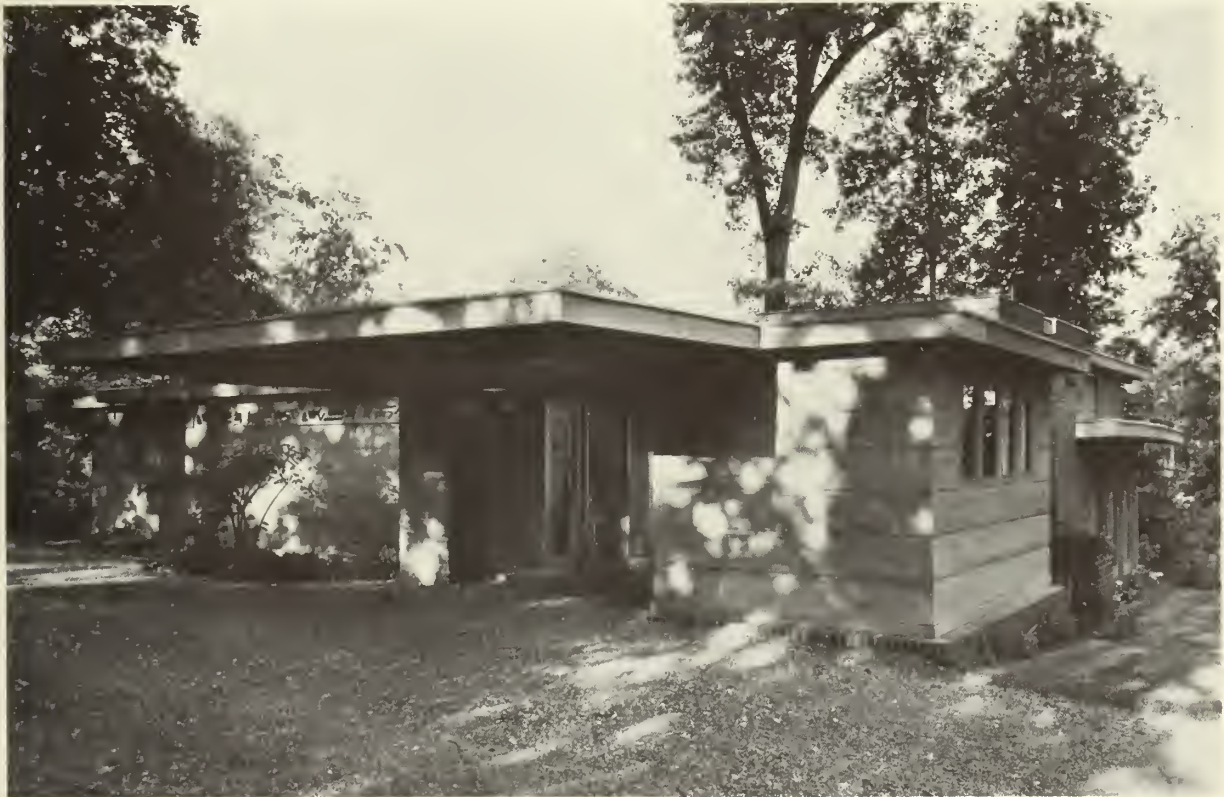
Figures 28–29: A Suitable site for relocation of the Pope-Leighey House

Selecting the proper relocation site is always a significant aspect of building moving, but it is even more important when a Frank Lloyd Wright designed house is involved because of the close relationship between his houses and their natural surroundings.

Comparing the terrain of the original site (figure 28) with the new site (figure 29), one can see that the Pope-Leighey House has indeed been successfully integrated into its new site. [Photographs: Courtesy of the National Trust for Historic Preservation]

Selection of a new site for the relocated structure requires careful planning well in advance of the actual move. It is desirable to find a setting as much like the original as possible (figures 28 and 29). Some earlier architects gave careful consideration to the relationship of the building to its setting. The sensitive preservationist should not compromise a structure's design integrity with a setting that is unsympathetic or incompatible with the original. Buildings of a classical design generally have a principal façade that requires a particular orientation to do justice to the entire structure. (Imagine a prostyle Greek Revival mansion sideways on its lot!) Architects often used mouldings to decorate a building; it is the play of light and shadow that gives these architectural mouldings their distinctive and decorative character. When choosing a site for

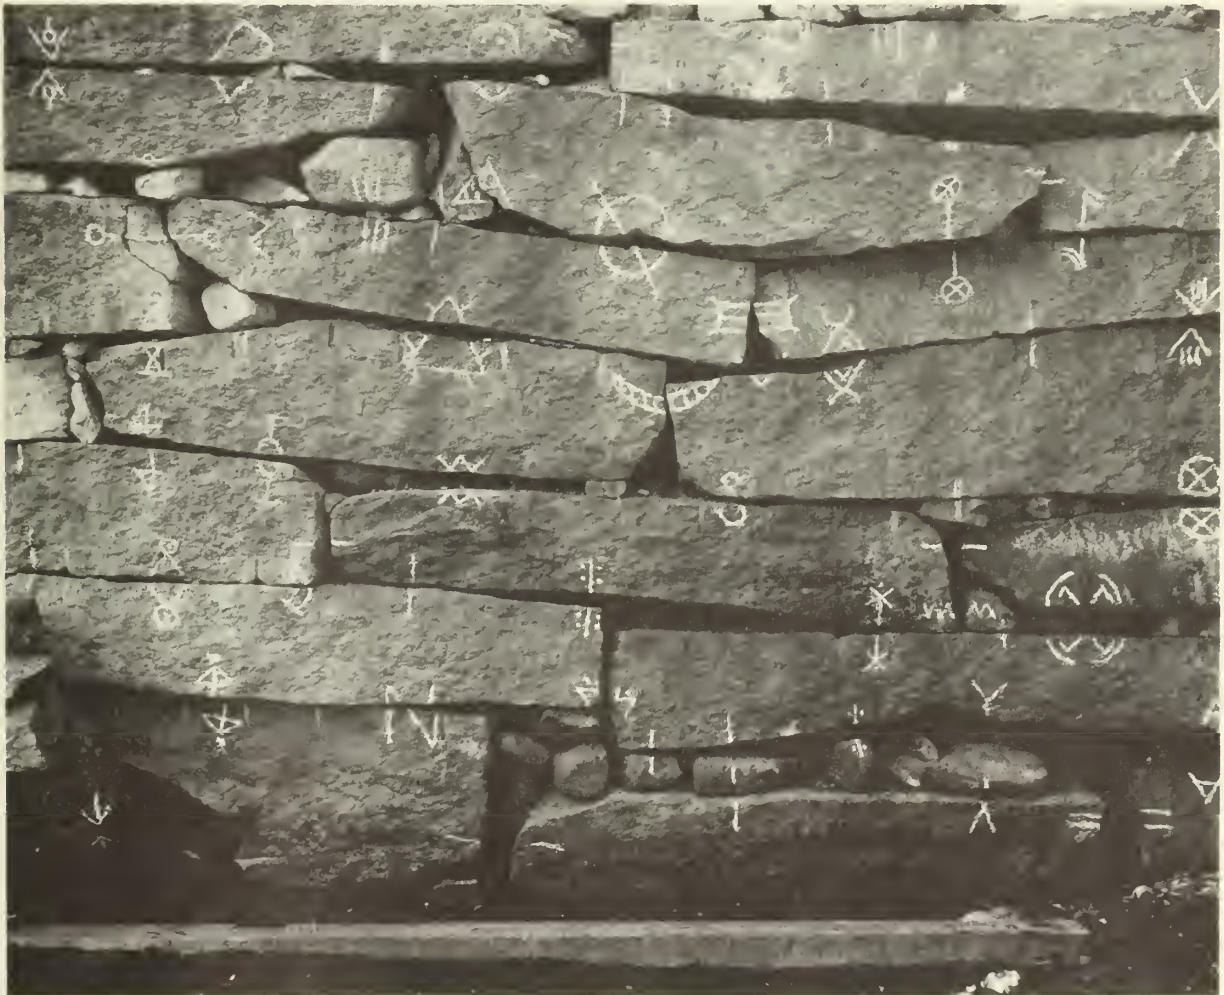
The unique character and disposition of rubble or fieldstone masonry requires a careful marking system to assure proper realignment during the reassembly process. In this instance, an impromptu chalk marking system was utilized to expedite the removal process. Stones were subsequently assigned identification numbers which were painted on the top surfaces.

For cut-stone masonry, a simple system of numbers and letters (to indicate orientation) may suffice, but it is important that the numbered wall be photographed prior to disassembly to facilitate reerection. [Photograph: John O. Curtis. Old Sturbridge Village]

When dealing with masonry units of sufficient size to make their handling as individual components economically feasible, mark each with a number code assigning it a position "left to right" within a given course of a particular wall. When practicable, numbering should be done in a permanent medium such as red lead on top surfaces which will be covered and hidden by successive courses. (figure 30. See also figure 22.) Individual stones should be padded with burlap or scrap wood in order to prevent abrasion by chains or cables during removal and subsequently during travel. Obviously, a brick or rubble foundation does not lend itself to transfer by this technique, and the best that can be done is careful dismantling and salvage of materials. The foundations would then be relaid in mortar mixed to match the original with care taken to replicate the original bond in both composition and color as well as textural character.

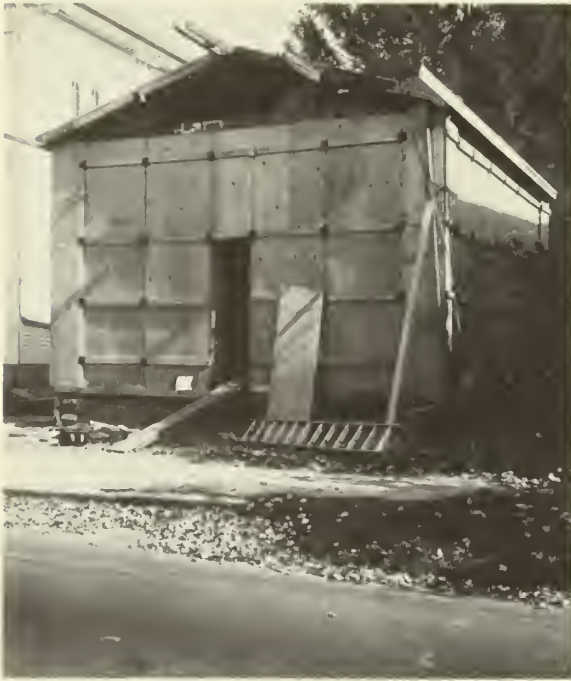
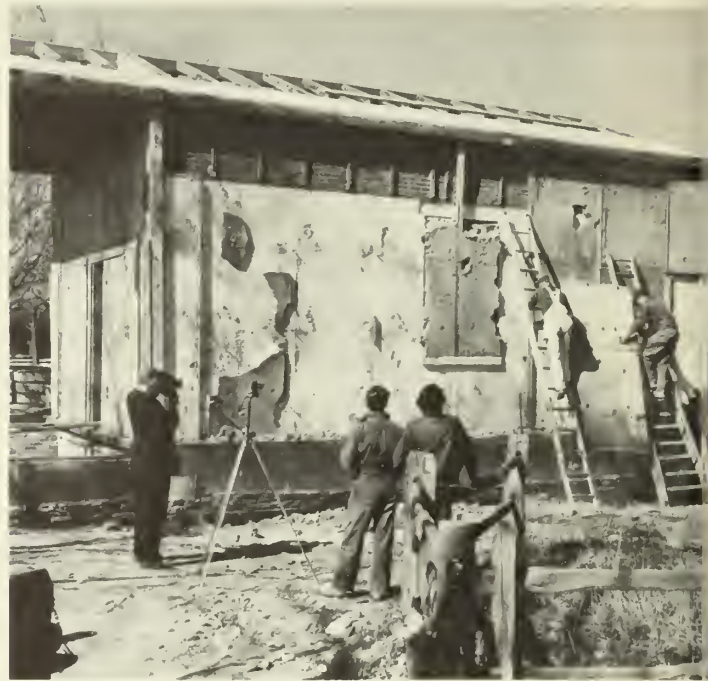
Figure 31: A protective crate for moving the Thompson Bank to Old Sturbridge Village

The sandwich "crate" used for this particular building consists of plywood and cleats (inside and outside) which are held together with bolts through the brick masonry. Voids between the masonry surfaces and the plywood sandwich were filled with insulating material blown in under high pressure to assure firm support between the sandwich and the brick walls. [Photographs: John O. Curtis, Old Sturbridge Village (left) James C. Ward, Old Sturbridge Village (right)]

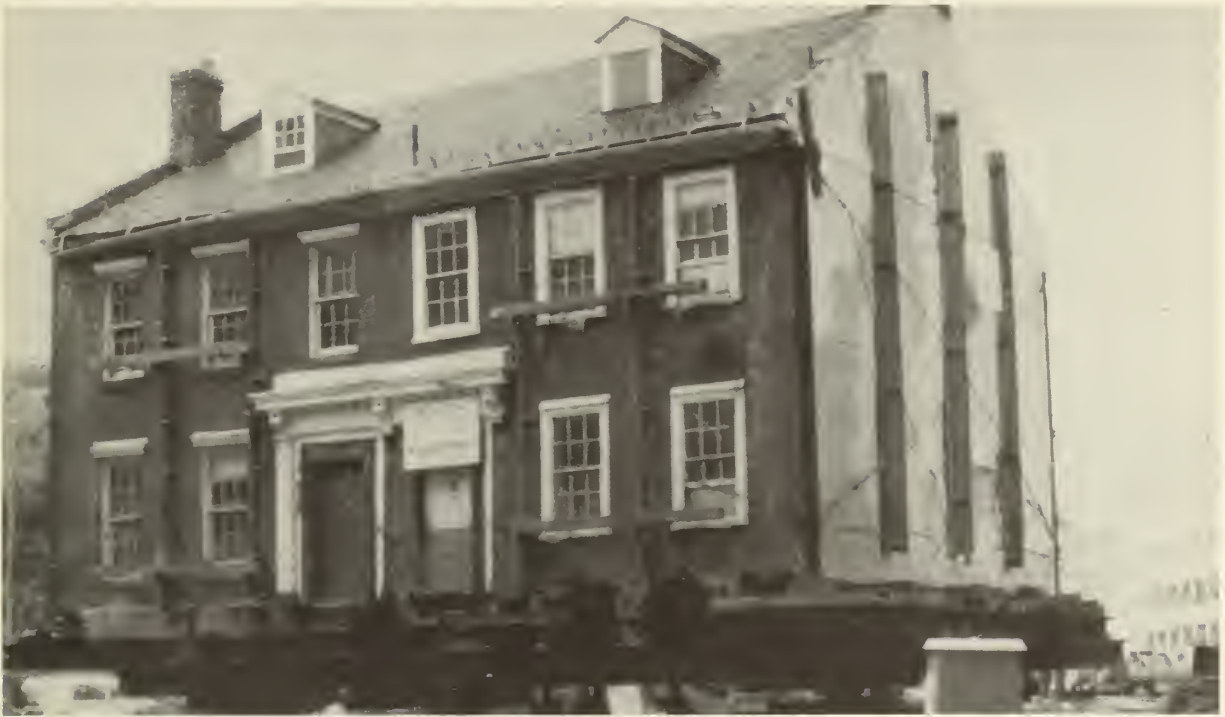
Figure 32: Lenthall Houses, Washington, D.C.

A much simpler bracing system provided adequate support for these attached brick houses when they were moved to make room for construction of a large office building in 1978. The structure has been "crated" with steel cables. The tensile stress of the cables is transferred to the masonry shell through the vertical wooden braces. Cable ties attached to exterior horizontal wooden members are stretched from front to rear through the windows for additional support. [Photograph: John Myers]

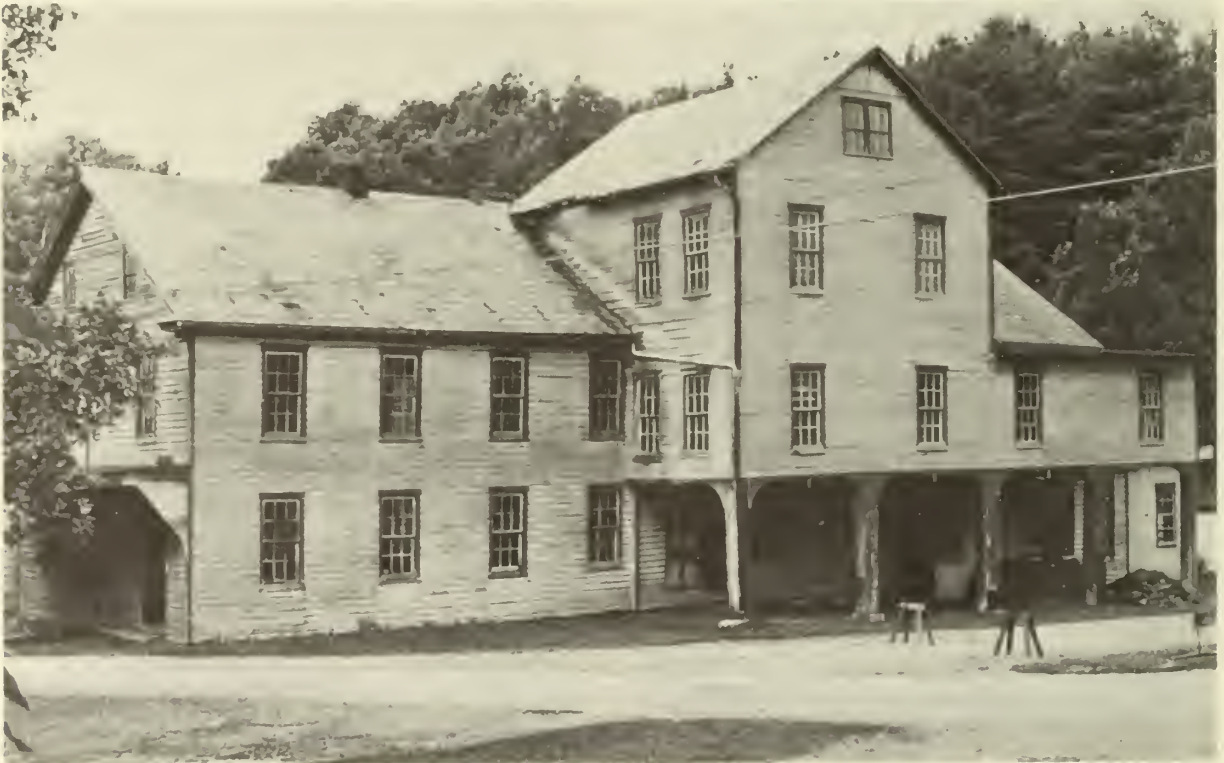
Figure 33: The Gruber Wagon Works, Berks County, Pennsylvania

An exterior view of the Gruber Wagon Works as the complex appeared in 1976 on its original site, and before its partial disassembly and relocation. The move was necessitated by the planned impoundment of this area for the Blue Marsh Lake Project by the U.S. Army Corps of Engineers. [Photograph: Courtesy of John Milner Associates]

The Gruber Wagon Works in Berks County, Pennsylvania, built in stages over the years 1882 to 1911, is a rare surviving family-operated factory, complete and unaltered since the early 20th century. Virtually all of its original machinery remains intact (figures 33 and 34). Its operation, the manufacture of wooden farm wagons, began to decline in the mid-1920s, with the last wagons built by the early 1950s. The buildings and all their tools, machinery, power generating and transmission equip-

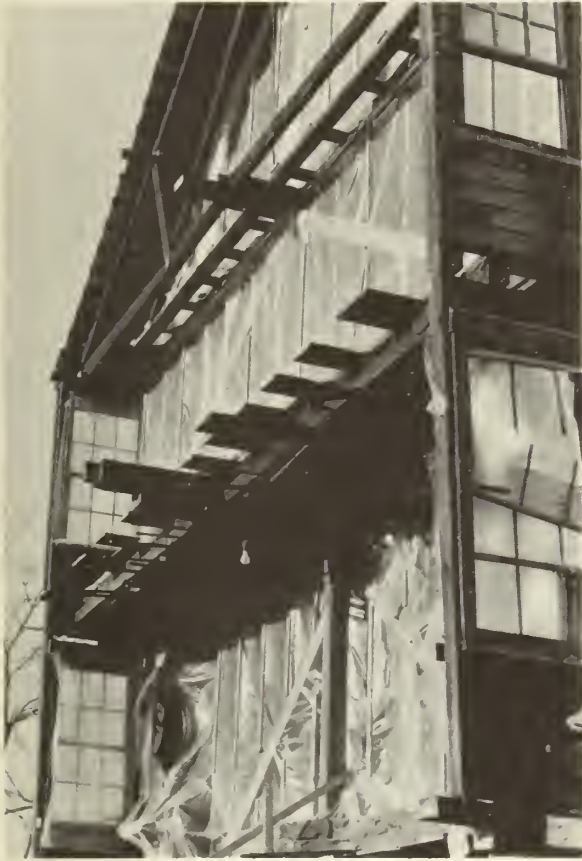
Figure 35: Separation planes

Care was taken so that the joints between all disconnected or severed parts came apart horizontally to insure that the sections would separate and rejoin without conflict. Disconnection of joints along the same separation plane was systematically studied to make certain that any member continuous between two adjacent joints was included with

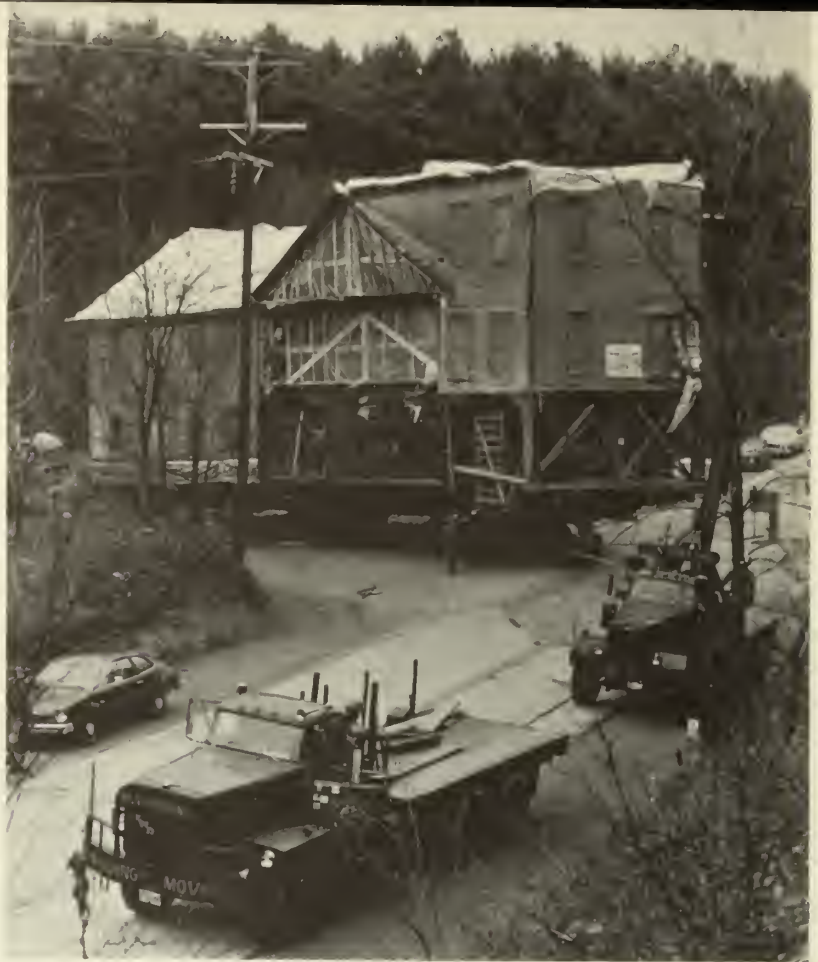
Figure 38: The Gruber Wagon Works and obstacles en route

The largest section and central portion of the Gruber Wagon Works, 26 feet in width by 71 feet in length, was moved on December 8 and 9, 1976. This photograph shows some of the difficulties encountered in moving an unwieldy structure of this size, such as negotiating sharp corners on narrow country roads. Note the extension and cross-arms atop the utility pole to allow for temporary raising of the power lines to permit passage of the structure. The openings left by the removal of roofs and gables have been covered to protect the interior of the structure from the harsh winter weather. [Photograph: Courtesy of John Milner Associates].

Before moving the first of the three largest sections (figure 38), the overhead electrical primaries that crossed the route with less than 40 feet of clearance were temporarily raised. The secondary lines were extended with temporary wire coiled to their poles. The roof and gables of the elevator penthouse of the central section were removed to bring its overall height down to that of the other two large sections. Thus, the cost of relocating the electric primaries was minimized. The temporarily lengthened electric secondaries and telephone cables were then dropped directly on the road ahead of, and crossed by, the moving rigs. At no time was any service interrupted. The cost of utility relocation came out of the original contract sum along with all other costs.

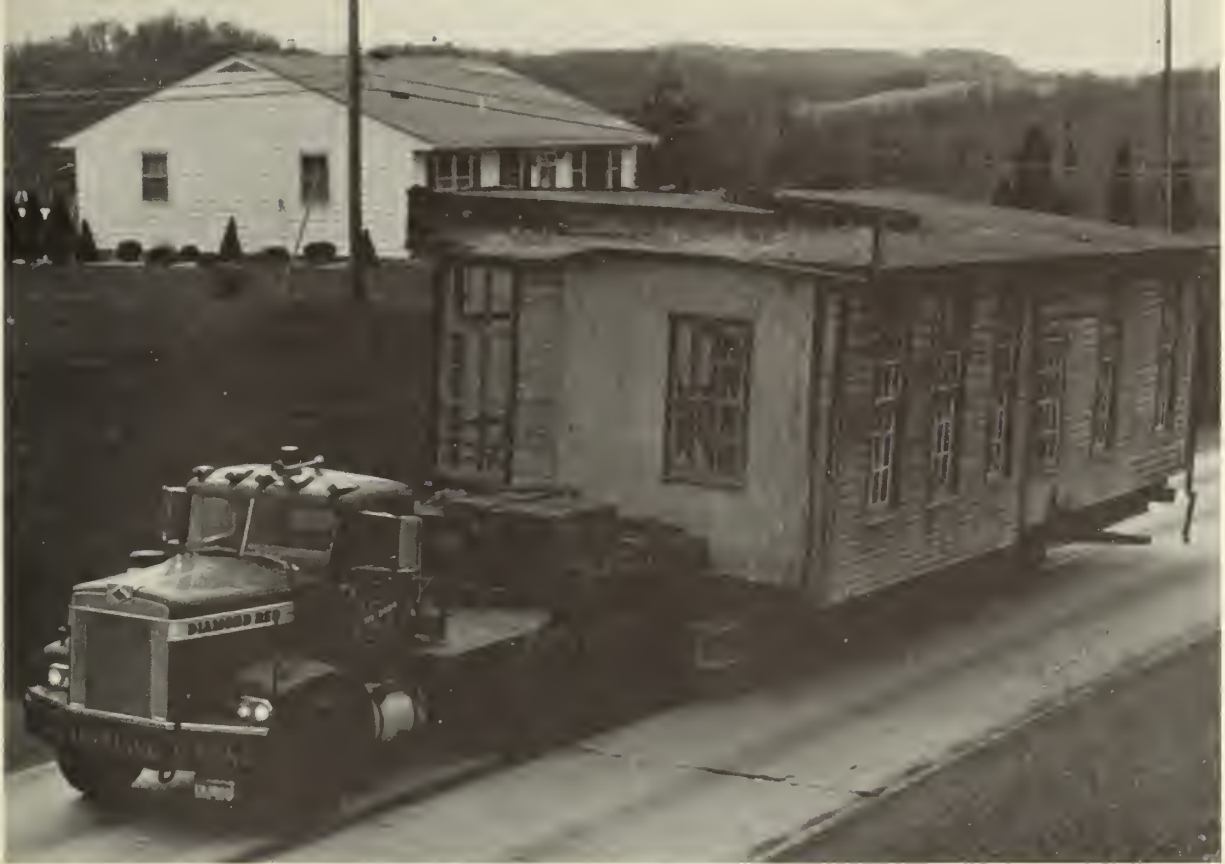
Figure 39: This section of the Gruber Wagon Works, only somewhat wider than a house trailer, was small enough to be transported over the narrow country roads on a "low-boy" flat-bed trailer. [Photograph: Courtesy of John Milner Associates]

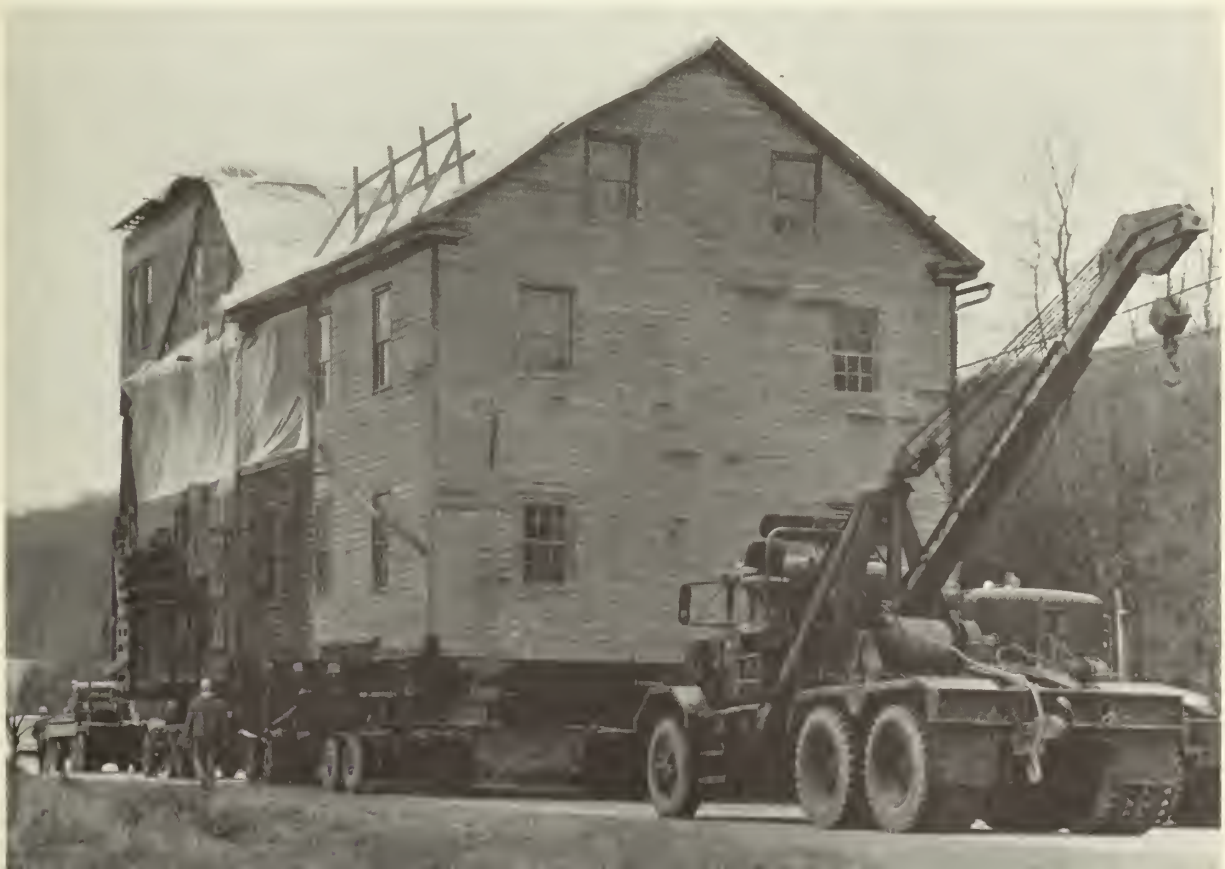
To balance a building properly during a move, it is often necessary to attach heavy vehicles behind as well as in front of the structure. Pictured here is the largest section of the Gruber Wagon Works on its way to a new site, its weight suitably aligned through careful positioning of two truck tractors in the rear to offset the momentum being created by the two trucks in front pulling the structure. [Photograph: Courtesy John Milner Associates]
