**NEWTON PUBLIC BUILDINGS SURVEY  
PHASE II – ANALYSIS OF HISTORICAL SIGNIFICANCE**

**City Hall**

Address: 1000 Commonwealth Avenue

Year of Construction: 1931

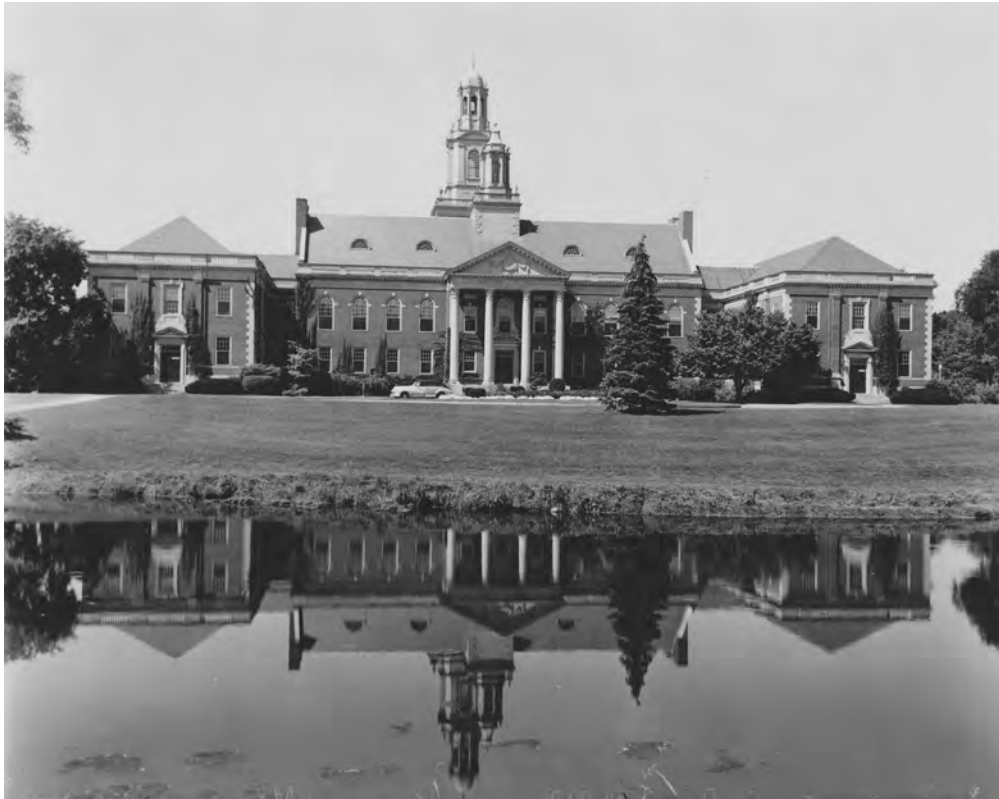
Figure 1: City Hall entry (east elevation), c.1940s. The landscape plan was designed so that the building would be mirrored in the reflecting ponds, with the reflection visible from the front steps of City Hall (Credit: Historic Newton).

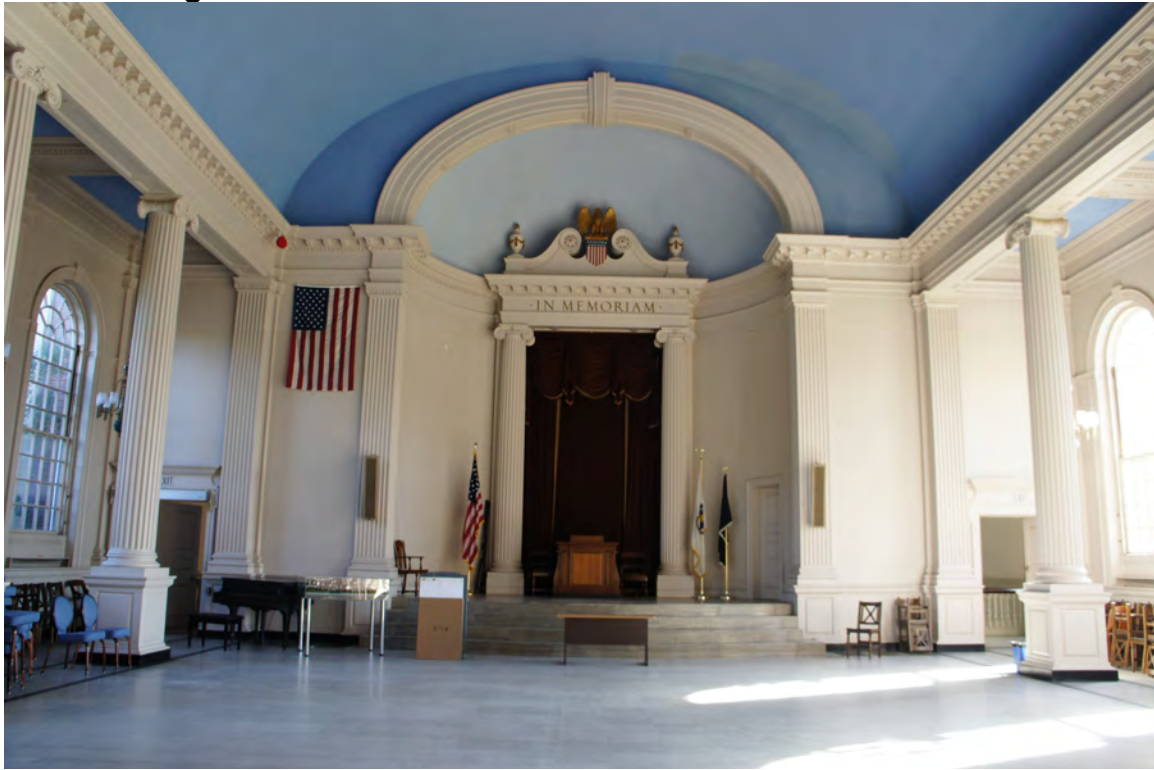
- Barrel-vaulted, symmetrical space; Ionic colonnade, side aisles; west balcony with solid, paneled wood guardrail
- Half-dome ceiling of apse originally had gold stars painted on the field of light blue
- Walls- flat plaster surfaces, pilasters, wainscot, chair rail, two cornices
- Original lighting concealed within vault springline; chandelier centered on each window

Figure 3: view of Memorial Hall, looking east. The light blue half-dome was originally painted with gold stars.

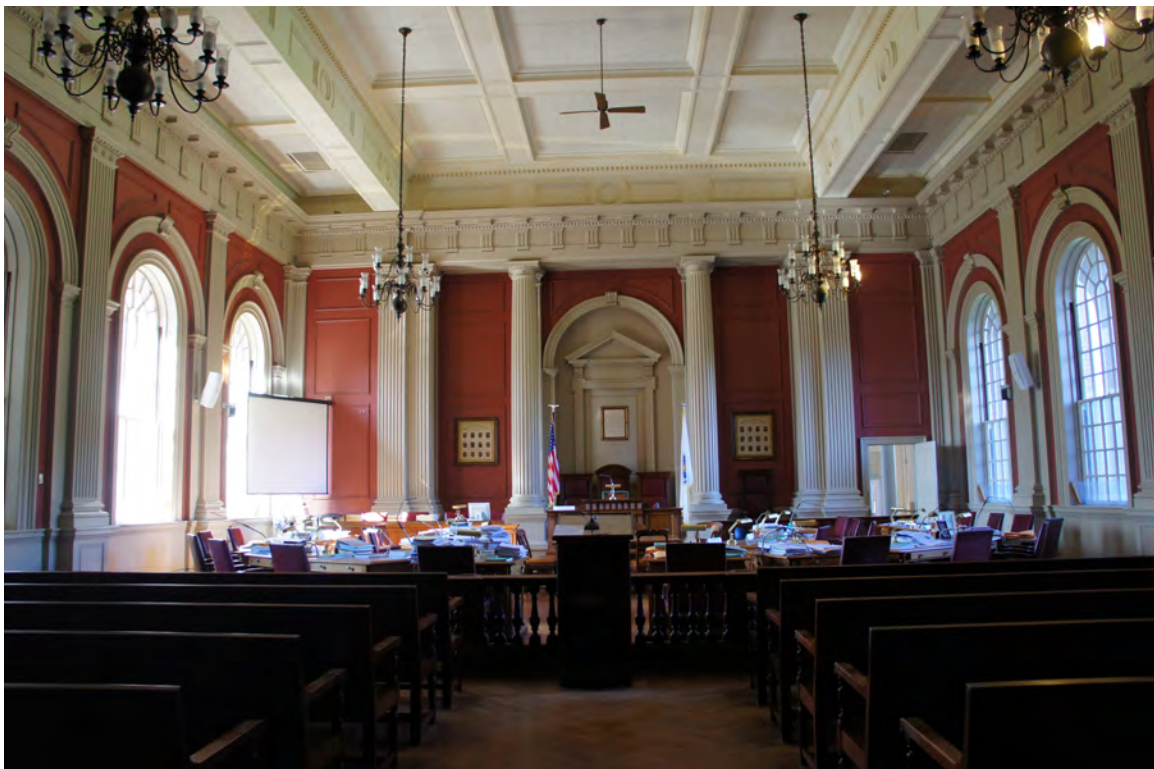
- Ceiling- coffered with acoustic tiles added. Decorative panels on the beams
- Walls- pilasters between windows; frieze with triglyphs. In the space remaining the walls have panels defined and are painted, originally pale red. At west wall, recess defined with pilasters and two columns
- Windows- tall, arched operable windows
- Floor- the plain white oak in the bid set was upgraded to Burma teak-wood in a herringbone pattern.
- Four multi-armed chandeliers, centered in the ceiling coffers

Figure 4: view of Aldermanic Chamber, looking west

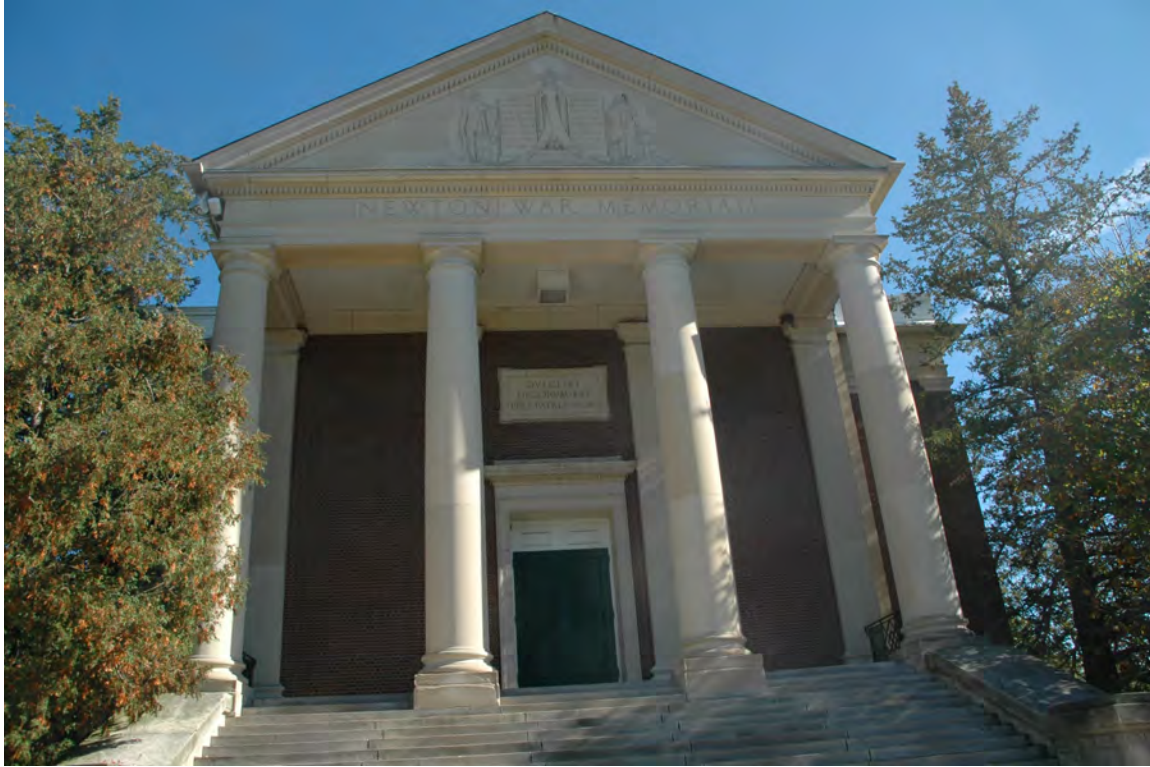
- The War Memorial side has a monumental pedimented stone portico supported by Tuscan columns.
- The City Hall side has a smaller pedimented stone portico supported by Corinthian columns.

- The pediment at the War Memorial Entrance is carved with a Symbolic Pediment Group, designed by Charles Collens. The three figures represent Patriotism, History and the Spirit of Sacrifice.

Figure 5: Portico at the main entrance to the War Memorial. Note the figures at the pediment, representing Patriotism, History and the Spirit of Sacrifice, designed by Charles Collins.

- Monitor the erosion at the column bases at both porticos for further damage.
- Continue regular maintenance of character-defining features.
- Maintain all gutters, leaders and drains to keep clog-free.

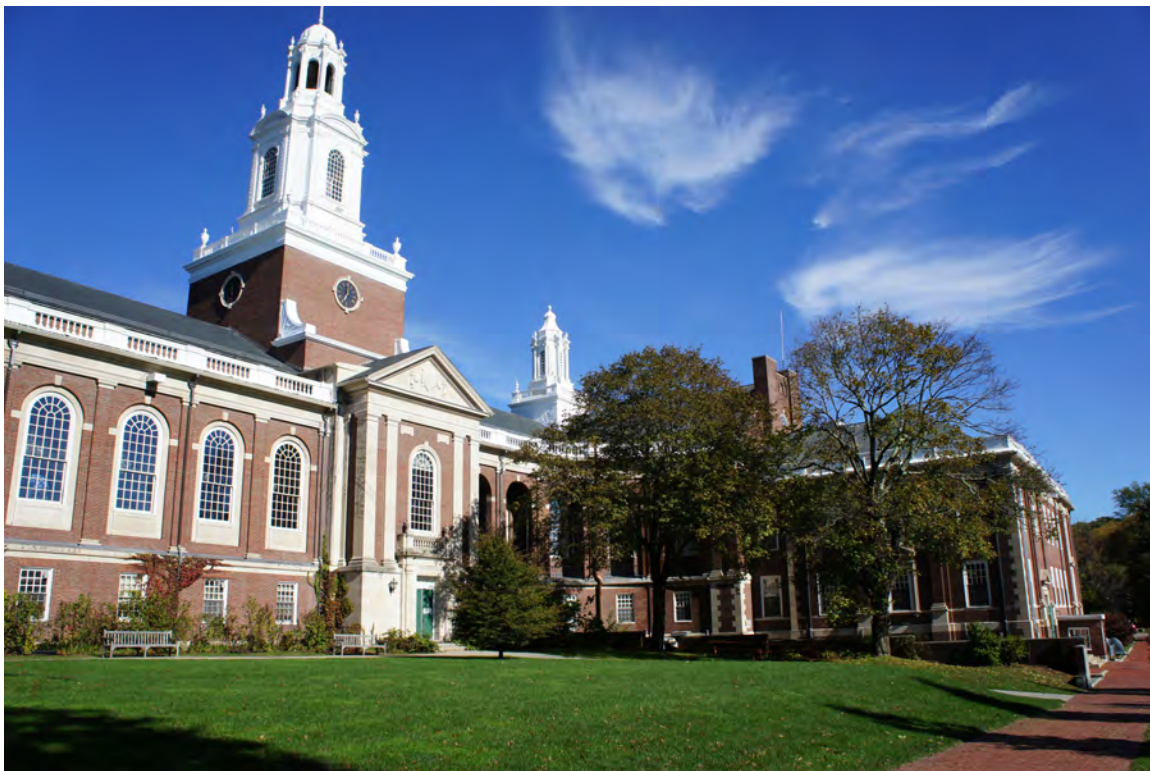
Figure 6: view of the exterior, from the southwest.
