**Newton, Massachusetts Community Preservation Program  
Fy12-13 FUNDING REQUEST**

TIMELINE				
Project or Program Title: <b>City Hall Window Restoration/Replacement</b>				
Steps (for a project) or Projects (for a multi-project program) <i>For requests over \$300,000, show how funding could be phased over multiple years.</i>	Assistance Required <i>(fundraising, permits, etc.)</i>	Start <i>season/ year</i>	Finish <i>season/ year</i>	Cost <i>estimate</i>
<b>1. Design</b> – Study and Inventory Existing Conditions to Develop Recommended Solution for Repair, Restoration and/or Replacement of City Hall Windows.	Design Review Committee; Newton Historic Commission Approval	Spring 2013	Winter 2013	\$250,000
<b>2. Bidding</b> – Determine options for bidding and constructing the project. Project could be bid as one project and implemented in a phased approach.		Winter 2013	Spring 2014	\$0
<b>3. Construction – Phase I</b> – Phase I may address one or two floors of the building, or a wing. Funds are needed to sign a contract; however, expenditures could be spread out over 18 months.		Spring 2014	Fall 2014	\$843,000

**NEWTON PUBLIC BUILDINGS SURVEY  
PHASE II – ANALYSIS OF HISTORICAL SIGNIFIC

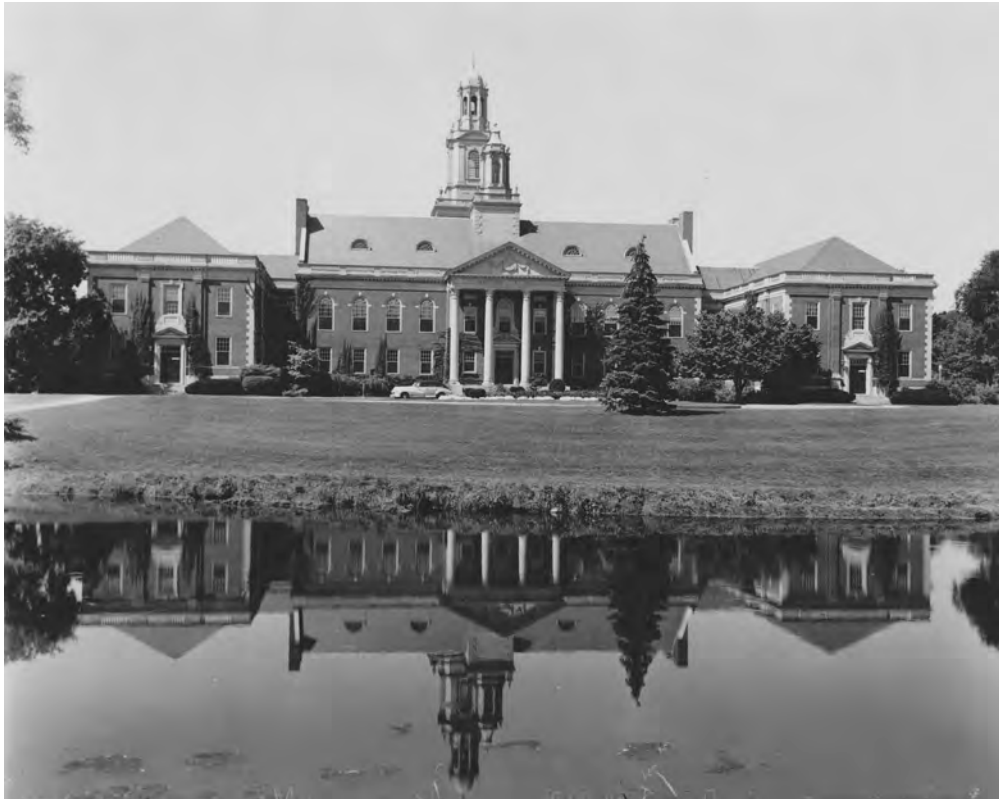
Figure 1: City Hall entry (east elevation), c.1940s. The landscape plan was designed so that the building would be mirrored in the reflecting ponds, with the reflection visible from the front steps of City Hall (Credit: Historic Newton).

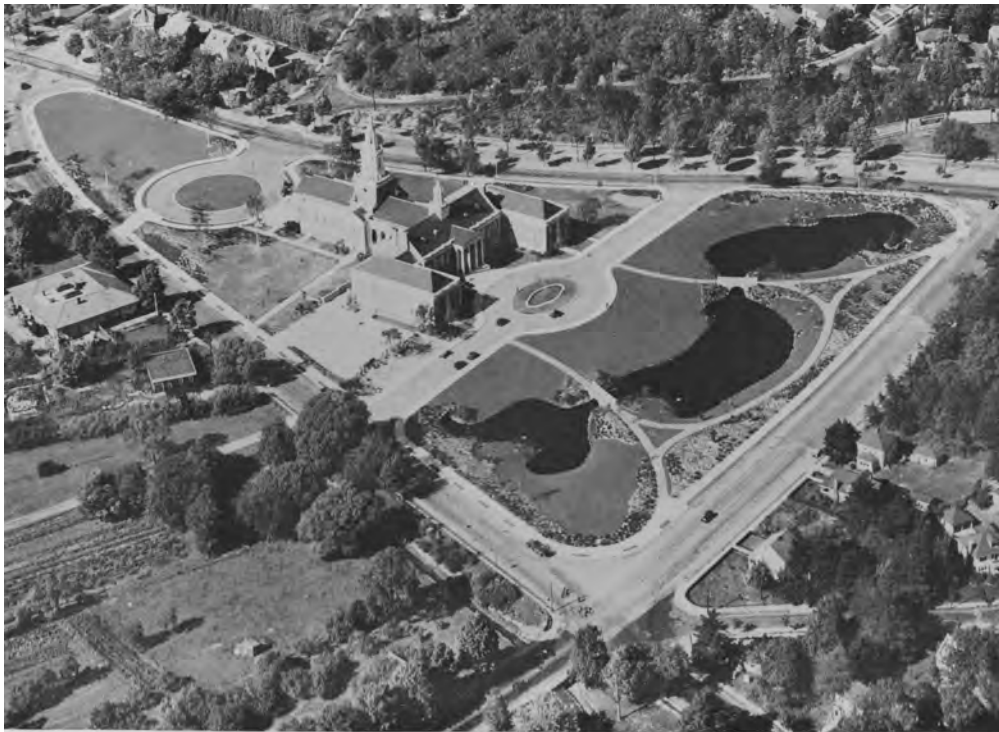
Figure 2: Aerial view of City Hall and landscape after construction (Credit: Historic Newton).

- The building is located within a park-like setting designed by the Olmsted Brothers. The organically shaped ponds to the east, now obscured by trees and undergrowth, were intended to serve as reflecting pools for the building.

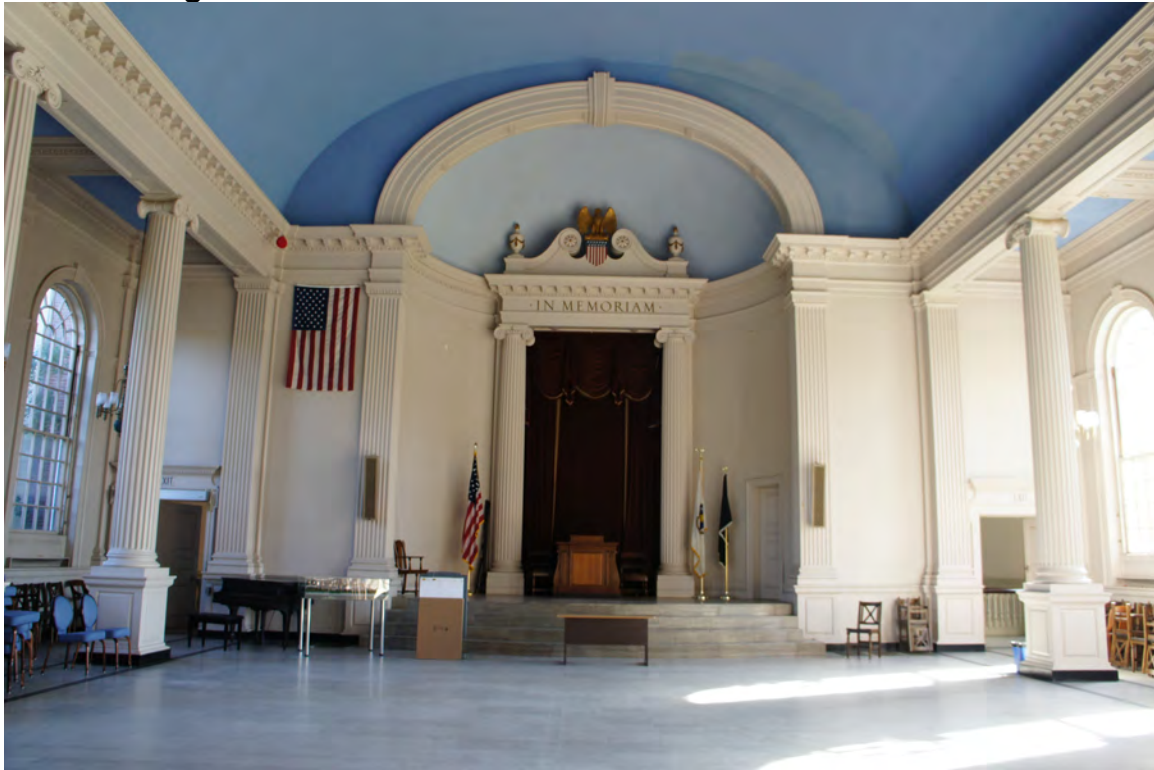
- Barrel-vaulted, symmetrical space; Ionic colonnade side aisles; west balcony with solid, paneled wood guardrail
- Half-dome ceiling of apse originally had gold stars painted on the field of light blue
- Walls- flat plaster surfaces, pilasters, wainscot, chair rail, two cornices
- Original lighting concealed within vault springline; a chandelier is centered on each window

Figure 3: View of Memorial Hall, looking east. The light blue half-dome was originally painted with gold stars.

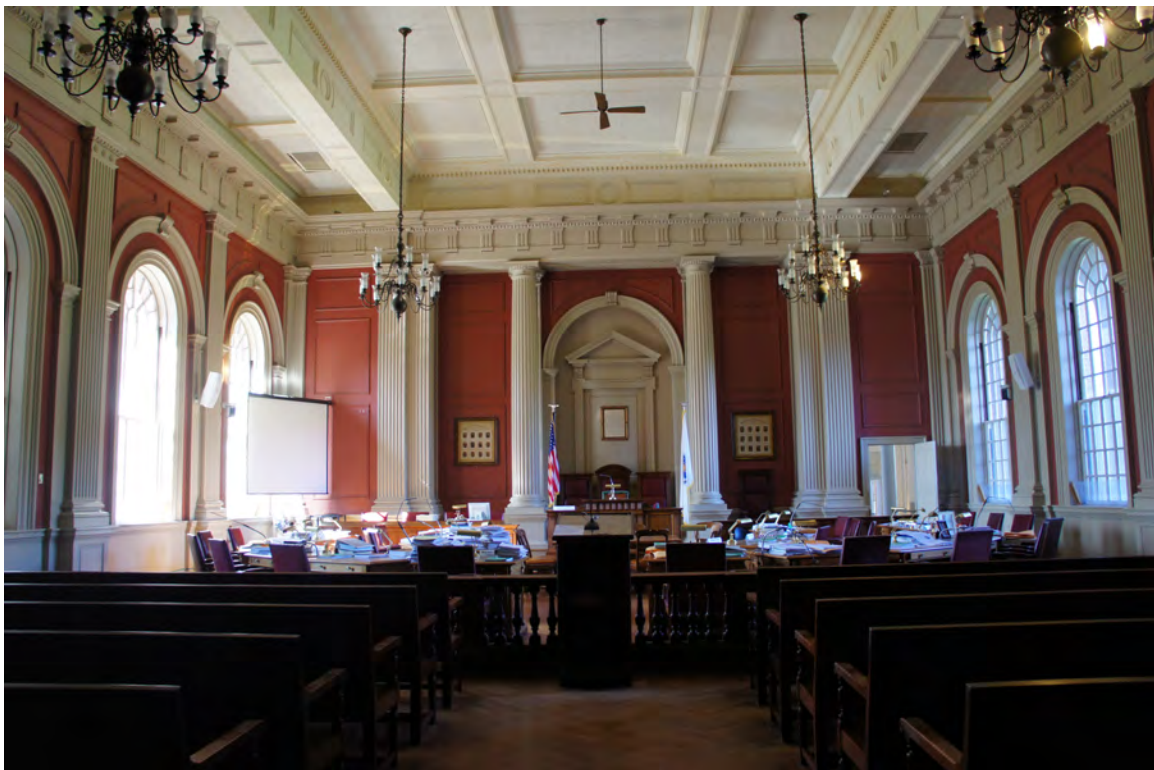
- Ceiling- coffered with acoustic tiles added. Decorative panels on the beams
- Walls- pilasters between windows; frieze with triglyphs. In the space remaining the walls have defined panels and are painted, originally pale red. At the west wall, a recess is defined with pilasters and two columns
- Windows- tall, arched operable windows
- Floor- the plain white oak in the original bid set was upgraded to Burma teak-wood in a herringbone pattern.
- Four multi-armed chandelier light fixtures are present, centered in the ceiling coffers

Figure 4: View of Aldermanic Chamber, looking west.

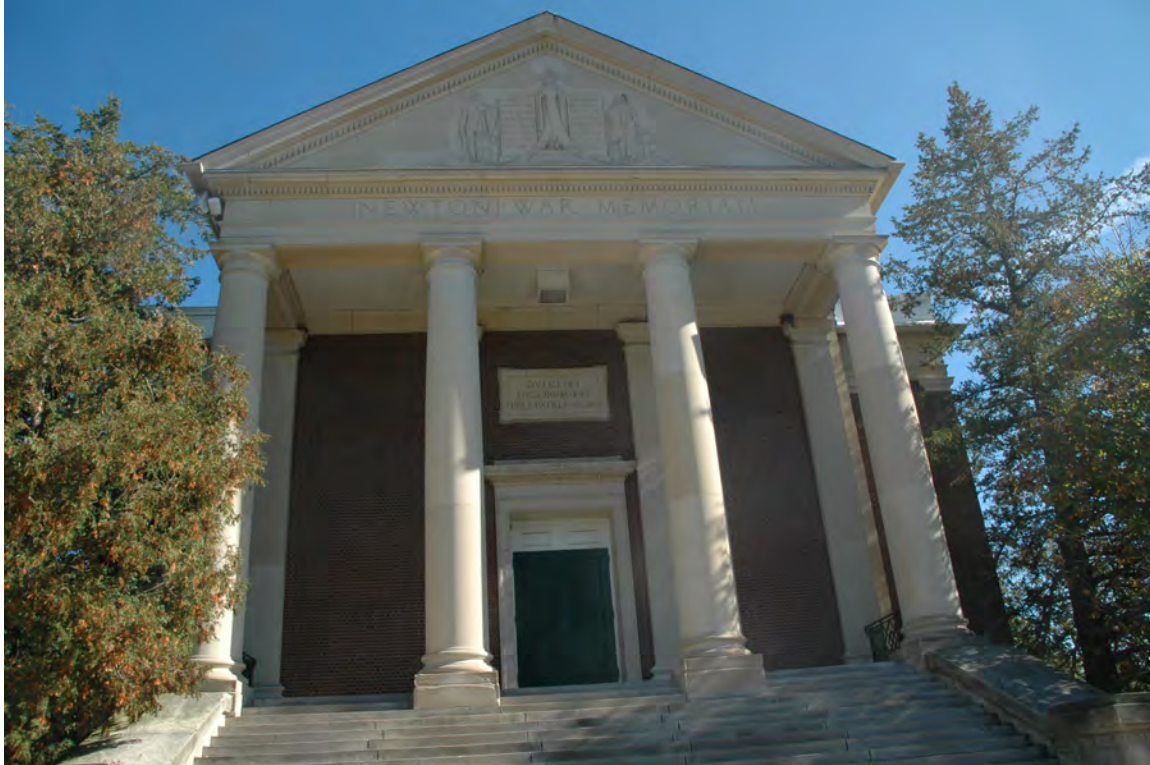
- The War Memorial side has a monumental pedimented stone portico supported by Tuscan columns.
- The City Hall side has a smaller pedimented stone portico supported by Corinthian columns.

- The pediment at the War Memorial Entrance is carved with a Symbolic Pediment Group, designed by Charles Collens. The three figures represent Patriotism, History and the Spirit of Sacrifice.

Figure 5: Portico at the main entrance to the War Memorial. Note the figures at the pediment, representing Patriotism, History and the Spirit of Sacrifice, designed by Charles Collins.

- Monitor the erosion at the column bases at both porticos for further damage.
- Continue regular maintenance of character-defining features.
- Maintain all gutters, leaders and drains to keep clog-free.
