Newton Center Intersection Summary Report

The Town of Newton has retained Traffic Solutions, LLC to evaluate current conditions, both operationally and geometrically, at three locations in Newton Center:

The focus of this study is to evaluate current transportation conditions for pedestrians, bicyclists, and vehicular traffic. This report summarizes the findings for these three intersections and recommends multi-modal improvements.

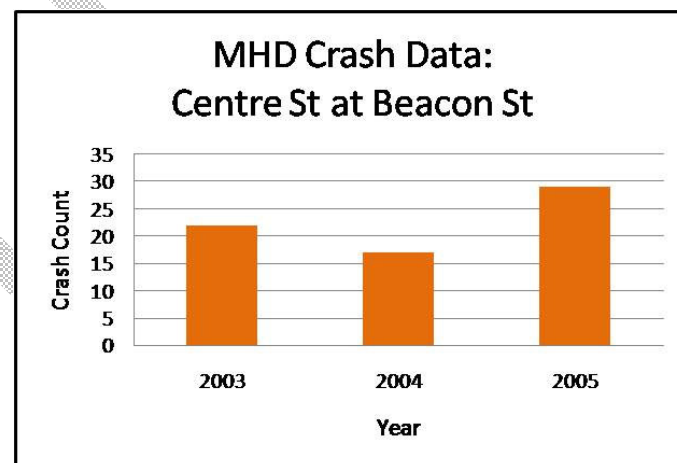
Figure 2. Centre Street at Beacon Street - MassHighway Department Crash Data for 2003-2005

Vehicle crashes reached 29 in 2005, the latest year of available data from Mass Highway (Figure 2). The crash rate at this intersection exceeds the Mass Highway District average (Table 1).

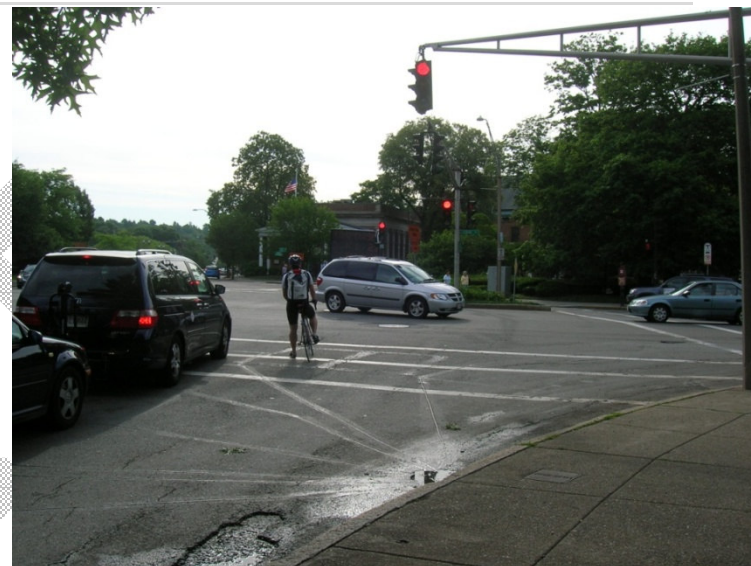
Figure 4. Centre St at Beacon St looking East - Potholes at southeast corner

Observation: Pavement is fairly well maintained and in good condition. However, some of the pavement at the intersection is deteriorating, and as a result, potholes have started to appear along Centre Street northbound and Beacon Street eastbound (Figure 4 and Figure 5).

Action: Repair deteriorated pavement surface.

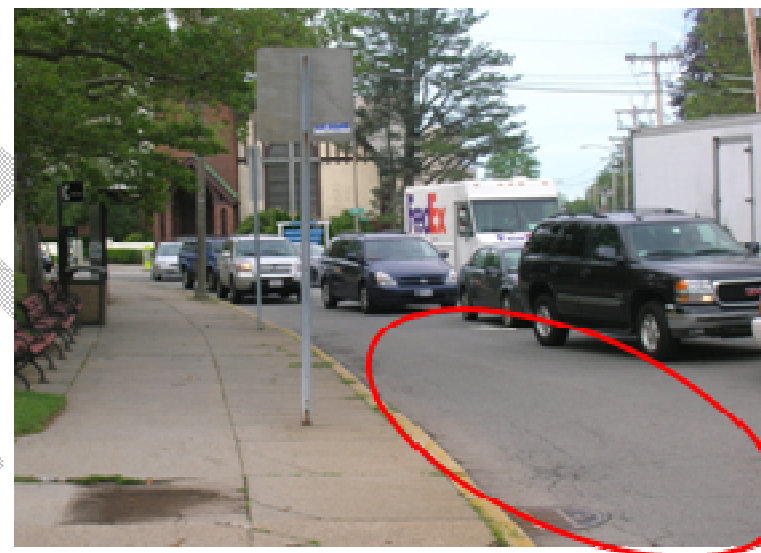
Figure 10. Centre Street looking South towards Cypress Street

Observation: Northbound drivers on Centre Street, during high traffic periods, are unable to access the right-turn slip lane, which contributes to congestion at the Centre Street at Cypress Street intersection (Figure 10 and Figure 12).

Action: See action under “Signals”. Optimized signal operations should improve this situation.

Long-Term Action: The right-turn slip lane may be eliminated, which would tighten up the intersection. Continue to provide space for right turn movements with a shared right and through lane to create an opportunity for greater continuous green space.

Long-Term Action: Alternatively, widen the pavement near Cypress Street to allow right turning vehicles to access the right turn lane (Figure 39).

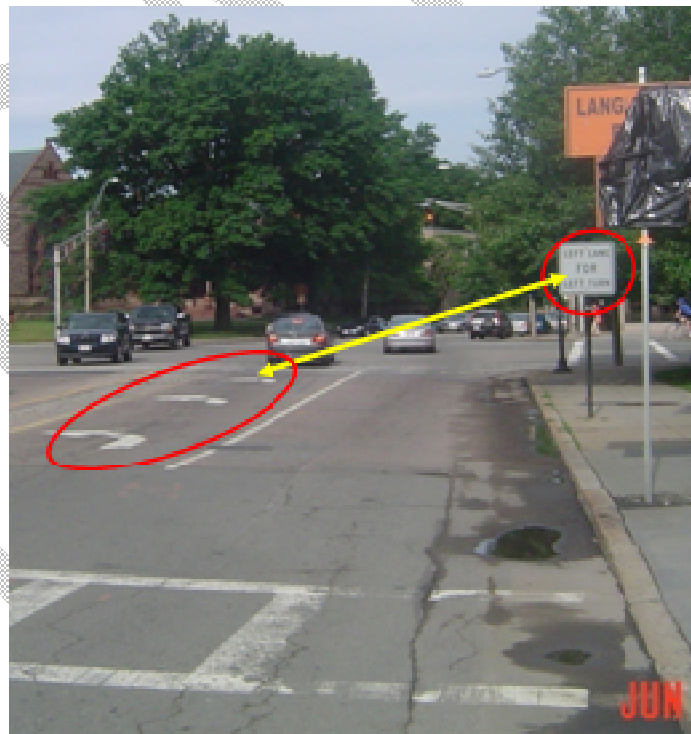
Figure 14. Beacon St looking West towards Centre St - Existing Sign

Observation: Lane markings were recently changed along Beacon Street Westbound from a shared left and through lane to an exclusive lane for left turns. However, the sign still reads “left lane for left turn” (Figure 14).

Action: Update the sign to Manual on Uniform Traffic Control Devices (MUTCD) standards to read “left lane must turn left” to reflect the lane change to left-turning vehicles only (Figure 13).

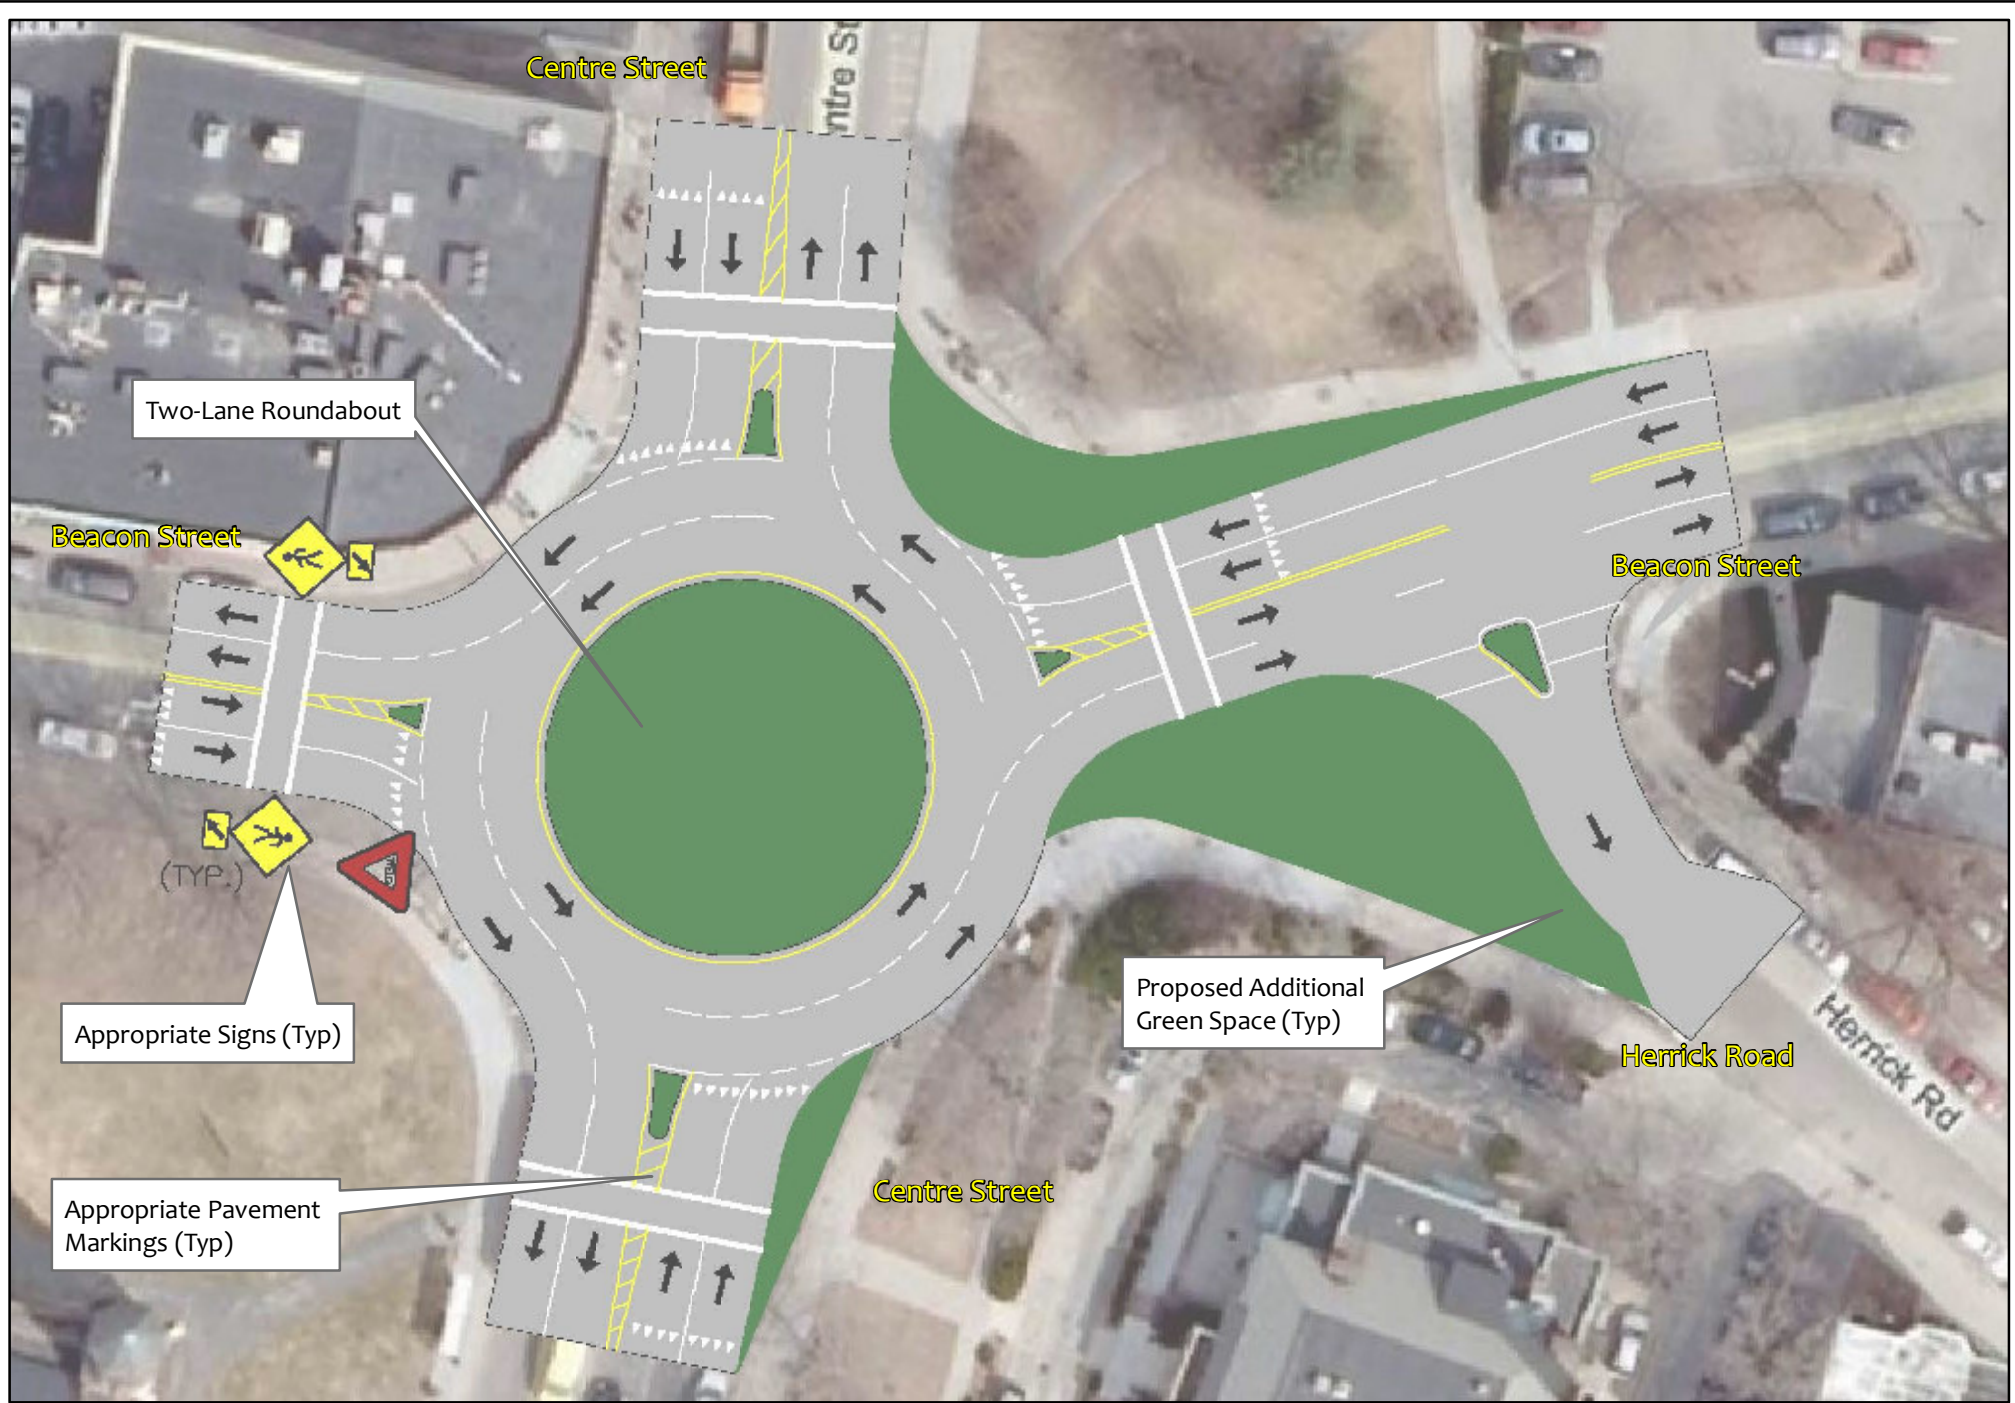
FIGURE 19

TITLE: Centre St at Beacon St - Long-Term Improvements

Long-Term Action: Consider modifying the intersection to include a two-lane roundabout (Figure 19).

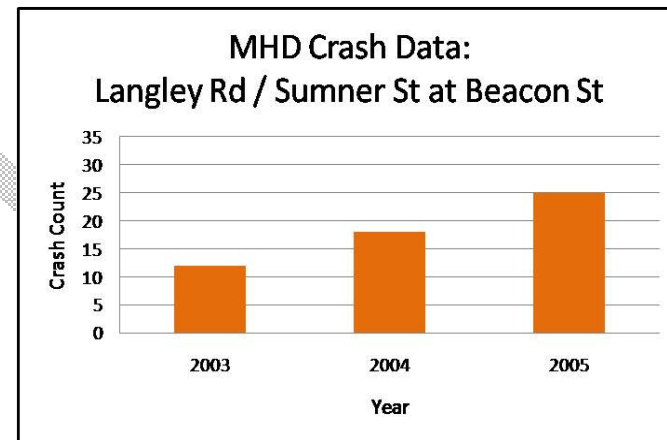
Figure 21. Langley Road/Sumner Street at Beacon Street - MassHighway Department Crash Data for 2003-2005

Crashes have steadily increased from 2003-2005 (Figure 21). The crash rate at this intersection greatly exceeds the Mass Highway district average (Table 4).

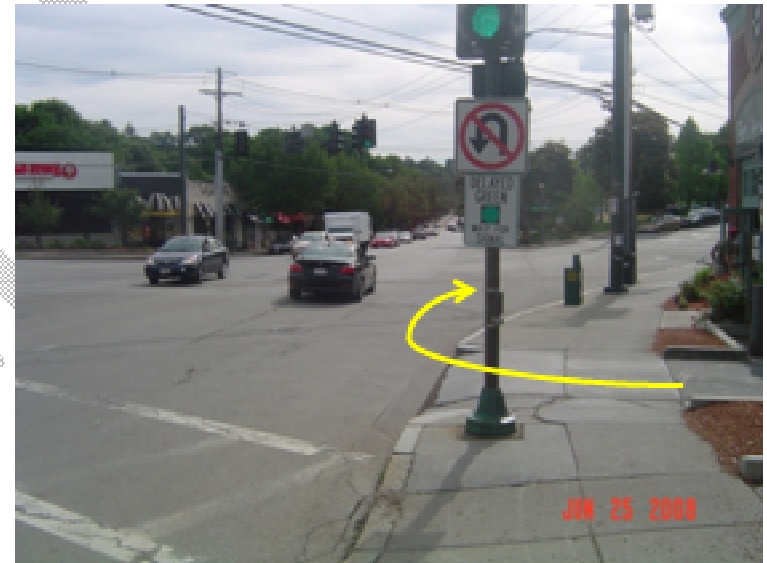
Figure 23. Langley Rd/Sumner St at Beacon St Intersection looking East - Existing Driveway for Peet's Coffee

Observation: Peet's Coffee exit drive is currently uncontrolled. As a result, drivers exiting the parking lot behind Peet's Coffee currently bypass the traffic signal, creating a potential safety hazard as vehicles directly enter the intersection at their own risk (Figure 23).

Action: Move the stop line and crosswalk approximately ten feet East on the Beacon Street eastbound approach. This new location will encourage drivers to obey the traffic signal indication for the Beacon Street eastbound approach to the signal when exiting Peet's driveway (Figure 22).

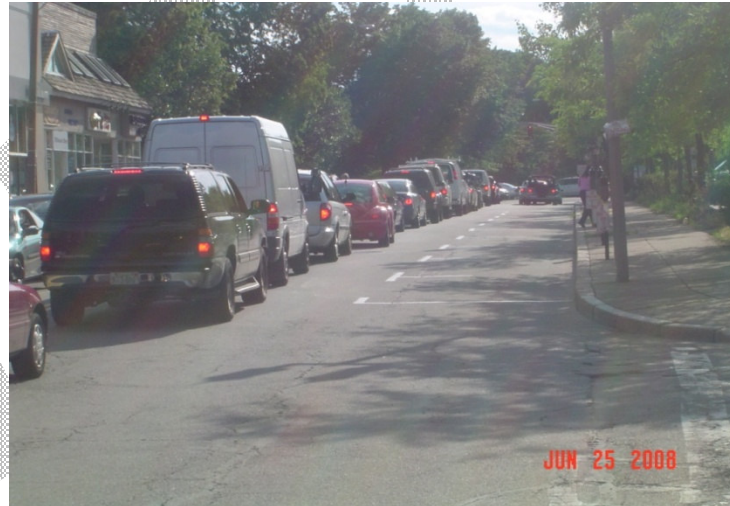
Figure 27. Beacon Street looking West - Parking Lane during PM Peak

Observation: The parking lane along the north side of Beacon Street in front of the municipal parking lot is restricted during the PM peak (i.e. no vehicles can park there); however, drivers appear hesitant to use the extra travel lane (Figure 27). This hesitation may be due to the parking stall markings and the parking restriction sign which is positioned low and facing the driver who would be parking, not informing a driver traveling westbound on Beacon Street. In addition, although parking is allowed during the AM peak, utilization of the spaces is low throughout the morning (Figure 26). The underutilization of this lane causes traffic to “back up” along Beacon Street westbound, creating a queue that extends into the Langley Road/Sumner Street at Beacon Street intersection.

Action: Restrict the parking lane during the AM peak, at a minimum. Update the parking restriction signs to inform drivers about the available lane during the peak hours. Consider restricting this parking lane during the entire day to eliminate confusion regarding when it is available for use as a travel lane. If full day restriction is not feasible, consider extending the PM restriction to start at 3pm and end at 7pm. Consider adding a lane use sign similar in design to the I-93 lane use signs that allow driving in the breakdown lane during peak hours (Figure 24).

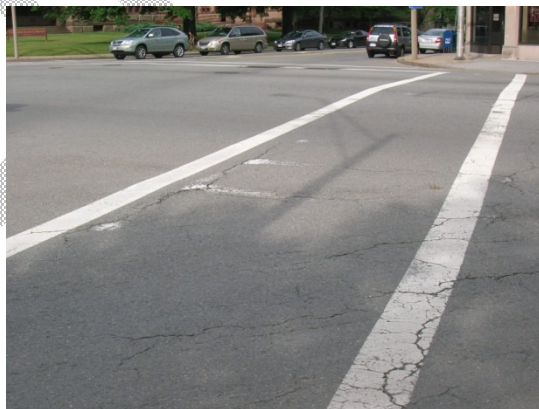
Figure 33. Standard crosswalk at Beacon Street

Observation: The crosswalks at Cypress Street and Centre Street have the ladder design (Figure 32 and Figure 34) whereas the other two intersections have the MUTCD standard design (Figure 33 and Figure 34).

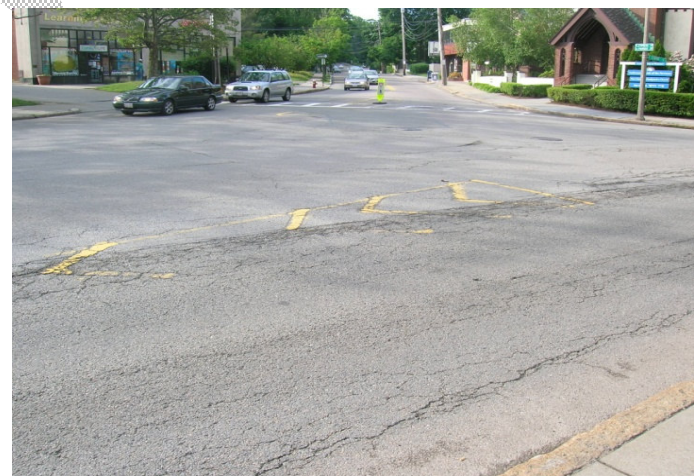
Figure 36. Centre St at Cypress St looking Southwest - Fading Pavement Markings

Observations: Pavement markings are not provided for southbound left-turning drivers on Centre Street to yield at the intersection (Figure 36).
