## Walk Assessment

Newton, MA

January 19, 2015

Prepared for the Massachusetts Department of Transportation Bicycle and Pedestrian Safety Program in partnership with the Massachusetts Department of Public Health

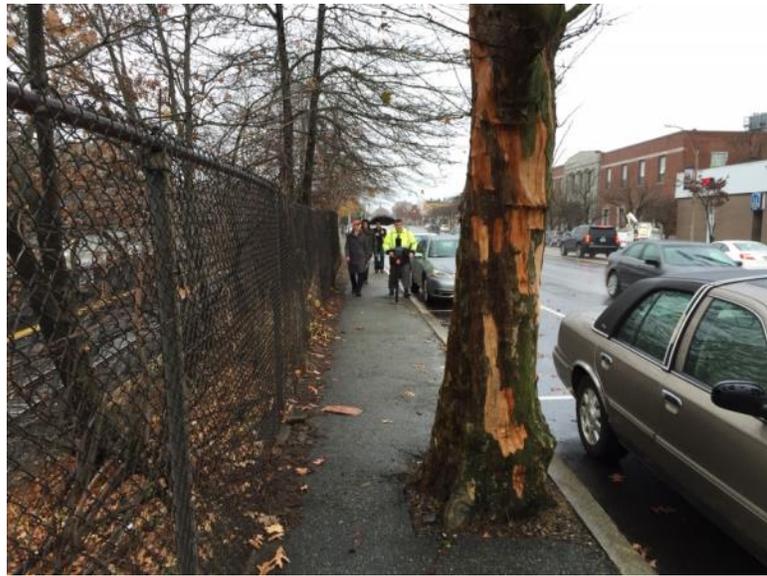
The assessment team discussed the importance of maintaining clear sidewalks by locating utility poles, hydrants, signal posts, and other street furniture in order to maintain a minimum three foot clear width to comply with current ADA/AAB standards. In addition, the sidewalks should be clear of any potential tripping hazards and overgrown vegetation. The assessment team noted several locations along the south side of Washington Street where large trees reduced the clear sidewalk width below the minimum

Figure 2 - A tree blocks the sidewalk.

of three feet required for ADA accessibility. Additionally, there were many tripping hazards observed, including heaving sidewalk panels and improperly removed parking meter posts. Existing sidewalk materials are inconsistent and in poor condition, with frequent transitions between concrete and asphalt sidewalks as well as missing segments with gravel or earth paths.

- Provide ADA-compliant curb ramps at all crosswalks including detectable warning panels.
- Remove parking meter post stubs to eliminate tripping hazards.
- Maintain minimum ADA clearance on all sidewalks through the widening of sidewalks or removal of obstacles.
- Conduct parking utilization study

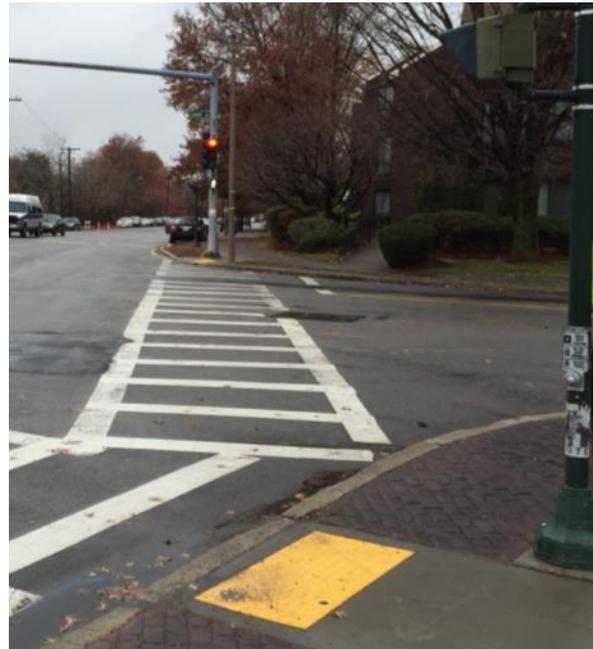
Washington Street at Lowell Avenue is a four way signalized intersection. The City has recently constructed curb extensions, however the crosswalks are still long on the Lowell Ave legs due to the skew of the intersection and the large turning radii provided for trucks. The traffic signal provides a pushbutton activated exclusive pedestrian phase. The curb ramps at all four corners are ADA accessible and provide detectable warning panels.

Members of the assessment team noted that the existing pedestrian pushbuttons do not provide accessible features including locator tones, vibrotactile walk indications, pushbutton locator tone, tactile arrows, and/or vibrating pushbuttons. The team also noted that the pedestrian signal indications do not include countdown timers. The City should install pedestrian countdown indications and accessible pedestrian signals to enhance the existing crosswalk facilities for all users.

Team members also noted drainage issues on the northwest corner, which causes ponding at the curb ramp. The City should consider installing a new catch basin or otherwise improving the drainage patterns at this corner in order to prevent stormwater from collecting in the crosswalk.

Figure 3 - Curb ramps and pedestrian signals at Lowell Avenue

- Provide vertical separation between the sidewalk, such as curbing or planters, and the service station parking lot on the northeast corner.
- Upgrade drainage on the northwest corner to eliminate ponding issues.

- Consider installing a multi-space parking meter on the south side of the roadway to encourage Post Office visitors to cross at the crosswalk.
- Install accessible pedestrian signals including pedestrian countdown indications.
- Coordinate with the MBTA to relocate the eastbound bus stop to the far side of the intersection.

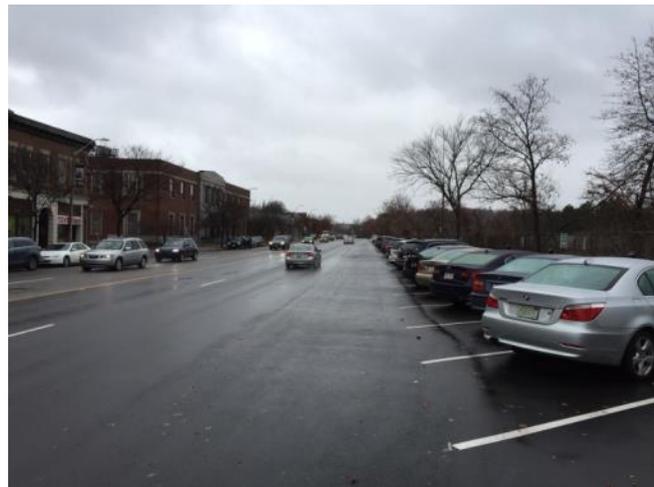
Members of the assessment team noted that east of Walnut Street, parallel on-street parking is provided on the north side adjacent to local businesses while angle parking is provided on the south side. Drivers parking on the south side are frequently observed crossing the street midblock to access businesses. The City should consider reconfiguring this section of the roadway to shift the angle parking to the north side and reduce the need for pedestrians to cross between the parking and businesses. The revised roadway cross-section may consider the use of back-in angle parking, which is safer for all roadway users.

Members of the assessment team noted that there are insufficient crossing opportunities for pedestrians throughout the corridor. The segment of Washington Street between Walnut Street and Harvard Avenue extends over 1,300 feet between crosswalks. Given the dense commercial land use on the north side of the roadway, there is demand for an additional crosswalk to connect the on-street parking with adjacent businesses. The City should consider installing an additional crosswalk,

Figure 4 - Angle parking and wide cross-section east of Walnut Street

- Consider reconfiguring the roadway to provide back in angle parking on the north side and parallel parking on the south side.
- Consider installing a crosswalk with curb extensions and a rectangular rapid flashing beacon or a pedestrian hybrid signal.
- Consider consolidating the two parallel parking lanes to a single back-in angle parking lane on the north side of Washington Street.
- Consider removing single space parking meters and installing multi-space parking meters on the south side of the roadway at designated crosswalks to encourage pedestrians to cross at the crosswalk.

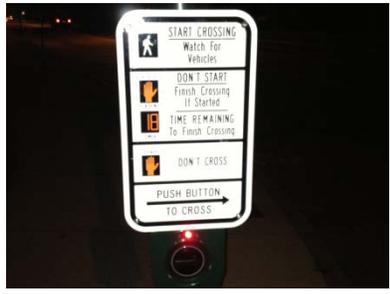
Facility Type	Description	Sample Photo
<p><b>Accessible Pedestrian Signals (APS)</b></p>	<p>Accessible pedestrian signals systems are the components used at a signalized intersection to alert pedestrians when they may cross a roadway. Accessible pedestrian signals include audible feedback during the pedestrian crossing phase, vibrotactile feedback, and locator tones to assist visually-impaired pedestrians.</p>

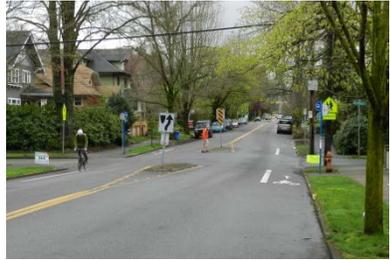
<p><b>Chicanes</b></p>	<p>Chicanes are a traffic calming device that horizontally deflects motor vehicles resulting in reducing vehicular speeds. Chicanes are typically designed by the addition of a median or by shifting on-street parking from one side of the roadway to the other side of the roadway.</p>

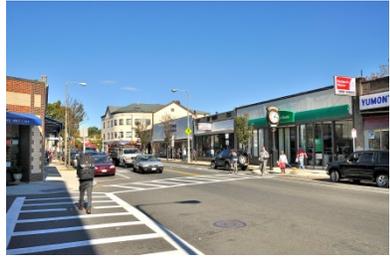
<p><b>Crosswalks</b></p>	<p>Crosswalks indicate to pedestrians the appropriate place to cross the street and inform drivers of potential pedestrian movements in the street. Crosswalk pavement markings may vary in styles; however, must follow the guidelines in the MUTCD. Additional enhancement measures should be used when the speed limit is greater than 40 mph, on multi-lane roadways, or based on engineering judgment.</p>

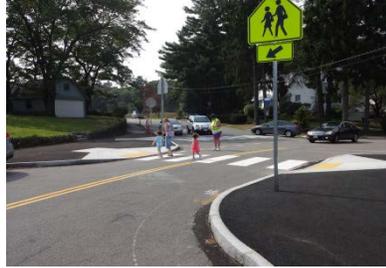
<p><b>Curb Extensions</b></p>	<p>A curb extension is an extension of the sidewalk at intersections or mid-block to reduce the pedestrian crossing distance and provide greater visibility for pedestrians waiting to cross a street. Curb extension should not impede on bicycle travel along the roadway.</p>

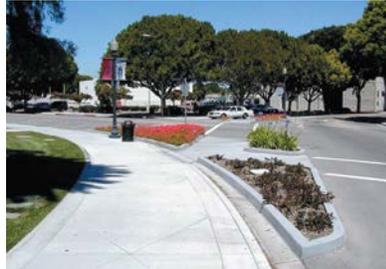
<p><b>Curb Radii Improvements</b></p>	<p>Curb radii improvements are modifications to existing curb lines or edges of the pavement at an intersection. These modifications typically are used to decrease crossing distances for pedestrians, increase pedestrian visibility, and/or to reduce vehicular speed by tightening the turning radii at the intersection corners.</p>

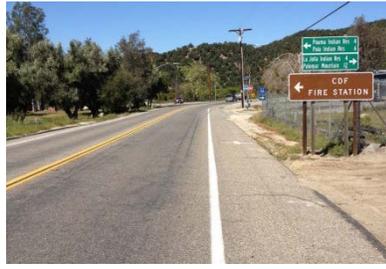
<p><b>Edge Lines</b></p>	<p>Edge lines are solid white lines painted along the roadside curb that defines the driving lane and visually narrows the travel lane.</p>

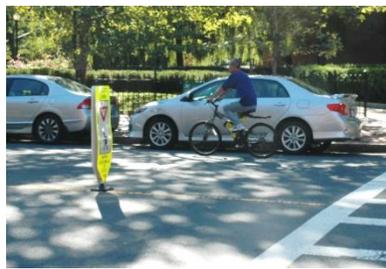
<p><b>In-Street Pedestrian Crossing Sign</b></p>	<p>A high-visibility sign placed on the centerline of a street prior to a crosswalk to alert motorists to yield when pedestrians are present in the crosswalk. When the sign is present, there tends to be an improved compliance of motorists yielding to pedestrians.</p>

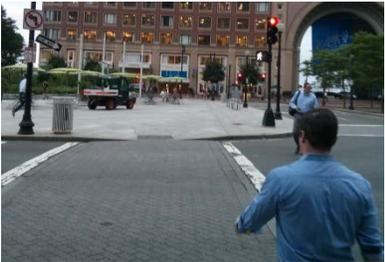
Facility Type	Description	Sample Photo
<p><b>Leading Pedestrian Interval (LPI)</b></p>	<p>A pedestrian crossing indication that permits pedestrians to move into the intersection 3-7 seconds before a green light is given to turning motorists that may cross the crosswalk. This increases visibility of pedestrians and reduces conflicts.</p>

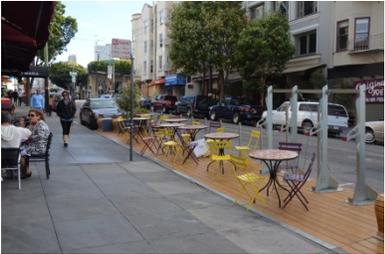
<p><b>Parklet</b></p>	<p>Temporary gathering area installed in the street adjacent to the curb as an extension of sidewalk space. This is temporary retrofit until a permanent curb extension is installed.</p>

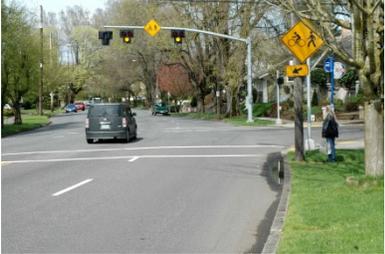
<p><b>Pedestrian Hybrid Beacon</b></p>	<p>An overhead pedestrian activated signal that requires traffic to stop during the pedestrian walk phase. When the beacon is not activated, the signals are dark.</p>

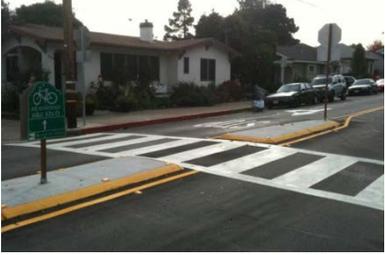
<p><b>Pedestrian Crossing Island</b></p>	<p>Raised median or island that provides in-street refuge at a pedestrian crossing. The island reduces the amount of exposure time for the pedestrian.</p>

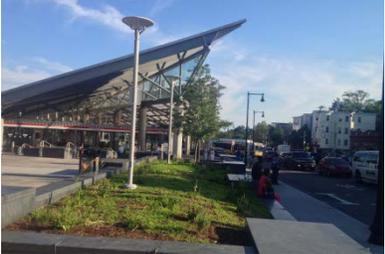
<p><b>Pedestrian-Scale Lighting</b></p>	<p>Light fixtures used to illuminate a sidewalk or pathway typically closer to the ground and placed closer together than roadway lighting.</p>

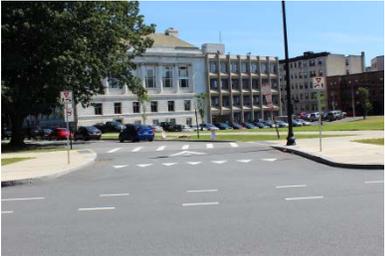
Facility Type	Description	Sample Photo
<p><b>Raised Crosswalk</b></p>	<p>A crosswalk raised from street-level to sidewalk-level. This elevated crosswalk increases pedestrian priority and visibility and slows approaching vehicles.</p>

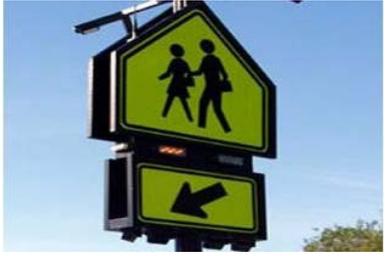
<p><b>Rectangular Rapid Flash Beacon (RRFB)</b></p>	<p>An on-demand activated flashing beacon with a strobe “wig-wag” pattern that alerts motorists to pedestrians in the crosswalk. The RRFB is currently an interim approved device in the MUTCD.</p>

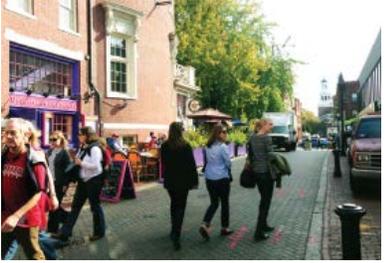
<p><b>Shared Street</b></p>	<p>The road surface is typically at the same level as the sidewalk surface to create a continuous pedestrian space. A shared street is for motorists, pedestrians, bicyclists, and heavy vehicles.</p>

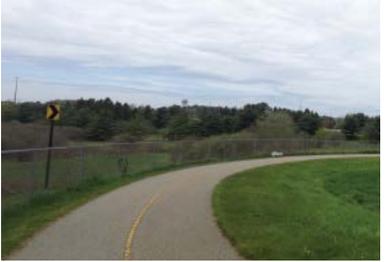
<p><b>Shared-use Path</b></p>	<p>A two-way path that is open for bicyclists, pedestrians, and other non-motorized users. The path wide may vary depending on demand according to AASHTO guidelines.</p>

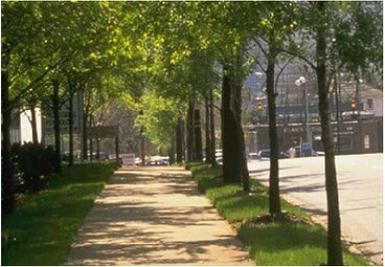
Facility Type	Description	Sample Photo
<p><b>Sidewalk</b></p>	<p>A concrete pathway adjacent to the roadway. A sidewalk must meet minimum dimensions and smoothness for ADA-compliance. Sidewalks may have decorative paving or plantings as a buffer from the roadway and should be wider where high pedestrian volumes are present or desired.</p>
