# Detailed Energy Audit for City of Newton - Phase 3

May 28, 2010

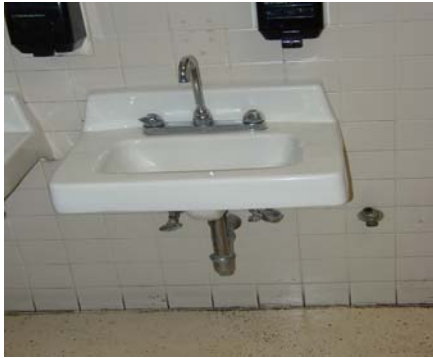
*Standard flow aerators will be retrofitted.*

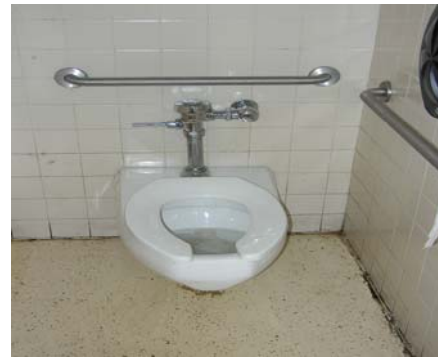
*Flushometer (tankless) toilets will be retrofitted.*

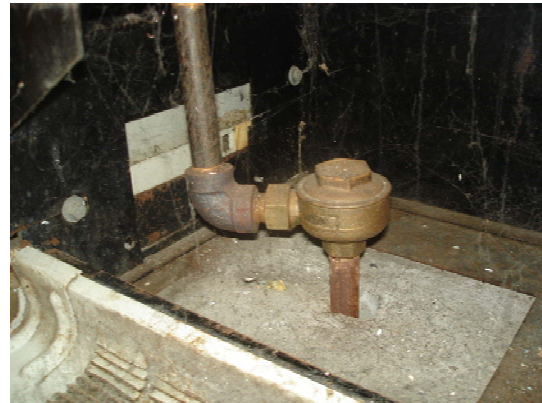
Thermostatic Steam Trap

Buildings all over the city have systems that generate steam for space heating. Integral components of an efficient steam system are the steam traps, which remove condensate from the distribution system and return it to the boiler plant. Older and unmaintained steam traps will fail over time and eventually allow live steam to pass through the trap into the condensate system, wasting significant energy. NORESKO's experience is that without a comprehensive maintenance program that includes the repair or replacing of failed traps, a significant number of traps will fail to operate properly over time.

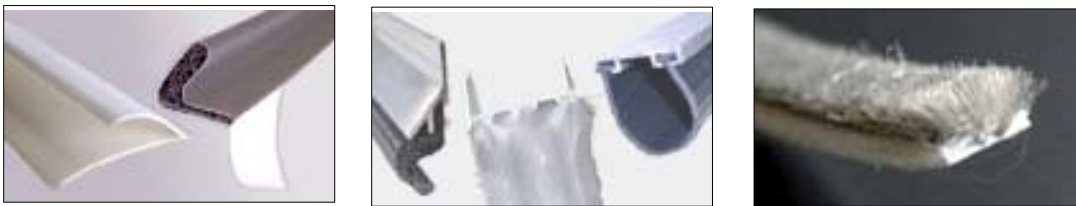
*Weatherstripping Materials*

Window and door openings present a challenge to reducing infiltration in a building. They must not only seal but also allow access. While most sealing installations are permanent, windows and doors must continue to operate as designed. As such there is friction from the constant opening and closing. These areas will be weather-stripped with a durable product that is both flexible and strong enough to withstand abuse, wear and tear.

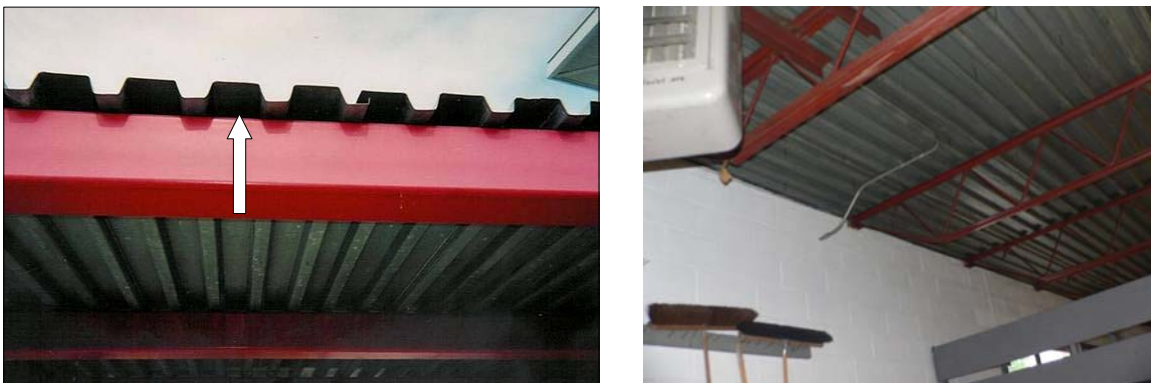
In several buildings, metal panning is installed as part of the roof system on top of a block wall, “I”-beams and/or bar joist. The corrugated metal panning, by design, does not seal. The openings between each rib (the roof/wall intersection running parallel with the panning and the bar joist penetrations) should be sealed. See photos below.

*File Photos of roof panning (notice the gap between corrugations)*

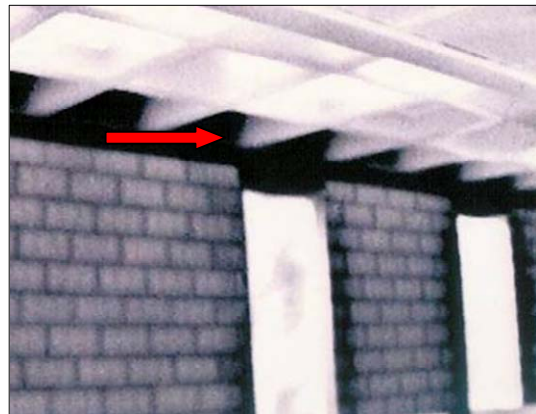
Several buildings could benefit from adding some type of insulation. In exposed areas where the installed product will be seen by occupants, the typical insulation that is installed is a pre-finished thermal panel. This product comes as a “sheets good”. One side of the product has a white pebble finish which helps maintain light reflectivity and thermal performance. The panel surface can be pressure washed if soiled and can also be painted. Its appearance is similar to a suspended ceiling; however, the panels are larger.

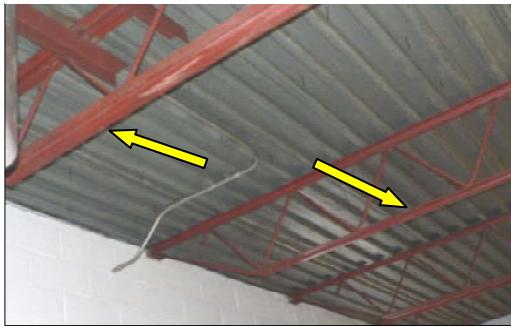
*Ceiling Mounted Thermal Panel Installation Schematic*

The specified product for this installation is STYROFOAM™ Ag Board and THERMAX White Finish/AG-THERM. These rigid boards have a reliable R-value of 5 or 6.5 per inch and provide quick installation.

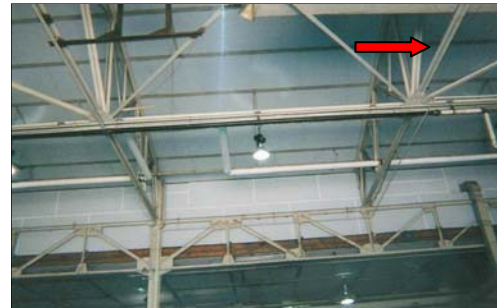
In some locations, a thermal ceiling will be installed. This energy savings measure allows the total conditioned building volume to be reduced. In the photo to the right the ceiling was installed using the bottom cord of the bar joists, however conditioned space volume could have been reduced had the ceiling been installed on the bottom cord of the metal truss (red arrow). Unfortunately in this application shown the height was needed for raising equipment into the air on lifts to be worked on from below. Not only does this ECM reduce heat loss in the winter; it also reduces heat gain in the summer which is an added benefit to areas that have no air conditioning or where the air conditioning seems to not cool. *Thermal Panel Installation (Wall/Ceiling)*

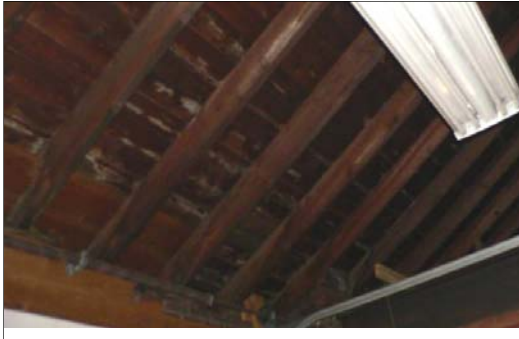
*Thermal Panel Installation (Attic)*

*Thermal Panel Installation in Attics:* The photo to the left details another roof style which can utilize the Thermax ceiling. The rafters are exposed to the occupants. Regardless of construction material, the Thermax ceiling can be installed as large sheets (much like sheetrock) except that the sheets are already prefinished and thermally enhanced. This reduces the labor costs for installation. The resulting ceiling will exhibit improved thermal performance.

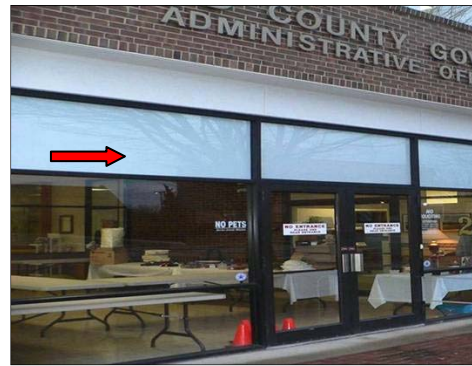
*Thermal Panel Installation (Window)*

*Thermal Panels on Glass Walls:* There are several areas identified where thermal panels will increase the R-value of glass walls. The photo to the right is an archive example of utilizing the thermal panel in a glass wall. In this case the top transom was closed off to reduce energy costs. The glass remains in place and the panel is installed from the inside. It has a finished surface on the inside which is white but is also paintable. This system can be installed with little or no structural changes to the existing systems.

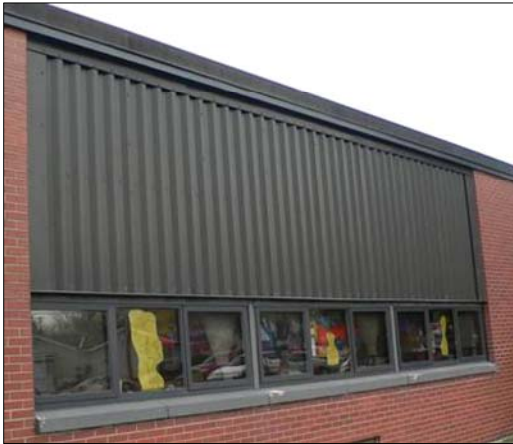
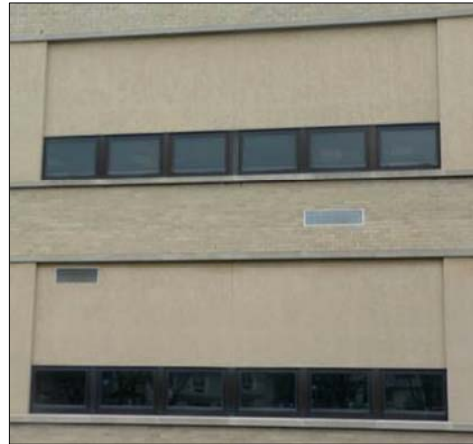
*Thermal Panel Installation (Windows)*

In several buildings, windows could be reduced in size thus providing energy savings due to increased thermal performance and reduced infiltration. If the exterior finish is a consideration, there are two options for covering the glass as viewed in the photos below. By adding the Thermax on the interior side, windows can become an option. The total glass area is reduced but the thermal performance of the glazing system will be improved significantly.

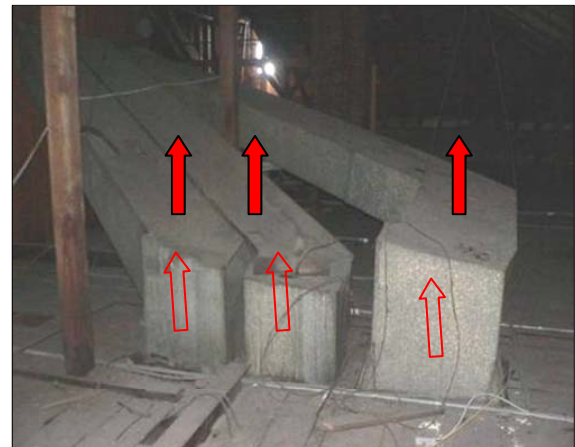
Where the attic is accessible, there are many exfiltration points that can be sealed. The drawing to the left shows some of those areas where leakage occurs. These will be sealed before insulation is installed or re-insulation occurs.

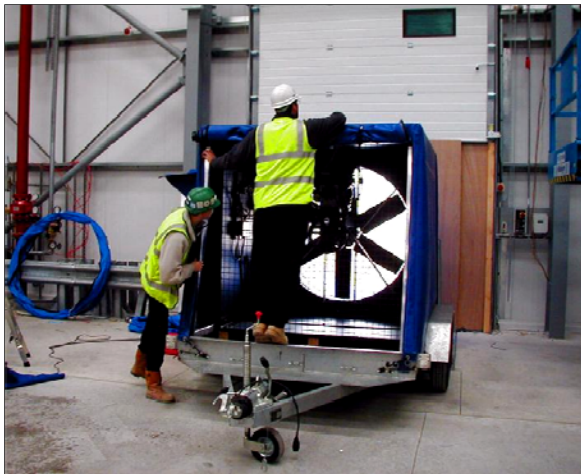
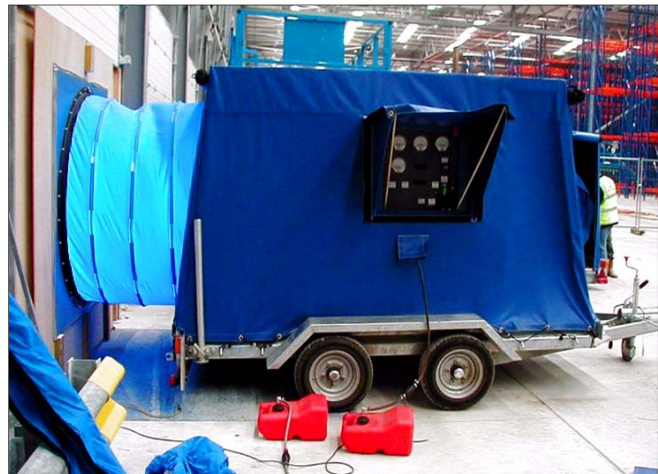
For large buildings the blower door may be larger as depicted above, however the process is the same. Pressure differentials are created to measure the uncontrolled leakiness of the structure.

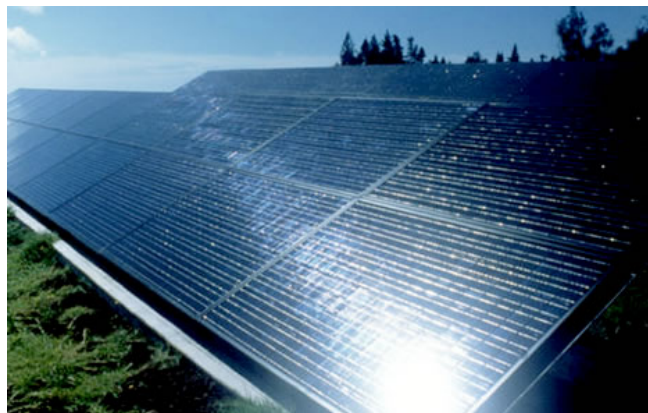
*Solar PV Panel*

NORESKO will install a 7.5 kW photovoltaic (PV) system at the Lower Falls Community Center. The system will be installed on the existing roof structure and will be incorporated into the existing building electrical service. A visual display will be included to allow visitors and interested parties to view the system's output over the internet. The 36-panel system will be self-ballasted, requiring no roof penetrations. Once installed, the PV system will not only help displace electricity purchased from the utility, but also serve as a symbol of Newton's effort to promote sustainability and environmental stewardship.

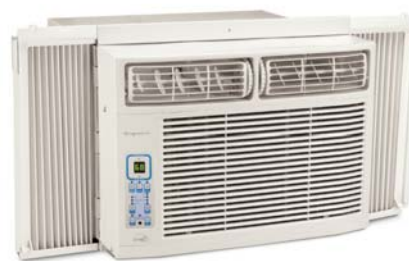
*EnergyStar Window A/C Unit*

Many of the window AC units inspected were found to be nearing the end of their useful life expectancy. Given the age and condition of the units, it is estimated that they currently operate at an efficiency level of 8.0 EER. Newer EnergyStar rated units can have efficiencies upwards of 11.0 EER. By installing newer units, the City would benefit from reduced electrical consumption through more efficient cooling of its year-round occupied spaces.

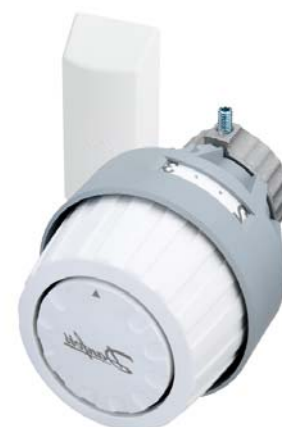
*Thermostatic Radiator Valve*

New TRVs will provide occupants the ability to manually adjust and automatically regulate individual heating output on an end-use level. This will not only reduce heating consumption, but also significantly improve occupant comfort by allowing for greater space temperature control.

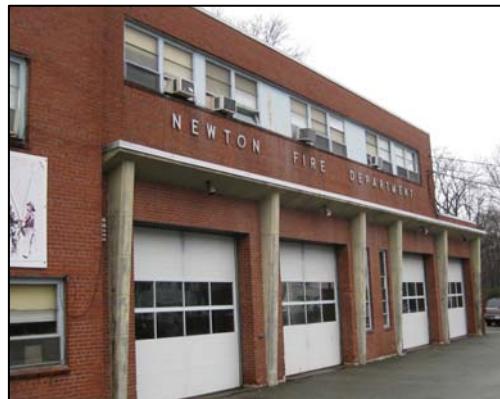
*Fire Station 3 Apparatus Bays*

The City’s public works division and fire departments utilize garage space for vehicle storage and maintenance. As expected, these high use facilities see very high infiltration rates due to overhead doors opening and closing, or being left open as necessary. Currently, these spaces are predominantly heated by gas-fired unit heaters or make-up air units. This heating method utilizes sensible energy exchange to cold air passed over a hot coil to heat the ambient air and warm the space. Unfortunately, this warmed air easily escapes the building once the doors are opened, resulting in significant energy waste.

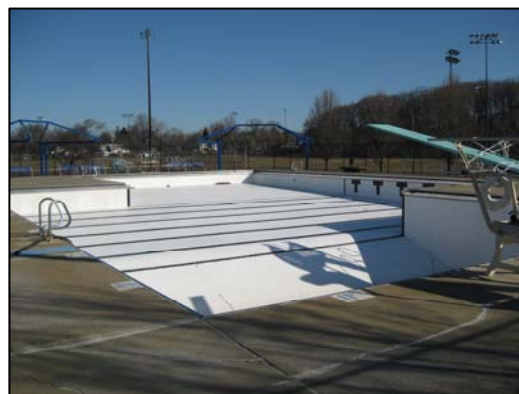
Pools lose energy in a variety of ways, but evaporation is the most significant mechanism for energy loss. One BTU is required to raise one pound of water one degree, but each pound of water that evaporates results in approximately 1,000 Btu of thermal energy lost. This evaporative energy loss resulting in the lowering of water temperature must be made up by the pool water heating system. By covering the pool during unoccupied hours, evaporation is greatly reduced and heating energy is saved. In addition, the requirement for make-up water is reduced. This lowers water consumption and chemical treatment costs.

Pool owners typically find that installation and removal of pool cover systems is easy enough for facility lifeguards to manage on a daily basis. Lifeguards install the covers at the close of their shift, and remove them prior to pool operating hours. The location of this pool facility in a Northern climate where nighttime temperatures can dip far below the 80°F pool temp makes this good application for a pool cover installation.

Installing pool covers to save energy and water costs tends to be cost effective for pools that operate year-round. However, for seasonal pools that only operate during the summer months, the savings are commensurately less and the payback is much higher. For these reasons, a pool cover for the Gath pool is not cost effective and this measure is not recommended.
