## PUBLIC BUILDINGS DEPARTMENT

### **Angino Farm Barn Rehabilitation, Post Substantial Completion Narrative**

Ted Callahan- P.M.; City of Newton, Public Buildings Dept.

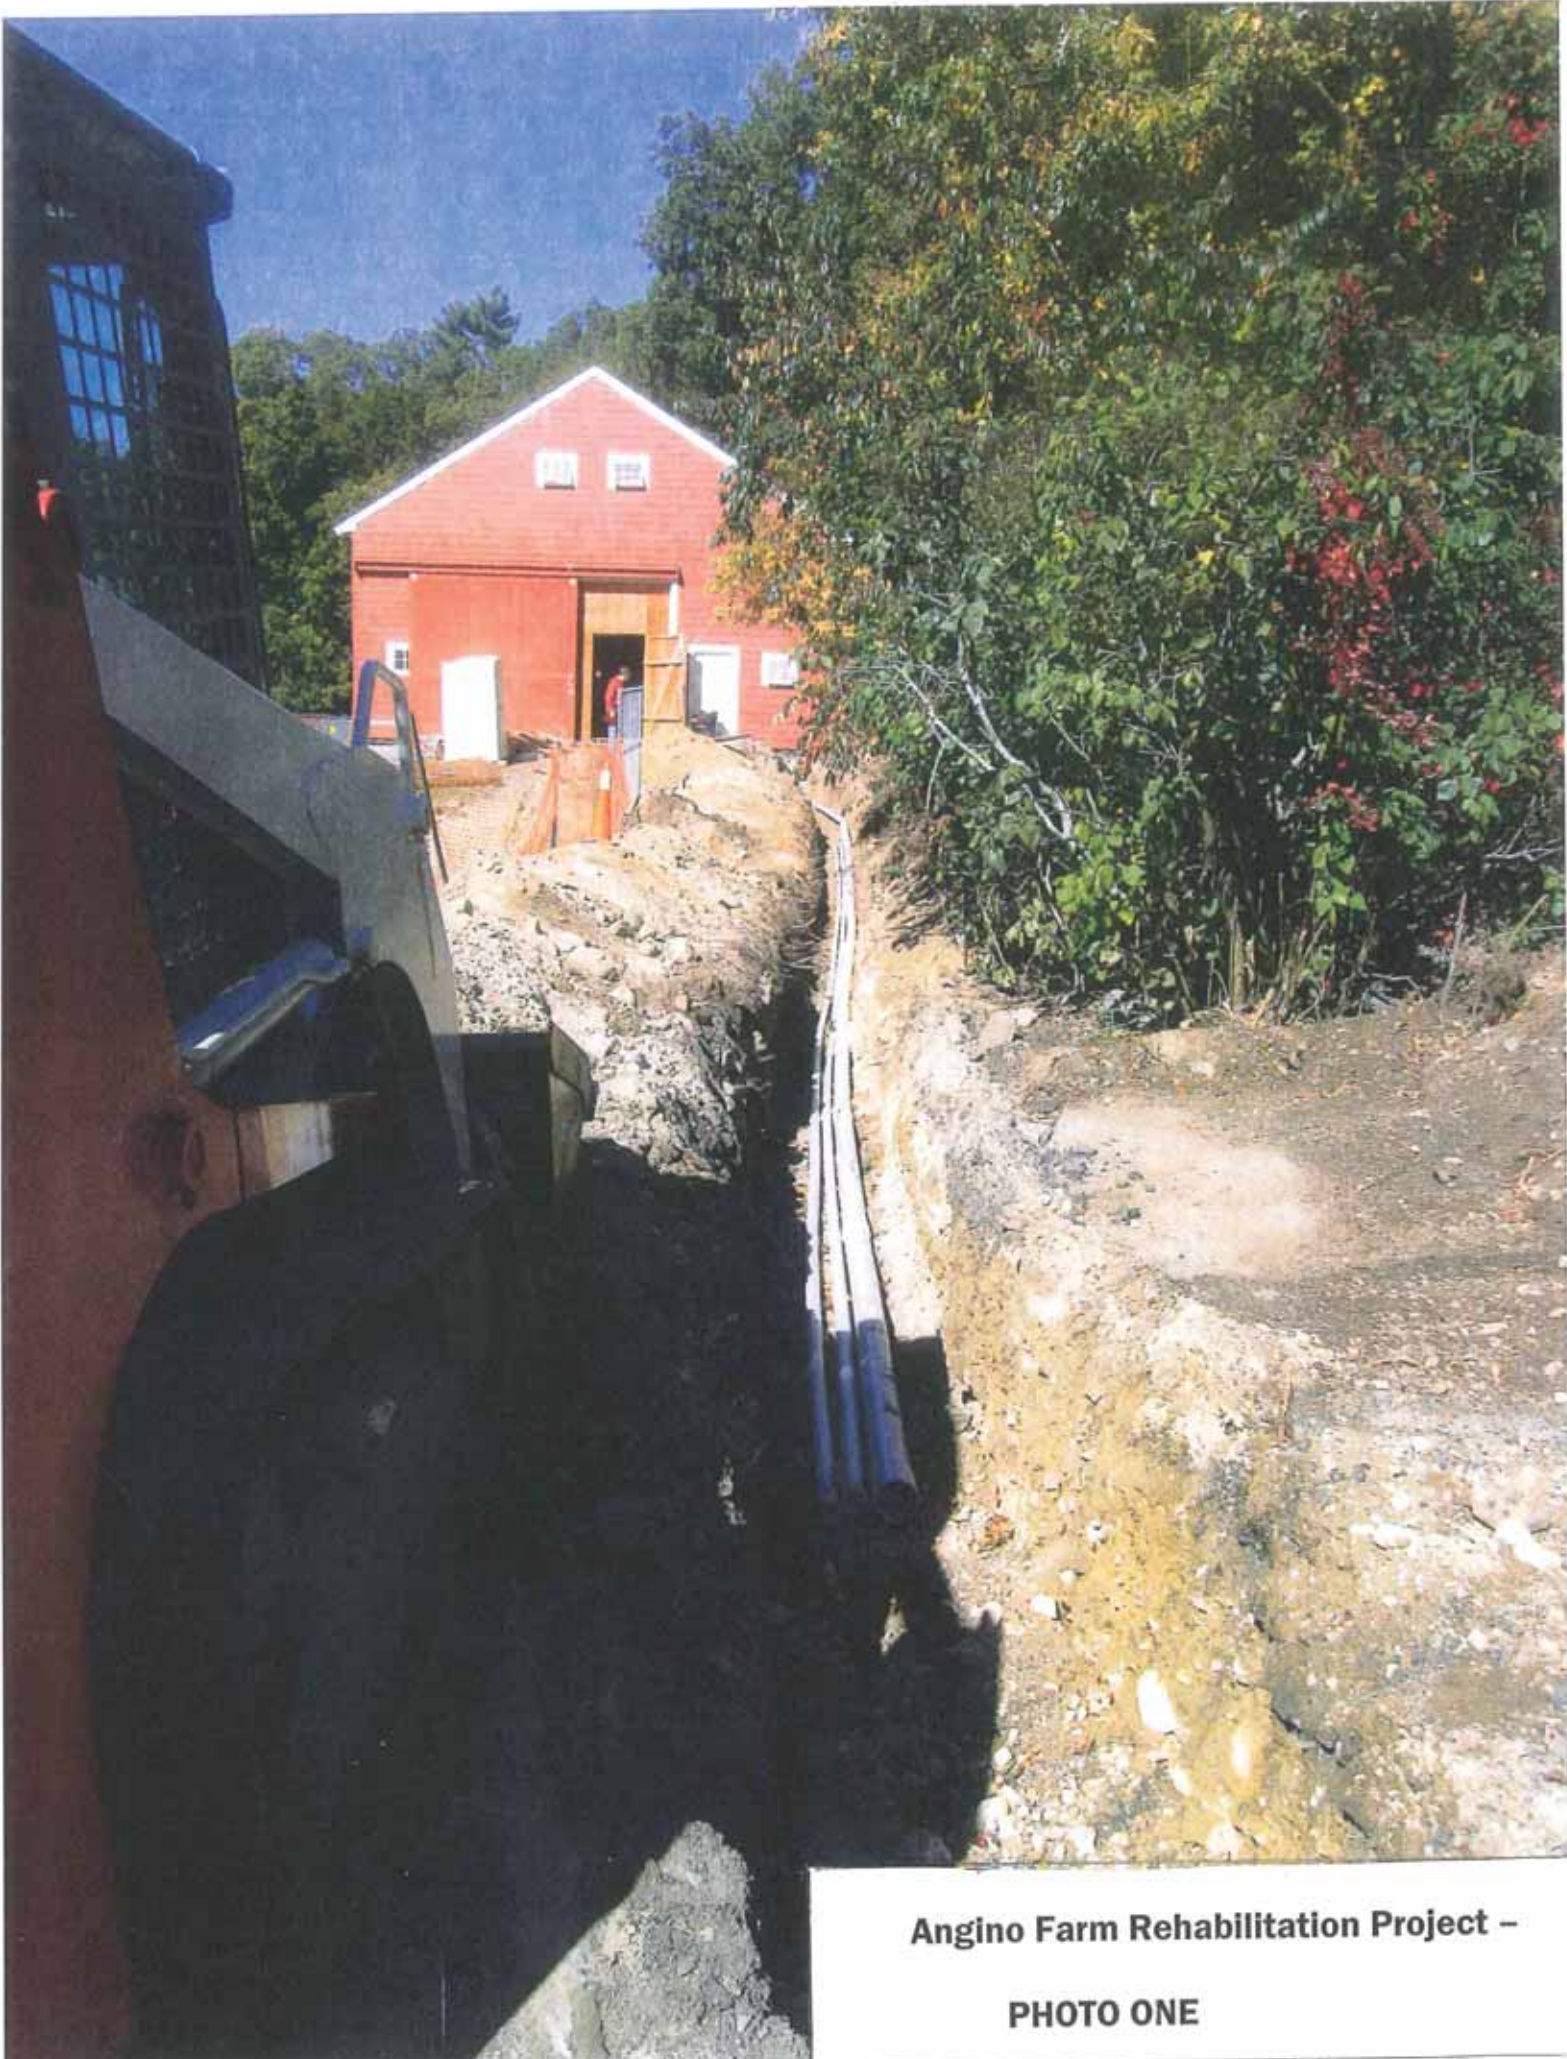
**Angino Farm Rehabilitation Project –  
PHOTO ONE**

Photo No.	Time Frame	Description of Work
ONE	Late summer 2013	The south side of site where the contractor has installed empty conduits for electrical power and IT services. The workman shown at the barn is coordinating the penetration for the conduits through the barn's existing stone foundation.
TWO	Mid summer 2013	Initial work site for the project was at the tractor shed at the north side. The photo shows that the existing roof has been demolished. The top of the old stone wall is being prepared for the reinforced concrete beam that will eventually support the new roof and open deck assembly. Note that the column footing forms are set in place and ready for the concrete. Structural wood framing is place and ready for roof sheathing, roofing and wood deck installations. Note that the concrete beam at the top of the stone wall is in place.

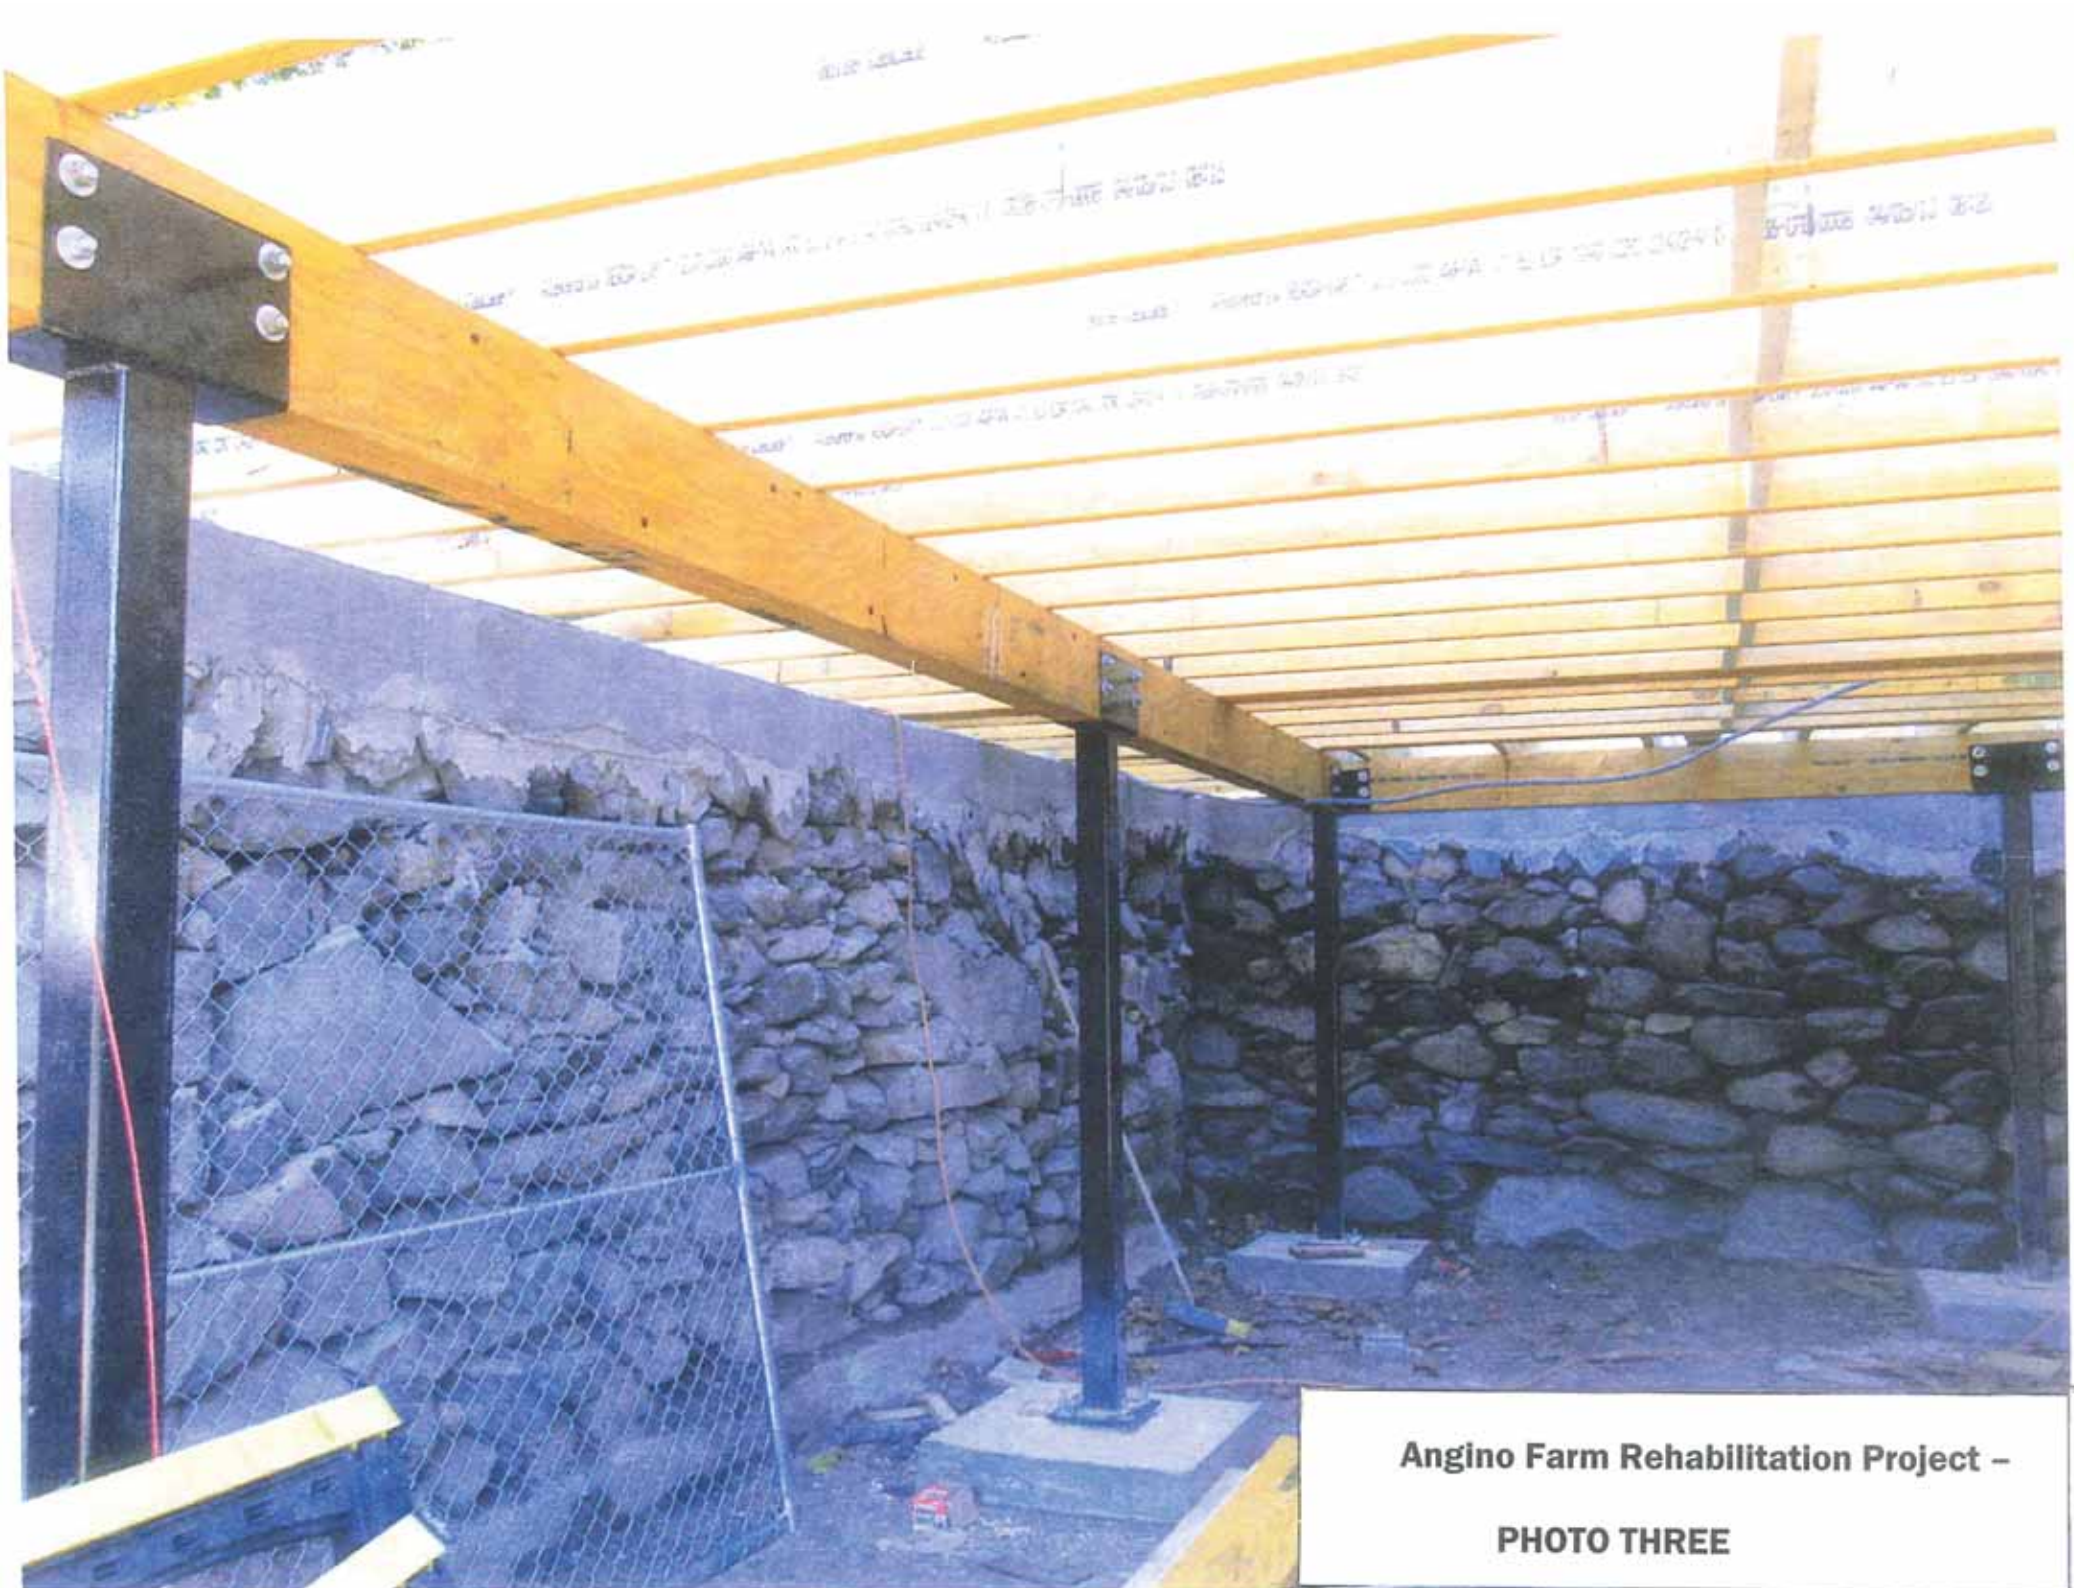
**PHOTO THREE**

<b>Photo No.</b>	<b>Time Frame</b>	<b>Description of Work</b>
THREE	Early autumn 2013	Structural wood framing is in place and ready for roof sheathing, roofing and wood deck installations. Note that the concrete beam at the top of the stone wall is in place.
FOUR	Autumn 2013	View of the existing opened framing at the barn after removal of the existing floor boards that were taken off site to be refinished. Note also, that the new structural carrying beams and supporting columns can be seen through opened joists to the basement area below.
FIVE	Winter 2013/2014	View of the existing first floor joists and the new perpendicular carrying beams located at the ceiling of the basement work area. Note new wood members "sistered" at existing joists were necessary to strengthen the existing joists and also to level the refinished floor boards at the 1st floor.
SIX	Late winter 2014	Exterior view of the rear of the barn that shows the new deck area nearing completion. Note that framing for the stairs to left in the photo and new replacement siding to be aligned with the deck for the flashing at the barn wall had not been completed.

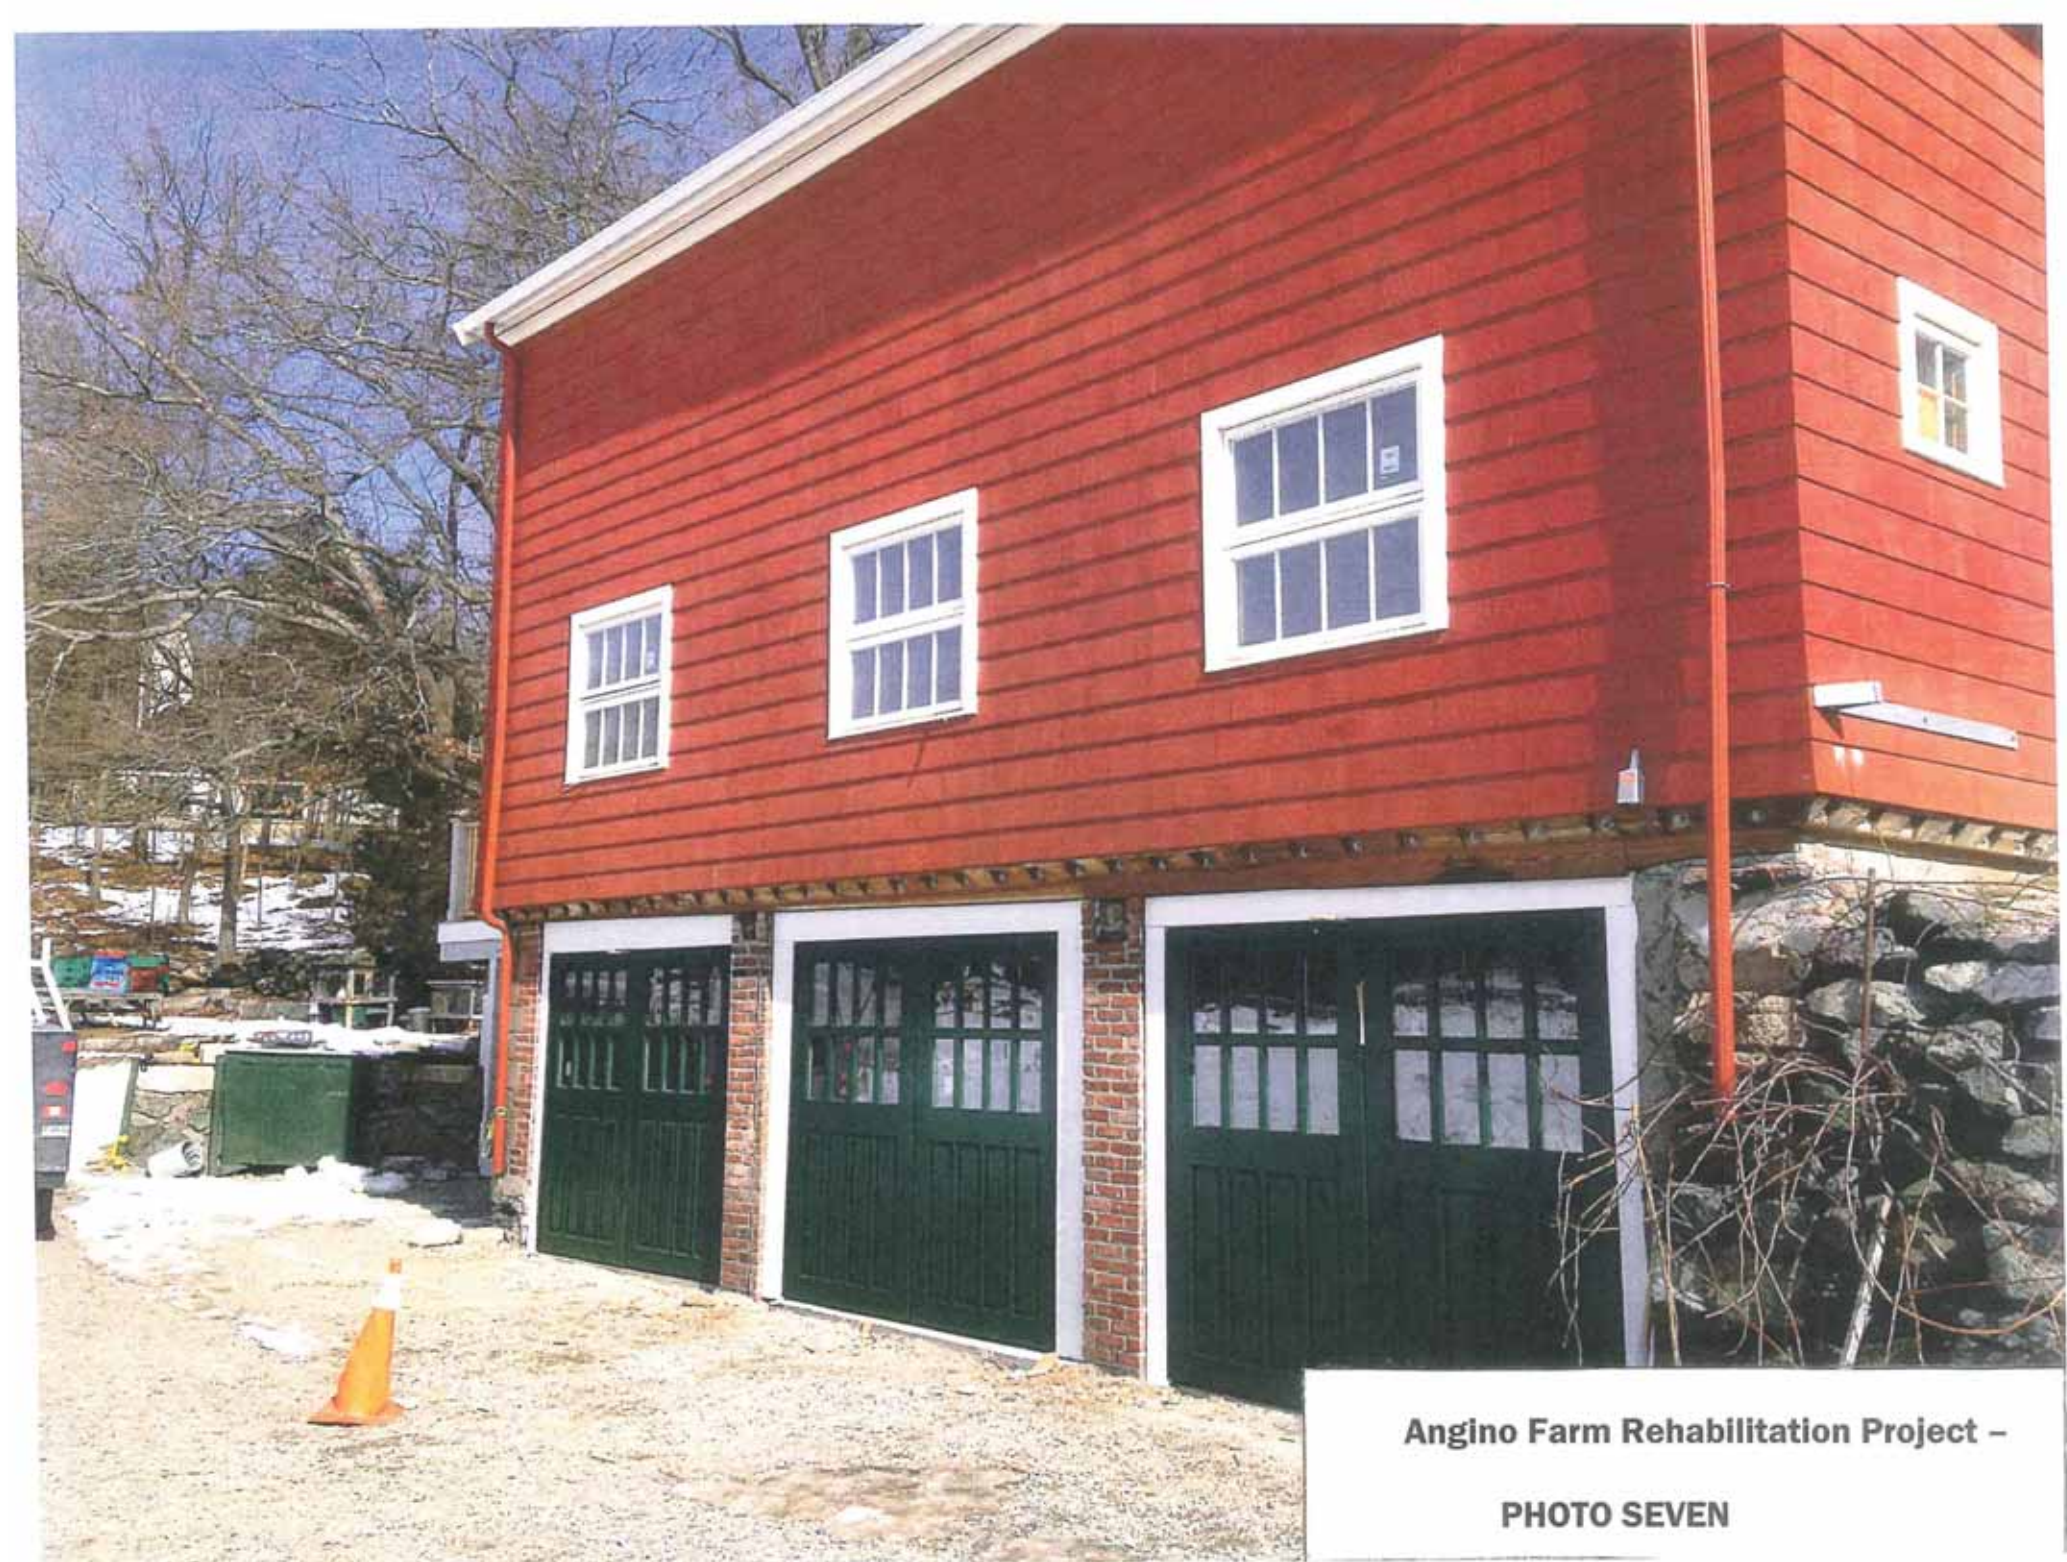
**PHOTO SEVEN**

SEVEN	Early Spring 2014	Exterior view of the west side of the barn shows three new traditional barn doors. All have insulating cores and have been installed to match existing ones that were no longer serviceable. Also the wood frames surrounding the doors were rebuilt. A similar door assembly was installed at the tractor shed beyond. The existing driveway repaving owned by contract had not been installed at the time of the photo.
EIGHT	Mid spring 2014	Interior view at the first floor of the barn shows finish work ongoing. Note that the refinished floor boards have been installed. Toilets shown at the left of the photo had been recently stud framed and finished with drywall sheathing. The glazed main front door unit is shown almost completed. New interior doors, wainscots, painted finishes, total plumbing fit-out, heating units and lighting fixtures were not installed at the time of the of the photo.

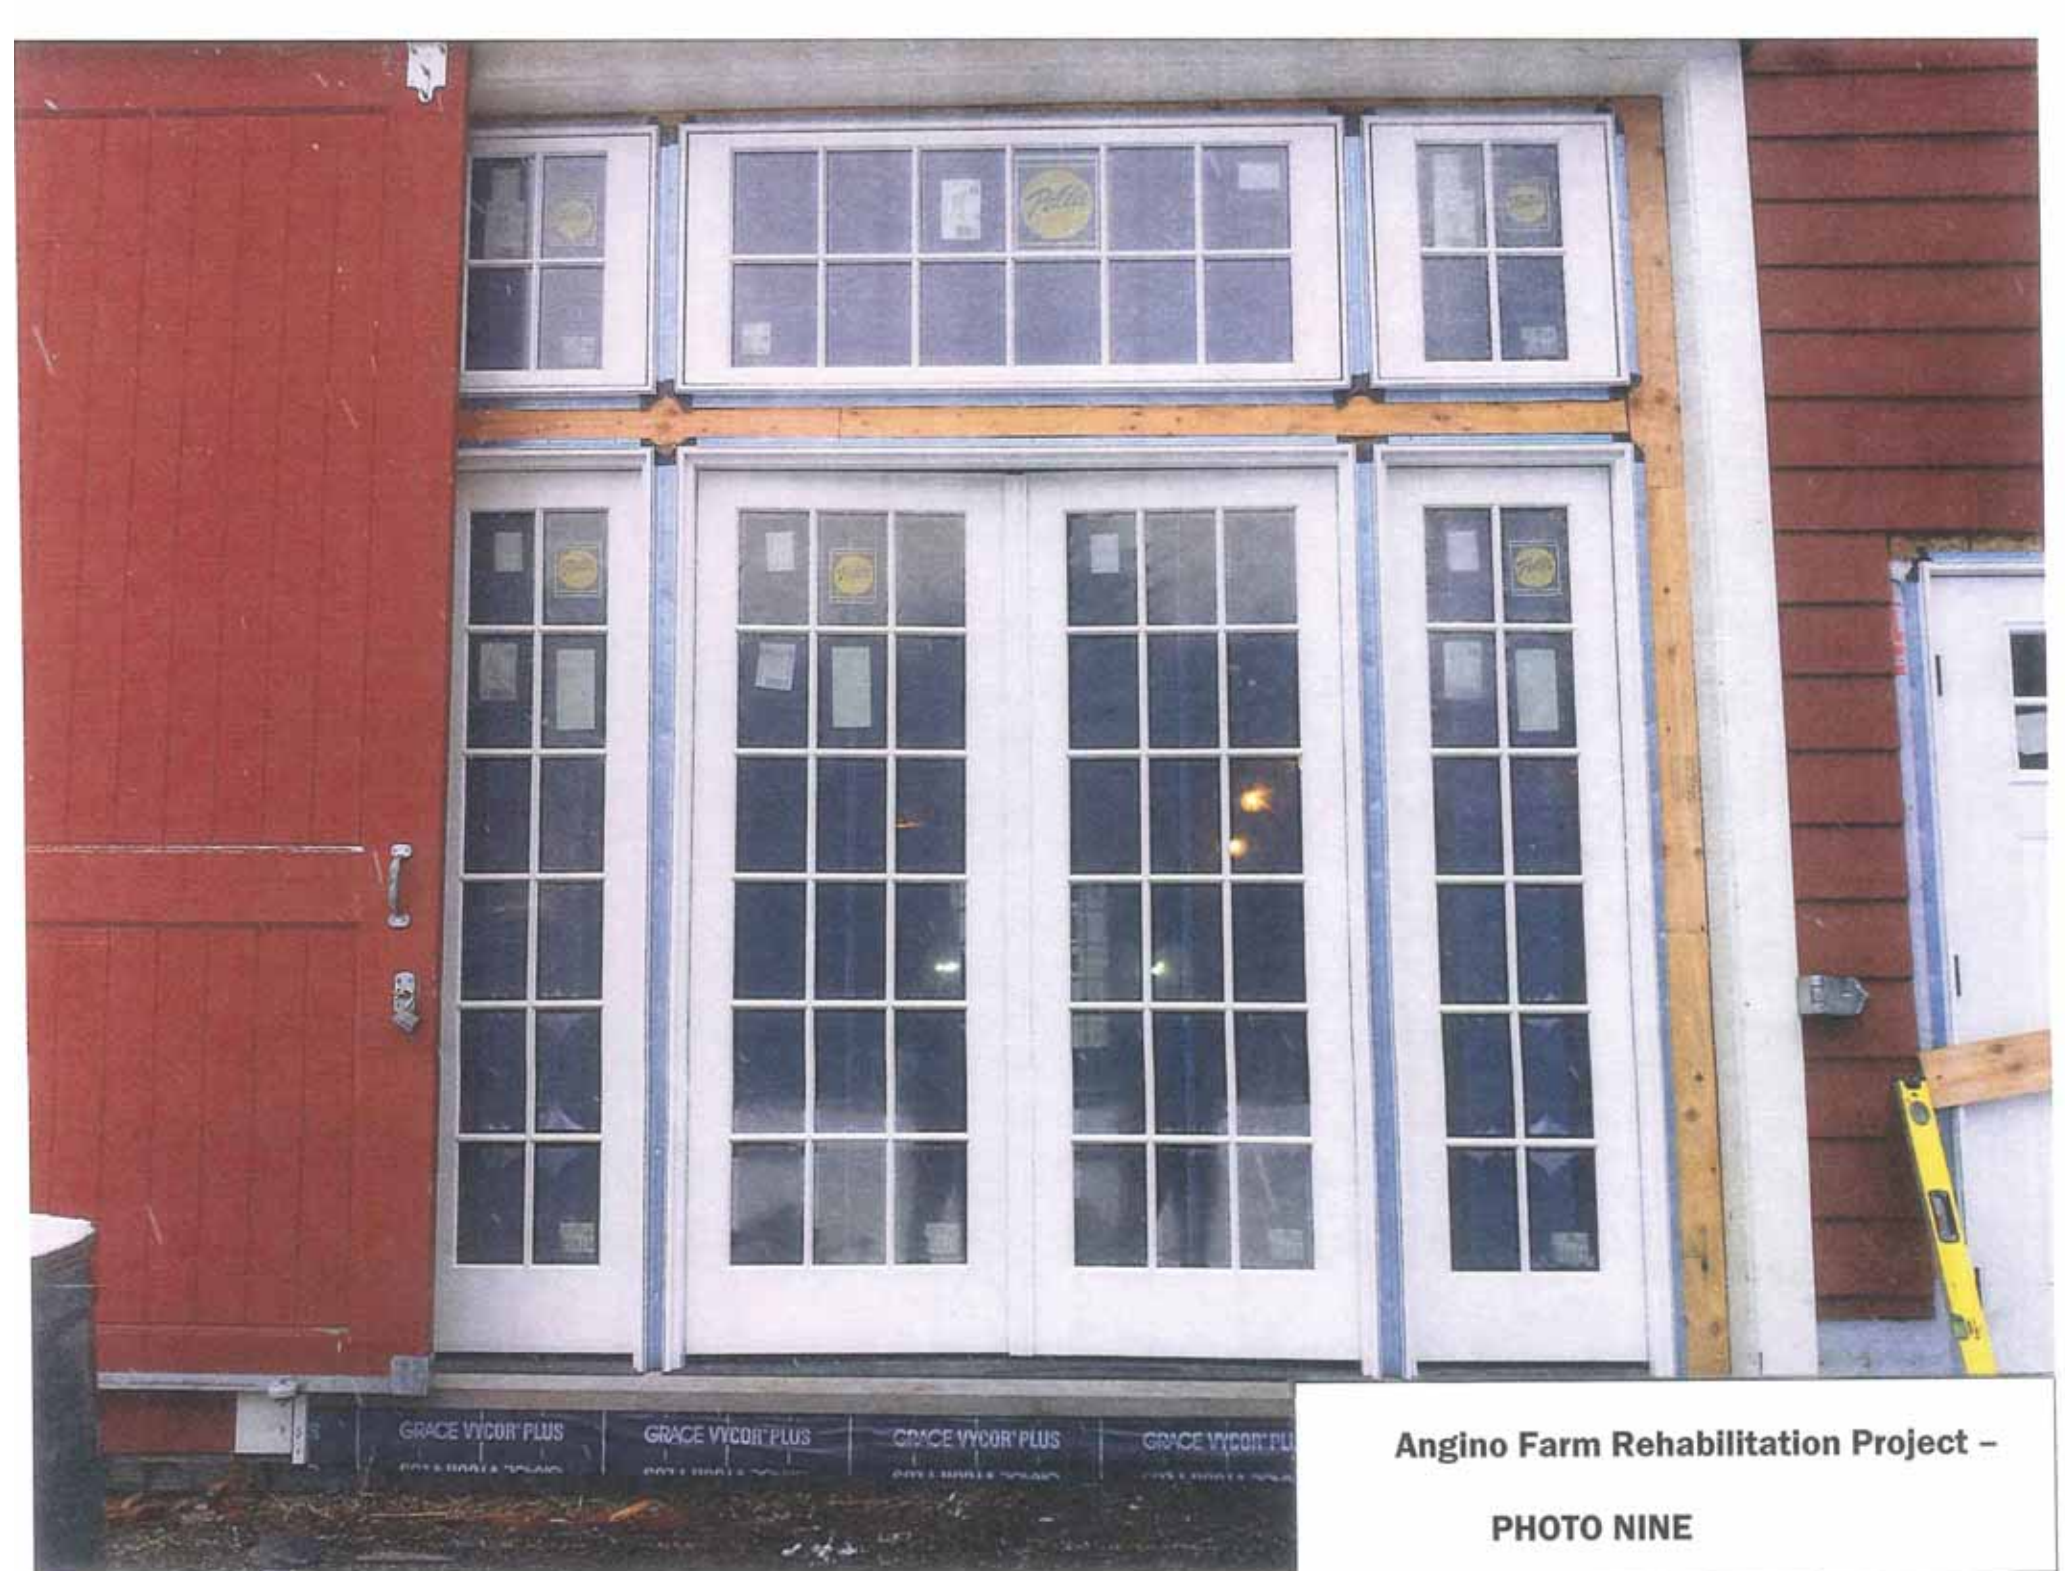
**PHOTO NINE**

NINE	Autumn 2014	Exterior view at the front of the barn with the new thermally glazed main entry doors shown in photo seven. Note that the large pair of doors are flanked by borrowed lites with ample clearstory that will allow the influx of daylight to the barn's interior creating a more inviting space.
TEN	Autumn 2014	Interior view of the new mechanical room with the wall hung gas fired furnace and hot water heater shown. The copper piping distributes both supply and return forced hot water for heating. Other pipes will supply domestic hot water to the various lavatories and utility sinks located at basement and first floor areas. Included in the overall system are expansion tanks, air separator, glycol system and other required equipment as noted in the Engineer's design. When this photo was taken pipe insulation and valve identity tags had not been installed. The mechanical room also contains electrical and fire alarm panels.
