City of Newton City Historic Buildings Survey

Phase I: Evaluation of Historic Significance of City Buildings

City Historic Buildings Survey Newton, Massachusetts

Evaluation of Historic Significance of City Buildings

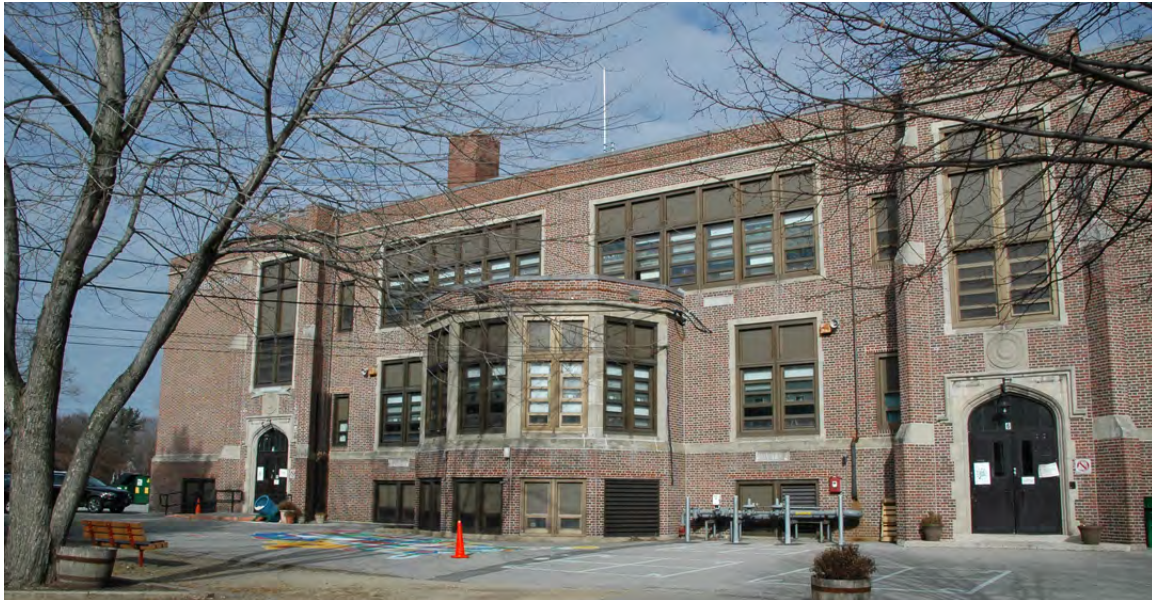
Angier Elementary School

Openings: Typically single tall openings or bands of horizontal windows with replacement aluminum sashes within stone surrounds. The metal sashes are divided into multiple fixed sashes and operable hoppers with areas of aluminum infill at transoms and are jarring compared with the delicate original sashes seen in historic photos. Arched entrances with stone surrounds and aluminum doors located at the street elevation on either side of the bowed projection.

Moderate. The building retains the many of its original design features and materials. However, the replacement of the windows has greatly changed the appearance of the building.

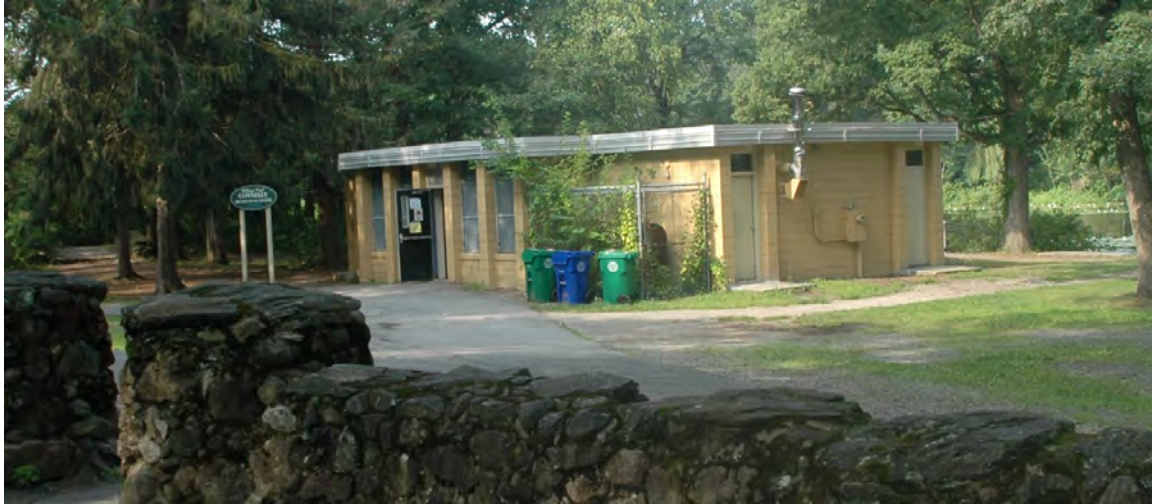
Auburndale Cove Fieldhouse

Windows are set behind exterior metal grates. Aluminum replacement doors at each side with transoms.

Level 3 – Low Significance. The building is a primarily utilitarian structure with few architectural features.

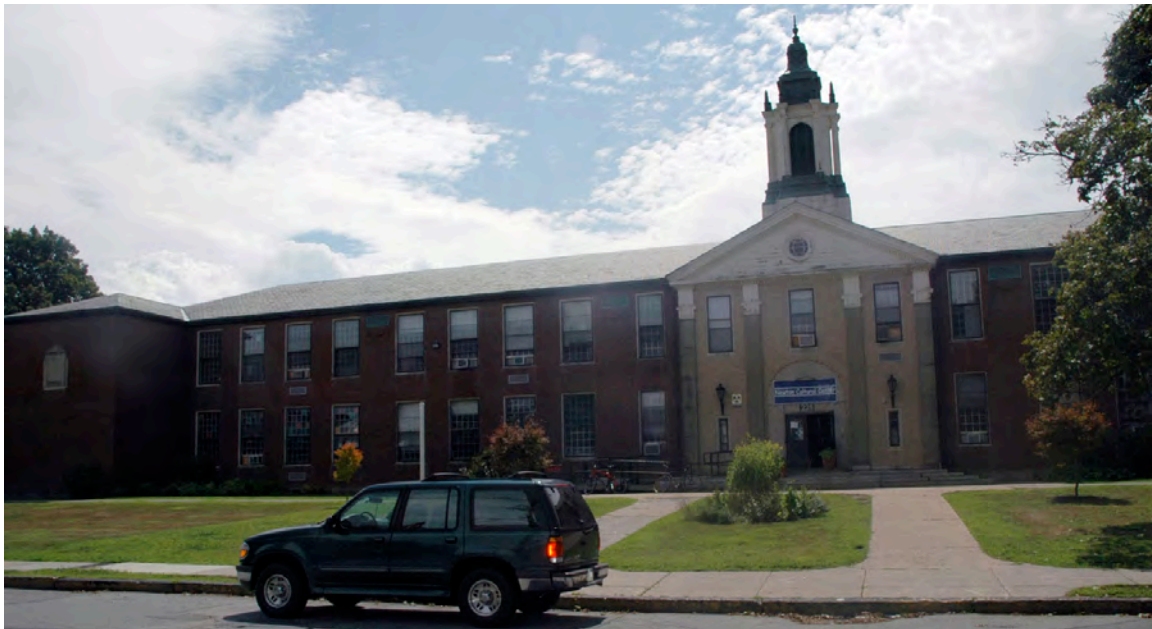
Carr School

Openings: Typically regularly-spaced window openings with 20-over-20 wood sashes. Exterior doors are aluminum replacements.

Moderate. Still retains many of its original materials and design features, however the quality of some of the original building materials and poor maintenance have caused some features to deteriorate. The modern addition does not overwhelm the original structure.

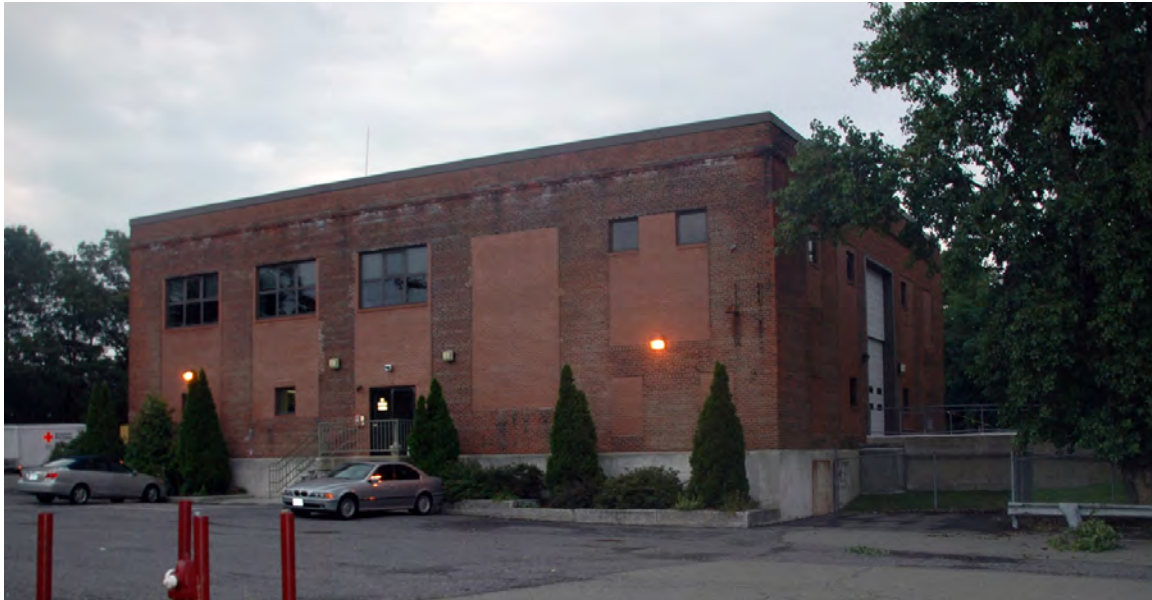
DPW – Water Utilities Department

Openings: The building originally had large double-height openings that have been infilled with brick. Aluminum double hung and fixed windows have been installed within some of the infilled areas. A large double-height door opening at the side elevation has a modern replacement aluminum garage door and aluminum trim.

Level 3 – Low Significance. The building has few architectural features and has been significantly altered from its original appearance.

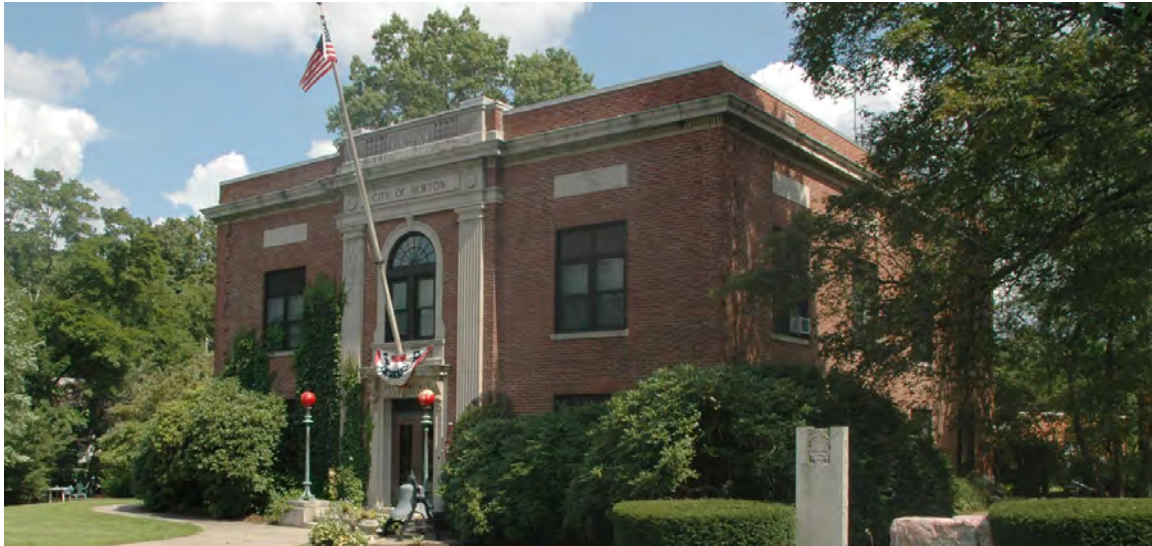
Fire Department Headquarters

Openings: Typically large rectangular openings with aluminum replacement windows set in pairs of double hung sashes with fixed transoms. The window over the main entrance is in an arched opening. The main entrance retains what appear to be the original bronze doors.

High. The building retains the majority of its original materials and design features with the exception of the replacement window sashes.

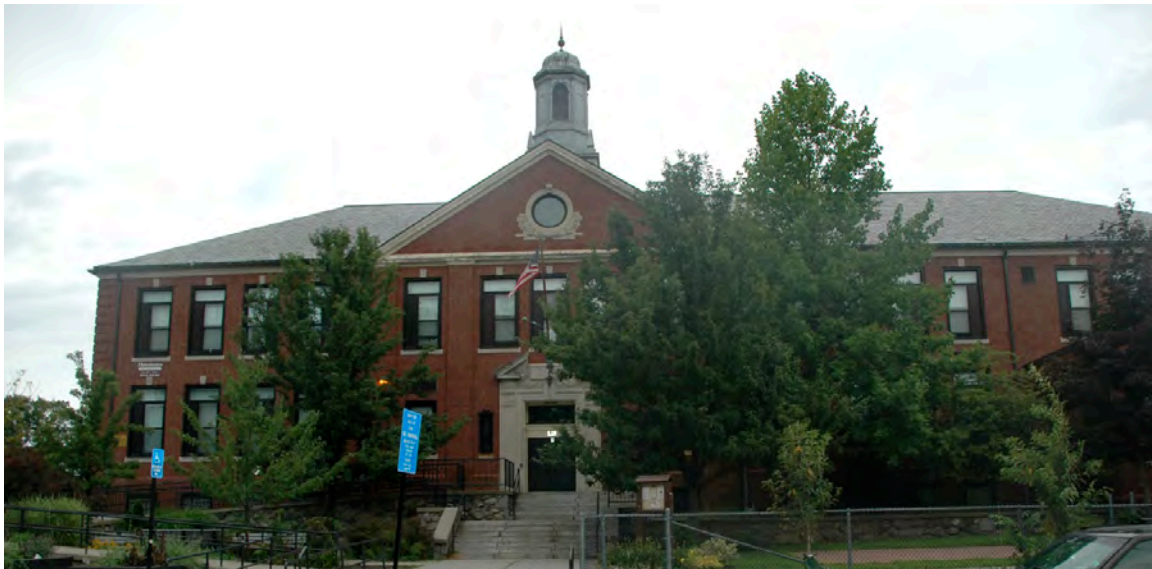
Franklin Elementary School

Openings: Regularly-spaced window openings that have been infilled with inappropriate aluminum windows. Original doors have been replaced with metal doors.
