# City of Newton

## City Historic Buildings Survey

*Phase I: Evaluation of Historic Significance of City Buildings*

BUILDING CONSERVATION ASSOCIATES INC

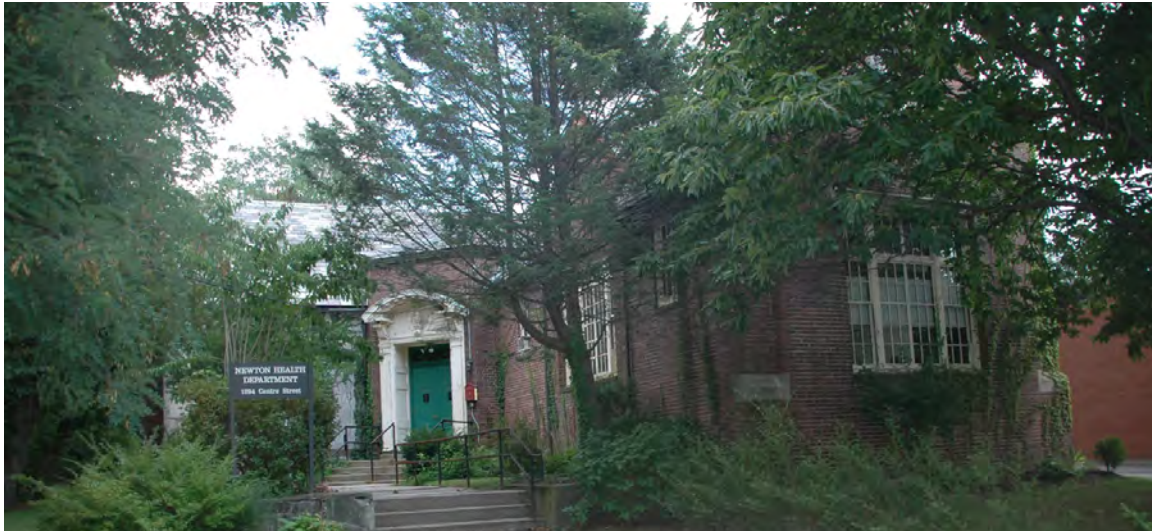
## Health Department Building

Address: 1294 Centre Street  
Year of Construction: 1927

*Shape:* One story with attic. The structure is "T"-shaped with the main entrance located in an angled section at one of the corners of the "T".

*Materials:* Brick with cast stone trim at the long side of the "T", stucco with cast stone and brick trim at the short side.

*Roof and Related Features:* Slate gable roof with raised end walls and exposed rafter ends.

*Openings:* The section of the "T" facing the street has large, square openings with original wood 6-over-9 sashes with transoms in cast stone surrounds and a small round window at the attic level of the gable end. Smaller openings with stone surrounds are located at the other elevations. The main entrance is contained within an elaborate wood surround with an arched pediment. The doors are wood replacements with a transom above.

Moderate. While the building retains the majority of its original design features and materials lack of maintenance has led to the deterioration of many of these features.

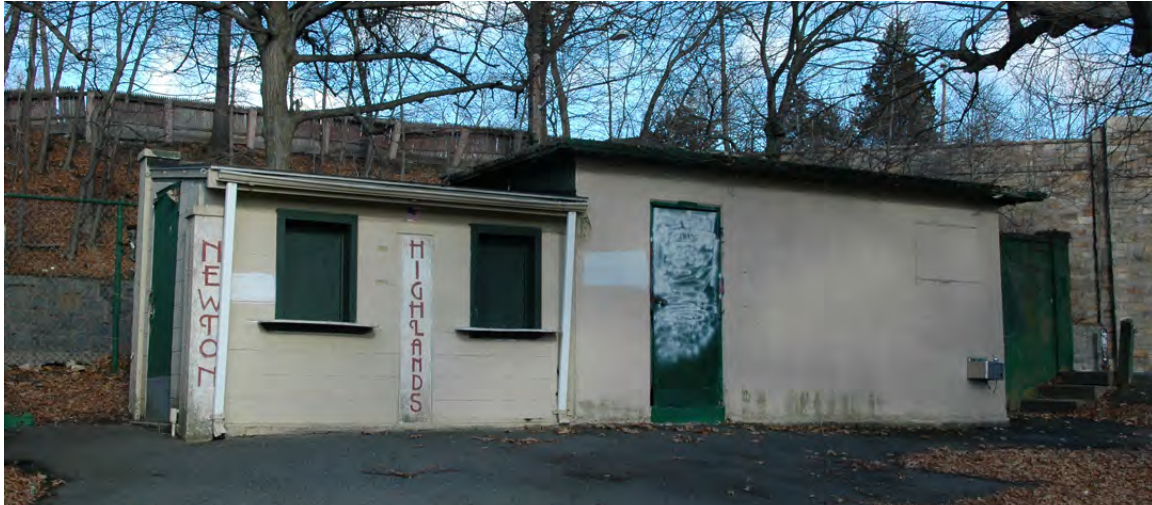
## Highlands Fieldhouse

Address: 10 Winchester Street  
Year of Construction: c. 1917

*Shape:* Rectangular, one story structure.

*Materials:* Painted concrete block.

*Roof and Related Features:* Flat roof at one half of the structure, shed roof at the remaining portion of the structure. Both roof forms are clad with asphalt shingles and overhang the building walls.

*Openings:* Wood doors at the front and one side of the structure. The front of the structure has two small window openings with transom top sills that have been infilled with plywood.

Low. The buildings have not been well maintained, leading to loss of original features. The addition of the two pre-manufactured buildings has overwhelmed the original building.

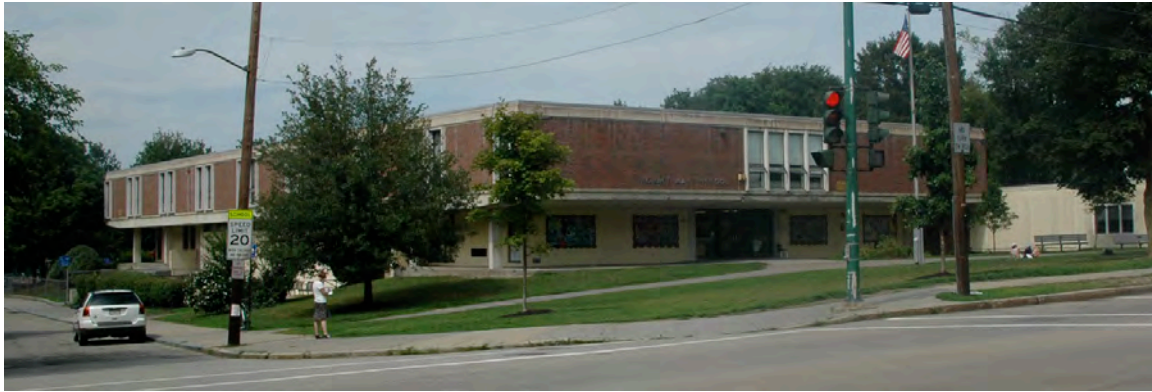
## Horace Mann Elementary School

Address: 687 Watertown Street  
Year of Construction: 1965

*Shape:* Two-story rectangular structure. The upper story projects over the lower story at all sides.

*Materials:* Red brick with precast concrete trim at the second floor, painted concrete block at the first floor.

*Roof and Related Features:* Flat roof with metal fascia.

*Openings:* Narrow vertical openings set in groups of 2-4, which retain their original aluminum window sashes. Sashes are fixed above and below an operable hopper. Aluminum storefront entrance at the first floor

High. The structure retains most of its original design features and materials.

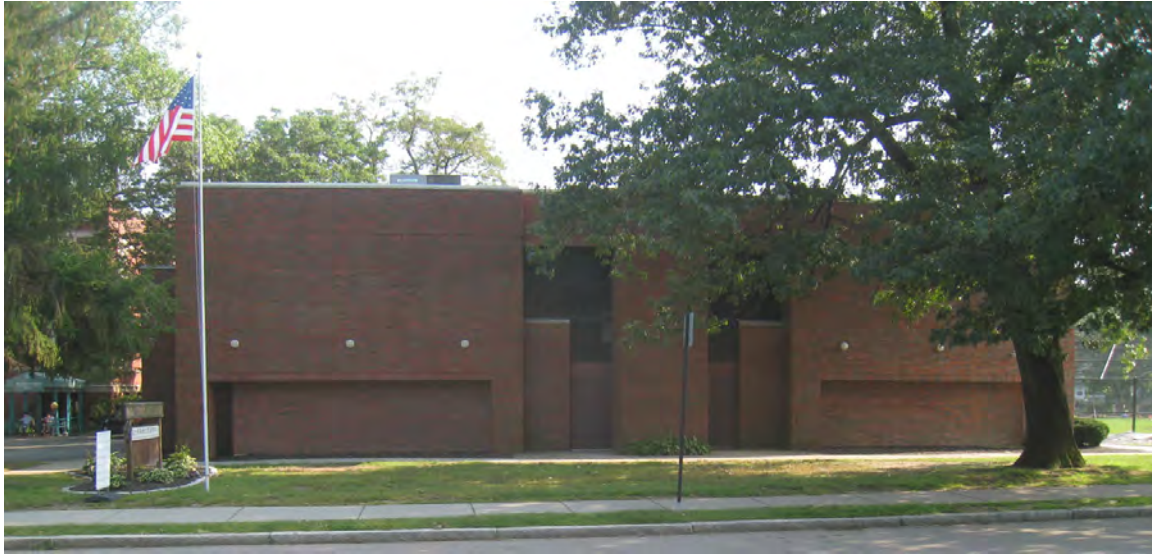
## Hyde Community Center

Address: 90 Lincoln Street  
Year of Construction: 1967

*Shape:* Double-height rectangular structure with lower projecting side bays. At the street elevation the upper part of the wall projects over the lower wall with brick piers at either side.

*Materials:* Red brick.

*Roof and Related Features:* Flat roof hidden behind a low parapet with an aluminum parapet cap.

*Openings:* Two L-shaped openings at the street elevation above aluminum doors. The main entrance is at the side of the building facing Hyde Park. The side bays have aluminum louvers set in openings high in the wall.

High. Still retains most of its original materials and design features.

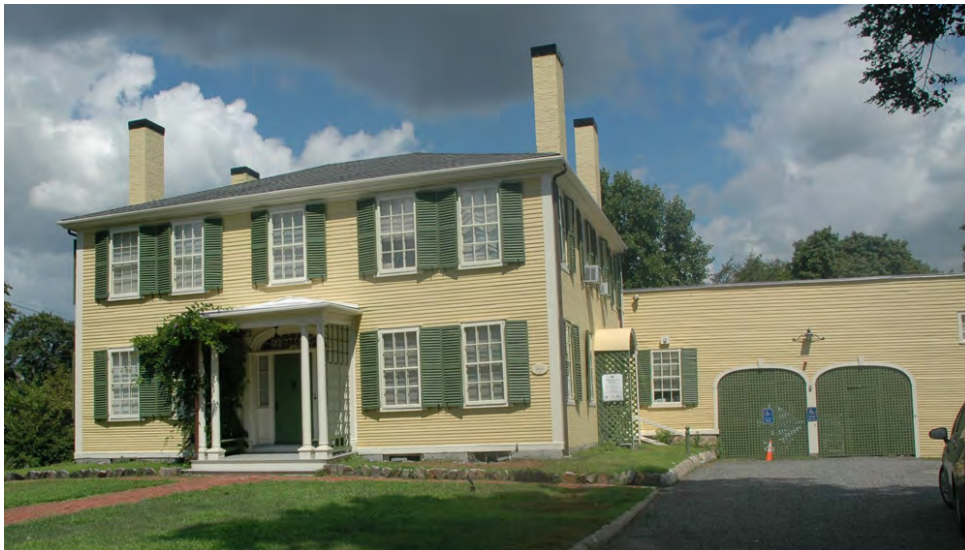
## Jackson Homestead

Address: 527 Washington Street  
Year of Construction: 1809

*Shape:* Two story rectangular wood structure with four interior end chimneys. A one-story carriage shed is appended to the rear of the building.

*Materials:* Painted brick sidewalls, wood clapboard front and back walls, stone foundation.

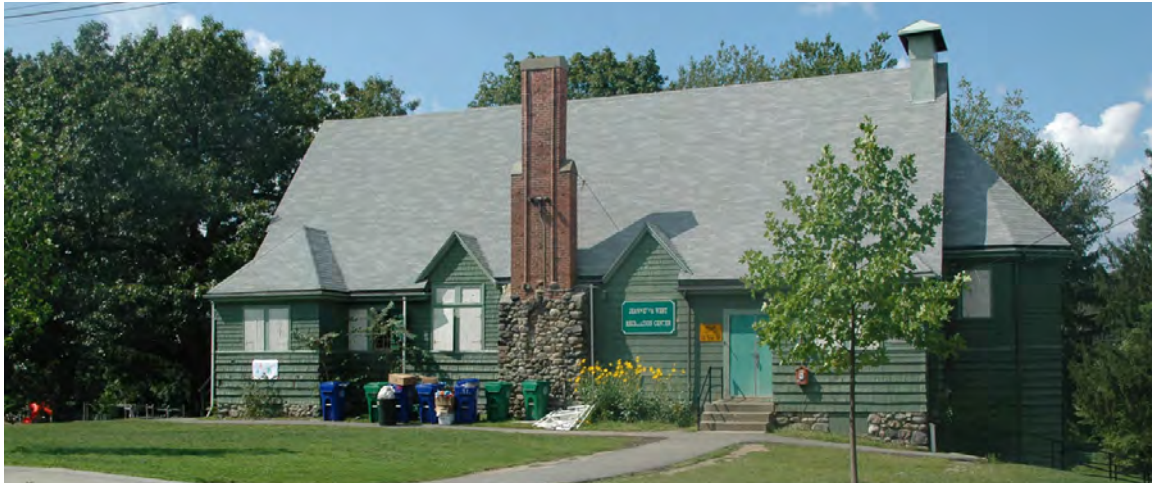
## Jeanette C. West Recreation Center (The Hut)

Address: 69 Tyler Terrace  
Year of Construction: 1892

*Materials:* Wood shakes with a rubble stone foundation. The lower story is entirely set within the foundation.

*Openings:* Small individual openings with transoms and 4-over-4 wood sashes. Larger windows with pointed arches at park side of building. Most of the windows have wood shutters. Exterior doors have been replaced with aluminum doors.

Moderate. The building has been poorly maintained leading to loss of original features such as the doors and shingle roof. Additional losses are imminent if repairs are not made to the building walls.

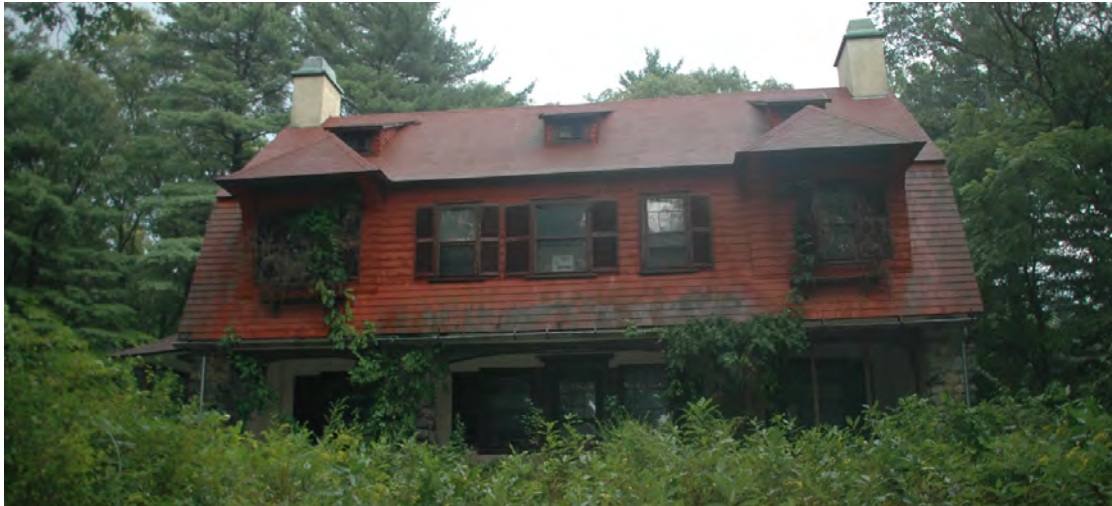
## Kennard Estate

Address: 246 Dudley Road  
Year of Construction: 1907

*Materials:* Wood shingles at roof and stucco walls. Rustic stone columns are located at the edge of the porch supporting the street-side edge of the roof.

*Projections:* A stucco-clad chimney rises from each gable end of the main roof. A pyramidal canopy is located at the entrance to the porch, supported by 4x4 lumber, a replacement for the original supports.

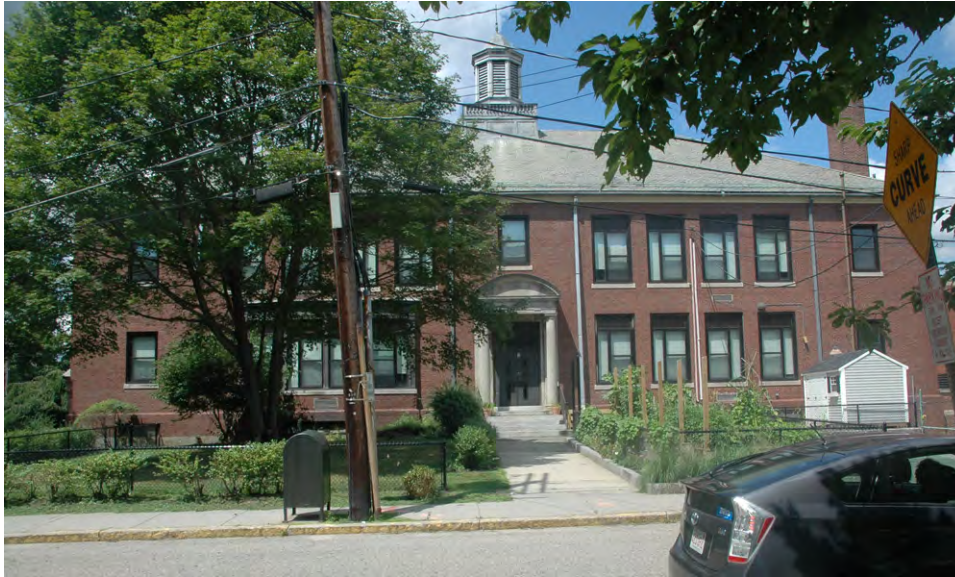
## Lincoln-Eliot Elementary School

Address: 191 Pearl Street  
Year of Construction: 1939

*Openings:* Regularly-spaced window openings that have been infilled with inappropriate aluminum windows. Doors have been replaced with aluminum doors.

Moderate. While there have been many alterations to the building, most significantly the replacement of the original windows, most of the historic features and materials of the original 1939 structure remain. The modern additions are connected to, but do not overwhelm, the original structure.

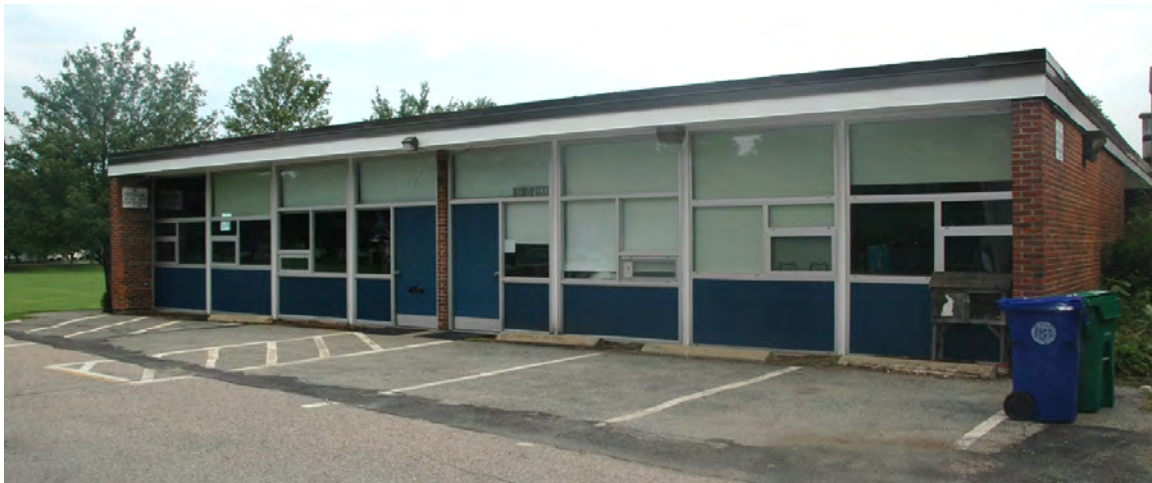
## Lower Falls Community Center

Address: 545 Grove Street  
Year of Construction: 1957

A utilitarian structure, with few architectural details, that has been severed from its original context.

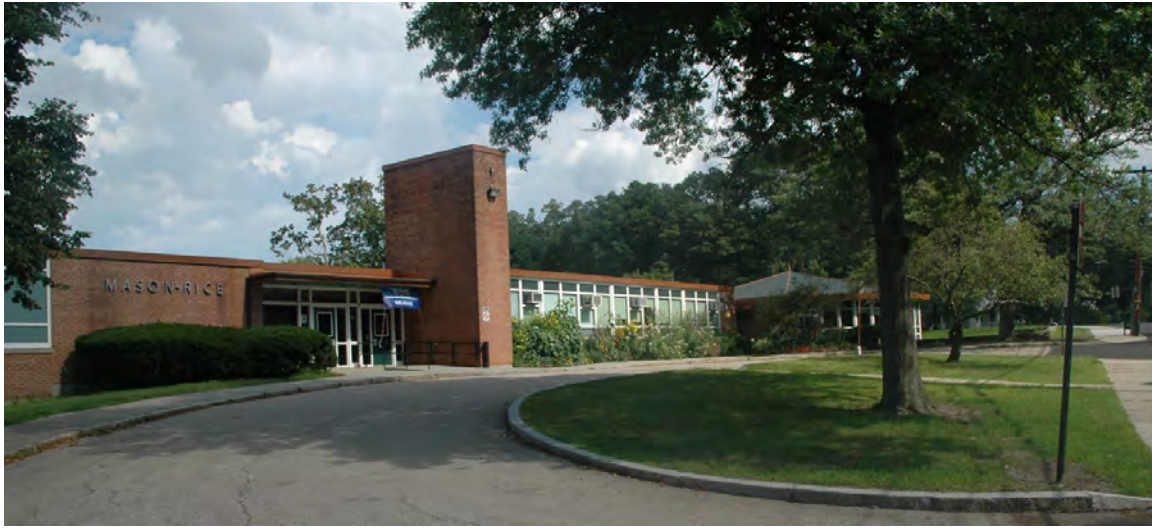
## Mason-Rice Elementary School

Address: 149 Pleasant Street  
Year of Construction: 1959

*Materials:* Brick with a concrete foundation. Walls at the entrance, the classroom wings and the octagonal structure are infilled with aluminum curtain walls.

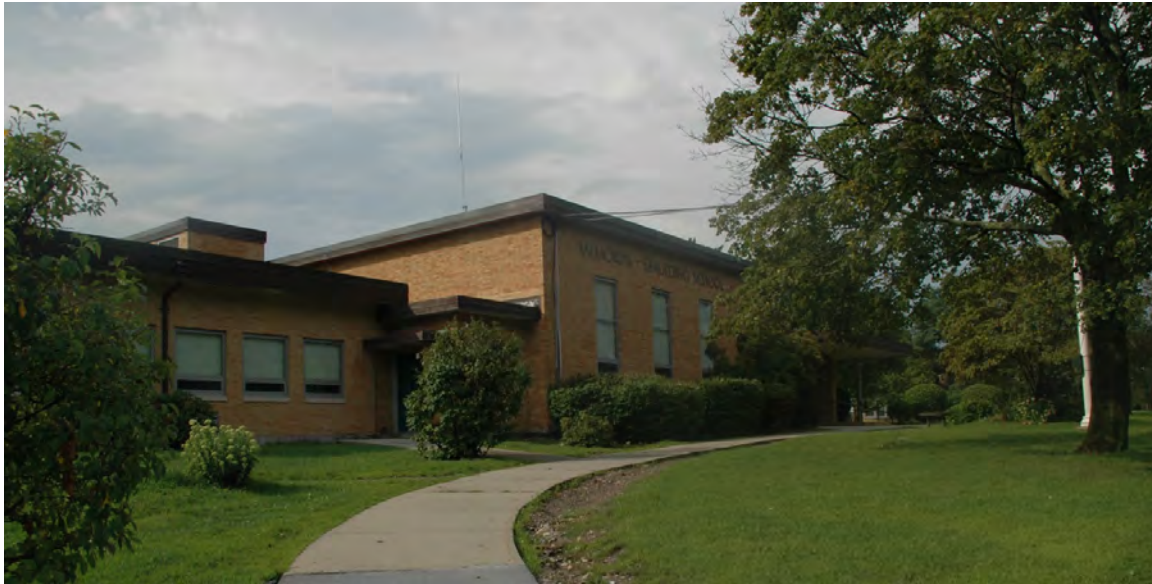
## Memorial Spaulding Elementary School

Address: 250 Brookline Street  
Year of Construction: 1954

A well designed building, but not an exceptional example of the Modern style or municipal typology.

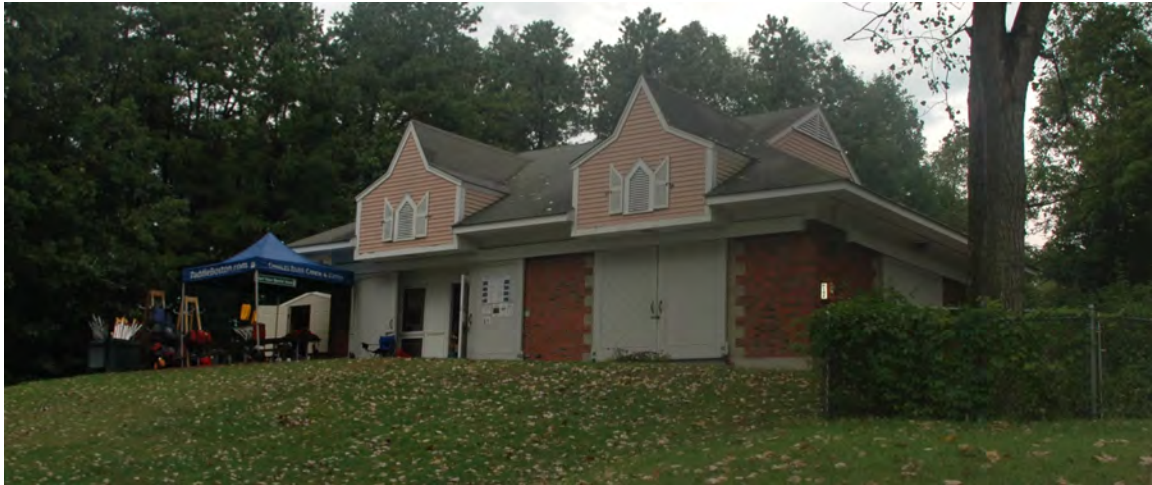
## Nahanton Nature Center

Address: 455 Nahanton Street  
Year of Construction: 1996

This building is of recent construction. While it may gain in historic significance with time it is too early for further historic investigation.

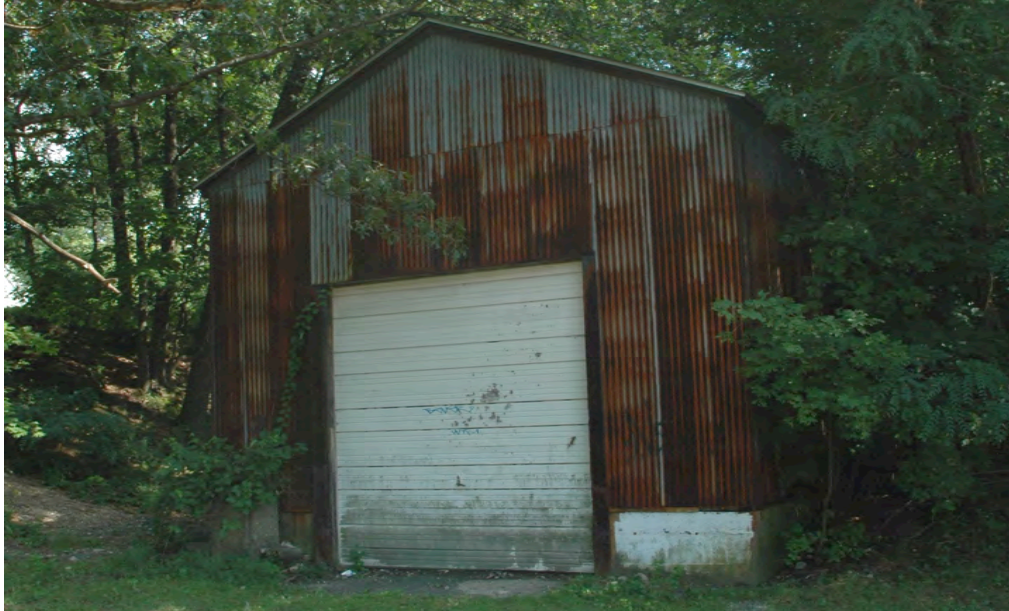
## Newton Center Metal Storage Building

Address: Tyler Terrace  
Year of Construction: Unknown

*Materials:* Corrugated metal with concrete foundation.

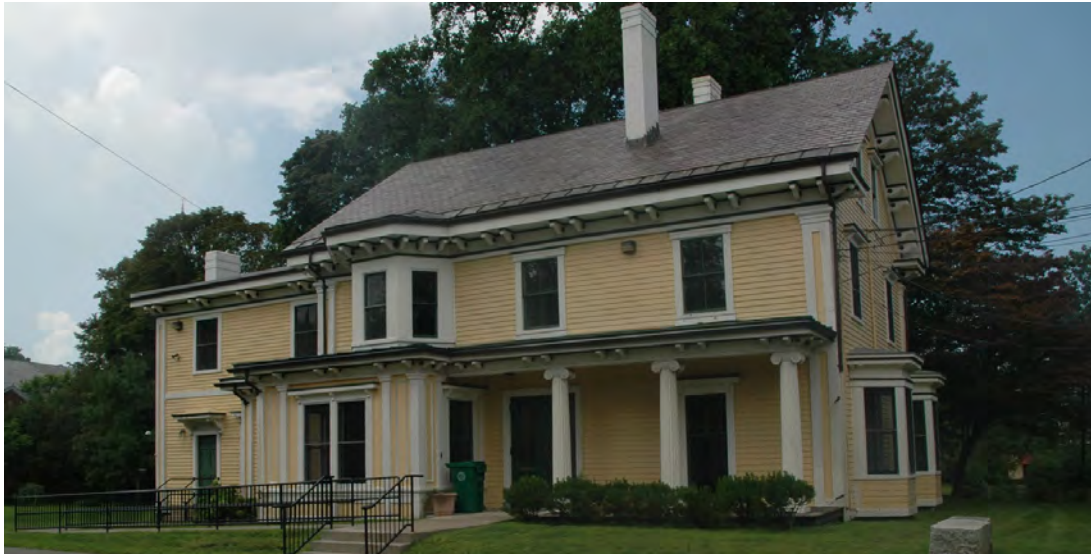
## Newton Corner Library

Address: 124 Vernon Street  
Year of Construction: 1848

One of the older surviving structures in this area, although somewhat altered by its transition from residential to institutional use. A contributing structure in a National Register district.

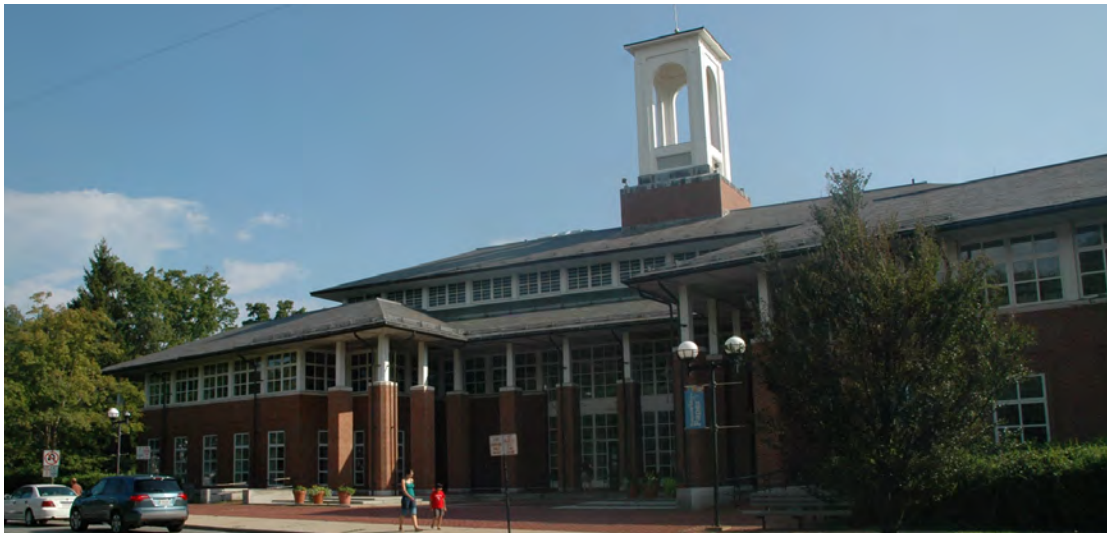
## Newton Free Library

Address: 330 Homer Street  
Year of Construction: 1991

*Materials:* Red brick, steel, aluminum curtain walls and concrete foundation.

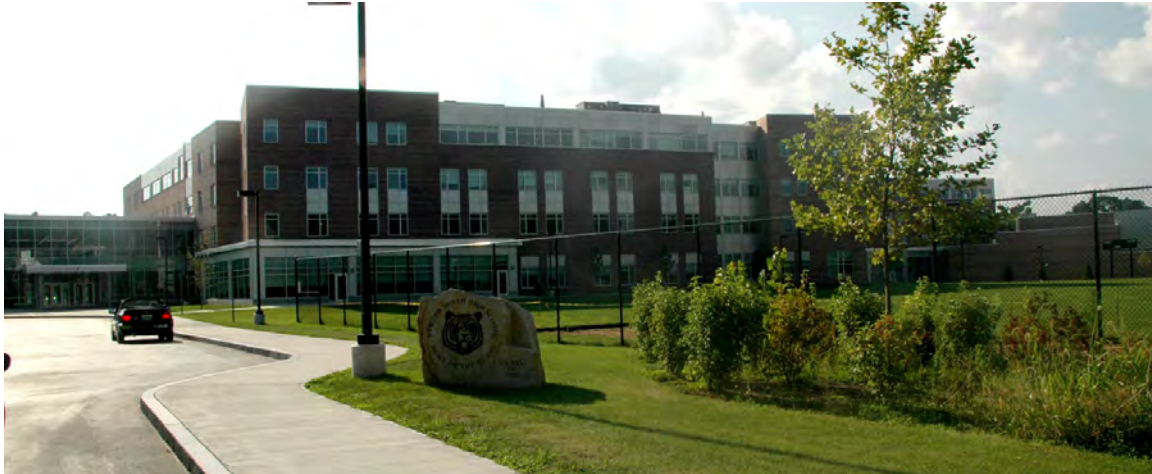
## Newton North High School

Address: 457 Walnut Street  
Year of Construction: 2010

This building is of recent construction. While it may gain in historic significance with time it is too early for further historic investigation.

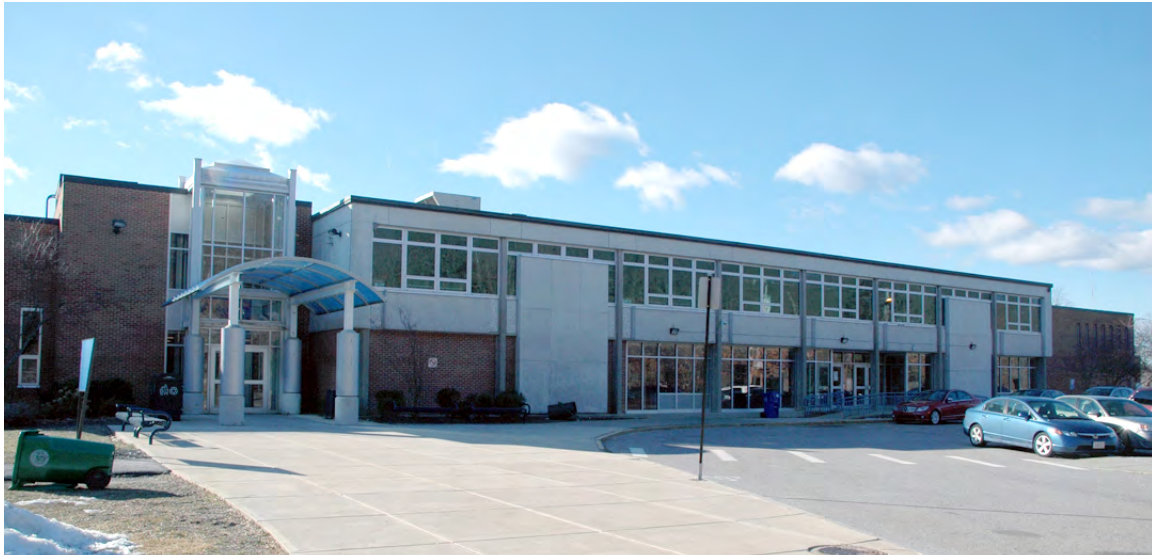
## Newton South High School

Address: 140 Brandeis Road  
Year of Construction: 1961

Level 3 – Low Significance. The building has been substantially altered from its original design.

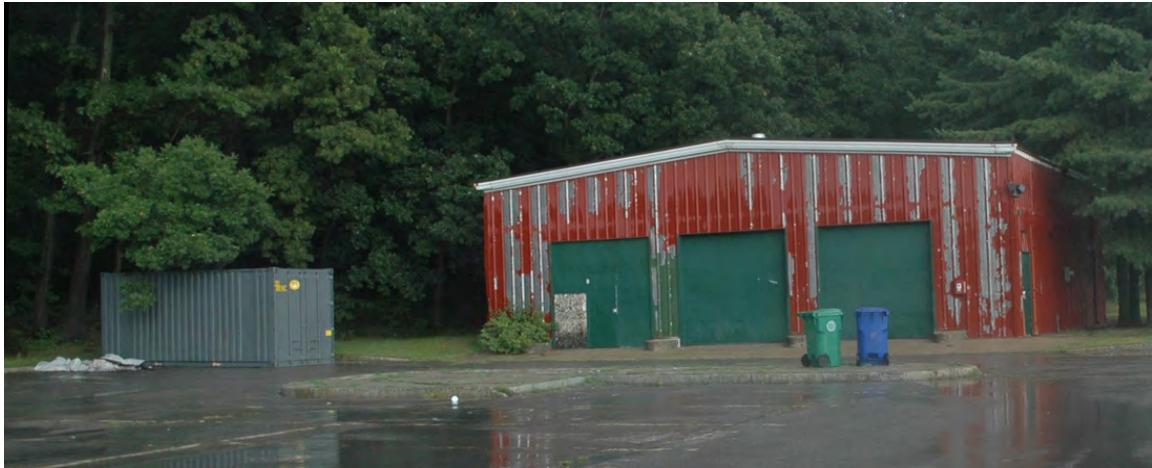
## Newton South Auto Shop

Address: 140 Brandeis Road  
Year of Construction: 1976

Level 4 – No Significance. The building is a utilitarian structure of a common form with few architectural details.

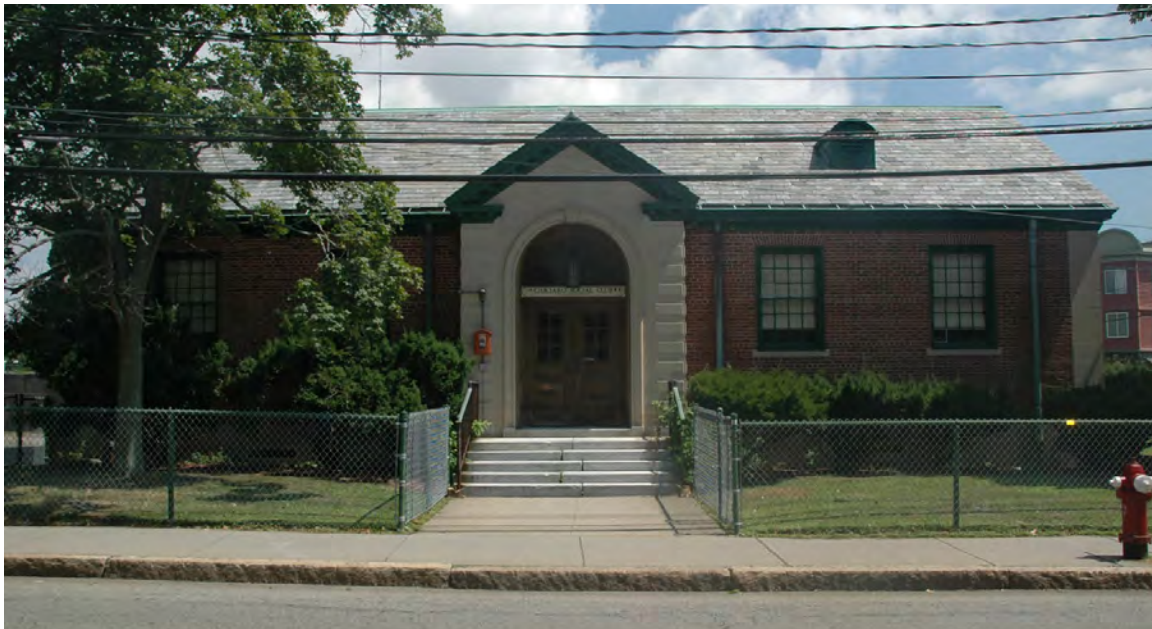
## Nonantum Library

Address: 144 Bridge Street  
Year of Construction: 1957

Designed to be a prominent municipal building for one of Newton's neighborhoods. The building was well designed with high quality original materials and remains relatively intact.

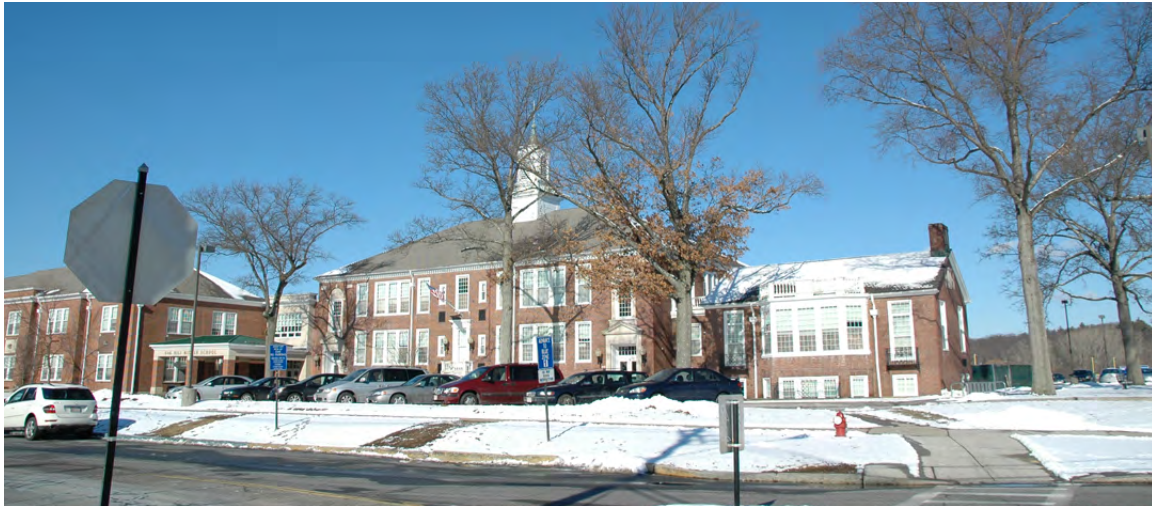
## Oak Hill Middle School

Address: 130 Wheeler Road  
Year of Construction: 1936

*Openings:* Window openings are either single or grouped in sets of three. Windows have been replaced, but retain their original 16-over-16 configurations. The library wing has two bay windows and single 16-over-16 window sashes with transoms. The building has symmetrically placed entrance doors at each side of the street façade with double doors and transoms.

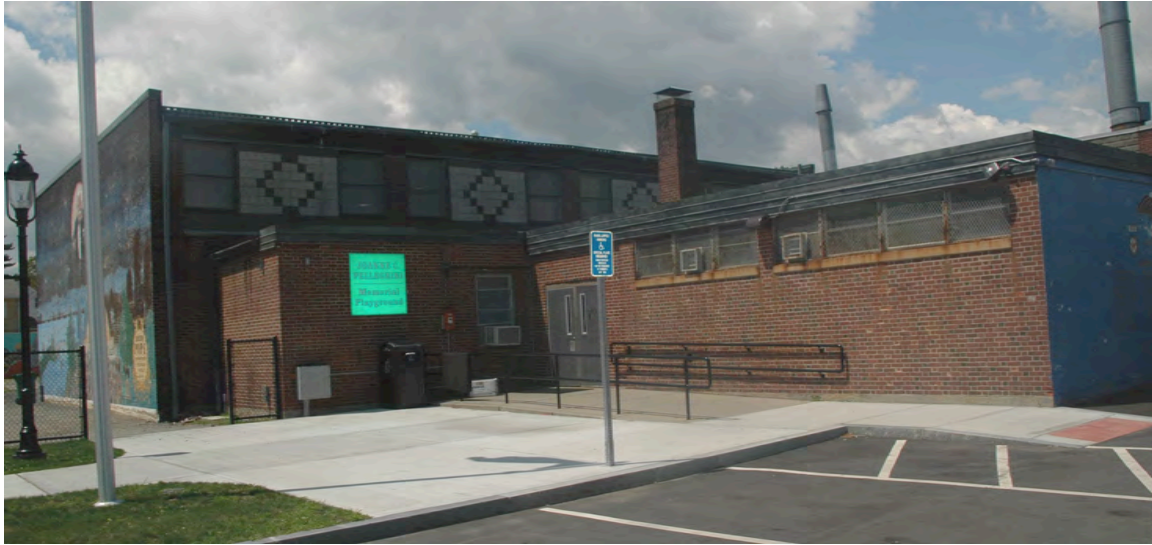
## Pellegrini Park Field House

Address: 17 Hawthorne Street  
Year of Construction: 1950

*Materials:* Brick with precast concrete trim and a concrete foundation. Large murals are painted over many of the brick surfaces.

While the building is over 50 years old it has few exterior architectural details and has been significantly altered from its original appearance.

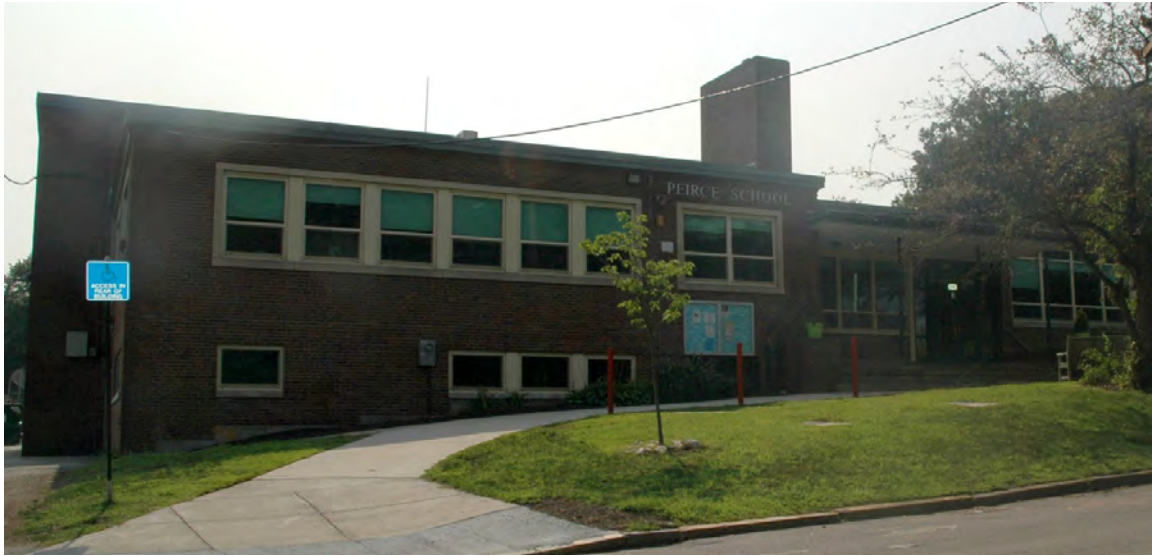
## Pierce Elementary School

Address: 170 Temple Street  
Year of Construction: 1951

*Openings:* Steel windows with fixed divided sashes. Windows at street elevation side wing have operable lower hoppers and transoms with colored infill panels. These windows replace a band of glass block that was originally a main feature of the street façade.

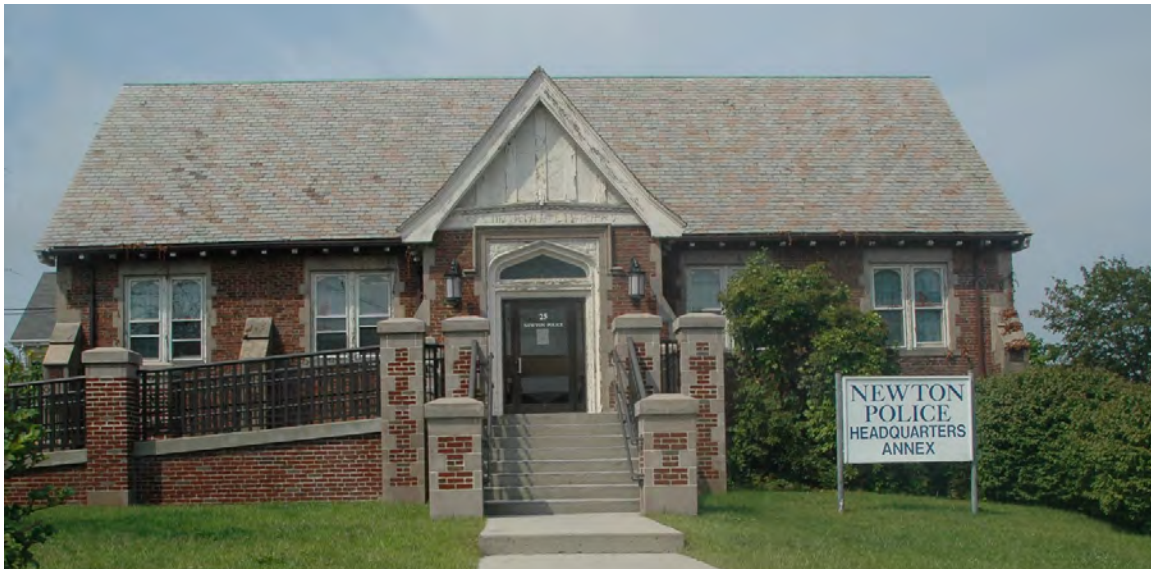
## Police Annex

Address: 25 Chestnut Street  
Year of Construction: 1926

*Roof and Related Features:* Steeply pitched side-gabled slate roof with center cross gable over main entrance. Exposed wood rafter tails, replacement aluminum gutters.

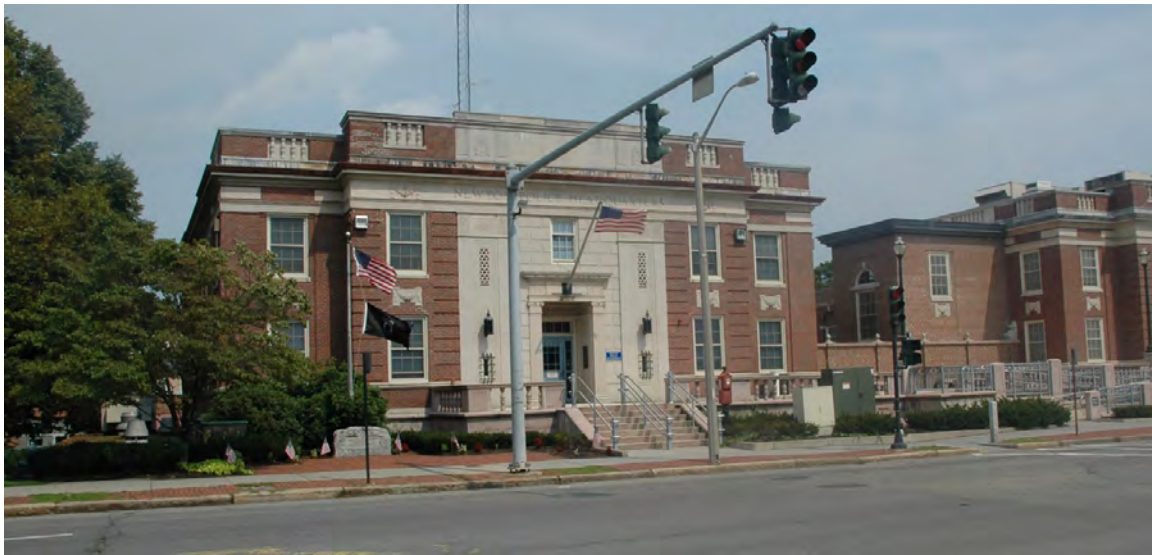
## Police Headquarters

Address: 1321 Washington Street  
Year of Construction: 1931

An imposing and elaborately-designed civic structure with a high degree of integrity. A contributing structure within a National Register Historic District and eligible for listing as an individual building along with the adjacent courthouse under criteria A and C.

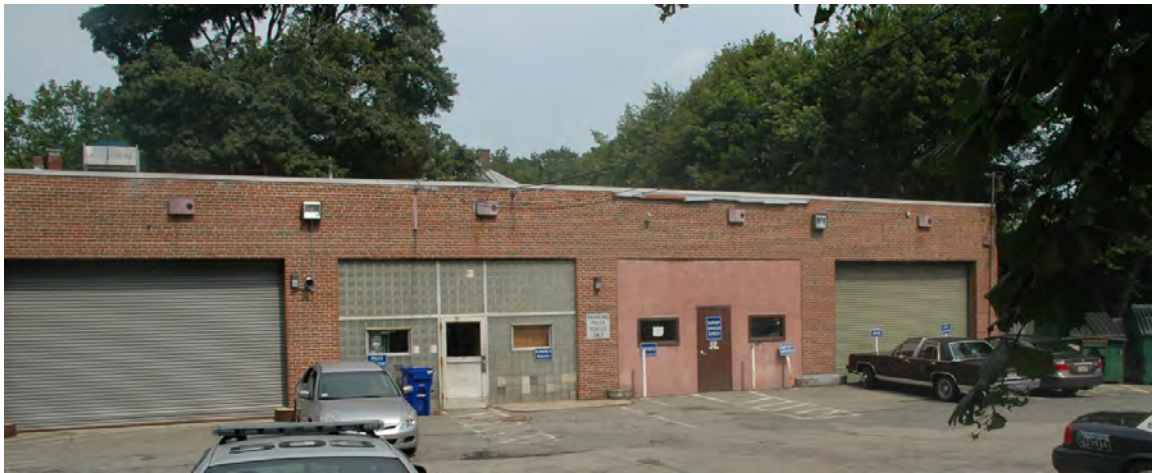
## Police Headquarters Garage

Address: 1321 Washington Street

Significant only for its location in the historic district. The building is a utilitarian structure with few architectural details that has a low degree of integrity.

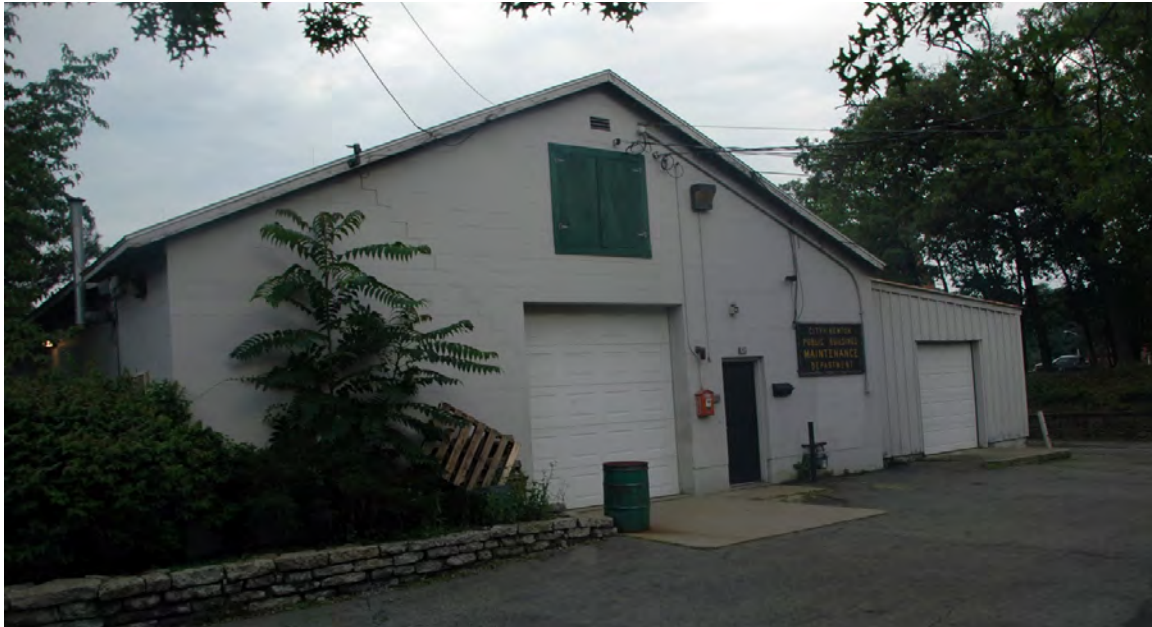
## Public Buildings Department

Address: 52 Elliot Street  
Year of Construction: 1968

Level 4 – No Significance. The original building was of utilitarian design and has been detrimentally altered by the construction of the additions, which are of low quality materials and design.

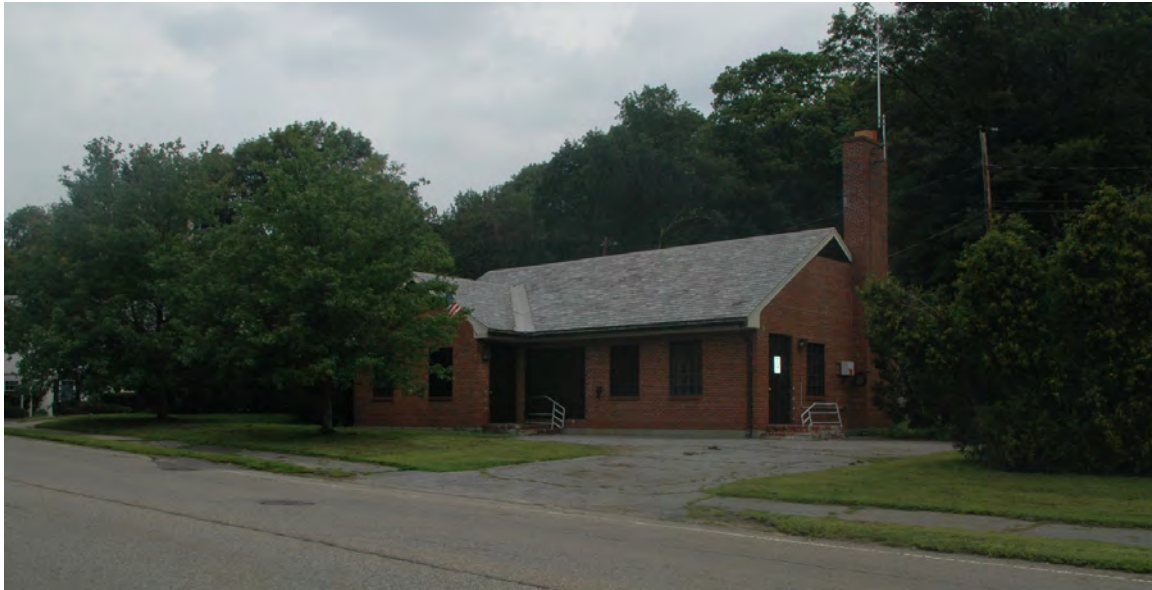
## Quinobequin Road Pump Station

Address: 136 Quinobequin Road  
Year of Construction: c. 1980.

Level 3 – Low Significance. The building has few architectural details and is of relatively recent construction.

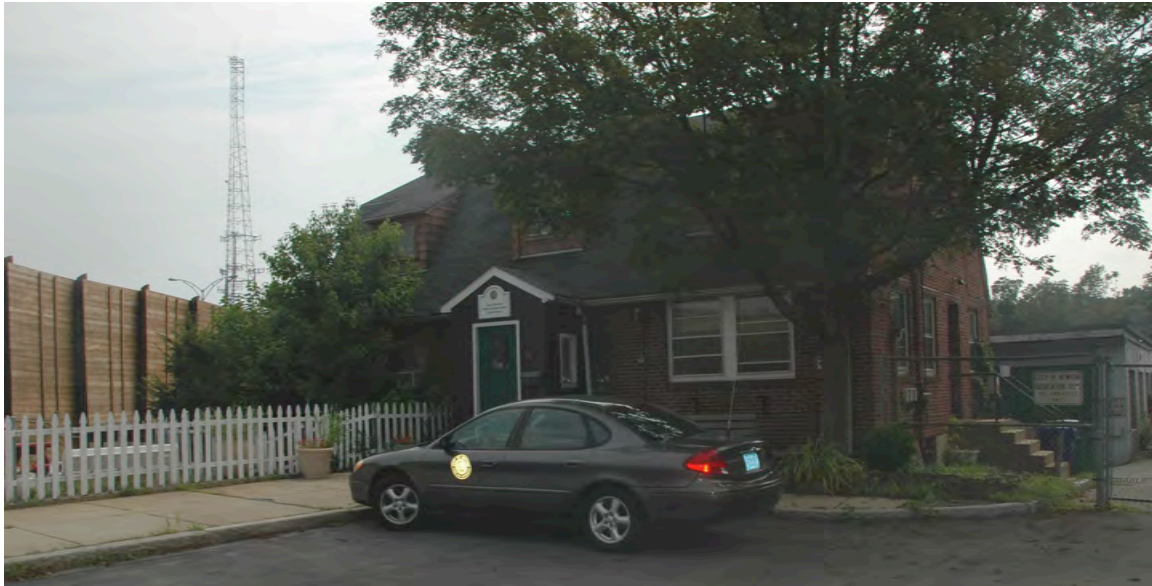
## Recreation Department

Address: 70 Crescent Street

*Roof and Related Features:* Gambrel roof with three shed dormers at the street elevation and one long shed dormer at the rear elevation. The roof is clad with asphalt shingles, likely a replacement for wood shingles.

*Openings:* Individual or pairs of double-hung windows with replacement aluminum sashes.

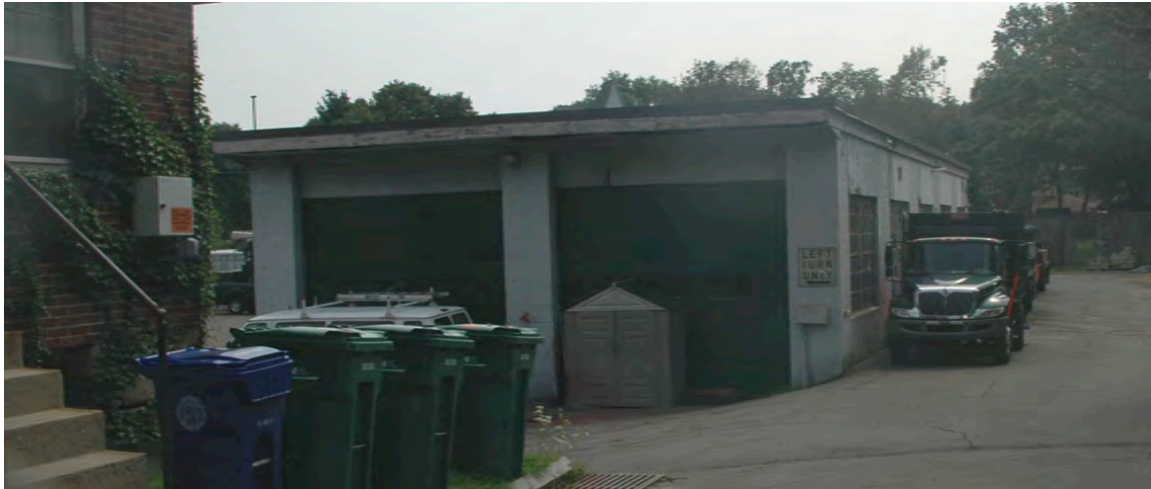
## Recreation Department Garage

Address: 70 Crescent Street  
Year of Construction: Unknown

Moderate. The building retains many of its original design features and materials. It has been poorly maintained, leading to deterioration of these features.

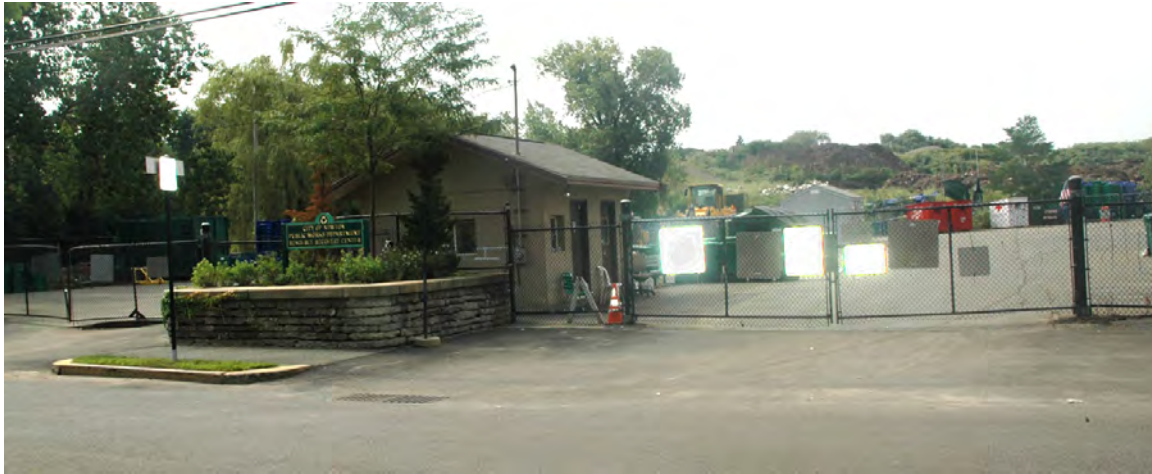
## Rumford Avenue Facility

Address: Rumford Avenue  
Year of Construction: Unknown

A utilitarian structure with few architectural features.

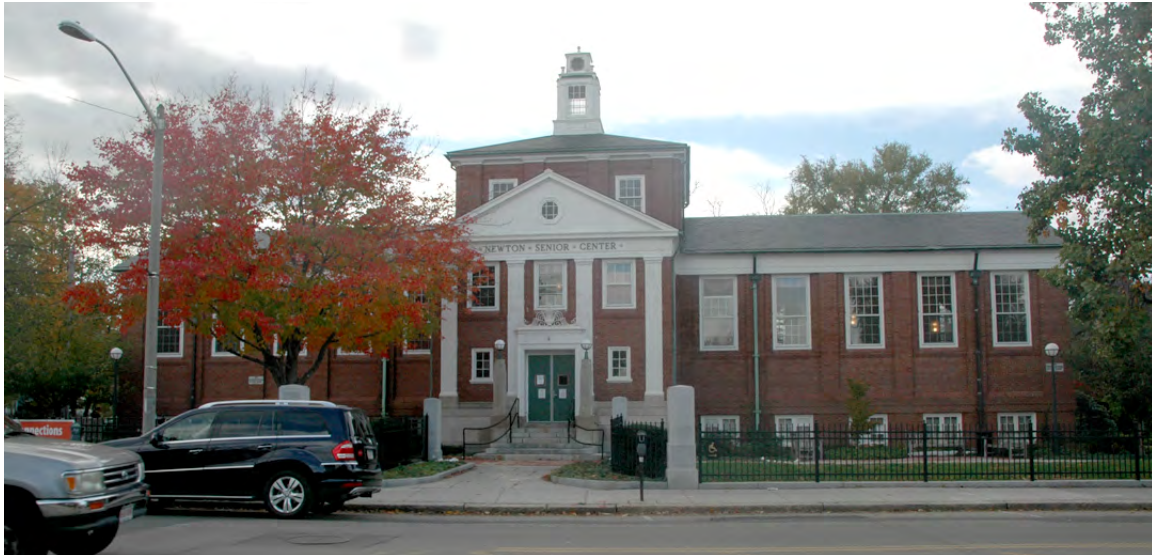
## Senior Center

Address: 345 Walnut Street  
Year of Construction: 1938

*Trim and Secondary Features:* Brick pilasters at the walls of the side wings. The building has a stained glass window designed by noted stained glass artist Charles J. Connick that commemorates a line from a poem read by Robert Frost at the building's dedication ceremony.

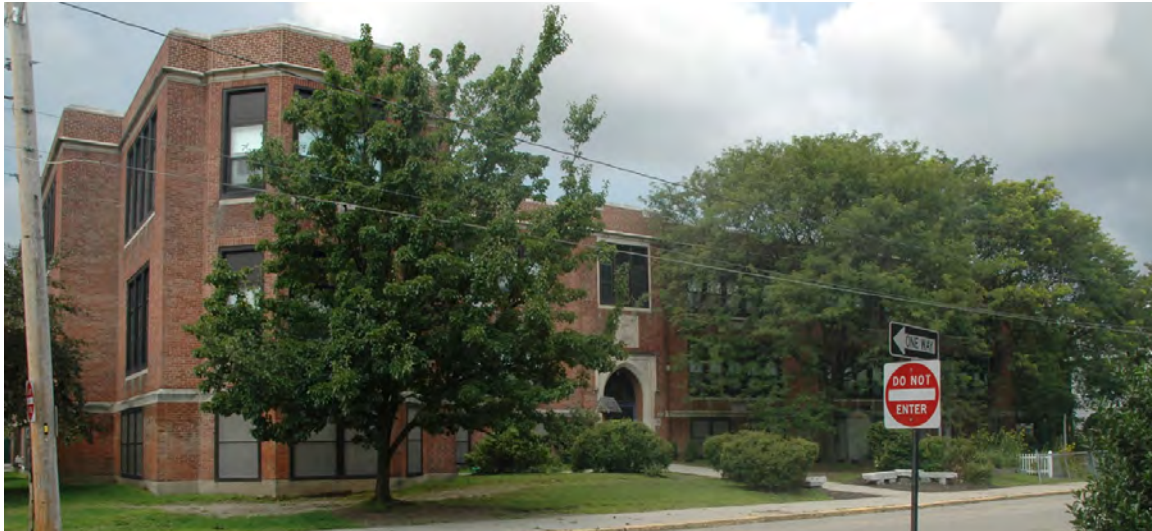
## Underwood Elementary

Address: 19-21 Eldredge Street (or 101 Vernon Street)  
Year of Construction: 1924

*Openings:* Horizontal bands of windows with replacement aluminum double hung sashes that replaced 9-over-9 wood sashes. The main entrance on Eldredge Street is set within a large arched opening with a cast stone surround. The rear ell has arched windows at the lower level that open into an assembly area.
