# City of Newton

## City Historic Buildings Survey

*Phase I: Evaluation of Historic Significance of City Buildings*

BUILDING CONSERVATION ASSOCIATES INC

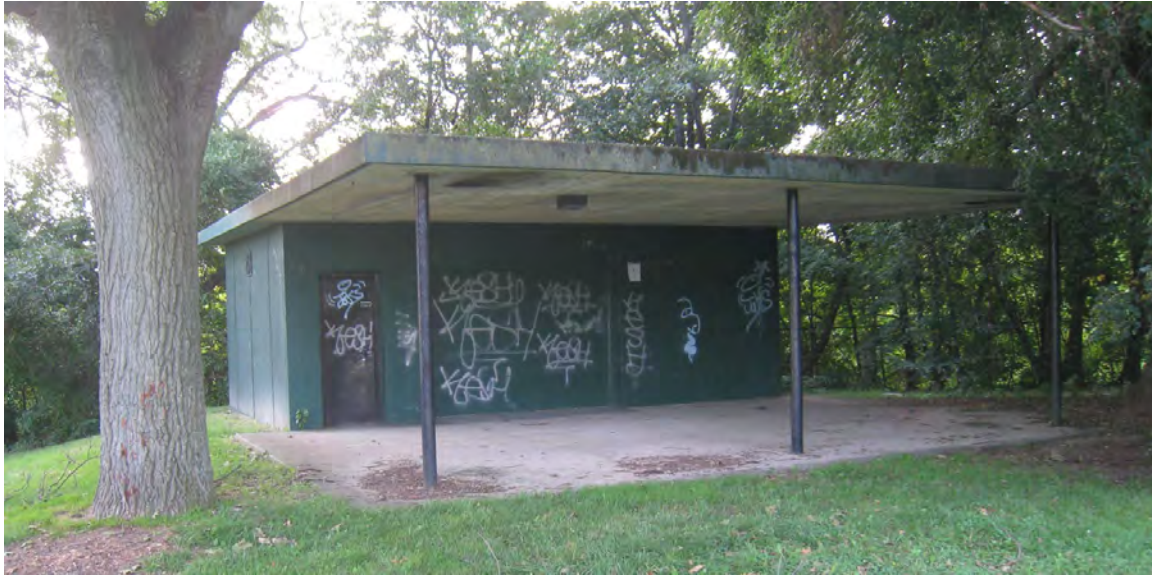
## Upper Falls Fieldhouse

Address: 86 Pennsylvania Avenue  
Year of Construction: 1965

*Roof and Related Features:* Flat concrete roof structure with a deep overhang. The edge of the roof is painted. The roof surface could not be observed.

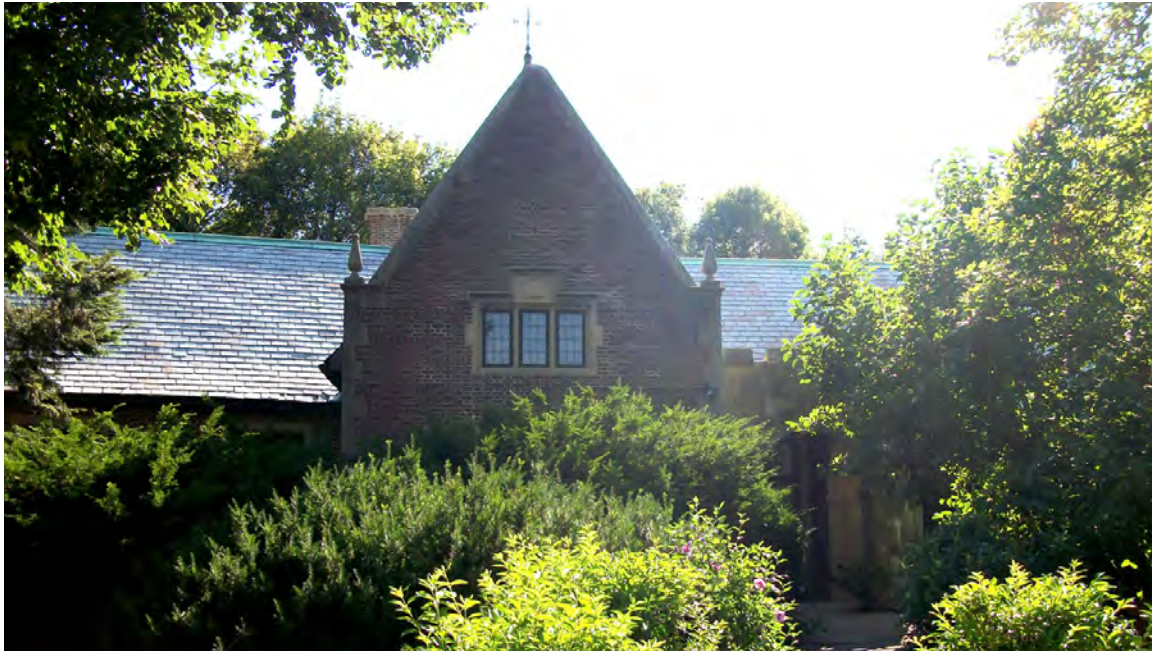
## Waban Library

Address: 1608 Beacon Street  
Year of Construction: 1929

The building is a well-designed municipal structure and is part of an important civic movement in Newton. Individually listed building on the National Register.

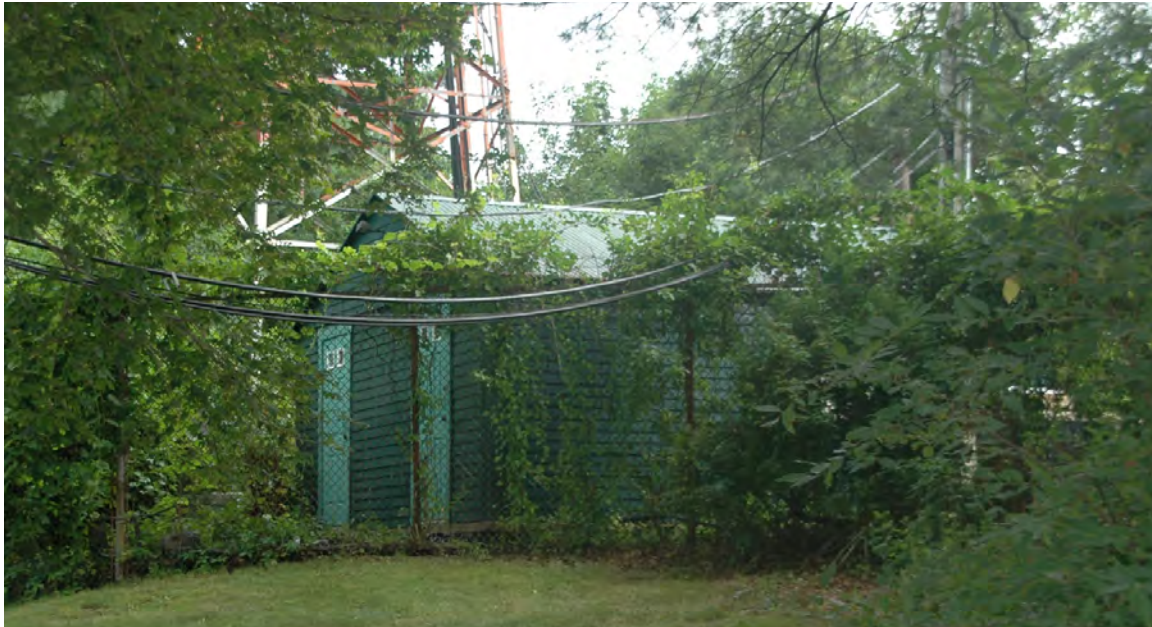
## Waban Radio Tower and Shed

Address: Manet Street  
Year of Construction: Unknown.

Level 4 – No Significance. The building is a utilitarian structure constructed of low-quality materials.

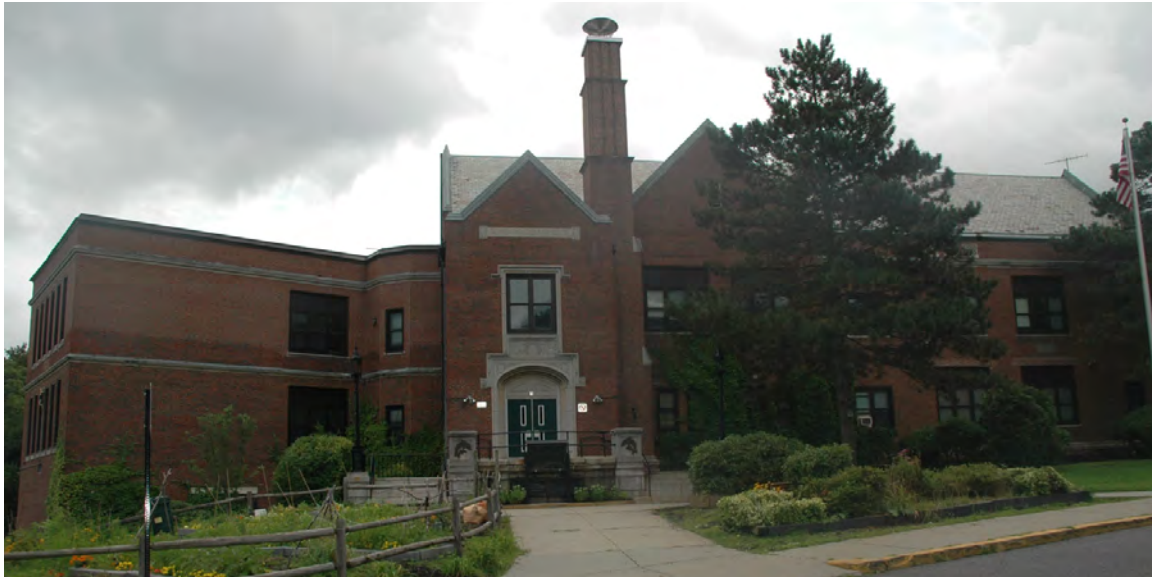
## Ward Elementary

Address: 10 Dolphin Road  
Year of Construction: 1928.

*Openings:* Large window openings with granite sills filled with replacement aluminum windows. Main entrance doors are aluminum replacements set into an elaborate stone surround with carved reliefs.

Moderate. The building has been added to multiple times, increasing the scale of the building. The replacement windows are non-appropriate.

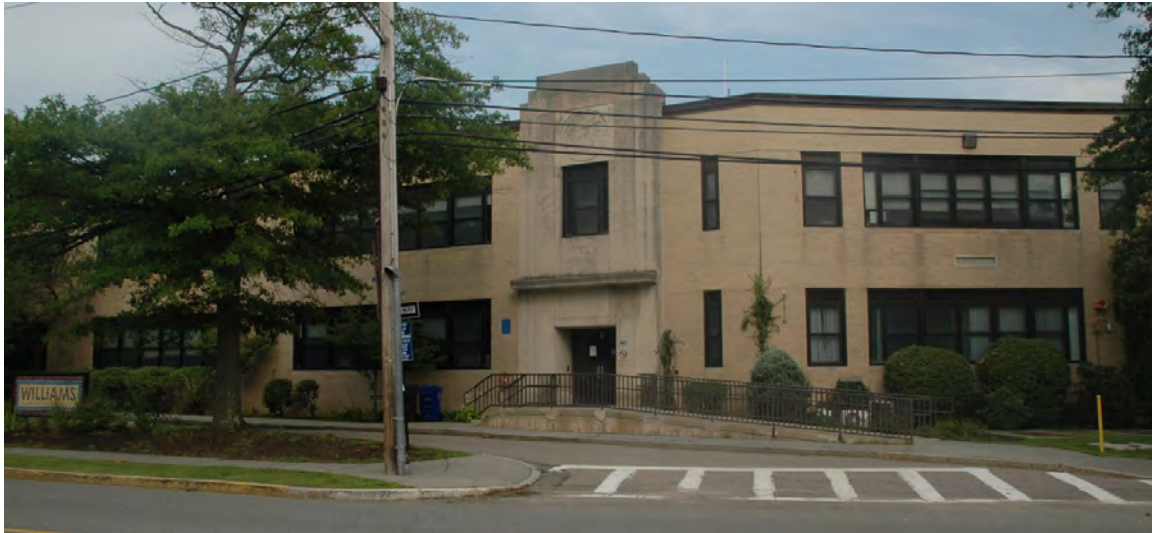
## Williams Elementary School

Address: 141 Grove Street  
Year of Construction: 1950

*Openings:* Single double-hung windows or horizontal bands of double-hung windows. Windows have replacement aluminum sashes with aluminum infill transom panels. Doors are aluminum replacements. The side auditorium wing may retain its original metal door, set within a glass block surround.

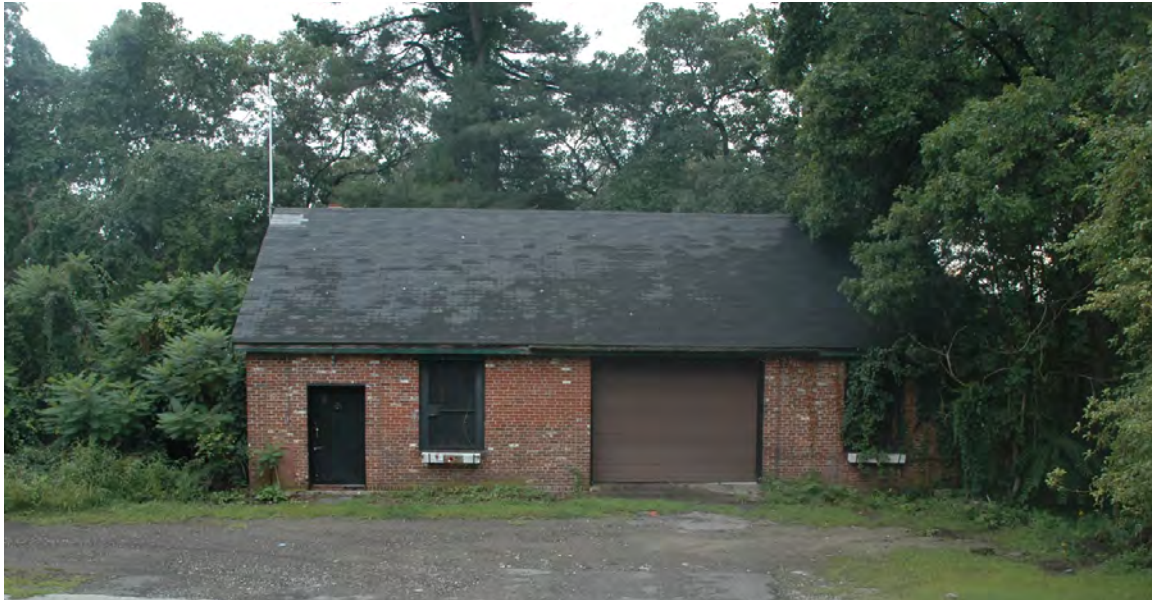
## Winchester Street Garage

Address: 525 Winchester Street  
Year of Construction: 1948

*Shape:* Rectangular structure that is one story at street level. An additional basement level is located within the stone foundation at the rear of the site where the grade is lower.

*Materials:* Brick with fieldstone foundation.

Moderate. The structure has been altered with the installation of the replacement garage door, but retains one original door and has not been added to or altered beyond recognition.

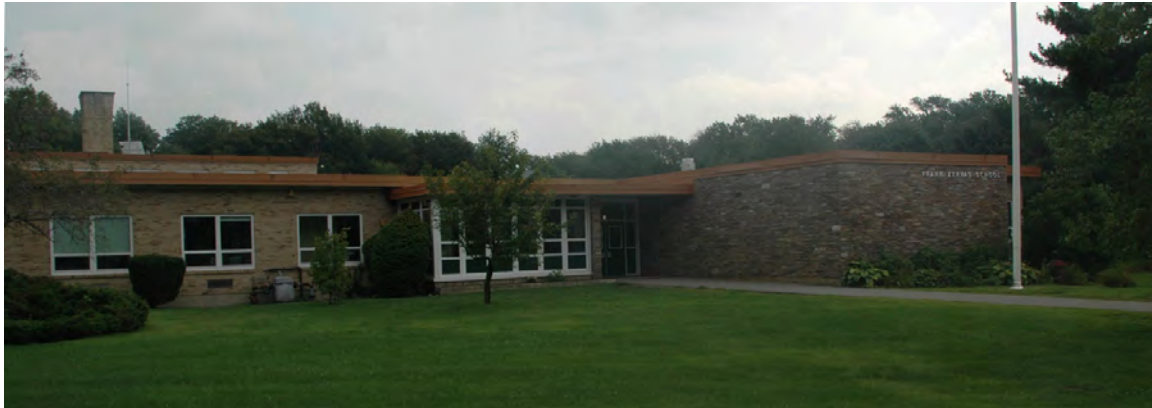
## Zervas Elementary School

Address: 30 Beethoven Avenue

*Materials:* Tan brick at the majority of the building with fieldstone cladding at the auditorium wing. The entrance vestibule is primarily contained within a glazed curtain wall. Concrete foundation.

*Openings:* Typically horizontal bands of windows with fixed sashes with fixed transoms and operable lower hoppers. The original window sashes have been replaced. Paired aluminum sashes are located in the structure adjacent to the main entrance. The main entrance door is recessed and is set within a glazed curtain wall, also a replacement. The new window sashes and curtain wall are less delicate than the original steel windows.

High. The building retains most of its original design features and materials and with the exception of the replacement windows has not been detrimentally altered.
