# City of Newton Historic Preservation

## GUIDELINES FOR ROOFING

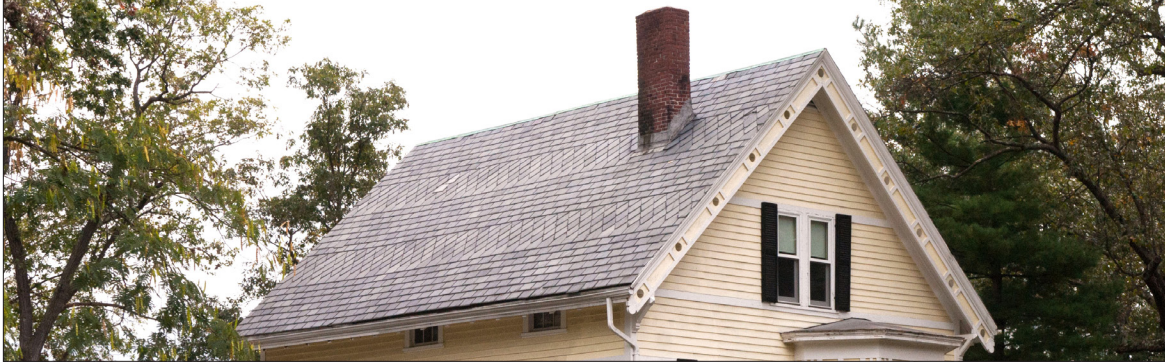
*The front gable roof on this relatively modestly scaled house in Auburndale includes distinctive alternating bands of standard and diamond-shaped slates. The vergeboard along the gable-end includes a decorative paneled motif with circular cut-outs.*

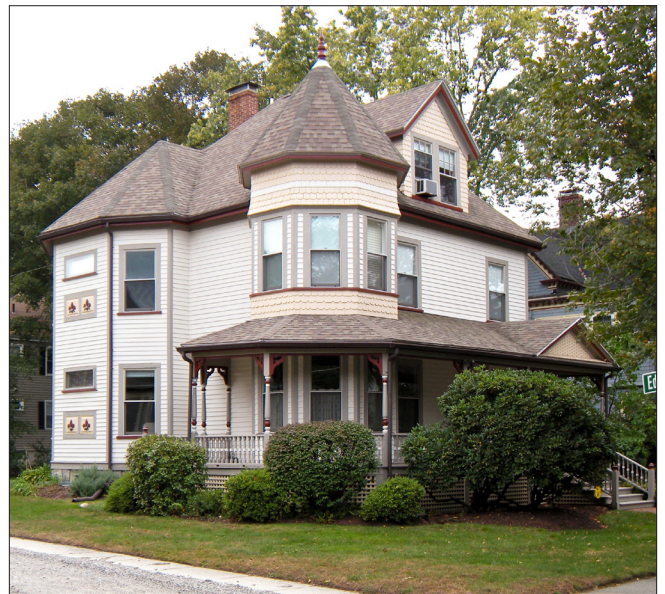
*The complex roof form of this Queen-Anne home in the Newtonville Historic District is an important element of the streetscape and adds to the character of the neighborhood.*

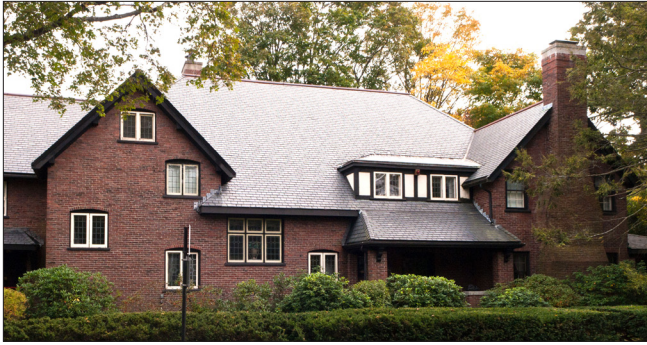
*Roofs can be a prominent feature of a building, with slate providing a distinctive and modulated color, veining and texture.*

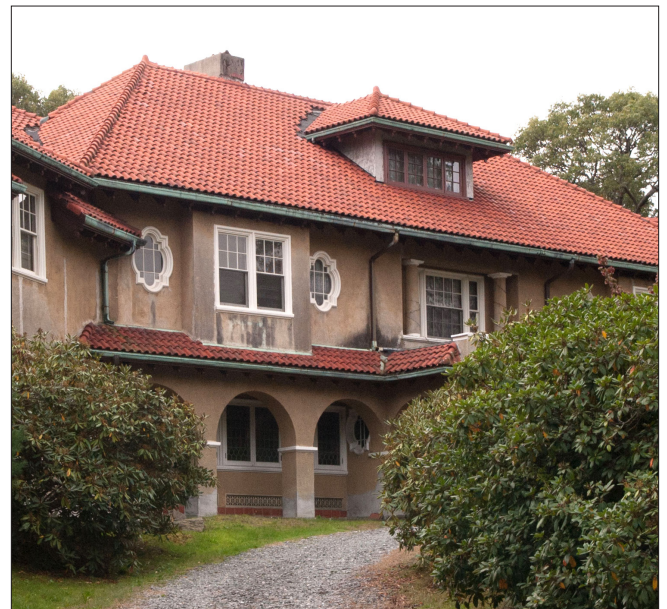
*Tile roofs can often last as long as slate roofs, and contribute greatly to the character of buildings such as this historic home.*

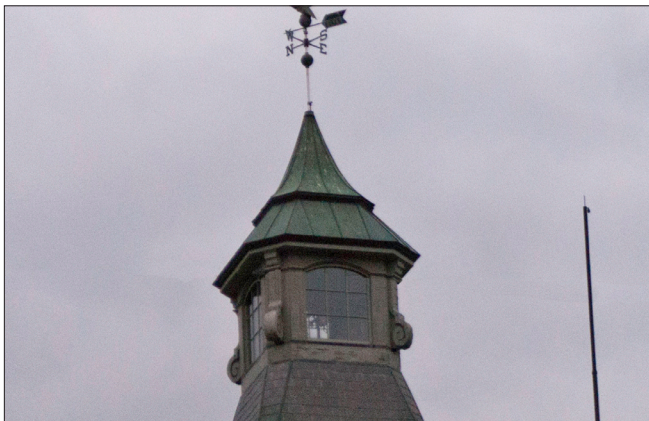
*Metal standing-seam roofs were popularized in the mid-19th century. Decorative or unusually shaped roof elements, such as this cupola, were often covered with metal roofing.*

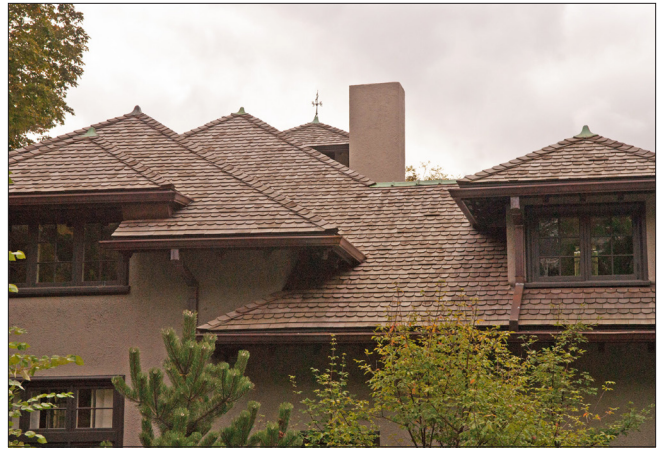
*Wood shingle roofs can be applied in a variety of decorative patterns and configurations. This example includes alternating rows of scalloped and square-butt shingles.*

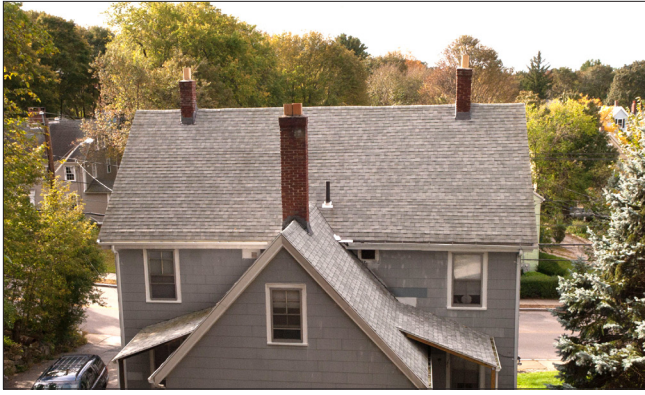
Asphalt shingles are a common 20th century building material, for both roof replacement and new construction.

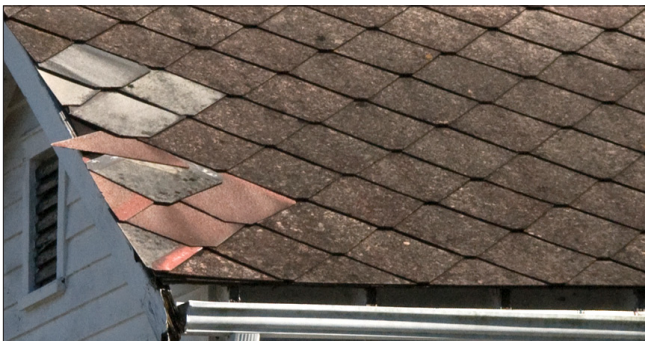
Asbestos roofing shingles came in various shapes, with diamond-shaped being the most common. This asbestos roof has some non-asbestos replacement shingles of similar size and shape as the existing roofing.

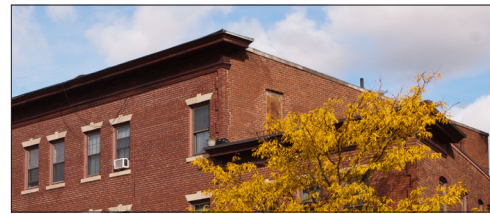
Flat roofs with parapets are frequently found on commercial or institutional buildings

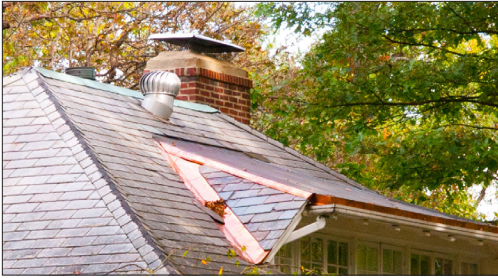
*Flashing is commonly found at chimneys, dormers and intersections of roof forms.*

**Flashing** is typically made of thin sheet metal formed to prevent water from entering a building at joints, intersections and changes of pitch. It is typically installed around chimneys, parapets, dormer windows, roof valleys, vents and intersections of porches, additions or bay windows. Flashing often fails before roof surfaces, particularly with more durable roofing such as slate, resulting in interior leaking. If the flashing deteriorates, it is possible to replace it without replacing the entire roof.

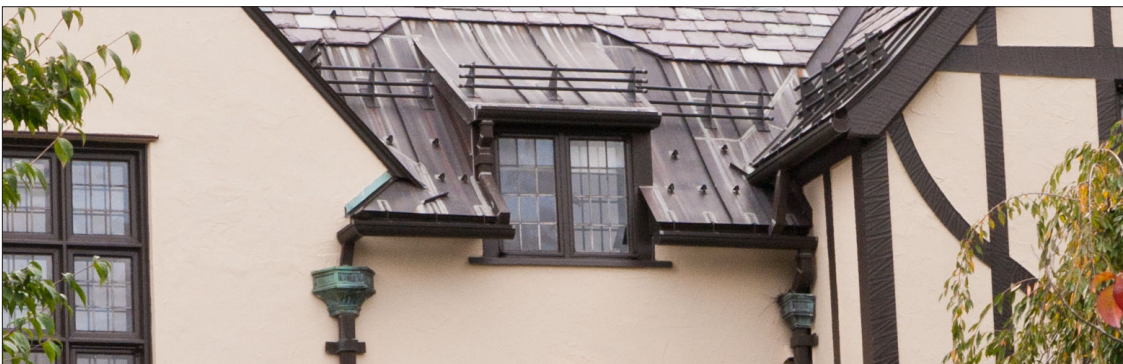
*Snow guards come in a variety of types and styles, as seen on this roof. Also note the standing-seam metal roof with copper gutters, downspouts and decorative copper scuppers.*

**Snow guards** are typically cast metal or bent wire devices arranged in a staggered pattern near an eave to prevent large masses of snow from sliding off a roof. Another form of a snow guard is spaced brackets supporting metal rods above the roof surface. Both types of snow retention can protect eaves, cornice and gutters, and take advantage of the insulating effect of snow.

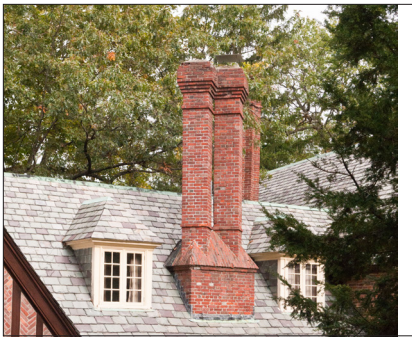
*Chimneys can range from simple forms to the complex as seen in this paired-shaft, corbelled brick chimney.*

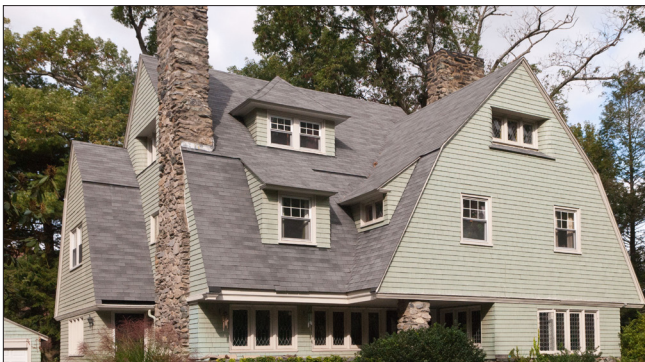
*Dormers can be a significant character-defining element of a historic house. Gambrel roofs typically have dormers to increase habitable space at upper floors.*

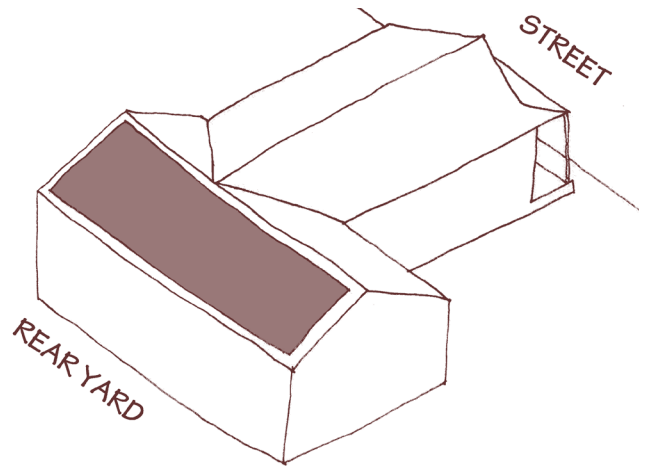
### PREFERRED LOCATION FOR ROOF MOUNTED EQUIPMENT / ADDITIONS (ALL)

- The NHC/HDC encourage the placement of all dormers, additions and roof mounted equipment (including mechanical equipment, vents, television dishes, solar collectors and skylights) in a manner that is as visually unobtrusive as possible.
- Placement facing a rear yard, wherever possible, is encouraged. If it is not possible, placement as far back on a side slope as possible is preferred.
- Applicants are encouraged to install skylights and solar collectors so that they are parallel to the roof surface and do not extend more than 8 inches above it.

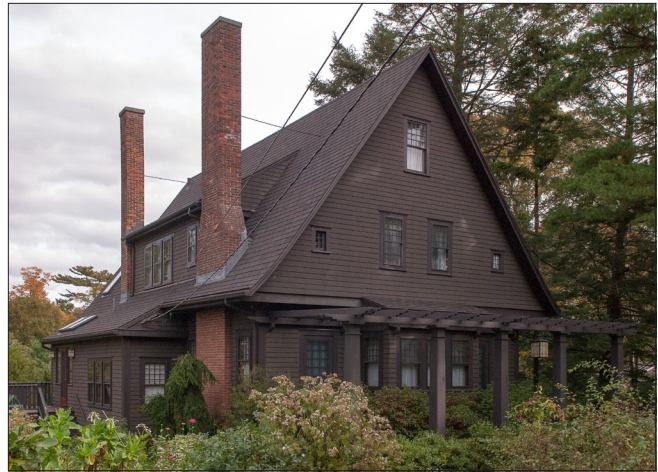
*Overall roof form, detailing and historic roof features are an important element of many of Newton's historic homes, such as this example in Auburndale.*
