# 80-90 Bridge Street Site (Newton) Public Meeting

Project Update and Request for Comments

80-90 Bridge Street Site Newton, MA

Meeting Date: February 25, 2021

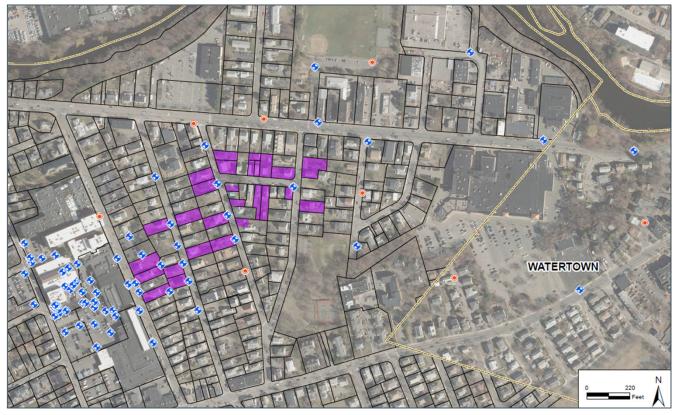
Monitoring wells (blue symbols), Geoprobe soil borings (red symbols), and residential properties investigated for vapor intrusion (purple shading)

- Sources of contamination were removed in the 1980s.
- The limits of soil and groundwater contaminants have been determined.
- A vapor intrusion assessment is ongoing in certain homes.
- A sub-slab depressurization system (SSDS) has eliminated vapor intrusion into 80-90 Bridge Street.
- No current risk to workers at 80-90 Bridge Street or 59-85 Chapel Street.
- Of the 51 homes tested to date, SSDSs have been installed in two residences to eliminate vapor intrusion where risks were identified.
- SSDS have also been installed in nine additional residences to eliminate Critical Exposure Pathways (CEPs).
  - 23 basements have been sealed to mitigate or eliminate vapor intrusion.

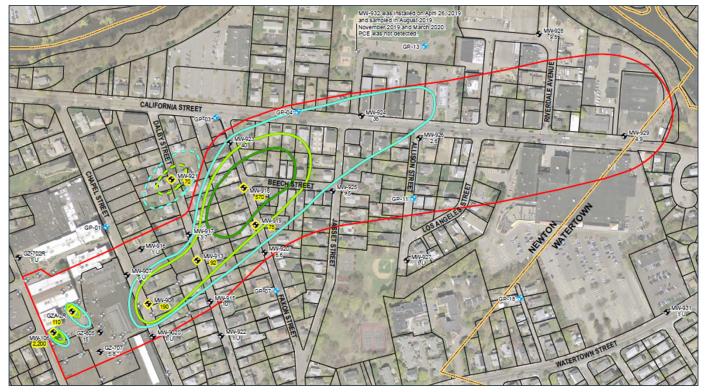
Tetrachloroethene (PCE) in shallow groundwater from May 2019. Yellow highlighted results exceed MassDEP GW-2 criteria.

- The horizontal and vertical extent of VOC, metals, and cyanide in groundwater has been delineated.
- The highest concentrations of VOCs are found in wells located within the former source areas and concentrations rapidly decrease by an order of magnitude, or more, downgradient.
- VOC contamination is limited to the shallow groundwater zone, except in the source areas immediately outside the 80-90 Bridge Street building.
- Other sources of chlorinated VOCs are contributing to observed concentrations in groundwater east of Chapel Street

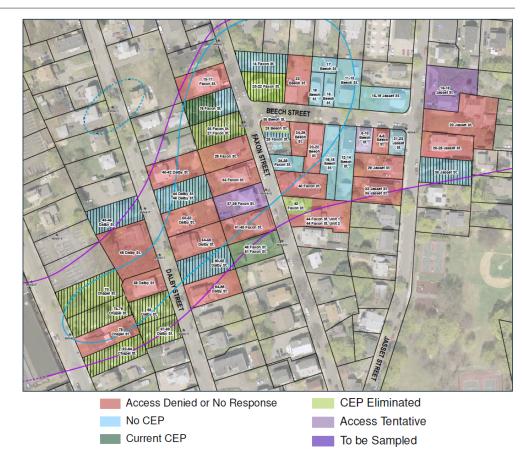
- Indoor air sampling conducted in 51 residences to date
  - No Critical Exposure Pathway (or CEP) in 34 residences (Site-related indoor air contaminants were not detected above MassDEP Threshold Values in living or working spaces).
  - CEPs identified in 15 residences (Site-related indoor air contaminants were detected above MassDEP Threshold Values in living or working spaces).
  - CEP eliminated, or mitigated, in 12 residences by sealing or installing sub-slab depressurization systems (SSDS).
  - Two residences had indoor air concentrations that posed a short-term or long-term risk. SSDSs were installed at both residences to eliminate vapor intrusion and mitigate risk.
- Access needed at additional properties to continue the vapor intrusion assessment

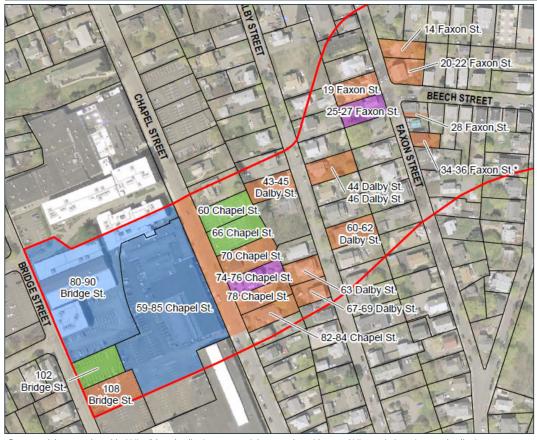
Commercial properties with AULs (blue shading), commercial properties with non-AUL restrictions (green shading), residential properties where AULs are needed (purple shading), and properties with no conditions (orange shading).

- No current risk to health
- No future risk to health with the implementation of AULs
  - 80-90 Bridge maintain SSDS and restrict residential use
  - 59-85 Chapel restrict residential use
  - 76 Chapel maintain SSDS
  - 27 Faxon maintain SSDS
- No current or future risk to public welfare, the environment, and safety

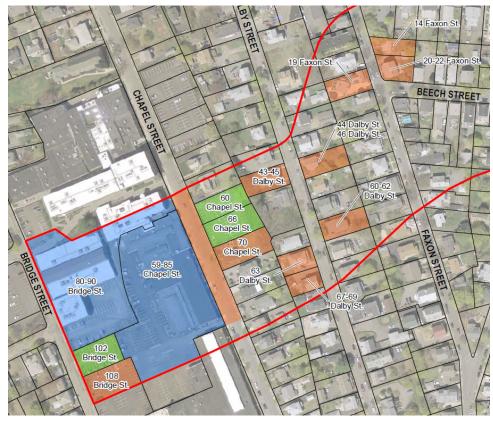
Commercial properties with AULs (blue shading), commercial properties with non-AUL restrictions (green shading), residential properties where AULs are needed (purple shading), and properties with no conditions (orange shading).

#### **Permanent Solution with AULs:**

- 80-90 Bridge Street (AUL needed to require continuous operation of the existing SSDS).
- 59-85 Chapel Street (AUL exists to limit future use of the property).

#### **Permanent Solution with non-AUL Conditions:**

- 60 and 66 Chapel Street
- 102 Bridge Street

## **Permanent Solution with No Conditions:**

- 108 Bridge Street
- 70 Chapel Street
- 43, 45, 44, 46, 60-62, 63, and 67-69 Dalby Street
- 14, 19, 20, and 22 Faxon Street

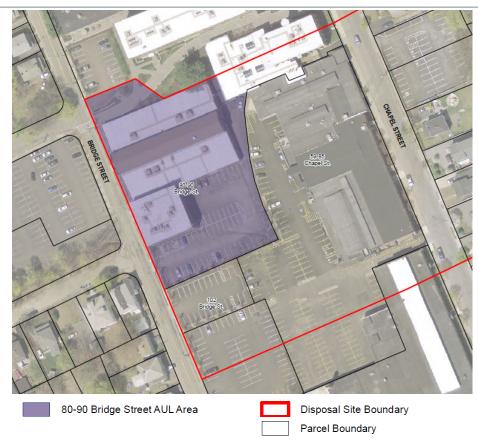
- Continue operation of the SSDS.
- · Limit future residential use, or
- Require actions to address soil-related and vapor intrusion-related indoor air exposures prior to residential use.
- Maintain the building slabs to minimize potential vapor intrusion.
- Prohibit use of groundwater for drinking water or other uses.
- Prohibit use of soil on the property for gardening of fruits and vegetables.
