City of Newton

Stormwater Infrastructure Improvement Plan

Supporting Documentation

February 2015

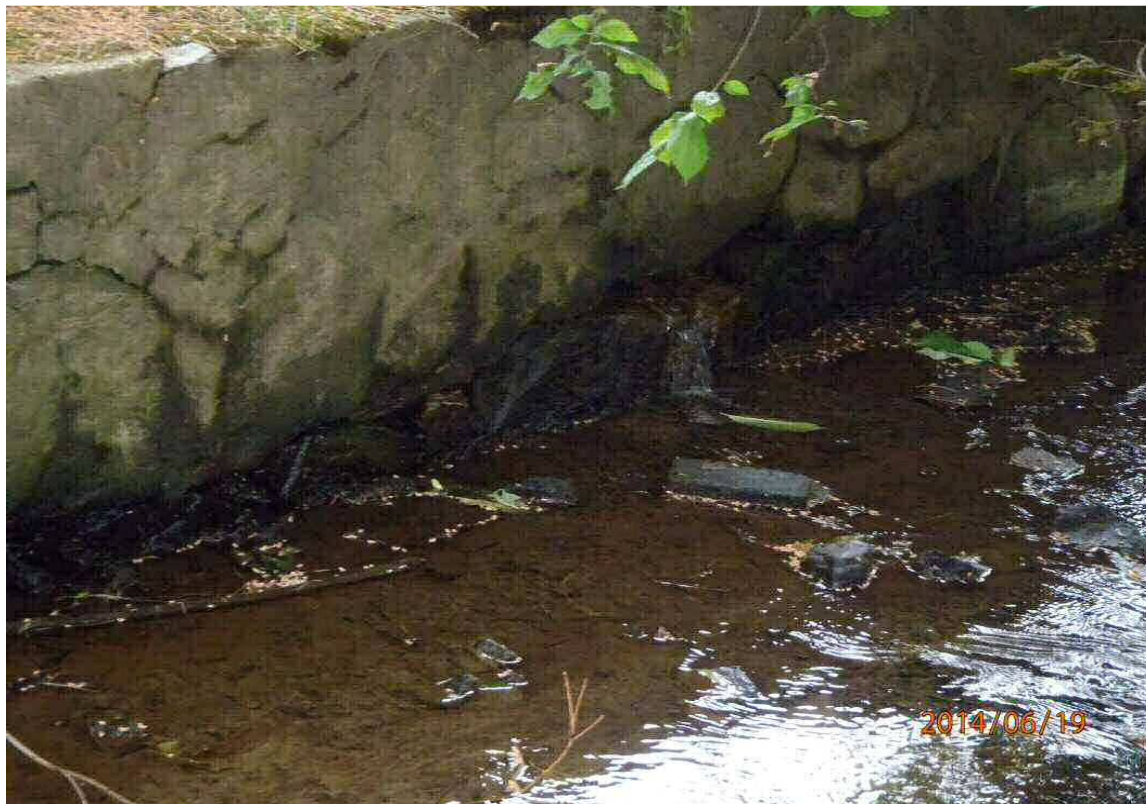
Underdrain Leaking into Hammond Brook

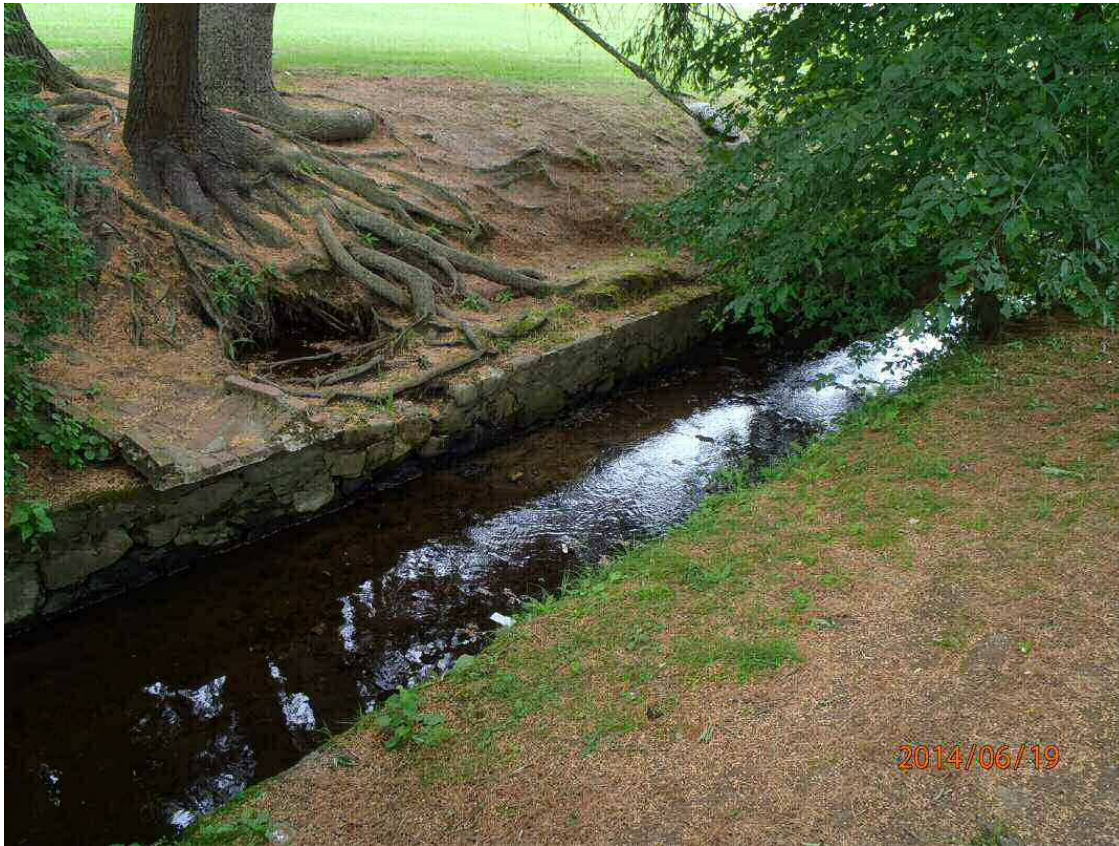
Sinkhole Near Hammond Brook from Underdrain Flow

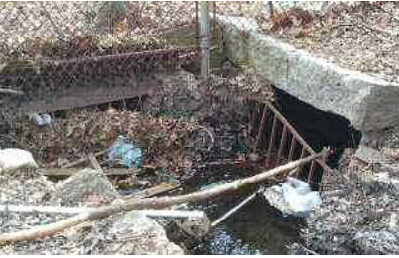
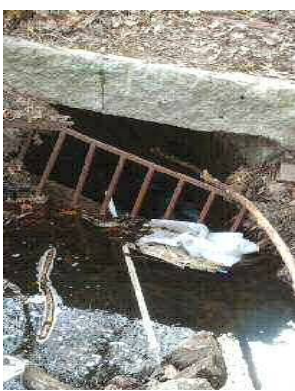
<p>South End of Culvert</p>	The steel grate is offset from the culvert opening. There is 20" sediment at the culvert inlet. The culvert is partially submerged and the retaining wall adjacent to culvert needs work.	W&S (2014)	\$0
Cheesecake Brook	Watertown Street – West Culvert (East End Outlet Only Exposed)	12.5' Wide Rectangular Culvert with Stone Masonry Walls and Granite Roof	5,085 ft +/- (Outlet to #70 Oldham Road Inlet above)

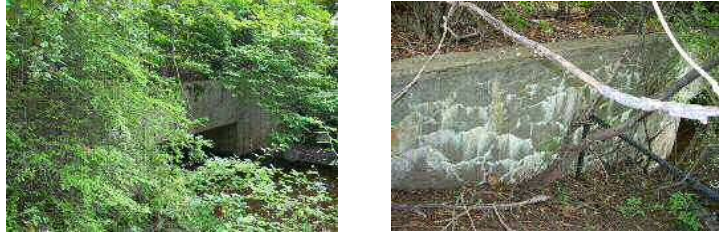
<p>North End of Culvert</p>	Map cracks in the concrete wingwalls with efflorescence.	FST (2008)	
Cold Spring Brook	Beaconwood Road - West End of Culvert - Outlet Only	Appears to be a Concrete Box Culvert (Culvert is Completely Submerged and Could Not be Fully Evaluated)	880 ft +/- (from MH at Beacon Street between #1139 and #1133)

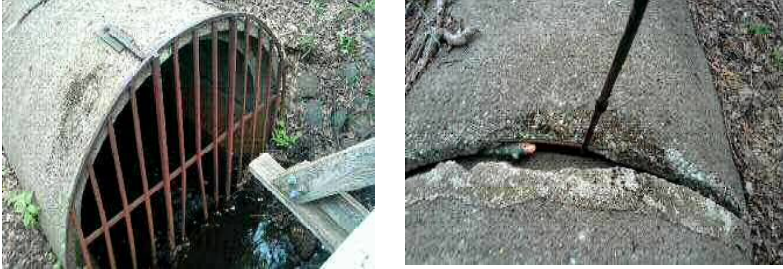
<p>East End of Culvert</p>	Concrete deterioration at top of culvert at joints; rebar exposed; 12" of sediment at culvert.	W&S (2014)

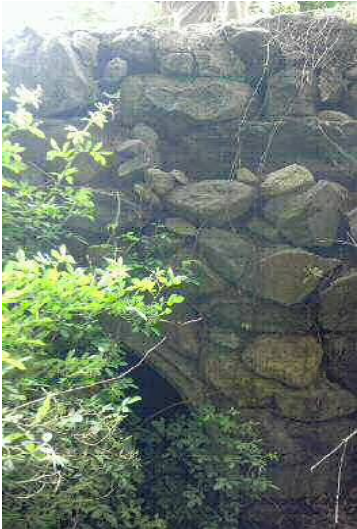
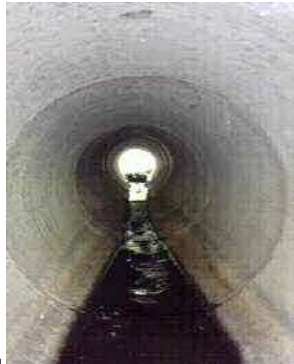
<p>North End of Culvert</p>

At the north end, stones are loose in the headwall. At the south end, there is minor spalling of the concrete and some minor cracks in the headwall.	FST (2008) W&S (2014)

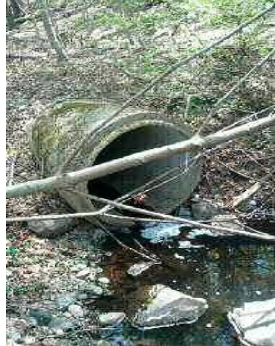
East end of culvert is mostly submerged; steel grate is rusted.	W&S (2014)	
Edmands Brook	Private Roadway on Boston College Property	48" Diameter Concrete Pipe Culvert	105 ft +/-

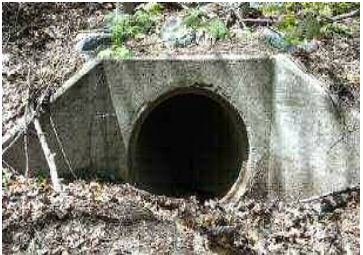
Minor spalling at west end of culvert	W&S (2014)	Boston College Property

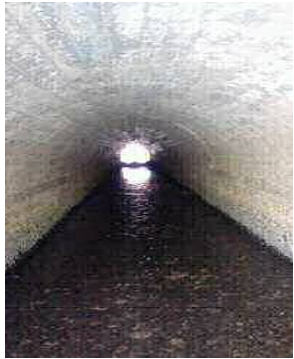
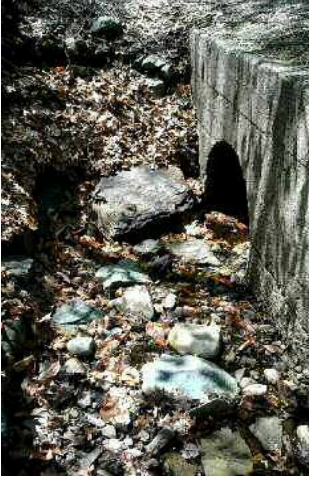
<p data-bbox="1566 687 1861 721">East End of Culvert</p>	Retaining wall at headwall at west end of culvert needs repair/rebuilding	W&S (2014)	
Edmands Brook	Edmands Brook Outlet at Dam Spillway	???	Unknown

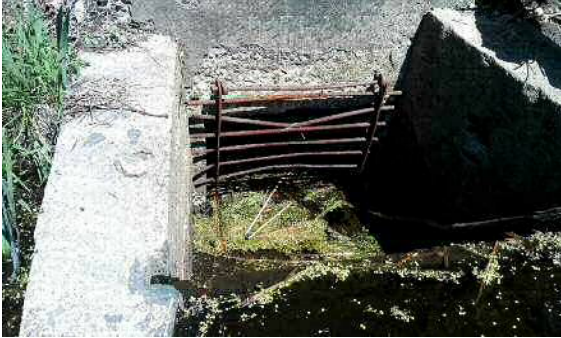
Steel grate is rusted and bent; concrete spalling at headwall	W&S (2014)

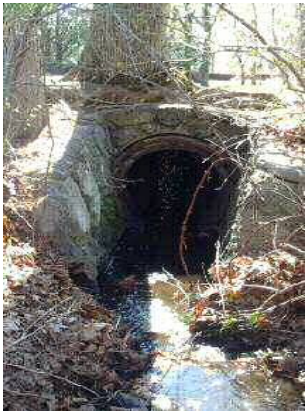
<p data-bbox="1566 1366 1858 1407">East End of Culvert</p>	At the west end, the stones in the headwall and wingwalls are loose and repointing is needed. At the east end, there are minor cracks in the stone headwall.	FST (2008) W&S (2014)	\$150,000

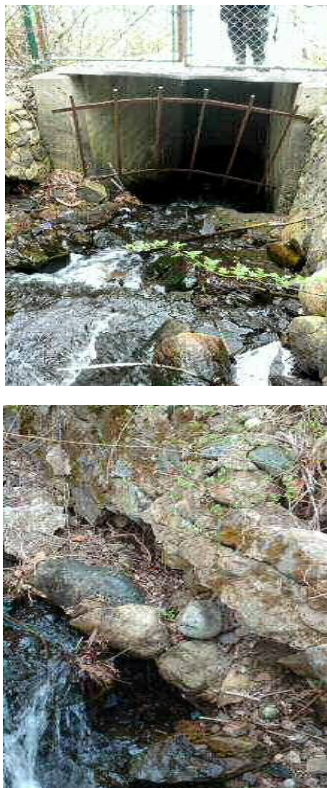
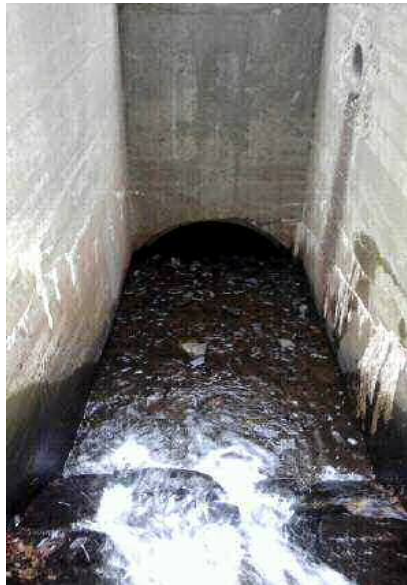
<p data-bbox="1526 762 1827 802">South End of Culvert</p>	Cracks w/ efflorescence visible at concrete walls at culvert; stone walls need work	W&S (2014)	
Hammond Brook	South of Suffolk Road - Culvert Goes Under the Green Line Train Tracks - Partial Access Only to North End of Culvert (Outlet) & No Access to South End	Stone Headwall	60 ft +/-

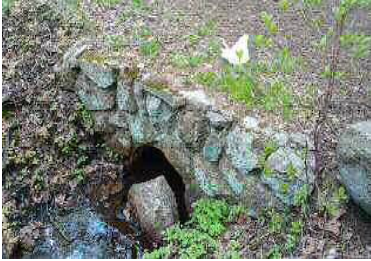
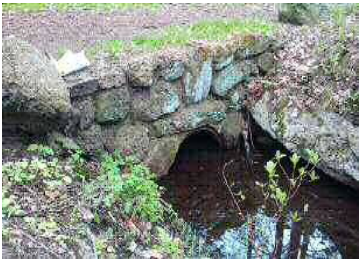
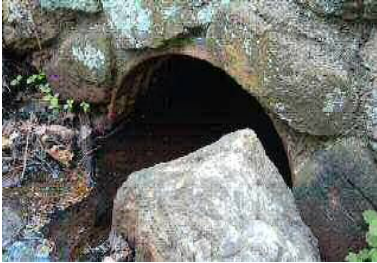
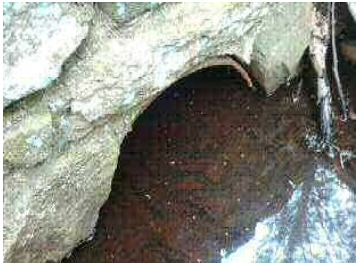
<p data-bbox="1168 1064 1470 1104">East End of Culvert</p> <p data-bbox="1541 1064 1843 1104">West End of Culvert</p>	Both stone headwalls could use some repointing and the CMP culvert is rusted.	W&S (2014)	\$50,000

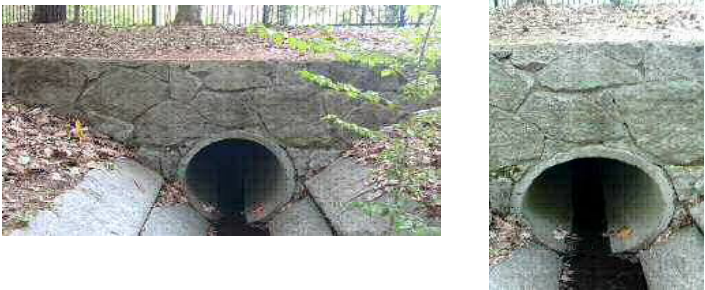
Some cracks visible in the stone headwall.	W&S (2014)	-
Hammond Brook	Clovelly Road/Suffolk Road - Inlet only	Could not obtain information regarding culvert size and material.	775 ft +/- (inlet to Clovelly Road/Old English Road outlet below)

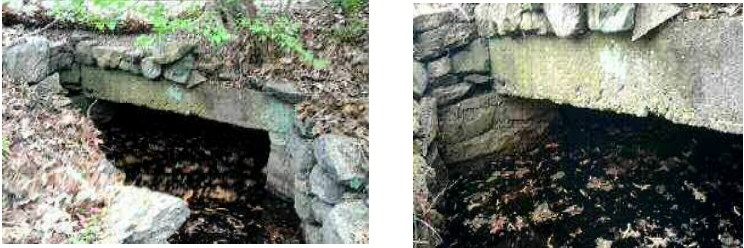
Some minor concrete spalling visible at culvert. Stones around culvert could use repointing.	W&S (2014)	
Hammond Brook	Hammond Pond Parkway – North Culvert	The East End is an 8' Wide Concrete Box Culvert with concrete headwall and straight wingwalls. The West End is a 6' Wide Concrete Box Culvert with concrete headwall and straight wingwalls	250 ft +/-

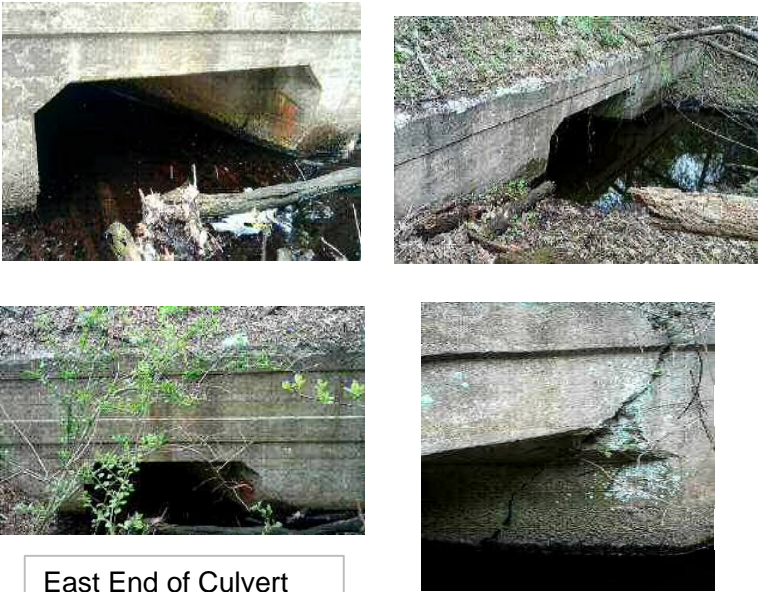
East End of Culvert West End of Culvert	At the east end, there is a 5" wide by 2" deep spall that runs almost the full length of the wingwalls along their top corner. The concrete walls are spalled at the top edge for the full length of wall. There is a large crack in the headwall at the edge of the opening.	FST (2008) W&S (2014)	\$150,000

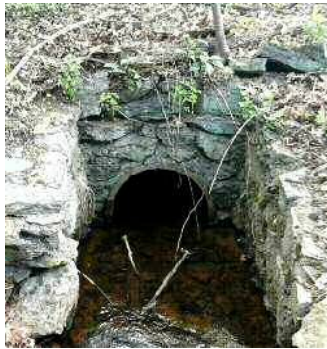
Stones are loose and could use repointing.	W&S (2014)	-
Hammond Brook	East of Glen Avenue & Under the Green Line Tracks (Could Only Inspect Outlet Due to Access Issues)	36" Concrete Box Culvert with Stone Walls	230 ft +/- (distance only measured under train tracks)

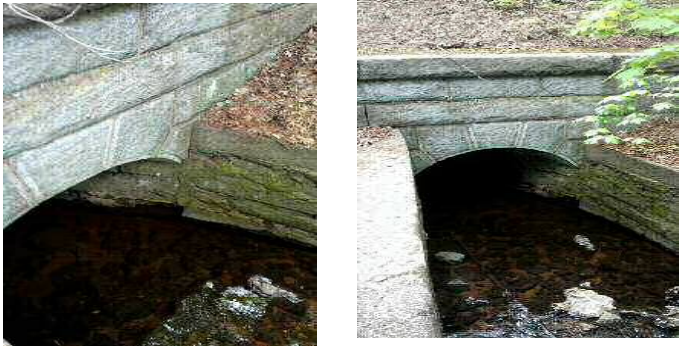
Some cracks/missing mortar visible in the bottom stone section of the culvert	W&S (2014)	
Hammond Brook	Sumner Street (Inlet Only Exposed)	12' Wide x 5' High Concrete Arch Culvert with Brick Walls & Brick Floor	715 ft +/- (inlet to Centre Street outlet below)

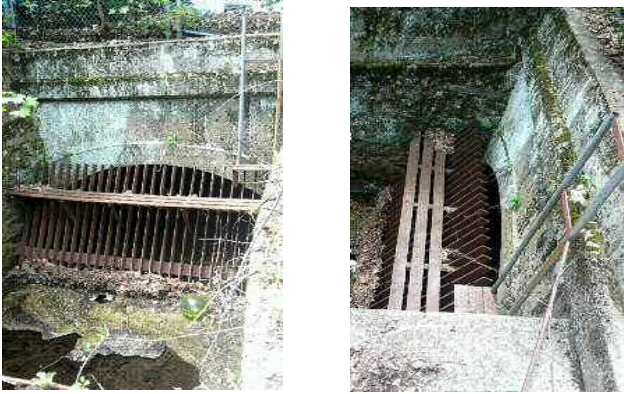
<p>East End of Culvert</p>	The concrete has minor cracks with moderate scaling. The northeast and southeast wingwalls are vertical stone masonry walls that have minor vegetation growing in the joints. Trash rack has some debris that needs to be removed.	FST (2008) W&S (2014)

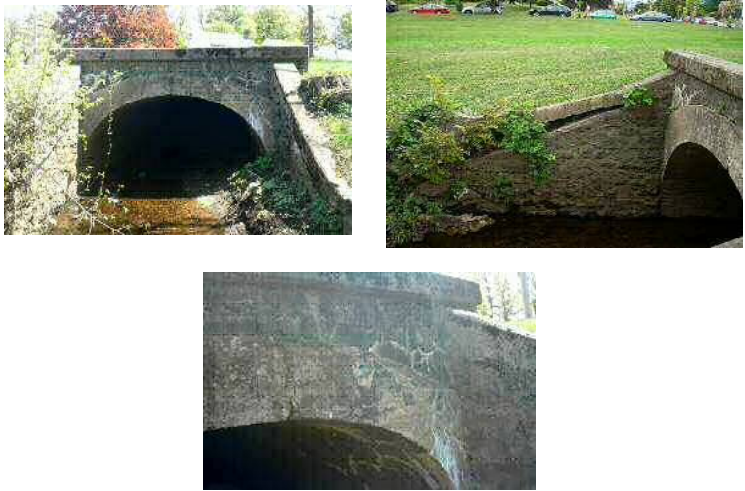
<p>West End of Culvert</p>	There are spalls and hairline cracks with efflorescence on the concrete arch and headwall. The wingwalls are in fair condition with some missing mortar. (Damage to concrete cap on wingwall due to adjacent trees, which have been cut down. - This may have been repaired. Confirm with City.) Approx. 6" of sediment in the culvert to be removed.	FST (2008) W&S (2014)

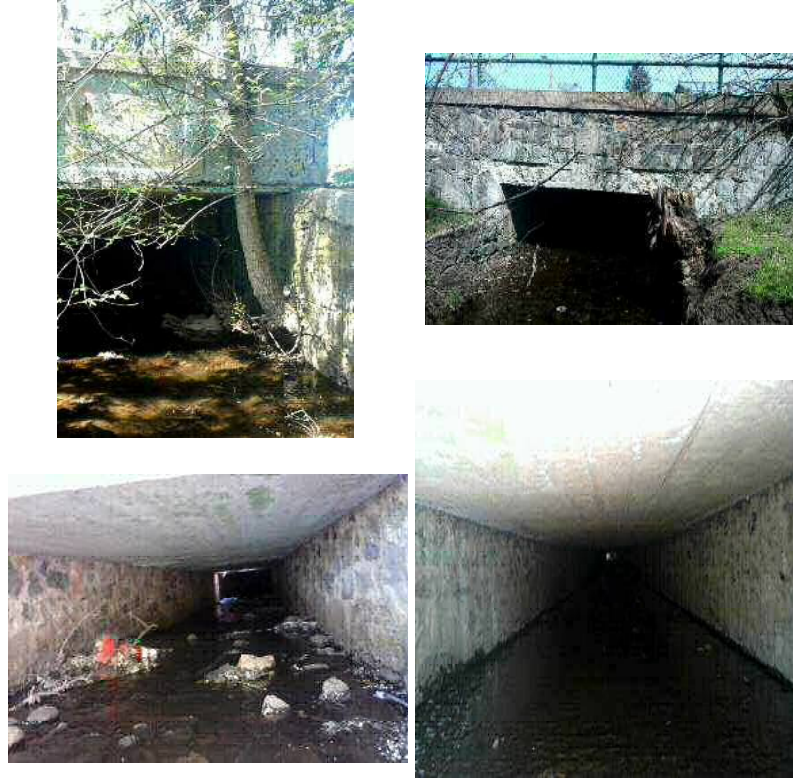
<p data-bbox="1174 929 1479 969">East End of Culvert</p> <p data-bbox="1547 929 1852 969">West End of Culvert</p>	Headwall shows some spalling/concrete deterioration. Tree growing out of stone masonry wall near east end of culvert that needs to be removed. Cracks visible in stone masonry wall. 6" of sediment in the culvert along with rocks and debris inside culvert.	W&S (2014)	
Hammond Brook	Homer Street (Outlet Only Exposed)	60" Diameter Brick Concrete Culvert with Stone Masonry Headwall	675 ft +/- (from MH on Commonwealth Ave)

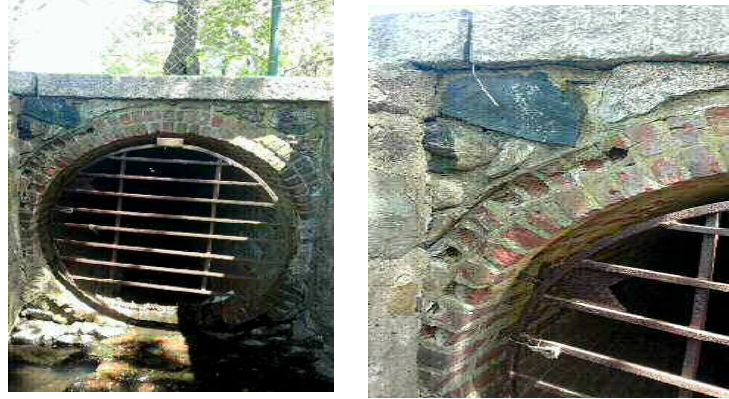
<p data-bbox="1361 1417 1665 1457">South End of Culvert</p>	Few bricks and some mortar/stone missing at culvert.	W&S (2014)

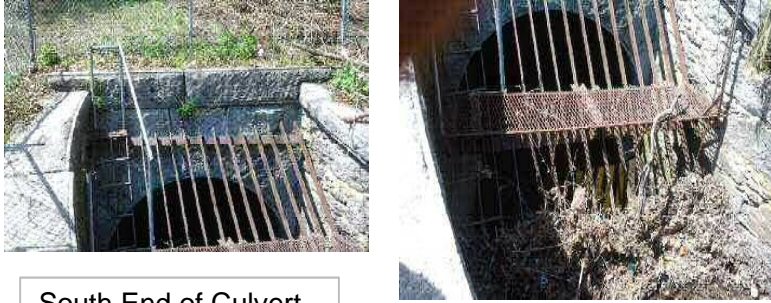
<p data-bbox="1190 1780 1463 1820">South End of Culvert</p>	Trask rack needs cleaning.	W&S (2014)

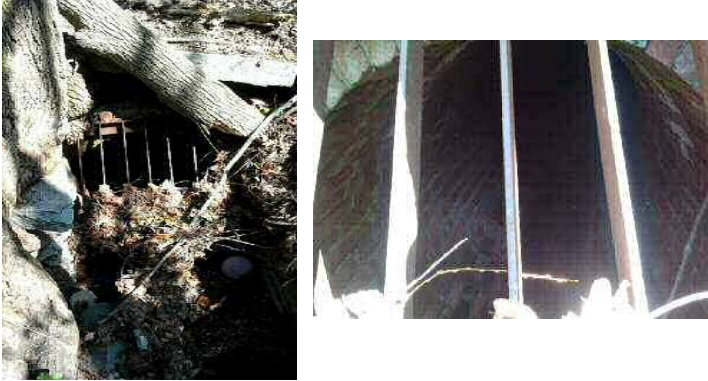
Trash rack needs cleaning. Tree is growing on top of the culvert, which needs to be removed. Interior of culvert looks good.	W&S (2014)	
Laundry Brook	Dexter Road	20' Wide Rectangular Culvert with Precast Concrete Deck Beams & Granite Walls	50 ft +/-

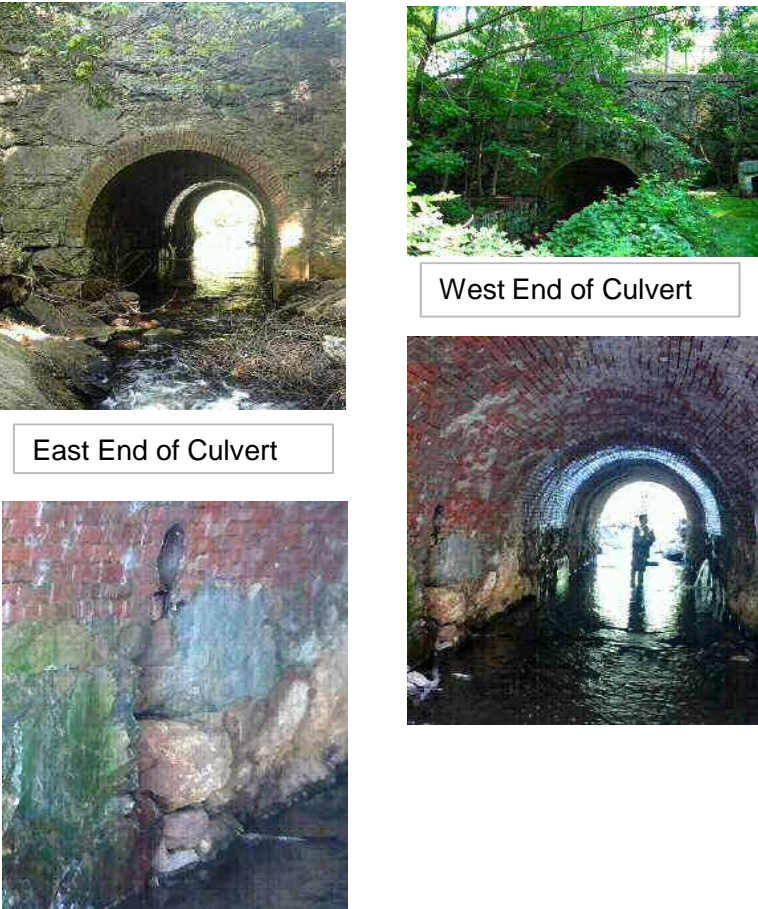
<p data-bbox="1174 1387 1479 1439">East End of Culvert</p> <p data-bbox="1560 1233 1858 1286">West End of Culvert</p>	Some bricks missing near the middle of the culvert. There are trees at the culvert that should be cut down to prevent damage to the culvert. There is some damage to the north stone masonry wall below one of the storm drains.	FST (2008) W&S (2014)	Estimated culvert repair costs based on 2001 Laundry Brook Culvert Inspection Report prepared by Woodard & Curran. Costs escalated to 2014.

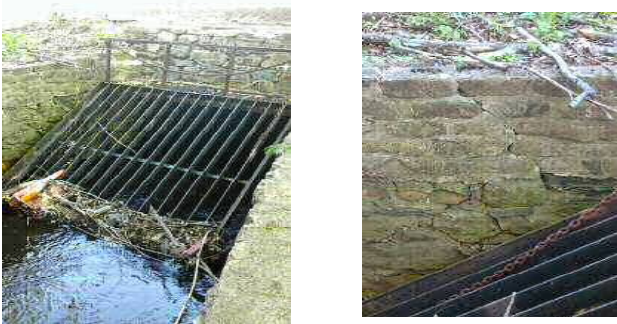
<p style="text-align: center;">South End of Culvert</p>	The trash rack needs to be cleaned. There are some cracks in the stone masonry walls. It looks like improvements previously recommended by FST have been completed, including replacement of the trash rack and repair of the granite blocks above the headwall.	FST (2008) W&S (2014)	\$1,140,000
Laundry Brook	Pulsifer Street (Outlet Only Exposed)	10' Wide x 6' High Concrete Box Culvert w/ Stone Masonry Walls	Unknown

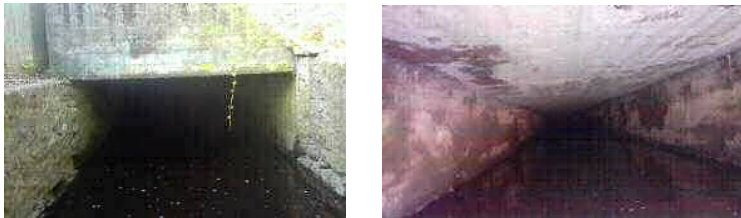
<p style="text-align: center;">East End of Culvert</p>	This end of the culvert has some spalling of the concrete and some missing mortar in the wingwalls, especially around the water line.	FST (2008) W&S (2014)	Repair Costs included under Hull Street for Laundry Brook.

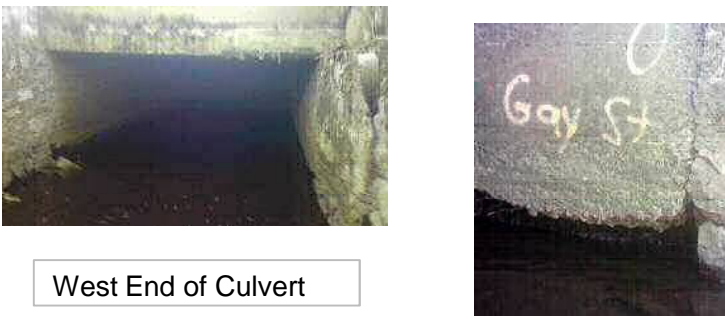
<p style="text-align: center;">West End of Culvert</p>	This end of the culvert has some spalling concrete and missing mortar in the stone masonry walls especially around the water line.	FST (2008) W&S (2014)	Repair Costs included under Hull Street for Laundry Brook.
Paul Brook	Boylston Street (Route 9) (Outlet Only Exposed)	5' x 3' Concrete Box Culvert	860 ft +/- (from MH on Jackson Street)

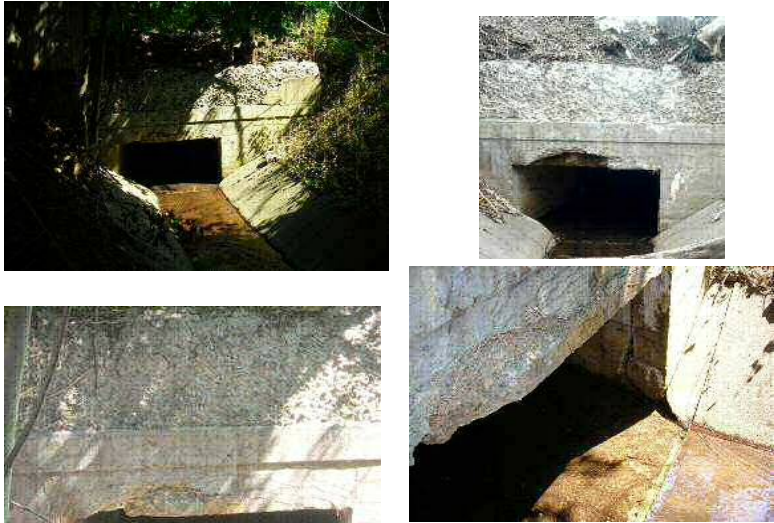
<p style="text-align: center;">South End of Culvert</p>	Heavy deterioration of south concrete headwall and large spall on south fascia at top of culvert opening. Large vertical crack in the east wall near the south end.	FST (2008) W&S (2014)	\$50,000

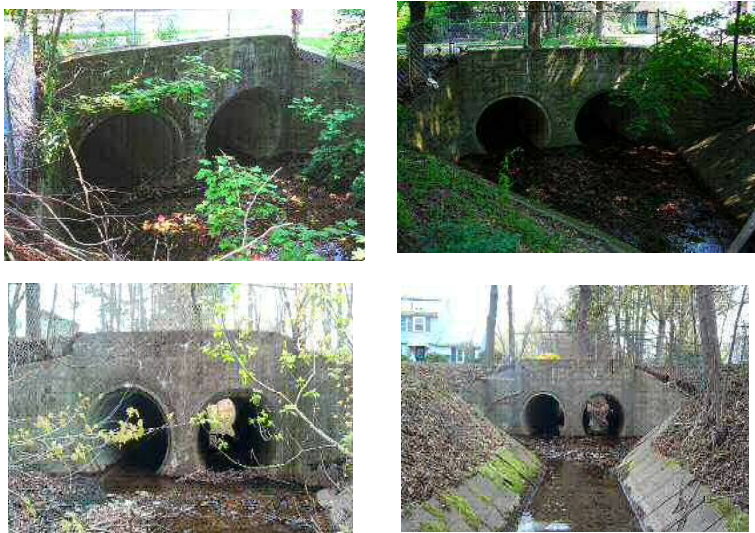
<div style="display: flex; justify-content: space-around; margin-top: 10px;"> <div data-bbox="1174 1310 1479 1360" style="border: 1px solid black; padding: 2px;">North End of Culvert</div> <div data-bbox="1547 1310 1852 1360" style="border: 1px solid black; padding: 2px;">South End of Culvert</div> </div>	<p>Minor cracks with light efflorescence on the north headwall. Fence on the north headwall is bent with some rust and has one post dislodged. (May have been repaired since FST inspection). The concrete walls at the south end of the culvert have minor cracks with efflorescence at the fence post locations. The south fence has some rust, is partly hanging over the edge of the culvert and needs to be repaired. There is a minor spall in the southwest wingwall.</p>	<p>FST (2008) W&S (2014)</p>

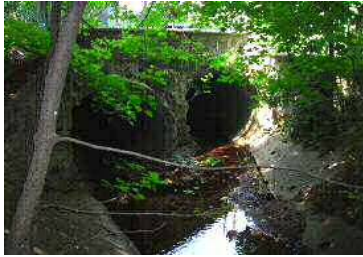
<p>East End of Culvert West End of Culvert</p>	Some debris at east end of culvert. Previous repairs to wall at west end of culvert.	FST (2008) W&S (2014)	-
Paul Brook	Parker Street	12' Wide x 6' High Concrete Box Culvert	200 ft +/-

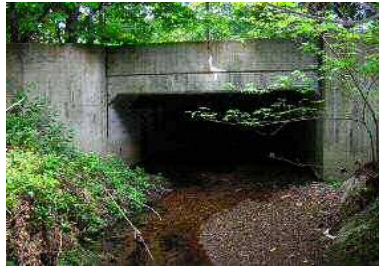
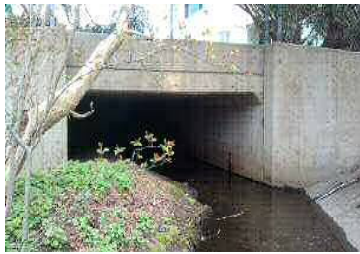
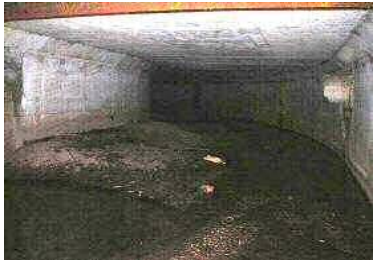
<p>West End of Culvert East End of Culvert</p>	The west end has minor cracks with efflorescence. There is approx. 2' of sand and debris buildup inside the west end of the culvert along the north wall that obstructs some flow. There is 1' to 2' of sand and debris buildup inside the east end of the culvert along the south wall that obstructs some flow.	FST (2008) W&S (2014)	-
Paul Brook	Mildred Road	2 - 60" Diameter Double Barrel Concrete Pipe Culverts	50 ft +/-

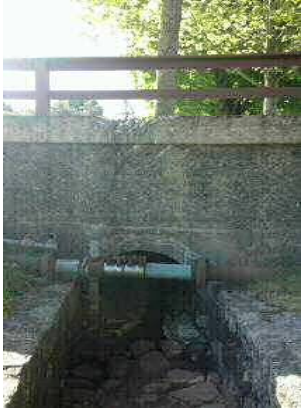
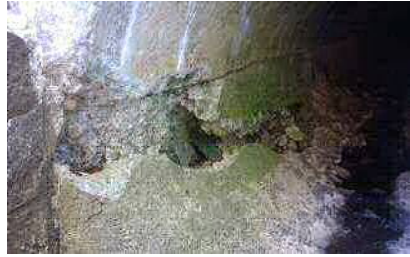
<p style="text-align: center;">West End of Culvert</p>	Some cracks visible in the headwall. The concrete is eroded along the interior of the pipe.	W&S (2014)	\$150,000
Runaway Brook	On Woodland Country Club Golf Course	36" Diameter Concrete Pipe Culvert	185 ft +/-

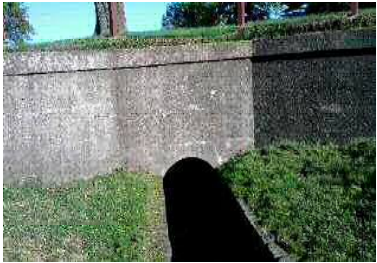
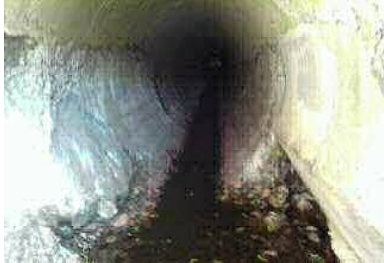
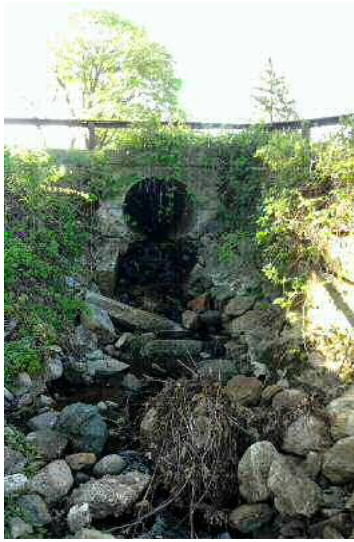
<p style="text-align: center;">East End of Culvert</p> <p style="text-align: center;">West End of Culvert</p>	West end has minor cracks in the headwall. The concrete is eroded along the interior of the pipe. East end has more substantial cracks in the headwall. Retaining wall adjacent to the culvert needs repair on both sides.	W&S (2014)	\$150,000

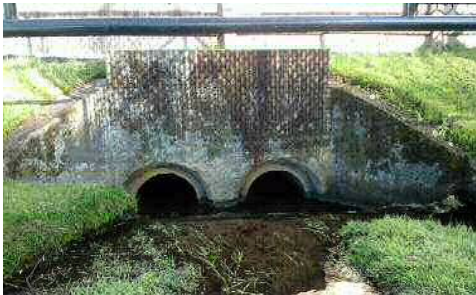
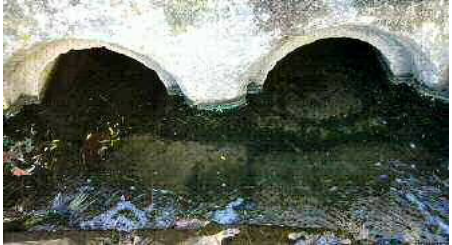
<p style="text-align: center;">West End of Culvert</p>	Culvert in good condition. No sediment inside of the culvert, but there is approx. 5" of sediment before the culvert.	W&S (2014)	-

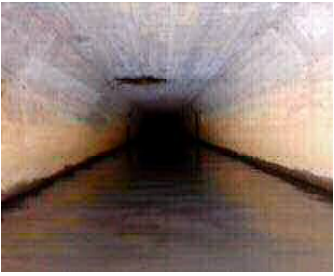
<p>South End of Culvert</p> <p>North End of Culvert</p>	At the south end, there is a crack in the headwall at the intersection of the southwest wingwall and the headwall. At the north end, the top of the northwest wingwall has a 3" deep spall that runs the full length and thickness of the wall. There is also minor scour at the base of the northwest wingwall foundation.	FST (2008) W&S (2014)	\$150,000

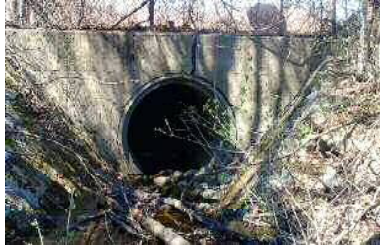
<p>East End of Culvert West End of Culvert</p>	At the East End, there is a large, deep crack in the culvert headwall along with additional minor cracks. At the West End, there are some minor cracks and some minor concrete deterioration.	W&S (2014)	\$150,000

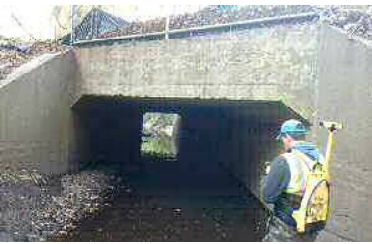
<div style="display: flex; justify-content: space-around;"> East End of Culvert West End of Culvert </div>	There is some spalling of concrete on the west headwall. There is minor scaling of the concrete on the east headwall. All 4 wingwalls have some spalling. Concrete is eroded along the walls inside the culvert. There is 6" to 12" of sediment in the culvert.	FST (2008) W&S (2014)	\$150,000

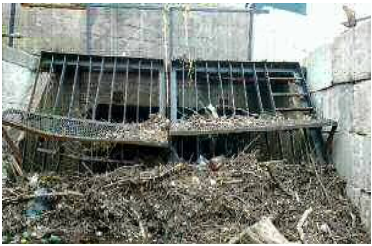
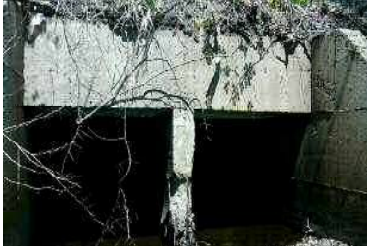
<p data-bbox="1162 419 1457 459">East End of Culvert</p>

<p data-bbox="1557 701 1852 741">West End of Culvert</p>	The trash rack at the east end of the culvert needs to be cleaned. There is significant deterioration at the west end. Rebar is exposed.	FST (2008) W&S (2014)	\$150,000
South Meadow Brook	Tower Road	Twin Concrete Box Culverts at North End Twin Concrete Box Culverts at South End	270 ft +/-

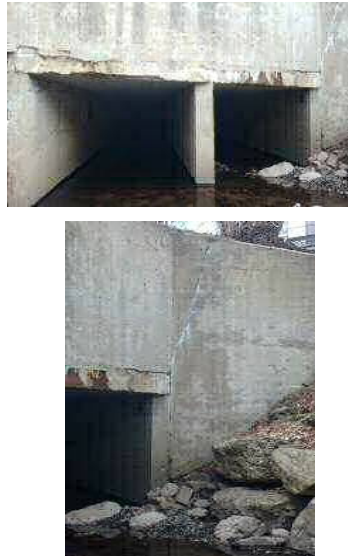
<p data-bbox="1588 1358 1883 1399">South End of Culvert</p>	Debris in front of culvert at North End. Light cracks visible in wingwall at North End. Concrete deterioration at headwall at South End. At South End, cracks visible at northeast wingwall. Up to 12" of sediment within the culvert.	W&S (2014)	\$150,000

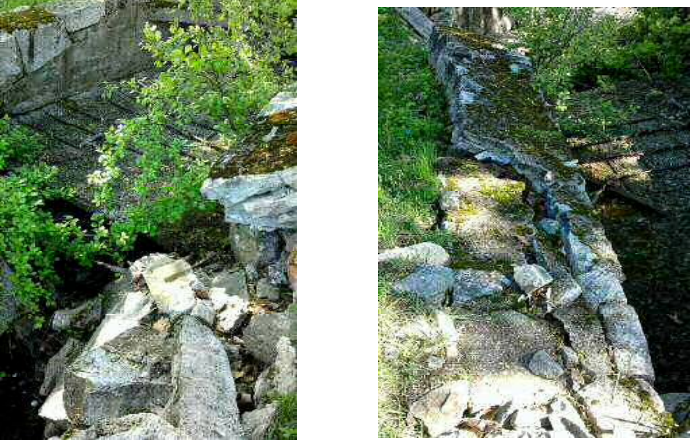
Culvert is collapsed; rebar exposed; retaining wall in vicinity of culvert is also collapsed	W&S (2014)	\$300,000
Strong's Brook	On Newton Commonwealth Golf Course near Montrose Street	24" Diameter Concrete Pipe Culvert - Outlet Only to Strong's Brook	305 ft +/- (from behind #10 Dolphin Road)

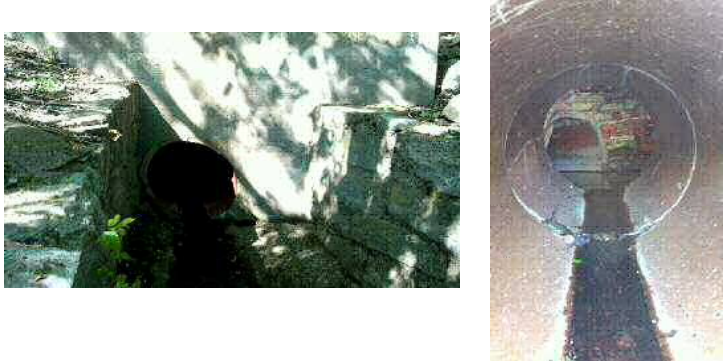
Crack visible in culvert pipe	W&S (2014)	\$150,000
							\$5,140,000
