Re: Grace Church Bell Tower Restoration, Project Status Report No. 9

As a representative for Grace Episcopal Church Newton, I want to provide you this Project Status Report. This report covers July 2022.

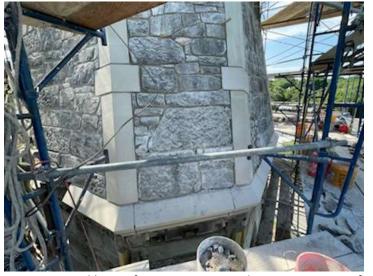
Existing and new masonry at base of spire was set in place and anchored to the inner masonry.

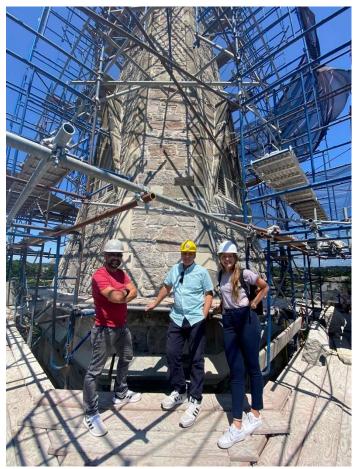
Reconstructed base of spire incorporated extensive areas of new material to replace fragmented stone.

In July, installation of internal steel reinforcements (post tensioned rings at three elevations) allowed Aniceto to move onto the reconstruction of the most damaged part of the structure – the cornice at the base of the spire, just above the bell loft. This reconstruction involved much repositioning of loose and misplaced masonry and the addition of new stone for the cornice including new dressed stone for decorative elements. John Wathne of Structures North and I participated in weekly meetings and made two on-site inspections in July to review Aniceto's careful work on this most dangerous section of the tower structure. Aniceto addressed the four sides of the tower by bracing, removing and carefully repositioning old stone, and setting new stone to match where existing stone was too damaged to reuse. Existing and new cornice stone were each individually secured to the interior brace with through-wall pin anchors. With this work, anticipated to be complete in August, the tower structure will be finally completely stabilized. Further work, below the cornice, while important, is essentially about restoration of the exterior for long-term durability and water tightness. This month and the next will be a watershed moment for the project.
