Crafts Street Elderly Housing with Services

Land Use Presentation

October 25, 2022

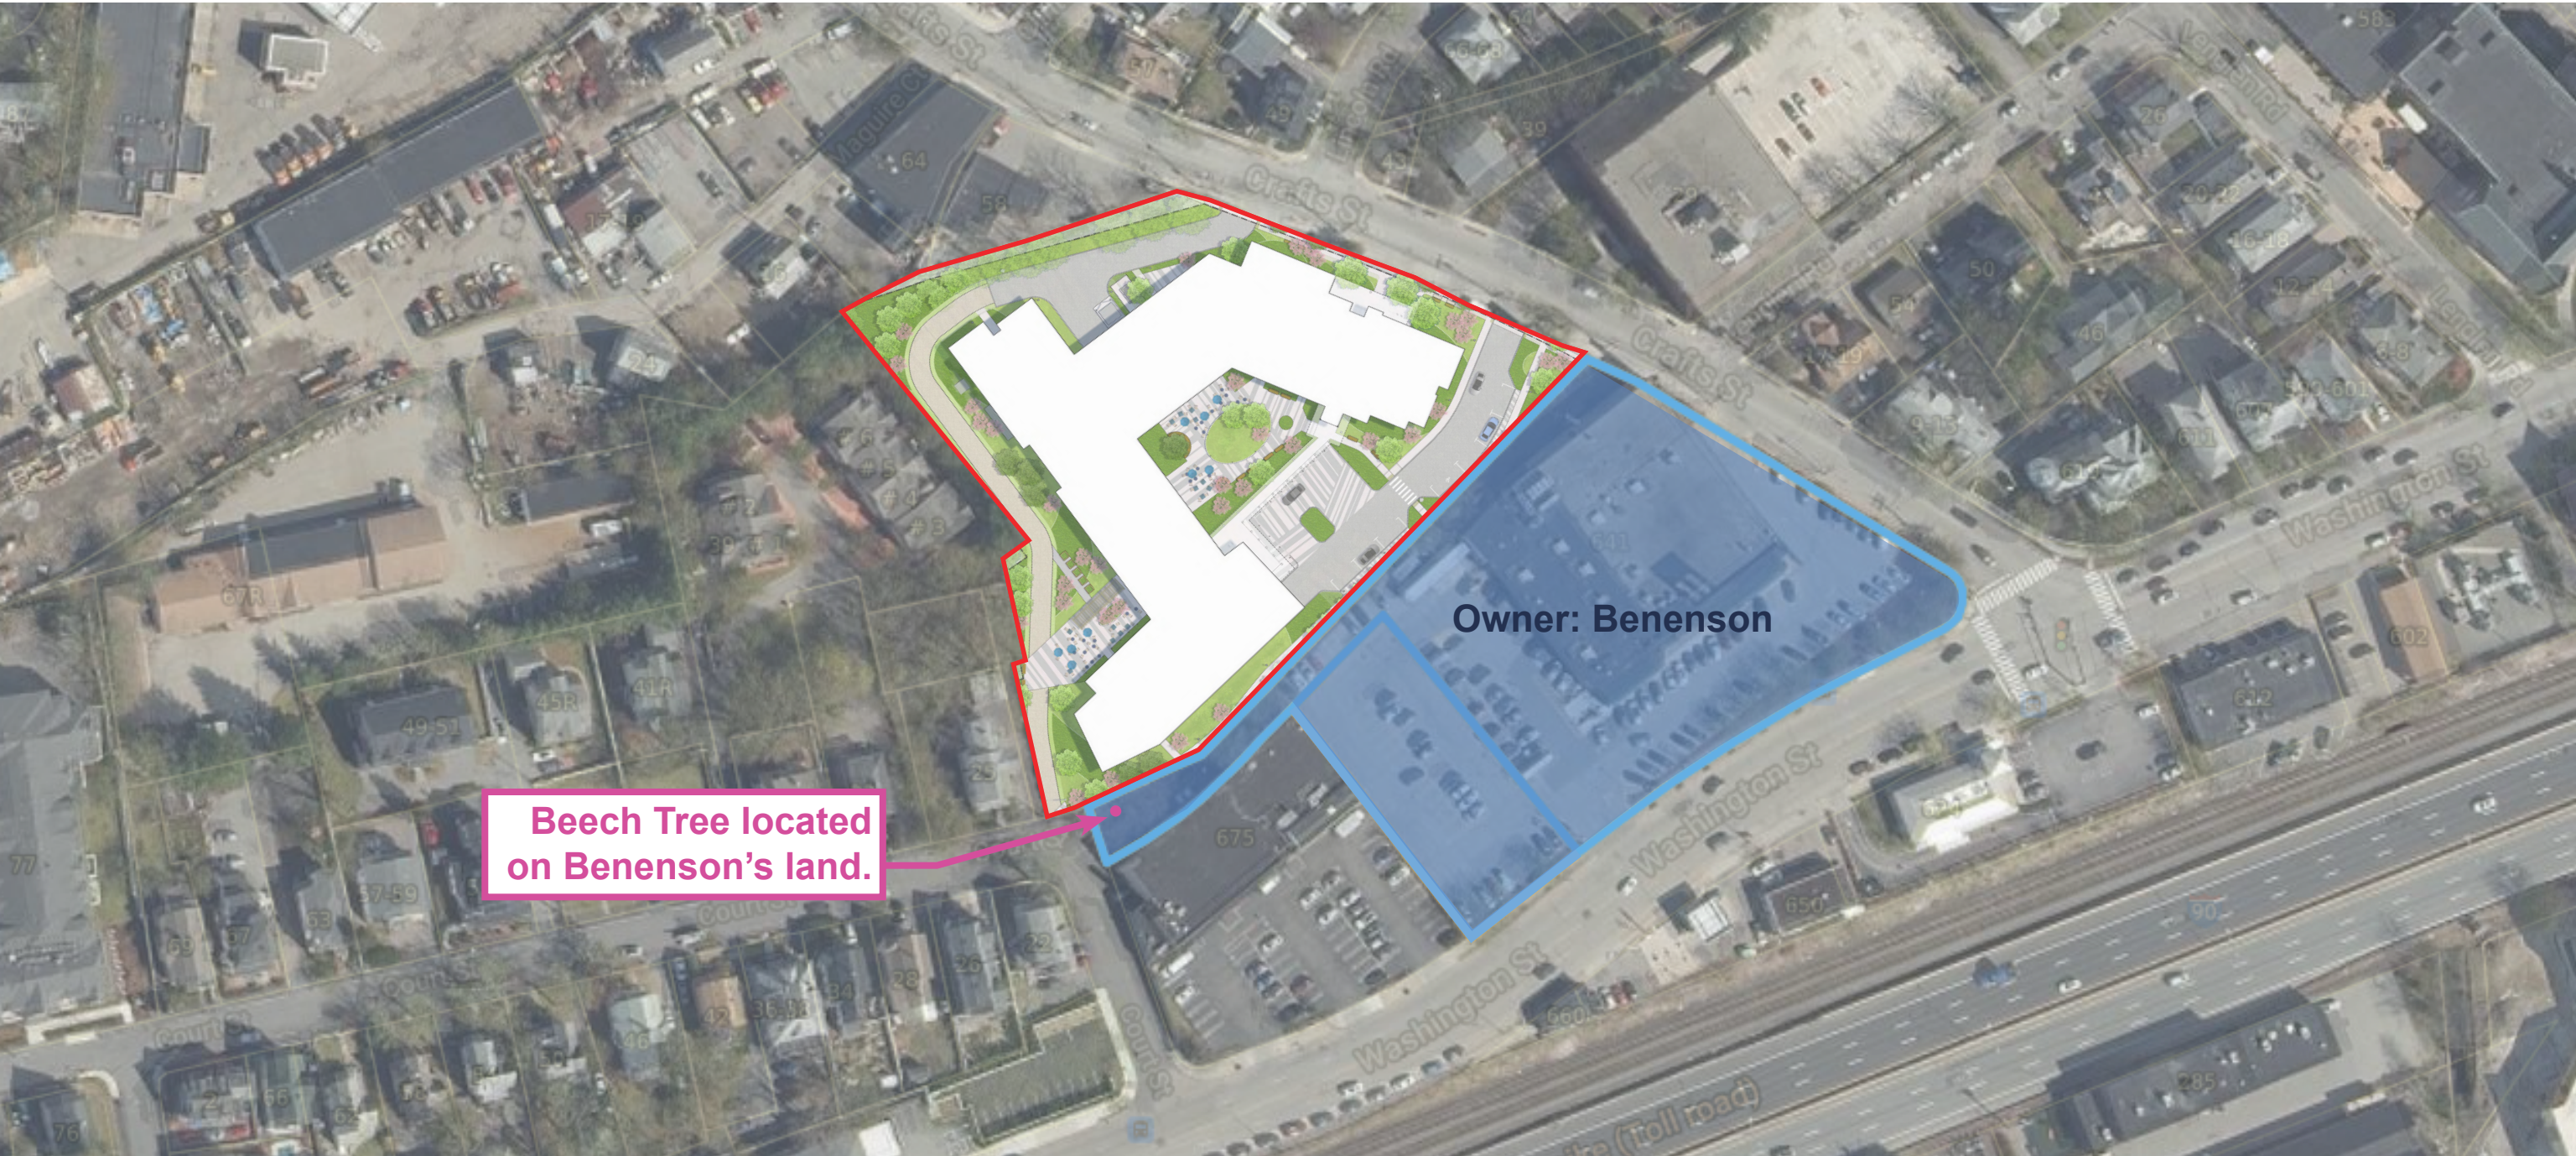
Location of Beech Tree

Beech Tree located on Benenson's land.

Owner: Benenson

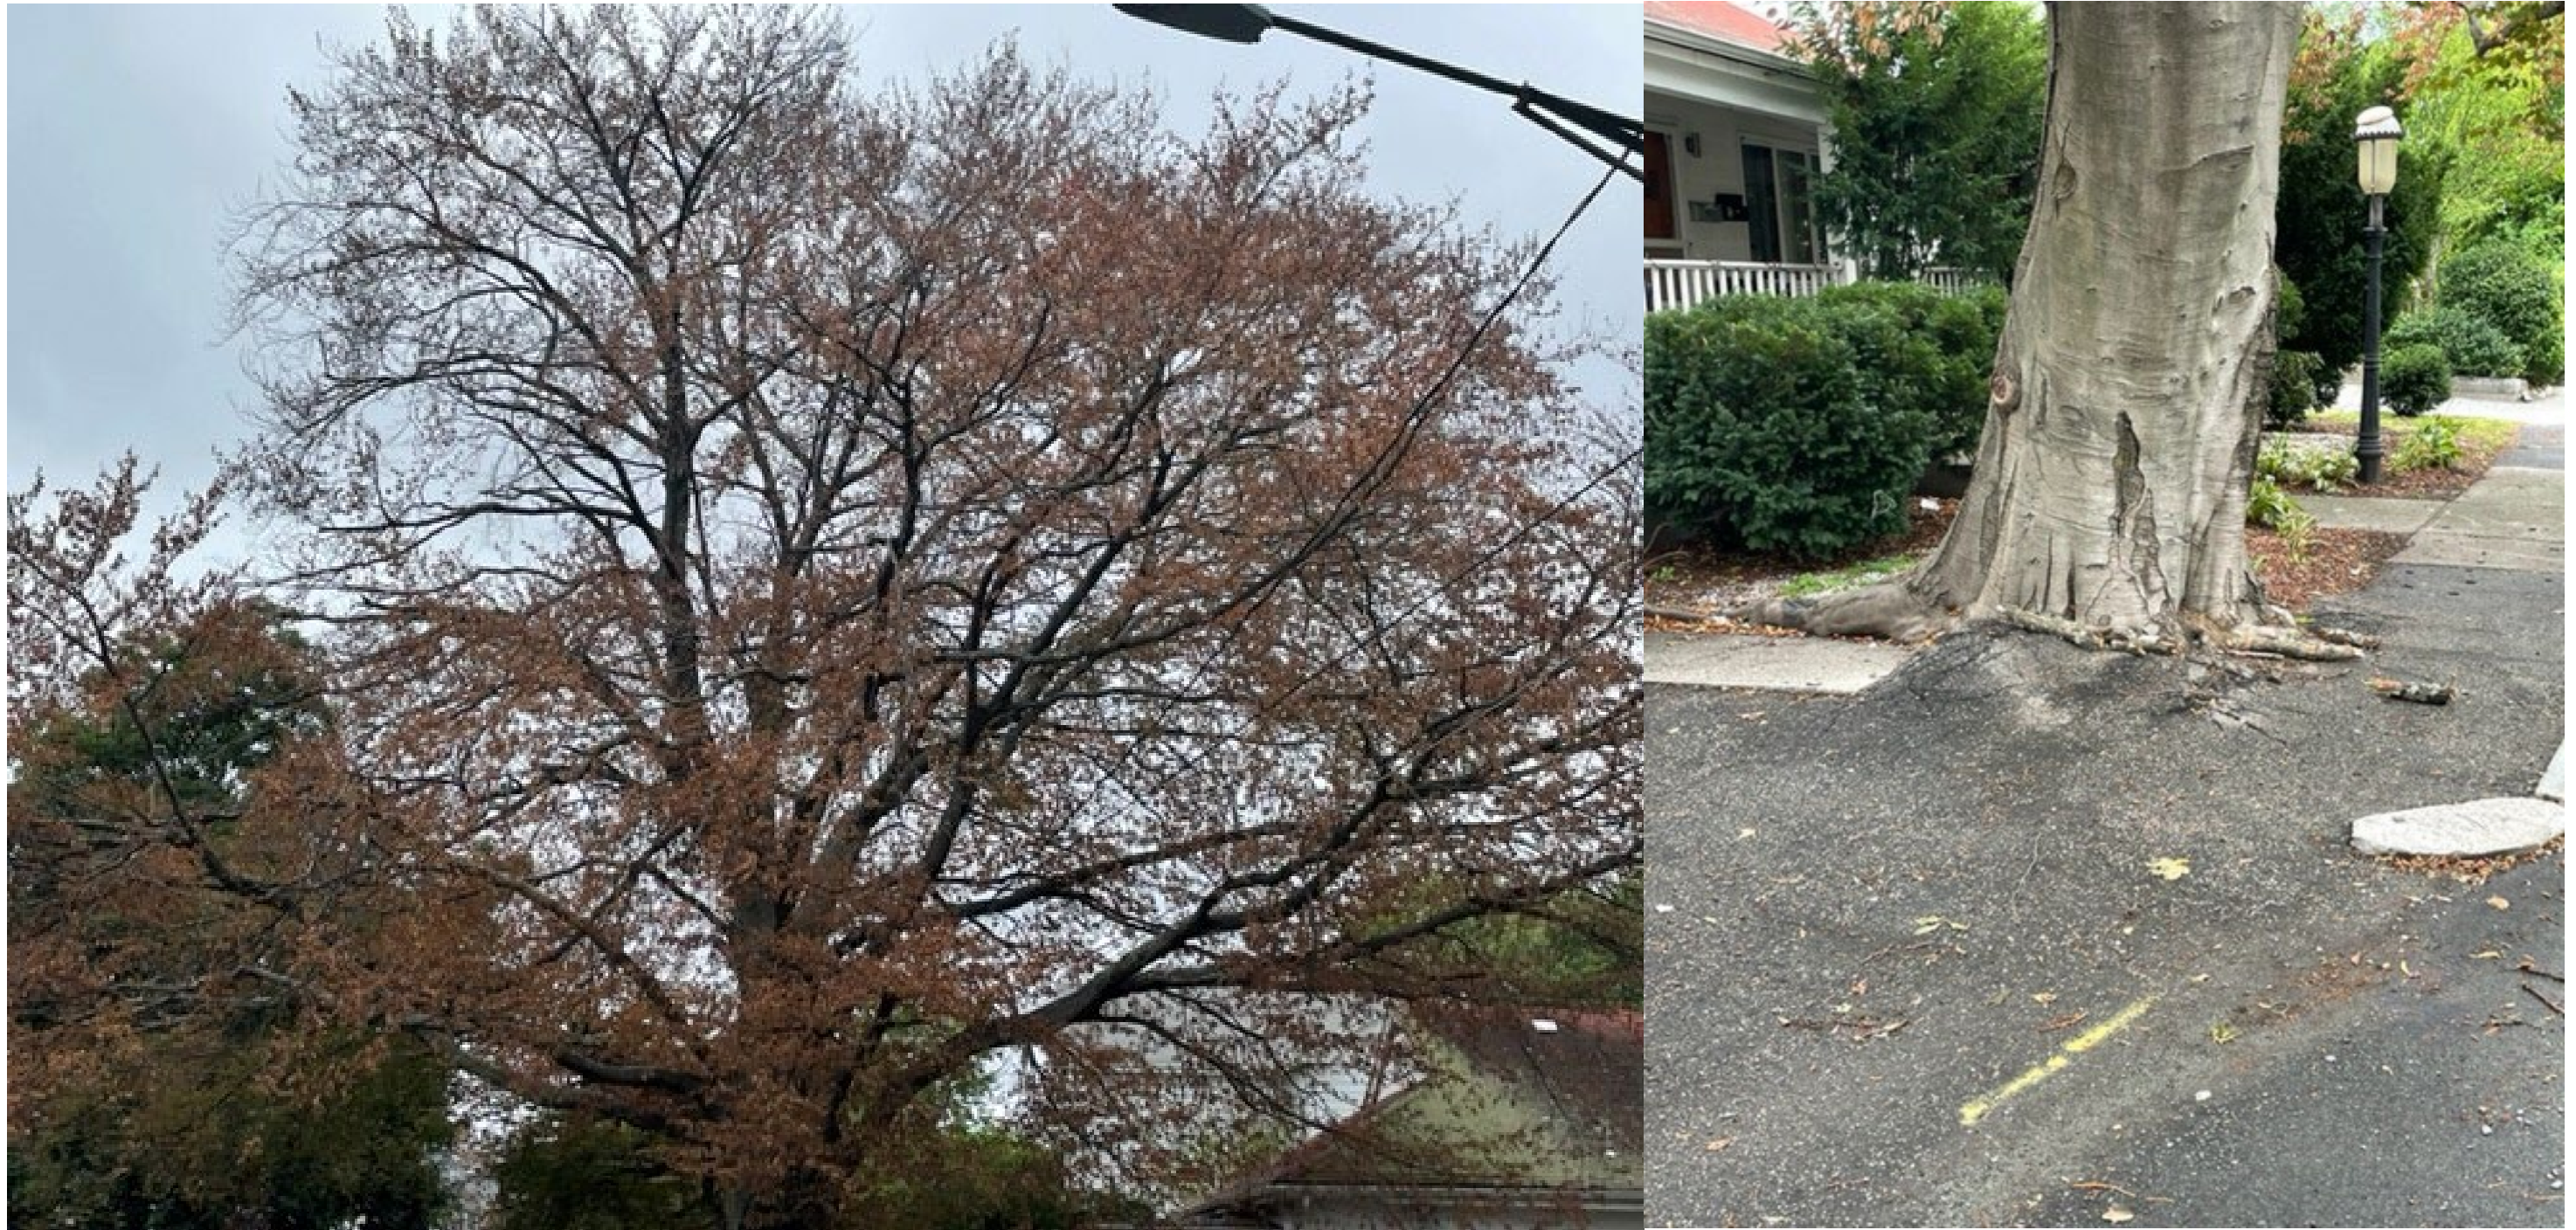
Image of assessed beech tree taken on September 27, 2022.

The tree is a European beech which is 45 inches in diameter. The tree is growing against the driveway of 21 Court St and the sidewalk along Court St. The canopy of the beech tree is very thin with most of the foliage having already dropped early in the season. The remaining foliage is undersized for this species of tree. **Approximately half the canopy is dead**, with the largest dead portion of stem being 18" +/- . It is uncertain if the remaining canopy will leaf out next season.

Due to the restricted root zone of the tree, soil therapies to slow decline will not be effective. Additionally, Beech Leaf Disease, a new invasive pest to beech trees, is in the area and expected to affect this tree in the near future. Beech leaf disease is shown to quickly cause mortality in trees in poor condition such as this tree.

I conclude that this tree is of very low suitability for preservation and should be removed as soon as possible to eliminate the potential for branch failures.
