Project Update and Request for Comments

80-90 Bridge Street Site, Newton, MA

Meeting Date: November 29, 2022

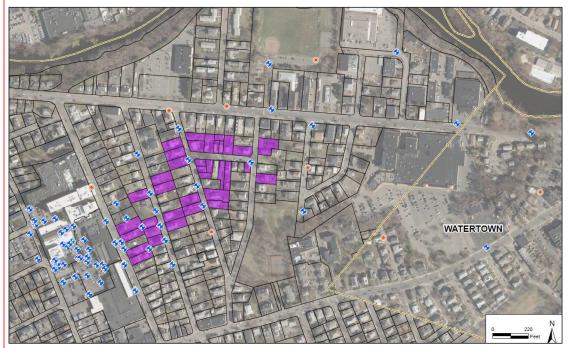
Monitoring wells (blue symbols), Geoprobe soil borings (red symbols), and residential properties investigated for vapor intrusion (purple shading)

Sources of contamination were removed in the 1980s.

The limits of soil and groundwater contaminants have been determined.

Indoor air sampling has found no significant risk to health in 73 of 75 residences where vapor intrusion assessments have been completed.

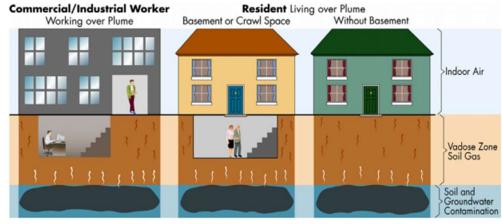
Figure 1-1. Typical conceptual model of vapor intrusion.

From "Vapor Intrusion Pathway: A Practical Guideline" prepared by the Interstate Technology Regulatory Council (ITRC)

What is Vapor Intrusion?

- Vapor intrusion is gas (vapor) entering a building from the subsurface.
- The most well-known example of vapor intrusion is radon.
- At the 80-90 Bridge Street Site, vapors are coming from contaminated groundwater.
- Note that groundwater in Newton is NOT used for drinking water!

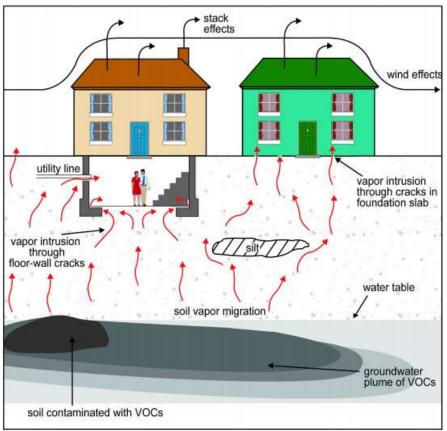
From the United States Environmental Protection Agency Vapor Intrusion website (https://www.epa.gov/vaporintrusion/what-vapor-intrusion)

- The concentration of the contaminant in groundwater.
- The depth of groundwater beneath the building.
- The construction of the building.
 - · Does the building have a basement?
 - Are there cracks or gaps in the slab or basement walls?

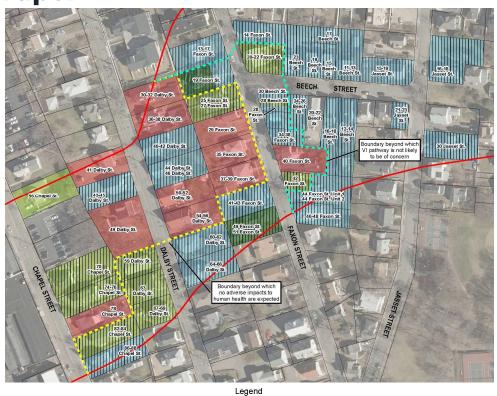
Access Denied or No

Current CEP
CEP Eliminated
CEP = Critical Exposure Pathway

No CEP

Boundary Beyond Which Vapor Intrusion Pathway Is Not Likely To Be Of Concern

Vapor Intrusion Assessment Complete

- Sampling results demonstrate that the vapor intrusion pathway is not complete for 40 of the 48 residences
 - Indoor air concentrations below MassDEP Residential Threshold Values in 23 residences
 - · Indoor sources identified in 17 residences
- In the eight residences where the VI pathway was complete, actions were taken to eliminate or mitigate the Critical Exposure Pathway (CEP) to the extent feasible.
- None of the eight residences with CEPs had indoor air concentrations that posed a short-term or long-term health risk.
- Access needed at additional properties to continue the vapor intrusion assessment.

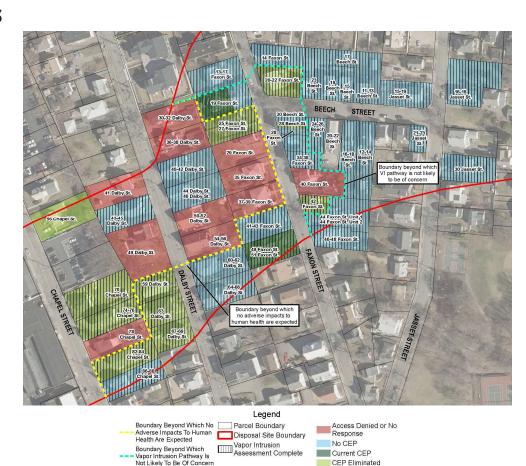
CEP Eliminated
CEP = Critical Exposure Pathway

Data from the Interim and Supplemental Phase II investigations have been used to establish two boundaries:

- Boundary beyond which no adverse impacts to human health are expected
- Boundary beyond which the vapor intrusion pathway is not likely to be of concern

Additional vapor intrusion assessment is not required beyond the boundary where the vapor intrusion pathway is not likely to be of concern in accordance with MassDEP guidance

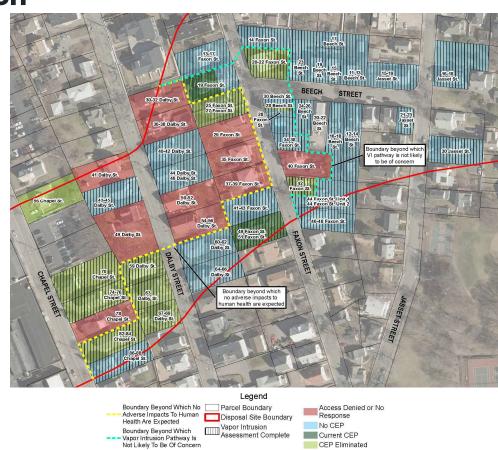
CFP = Critical Exposure Pathway

- Locations of the boundaries have been verified by extensive sampling
 - 62 residences sampled beyond the boundary for no adverse impacts to human health
 - 31 residences sampled beyond the boundary for which the VI pathway is not likely to be of concern

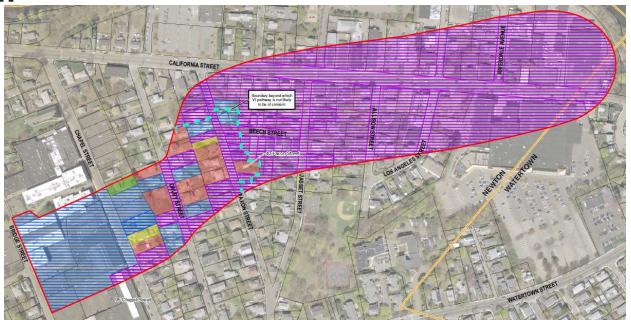
Properties included in this Partial Permanent Solution (purple hatching), properties included in Partial Permanent Solution No. 1 (blue hatching), properties where an AUL is required (gold shading), property where VI is currently being assessed (green shading), and properties where access has been denied (red shading)

- A portion of the property at 95 Chapel Street which was inadvertently omitted from Partial Permanent Solution No. 1
- Sixteen properties (in whole or in part) between Chapel Street and Faxon Street
- All the properties within the Disposal Site boundary east of Faxon Street to the Charles River (except for 40 Faxon Street where access has been denied)
