Property: 20 Rogers Street (Crystal Lake Park)
Newton Conservators Conservation Restriction
Monitoring-2022

2022 Crystal Lake Conservation Restrictions Monitoring

NEWTON CONSERVATORS CR MONITORING REPORT ATTACHMENT

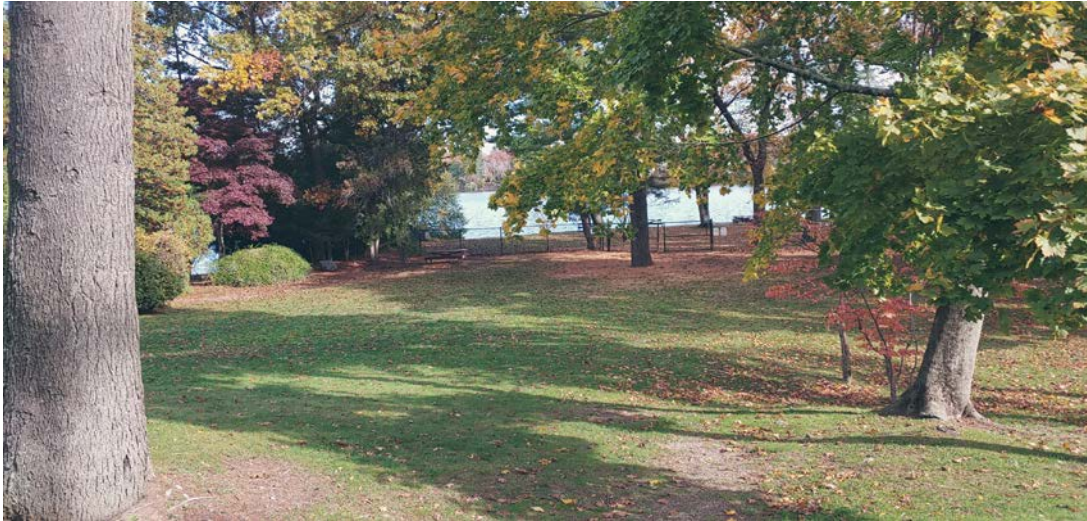
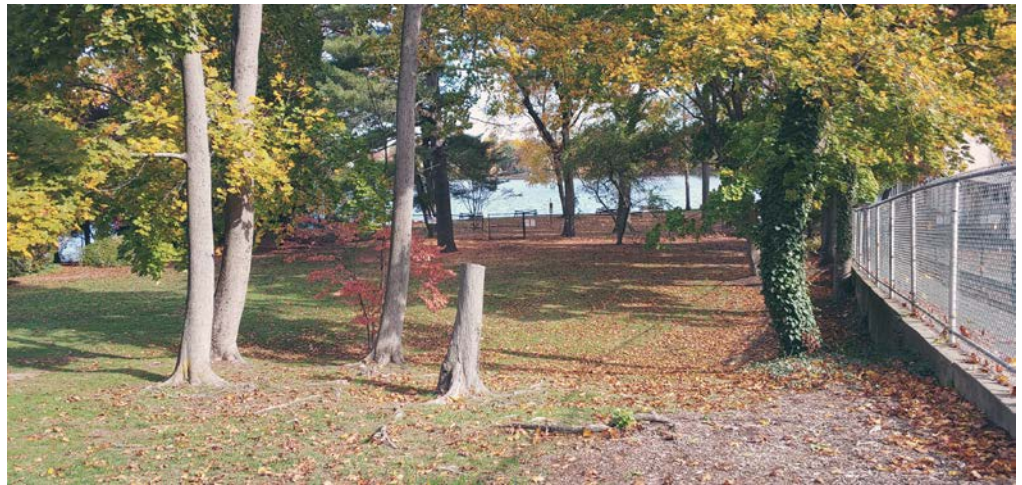
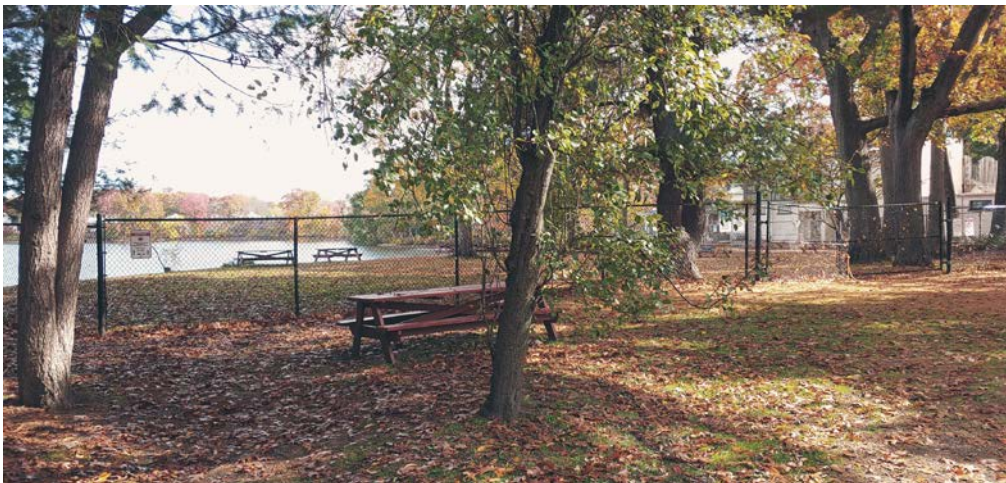
2, 3	Ingerson 108221107, 108221107a, 108221116	Looking roughly east, view from sidewalk toward the lake, and from grassy area of park toward the parking lot; invasive English ivy on trees near parking lot fence
------	---	---

- The invasive vines we noted last year have again grown significantly, and there appears to have been no systematic effort to control them. They include porcelain berry growing on and through the yews along the former driveway of 20 Rogers Street, English ivy growing on several mature trees (including cedars) near the edge of the stone patio/fountain at 230 Lake Avenue and along the (somewhat tumble-down) retaining wall along the original boundary between 20 Rogers Street and 230 Lake Avenue, and some *very robust* (2” or more in diameter) bittersweet vines growing along and through the original retaining wall between 230 Lake Avenue and the lake itself.

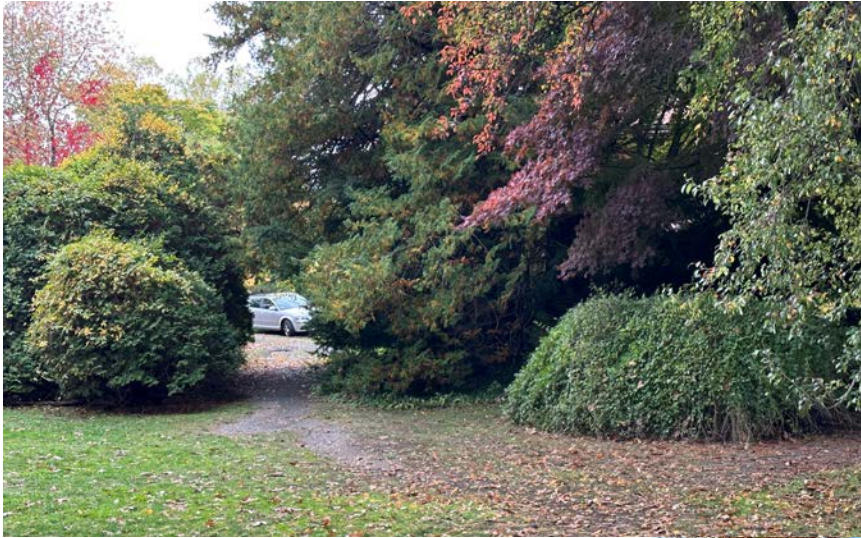
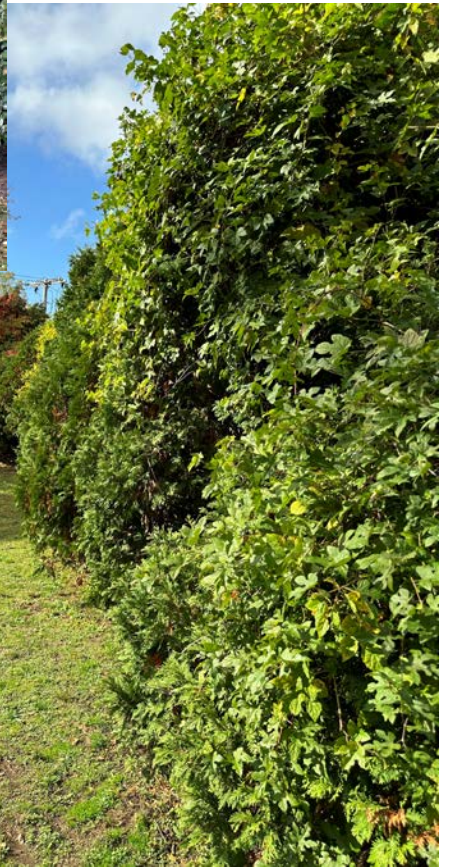
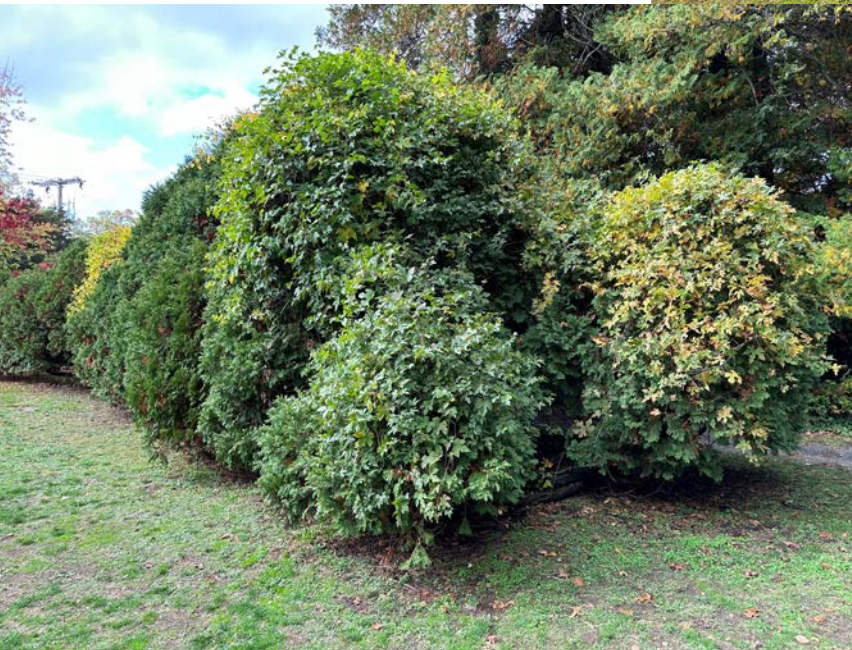
4

Mallory 0172, 0208,
0272

Looking roughly west, invasive vines
in shrubs that outline original
driveway for 20 Rogers Street

- As in 2021, we suggested that these existing plantings be replaced with new ones along the current boundary between public and private property. Some of the attached conceptual plans suggest such replanting is under consideration. In reviewing the City's plans for this landscape, the Conservators should discuss in detail with staff how to balance replanting with any value of the existing vegetation as habitat or food for wildlife.

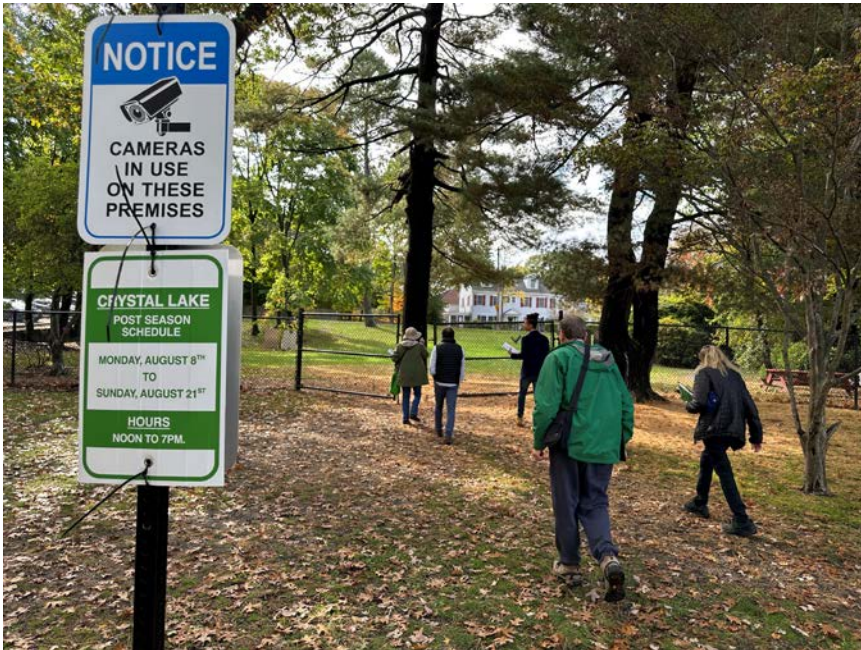
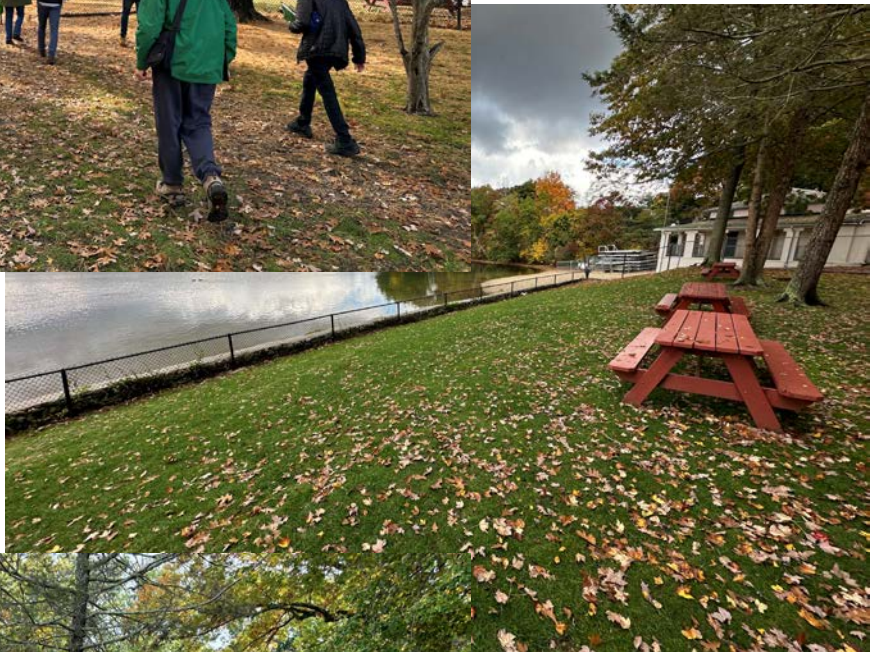
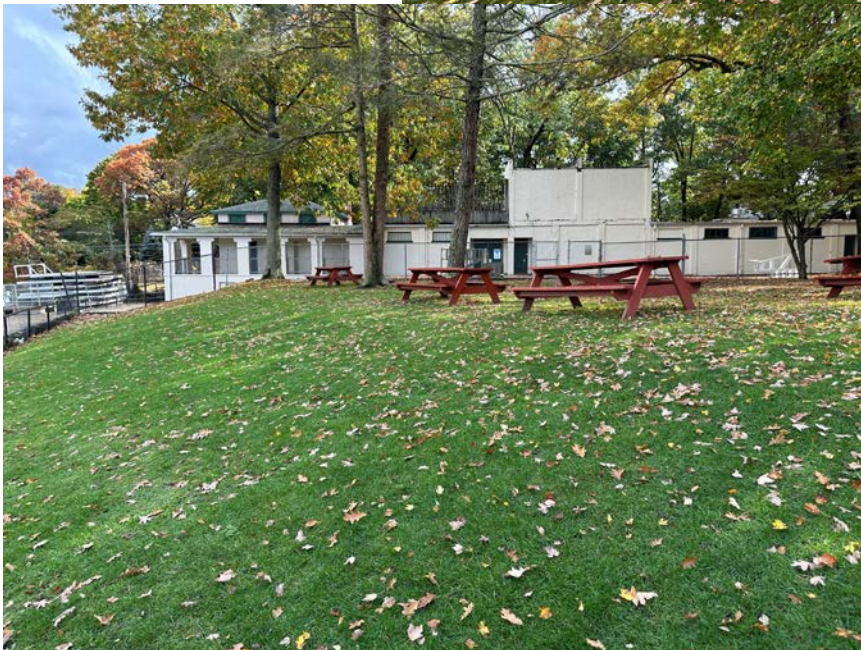
5

- The land slopes down from the Rogers Street sidewalk to the lake, quite steeply just before (on the street side of) the retaining wall. This topography poses significant challenges for accessibility. Some options being considered include a two-level deck along the lakeshore, which would allow non-swimmers to see the lake but still allow collection of fees for swimming.

Mallory 0203, 0178,
0196,

Looking roughly north, sloping
topography from park to retaining
wall

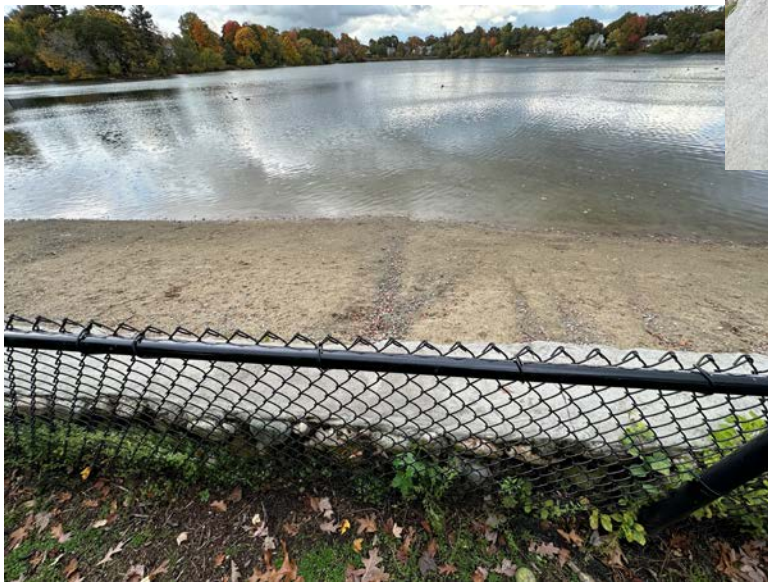
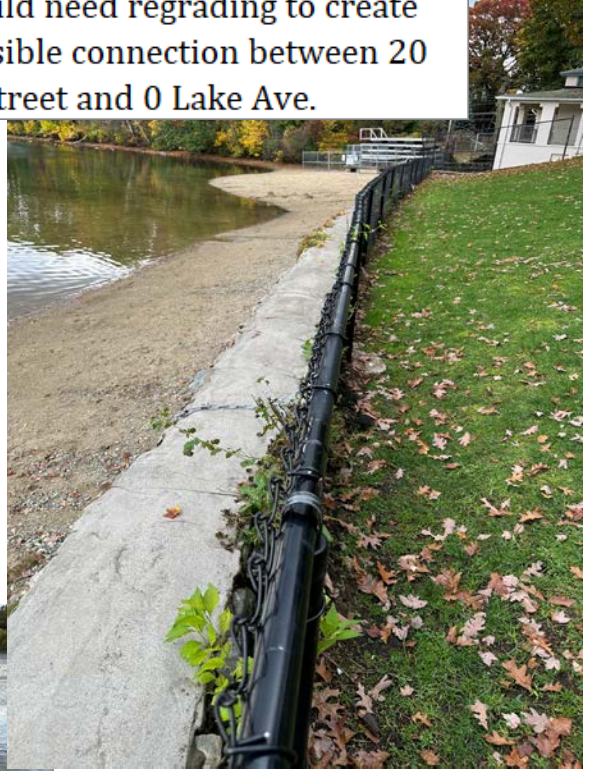
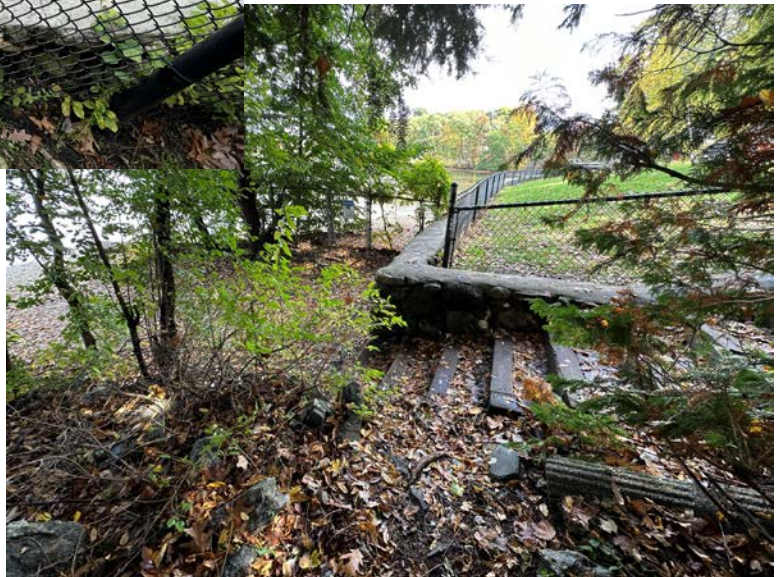
- In 2021, the lake lapped to within a foot or so of the retaining wall along “left beach.” However, during our 2022 site visit the recent and continuing drought had exposed several feet of sand between retaining walls and the waterline, at both 20 Rogers Street and 230 Lake Avenue.

6	Mallory 0182, 0185, 0220	Looking roughly northeast, swimming area and "left beach"
7	Mallory	Looking roughly east, stairs between City beach and 0 Lake Avenue; this area would need regrading to create an accessible connection between 20 Rogers Street and 0 Lake Ave.

- There is some potential for an ADA-compliant connection between 20 Rogers Street and Levingston Cove close to the lakeshore, but this would require both removal of some cedars and regrading along the original boundary between 20 Rogers Street and 230 Lake Avenue.
