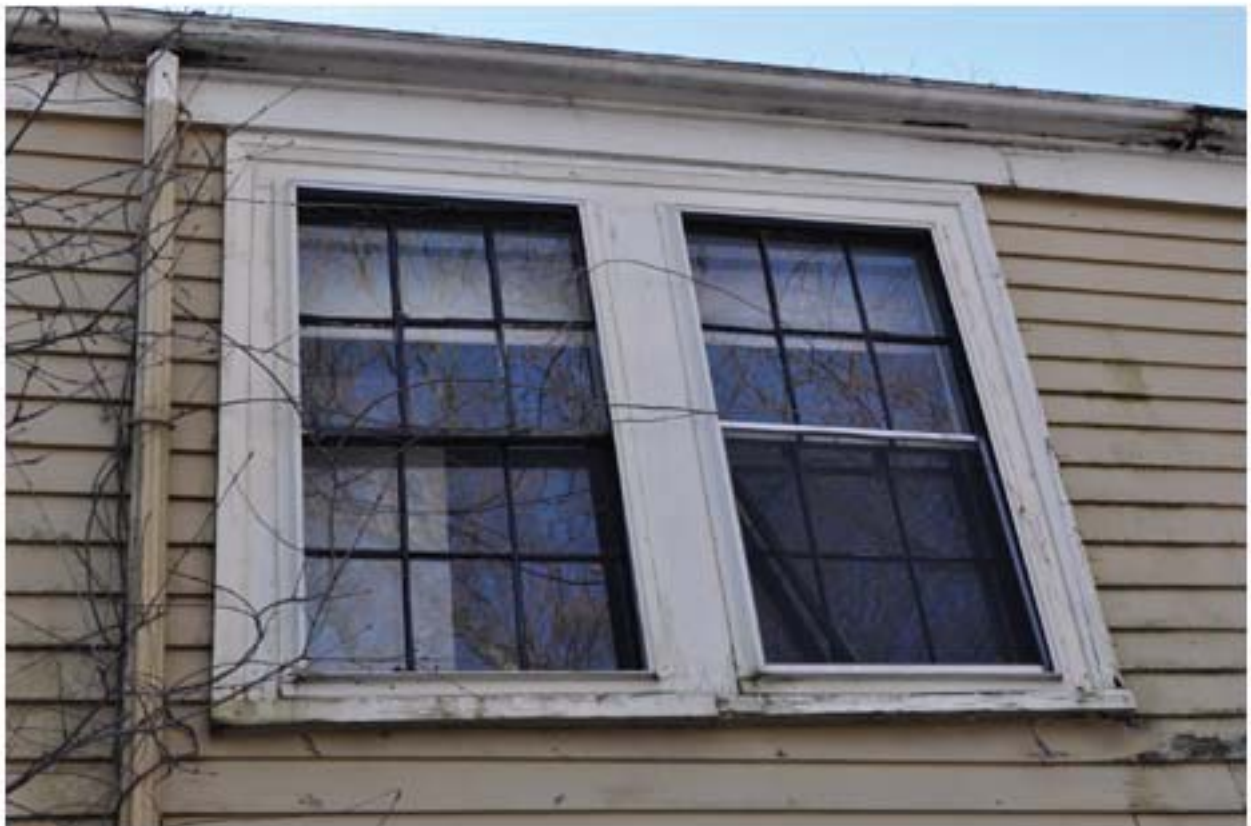
12D- Existing window trim
