Paul Cornell and Associates

**Inspection Report
prepared for:**

**Property Address:
236 Auburn Street
Newton, MA 02466**

Date of Inspection : 8/25/2016	Time Started 08:30 AM	Time Finished 02:00 PM
Property Address : 236 Auburn Street Newton, MA 02466	Report Prepared For : CAN-DO Inc	Report ID : AUG16_236 Auburn

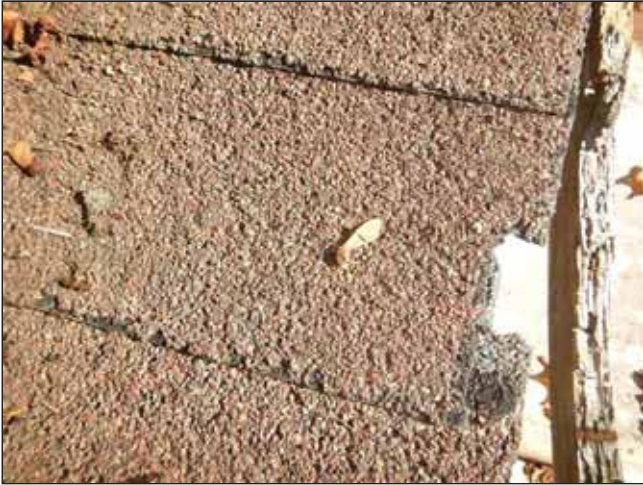
1.1 (Picture 2)

1.1 (1) ROOF COVERING : The roof covering has outlived the useful service life. Immediate replacement is needed. Shingles are dried out, cracked, pitted and are no longer water tight.

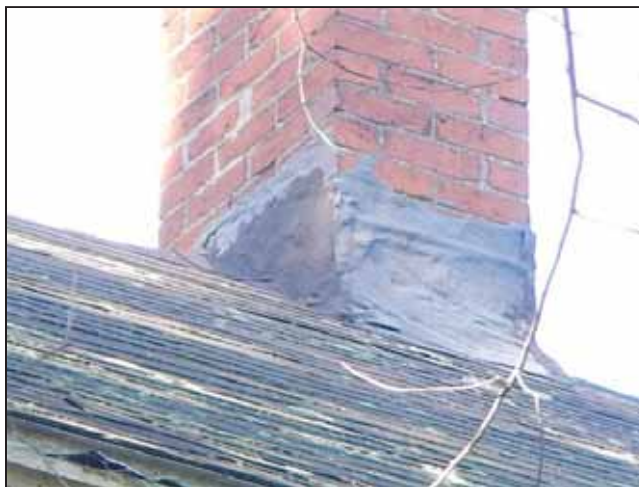
1.2 (Picture 1)

1.2 FLASHINGS : Chimney and plumbing vent flashings have been coated and sealed with roof cement(tar). This would indicate that flashing is damaged or worn and may indicate past leakage issues. This type of repair is temporary at best and must be periodically repeated to perform.

New flashing should be installed.

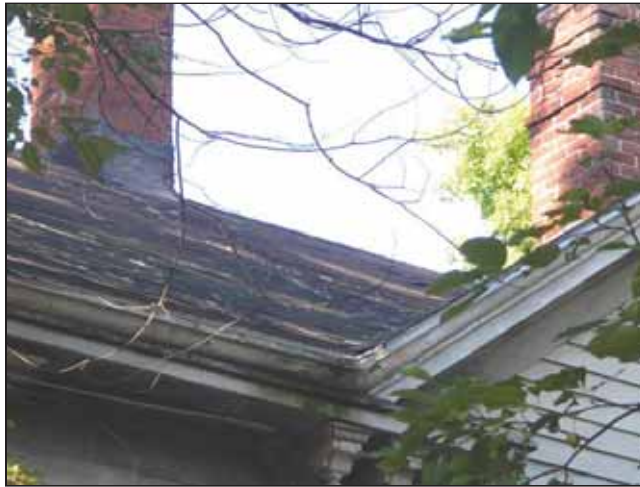
1.3 (Picture 1)

1.3 VALLEYS : Shingles in the right rear valley are cracked. This can contribute to leakage issues. Signs of water penetration in the soffits below the valleys were noted.

Valley systems are difficult to vent and tend to be prone to ice damming issues. Metal flashed valleys are recommended.

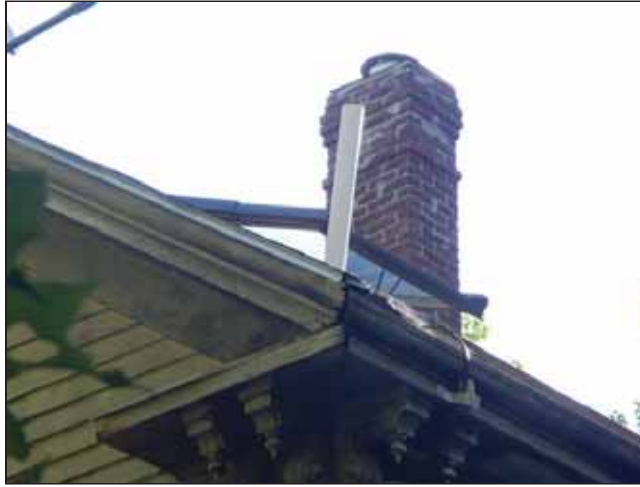
1.5 (Picture 1)

1.5 PLUMBING VENT(S) : The plumbing vents through the right and left rear roof terminate too close to a fresh air inlet. This poses certain health risks and needs immediate correction. Relocating the plumbing vents is recommended. A licensed plumber should be consulted.

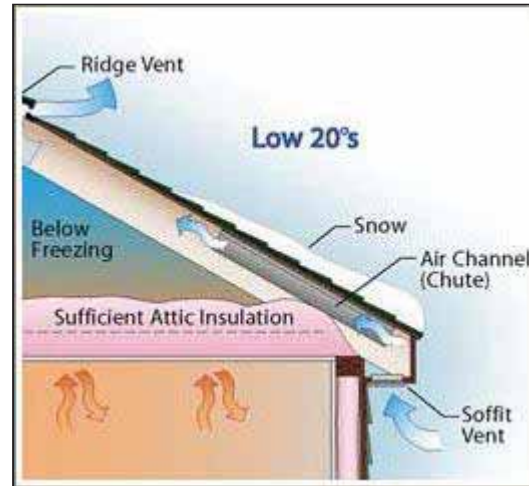
1.7 (Picture 1)

1.7 VENTILATION : Limited roof ventilation will contribute to ice damming and condensation problems during winter months, and excessive heat build up during warmer months. These conditions can considerably shorten the serviceable life of the roof cover as well as contribute to mold and decay issues. Continuous soffit and ridge venting is recommended. Signs of water penetration from ice damming issues were noted.

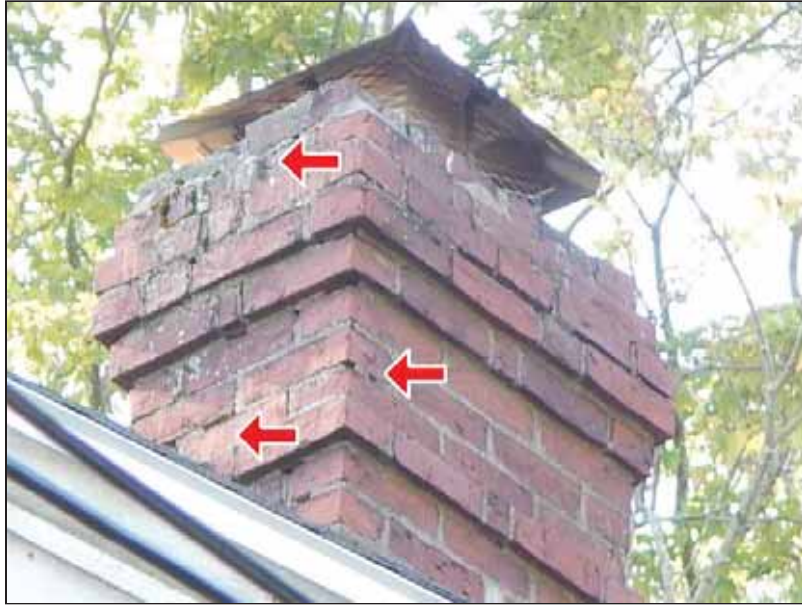
2.0 (Picture 2)

2.0 EXTERIOR SIDEWALLS : Masonry sidewalls of all three chimneys have deteriorated mortar joints and show signs of deep rooted water damage. Extensive repair and partial rebuilding is needed. A qualified masonry contractor should be consulted for needed repairs. Once needed repairs are completed sidewalls should be coated with water repellent to resist related damages.

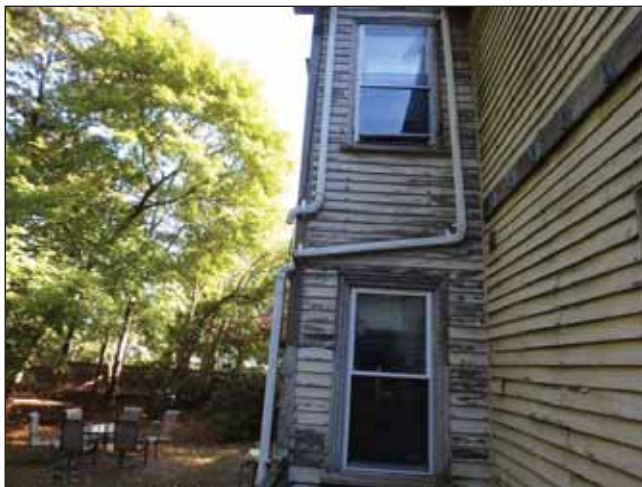
3.0 (Picture 1)

3.0 (1) SIDING : Siding needs to be painted. Siding at many points is loose and needs to be replaced.

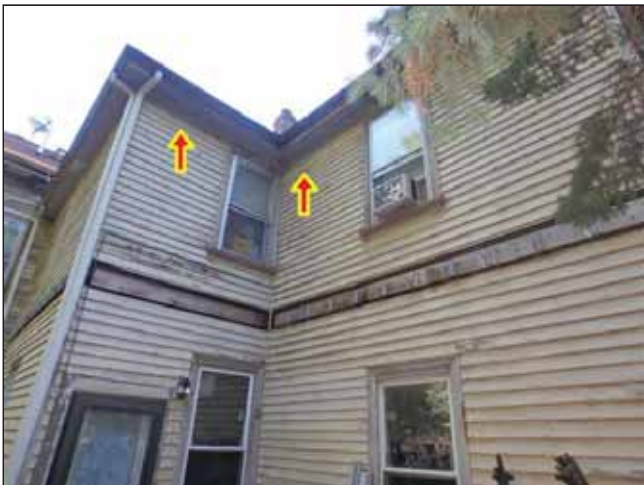
3.0 (Picture 6)

3.0 (2) Siding at many points around the exterior of the house shows signs of water penetration due to rotted and damaged soffits and rotted gutters.

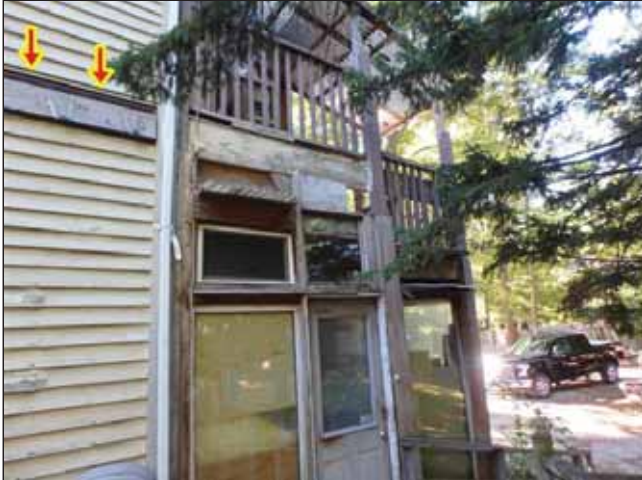
3.0 (Picture 8)

3.0 (4) Ledgers were installed in the 2nd floor left and left rear walls of the house for a deck. The deck was never constructed. The ledgers are not water tight as flashing was not installed and siding is incomplete.

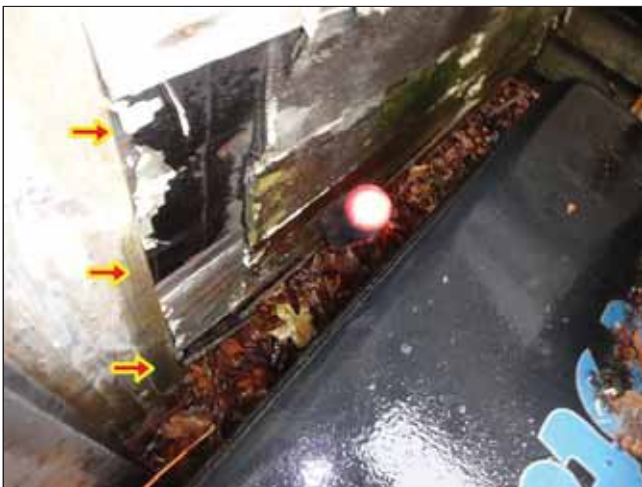
3.0 (Picture 10)

3.0 (5) Siding in contact with the right side deck is water damaged and is rotted. Damage in this area extends into framing behind. The extent of damage and need for repairs could not be fully evaluated due to clutter, storage and no access. Further investigation is needed. Storage and siding needs to be removed to allow for evaluation of damage and need for repairs.

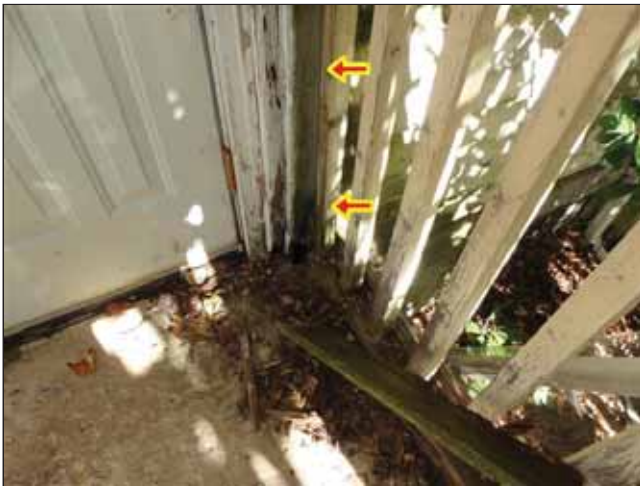
3.3 (Picture 1)

3.3 (2) Trim at the left rear inside corner, by the left side entry, is water damaged, rotted and need to be replaced. Damage and decay at this point extends into the exterior wall of the house. The extent of damage is unknown. Further investigation and repair is needed.

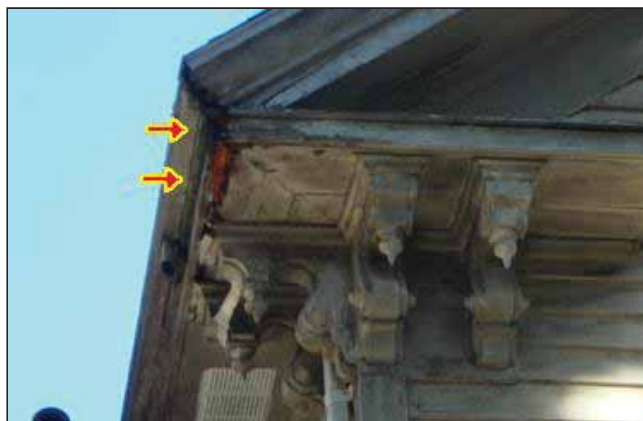
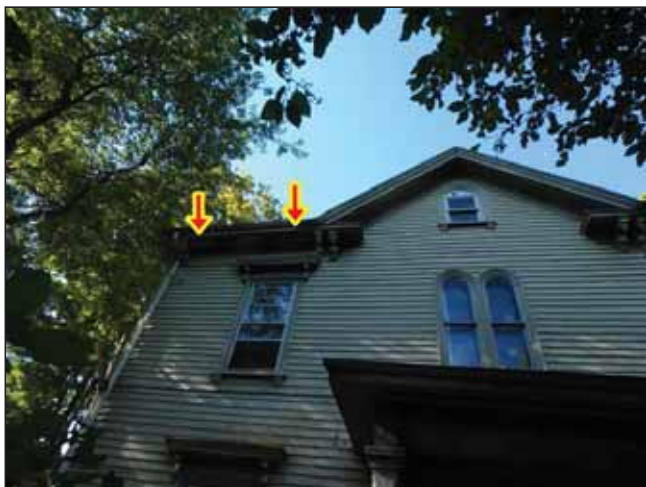
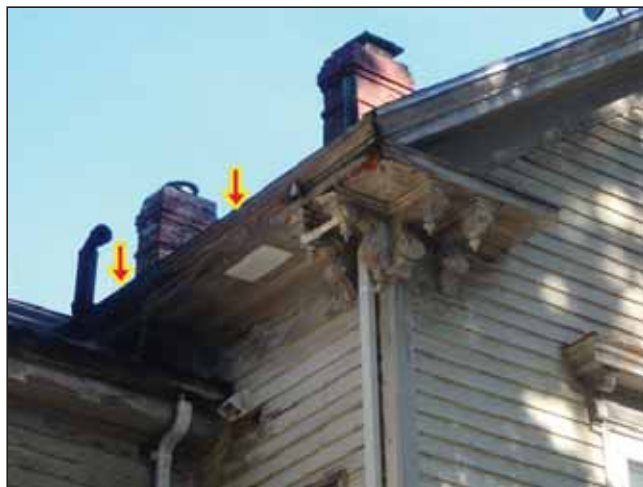
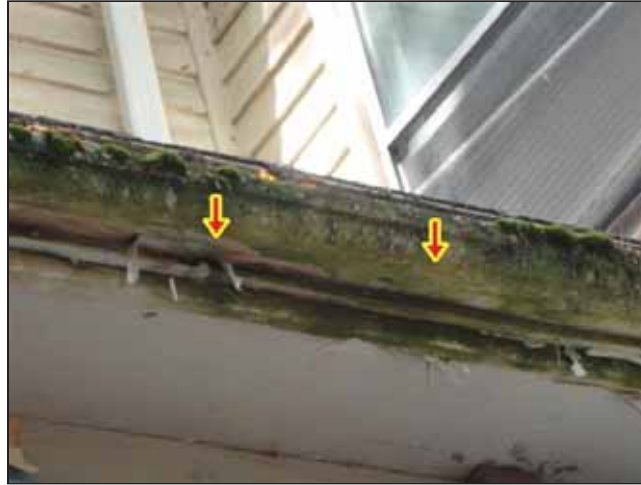
3.4 (1) FASCIAS AND SOFFITS : Soffits and fascias around most of the house show signs of water penetration due to rotted and decayed gutters, are water damaged, need significant restoration.

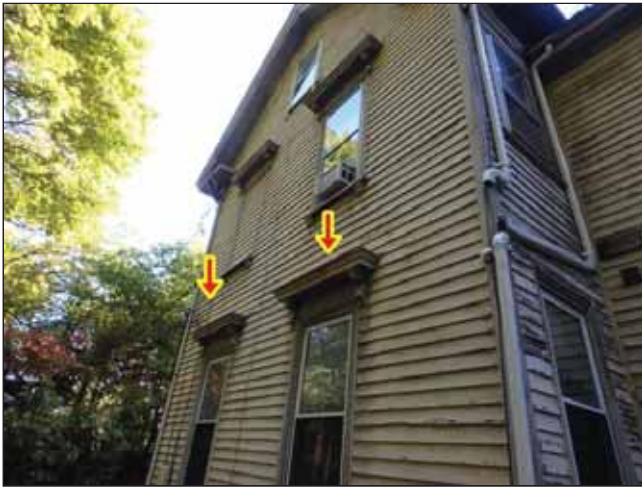
3.5 (Picture 2)

3.5 (2) Flashing on trim on the tops of the windows is rusted, damaged and needs restoration.

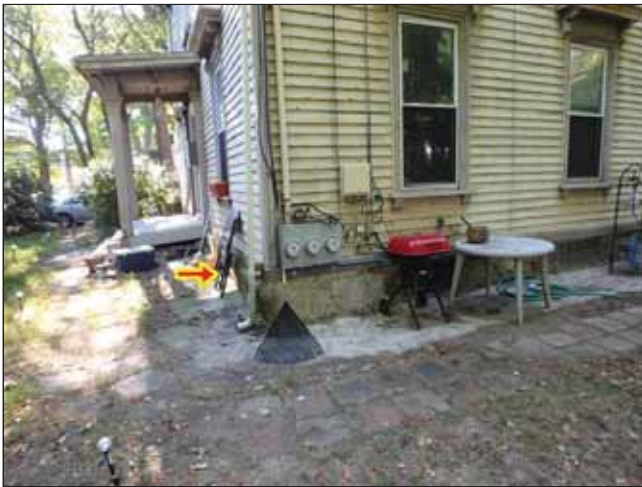
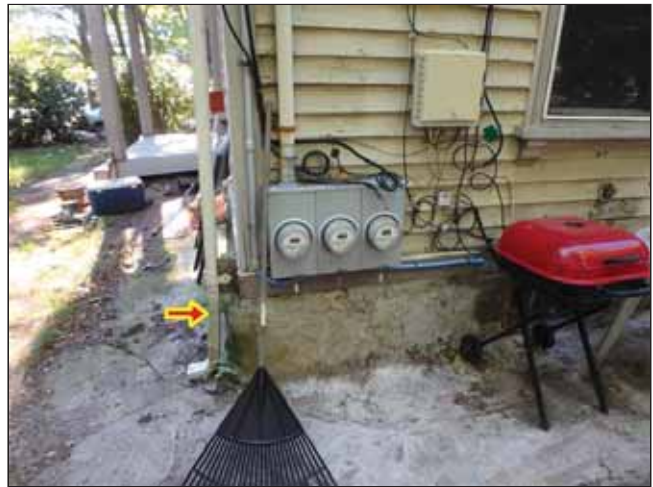
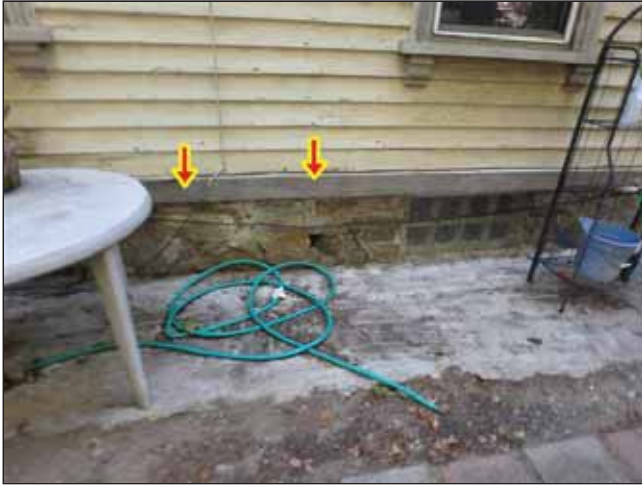
3.6 FOUNDATION WALLS : The front and right side foundation walls show noticeable and unusual signs of distortion. The foundation wall projects past siding. This appears to be a result of structural movement. The rear foundation wall also shows unusual signs of distortion, as well. The interior of the basement area was completely cluttered with storage. Foundation walls were not accessible or visible on the interior of the house as a result. Further investigation is needed. A structural engineer should be consulted for further evaluation, **prior to commitment**.

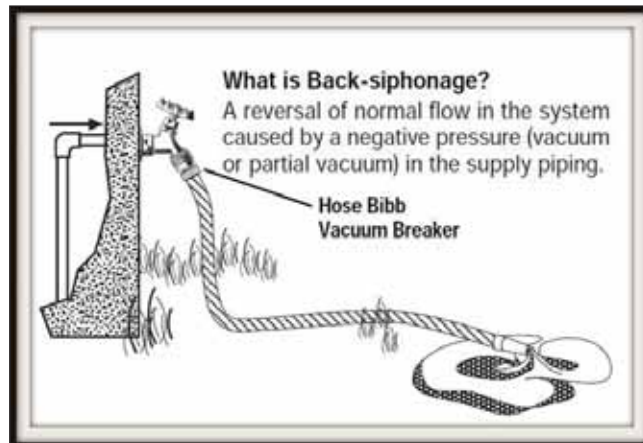
3.9 (Picture 1)

3.9 EXTERIOR FAUCET(S) : Exterior faucets should be fitted with vacuum breakers / anti-siphon devices to prevent potential cross connections and contamination of the potable water supply system. The installation of modern frost free faucets, with integral back flow preventers, is recommended.

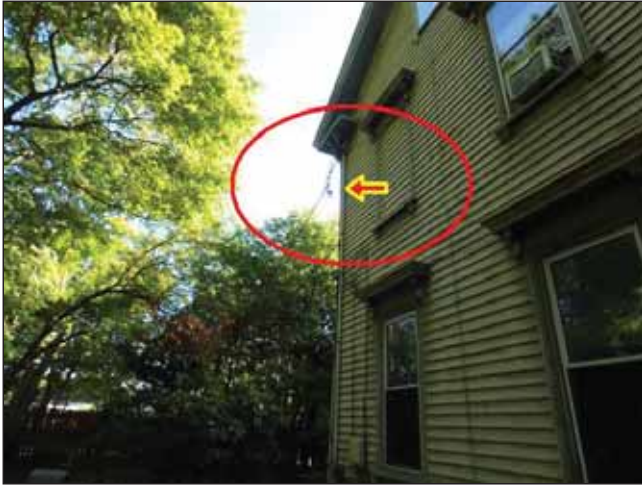
3.10 (Picture 1)

3.10 SERVICE DROP AND ELECTRIC ENTRY CABLES : The cleat attaching the electric service drop to house is not secured and poses a safety hazard as cables are not supported. Immediate repair is needed. The local electric service provider should be consulted for repair.

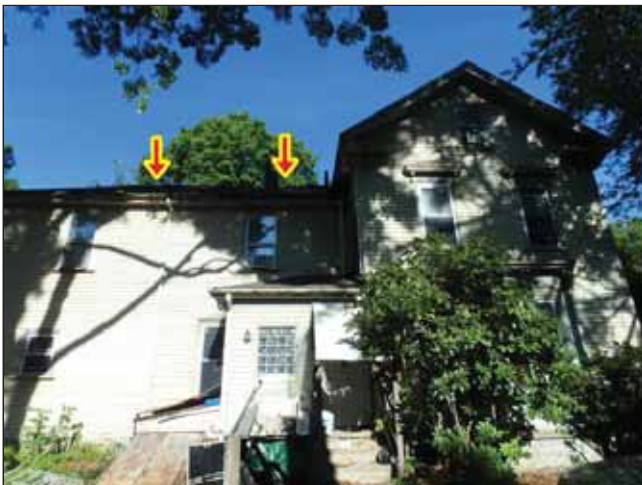
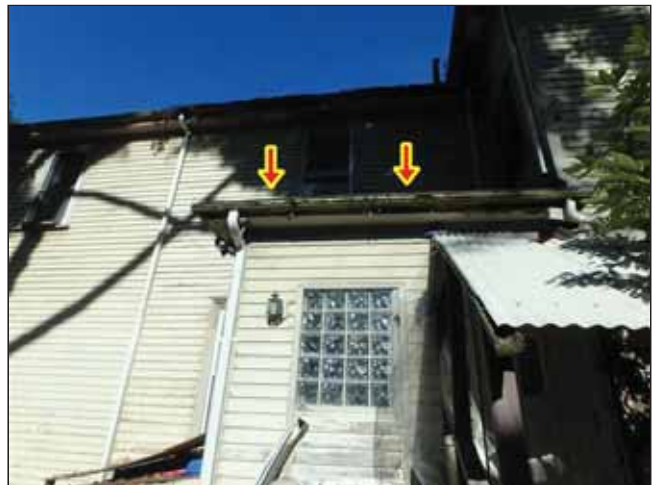
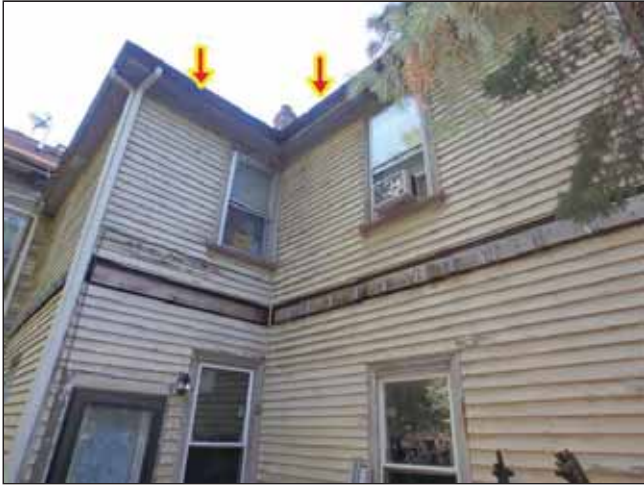
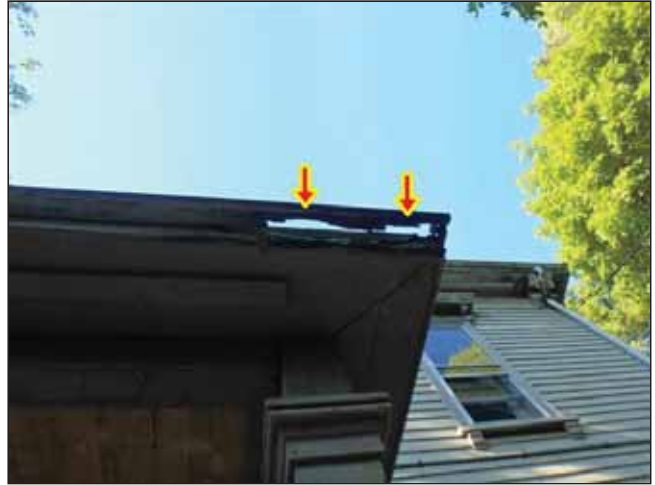
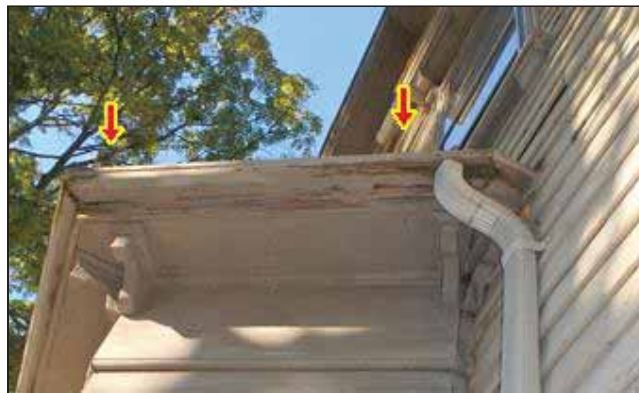
4.0 GUTTERS : Wooden gutters are completely rotted, damaged are leaking and need to be replaced. Rotted gutters are allowing for water penetration into the soffits sidewalls below and is contributing to decay and related issues. Replacement with seamless aluminum gutters is recommended.

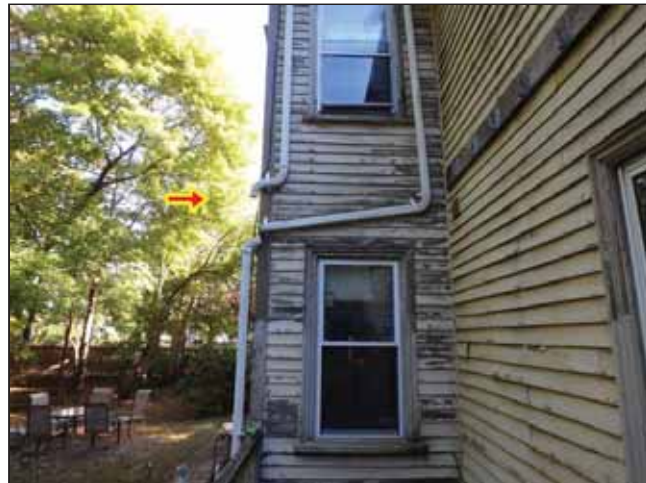
4.1 (Picture 1)

4.1 DOWNSPOUTS : Downspouts around most of the house are disconnected, damaged, missing and are ineffective. They need to be repaired, reconnected or replaced, as needed.

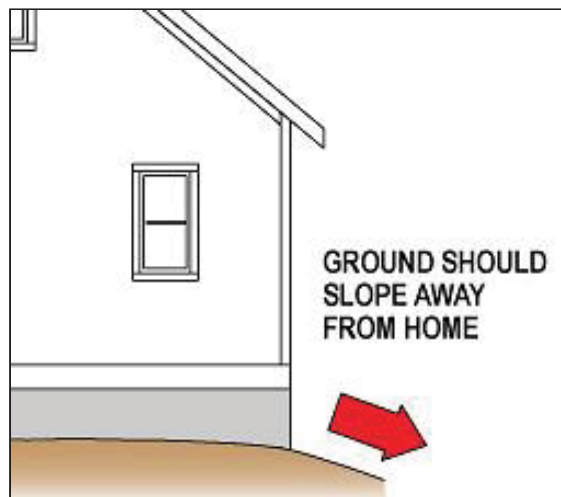
4.4 (Picture 1)

4.4 FOUNDATION GRADING :

For proper drainage, grading against the foundation, needs to slope away for a minimum of 1" per foot for at least 5 feet wherever possible. Negative grading that slopes and directs water into the foundation can contribute to basement dampness and water issues.

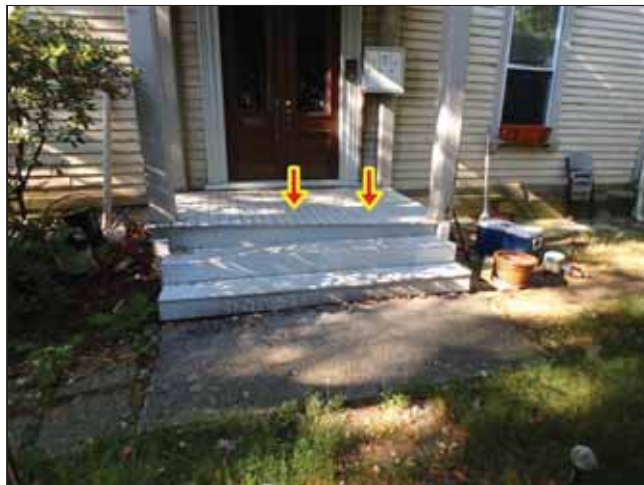
4.6 (Picture 1)

4.6 (1) STAIRS AND LANDINGS : The front entry steps are poorly constructed, are not level, have inconsistent rise are unsafe and need to be rebuilt.

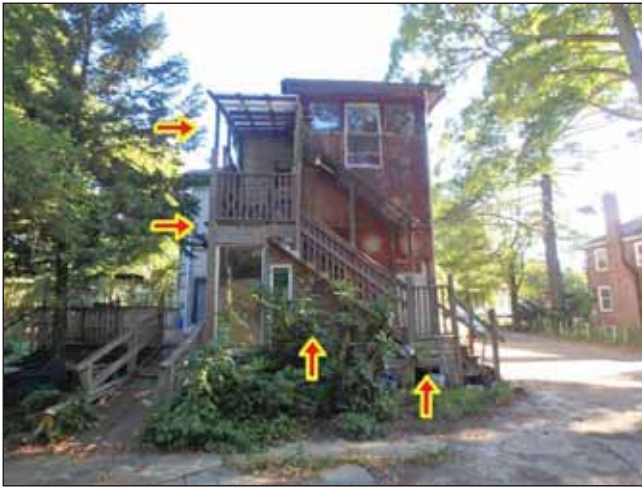
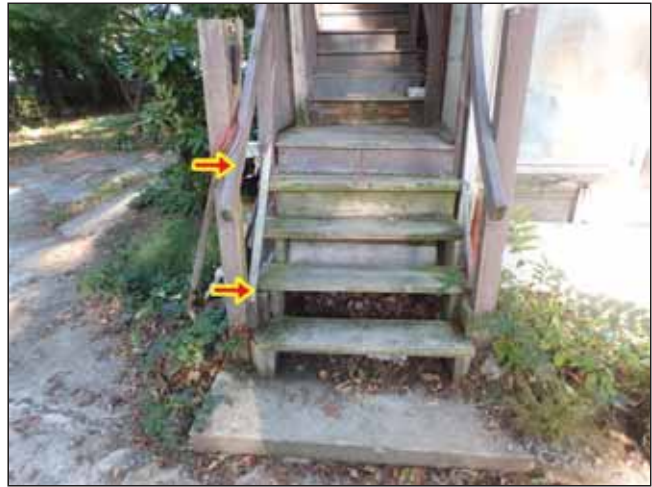
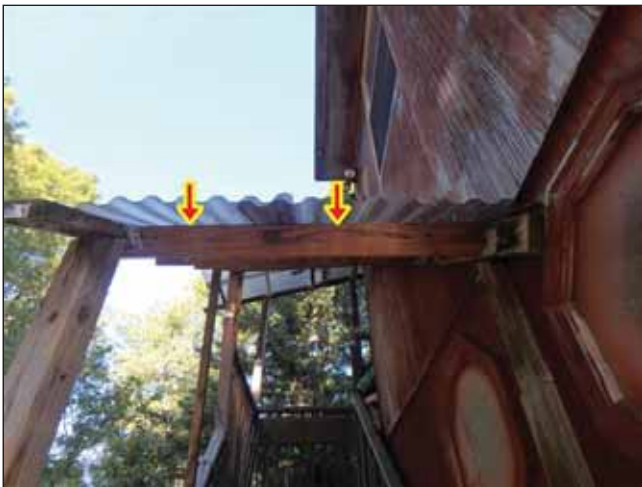
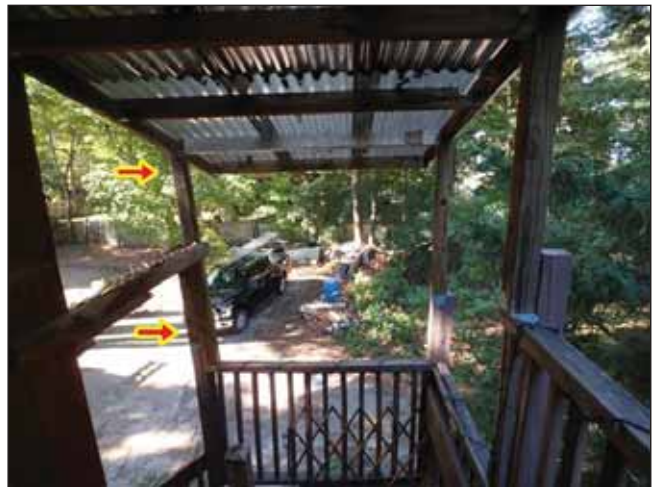
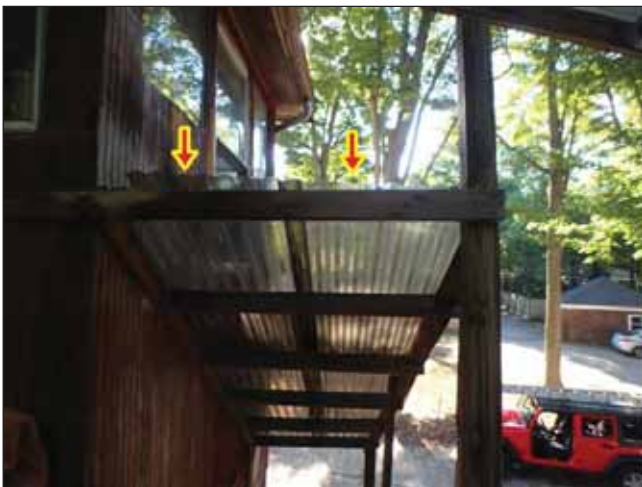
4.6 (2) The rear entry stairway and roof were poorly constructed, were not maintained, have rotted supports, damaged treads, loose and damaged railings are completely unsafe for use. This stairway and entire structure need to be torn off the house and completely rebuilt at once.

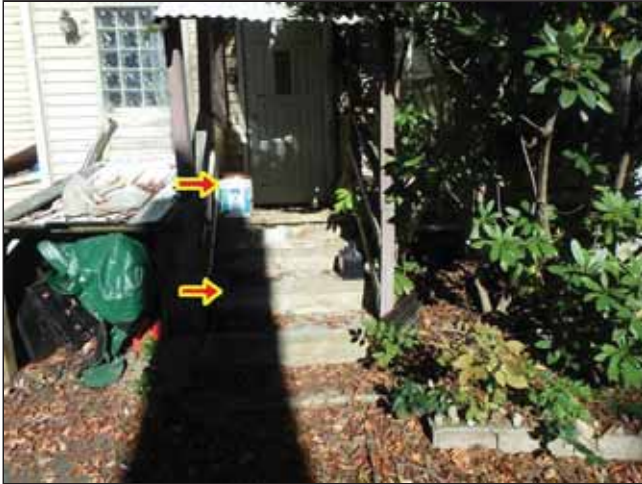
4.6 (Picture 8)

4.6 (3) The left side entry steps have inconsistent rise, are cracked, damaged and are unsafe Steps vary in height throughout the stairway. This is a trip hazard. Rebuilding is needed.

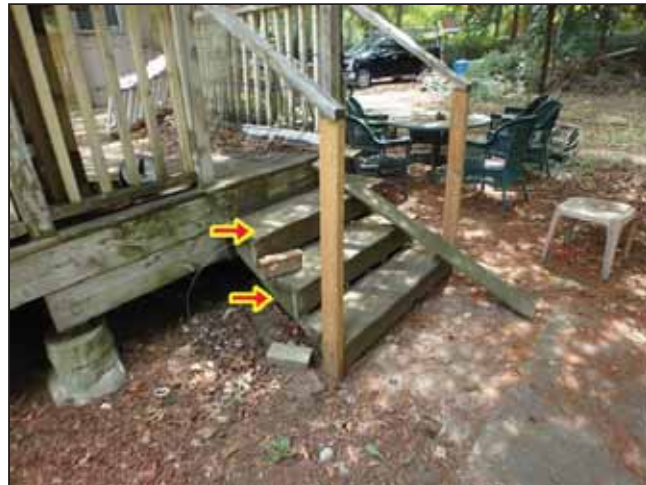
4.6 (Picture 10)

4.6 (4) Right side deck steps are decayed, damaged, are unsafe and need to be rebuilt.

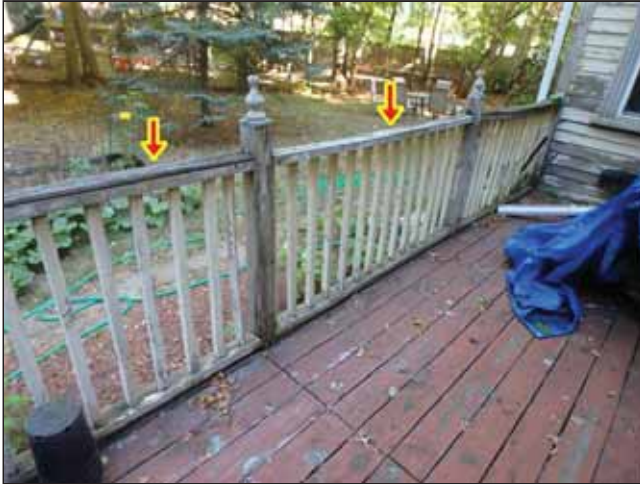
4.7 (Picture 1)

4.7 RAILINGS : Railings along the right side deck are rotted, damaged, are weak, are loose and are unsafe. They need to be completely rebuilt, at once.

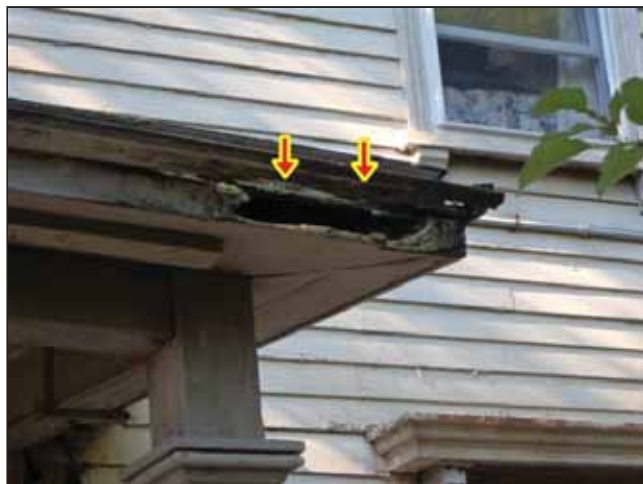
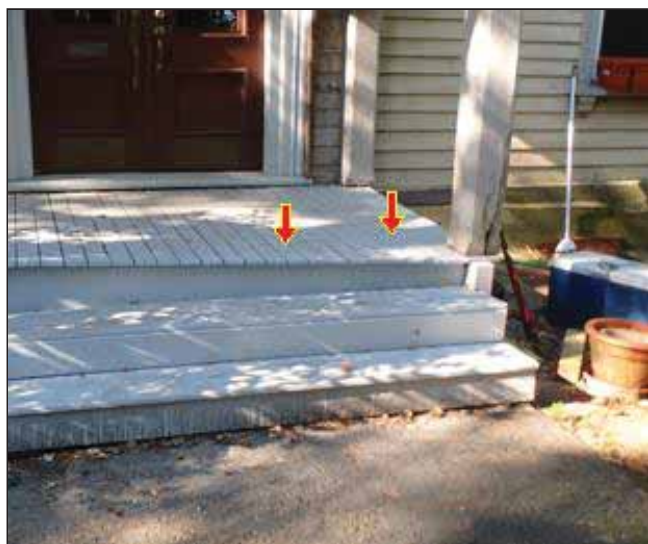
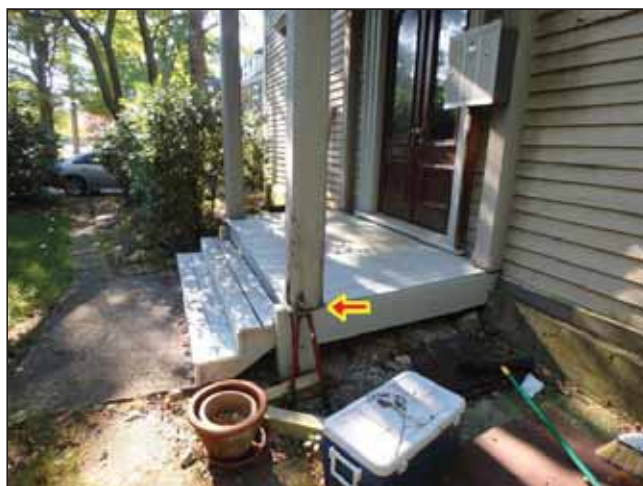
4.9 PORCH : The front entry porch is rotted, is collapsing, is unsafe, poses significant risk for personal injury and needs to be torn down and rebuilt.

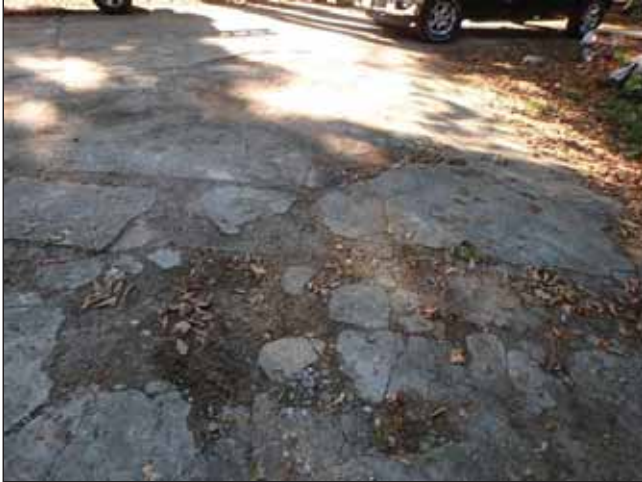
4.10 (Picture 1)

4.10 DRIVEWAY(S) : The driveway has settled, is cracked, heaved and is breaking apart. This will make snow removal difficult and poses tripping hazards. Replacement is needed.

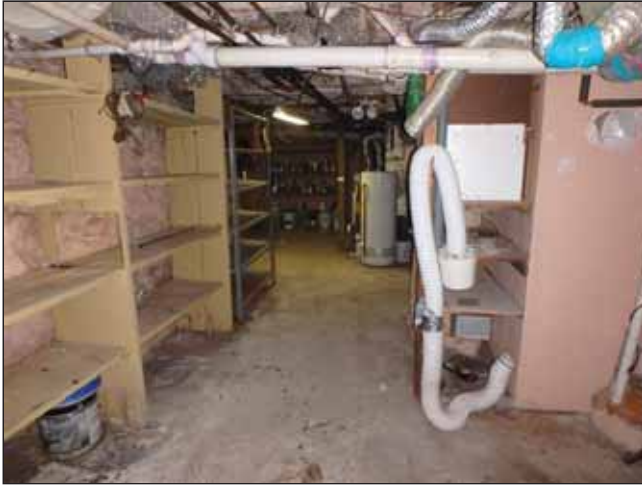
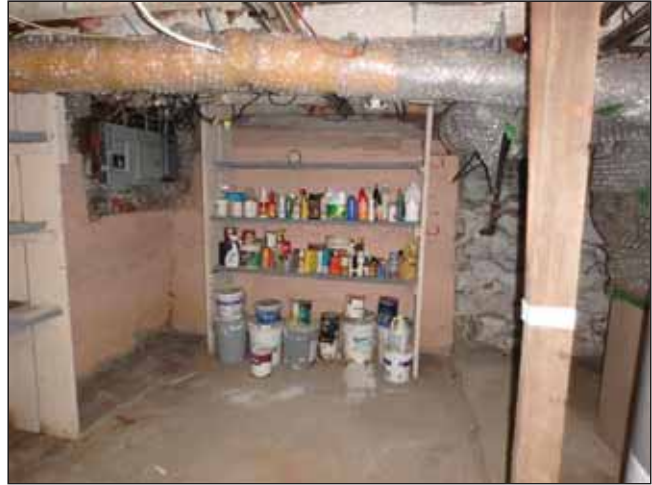
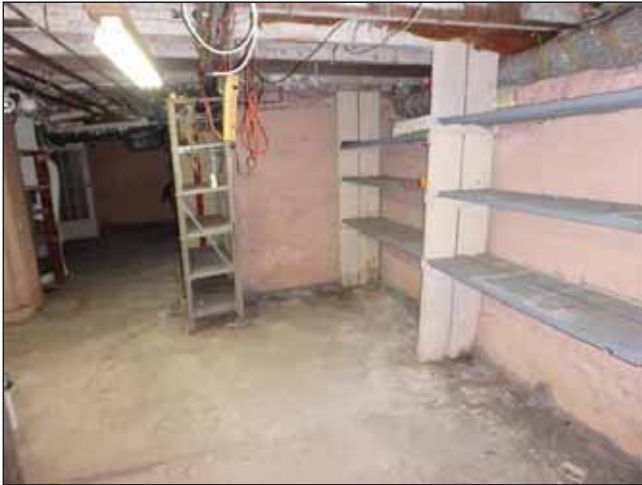
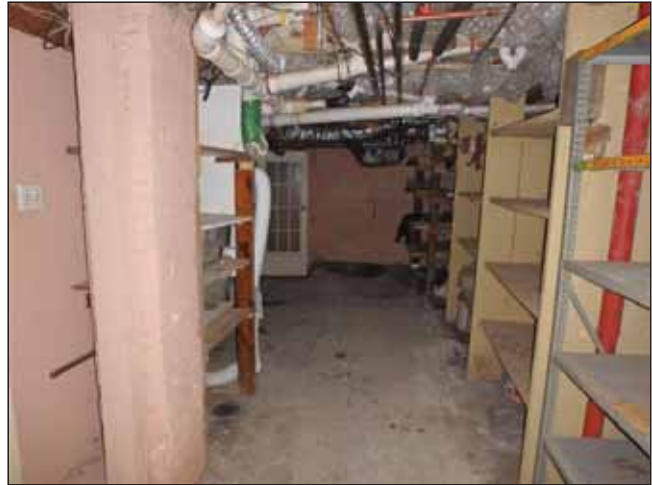
6.0 (3) RE-INSPECTION 09-06-16 : The basement was partially cleaned out.

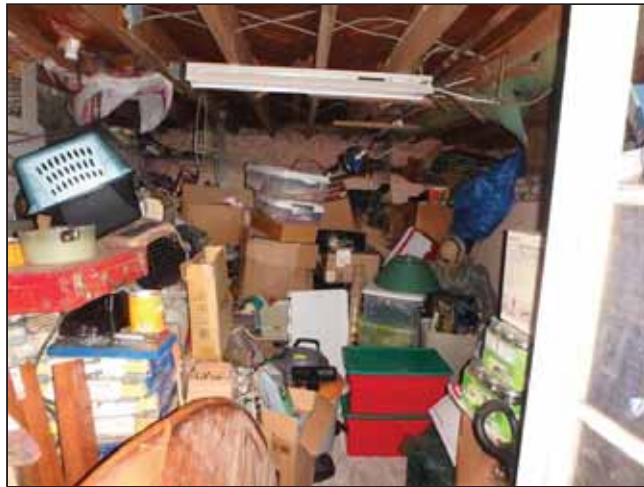
6.0 (Picture 5)

6.0 (4) RE-INSPECTION 09-06-16 : The rear portion of the basement was still filled cluttered with storage and was not accessible for inspection.

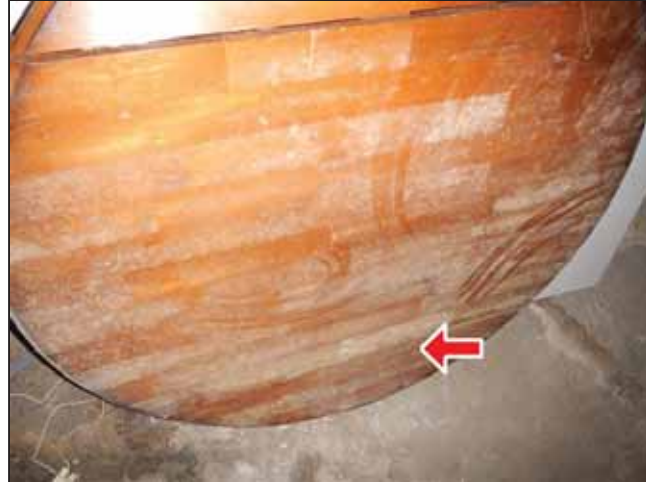
6.3 (Picture 1)

6.3 (1) FINISHED WALLS AND CEILINGS : Microbial growth was noted on the finished wall board. This can pose certain health hazards. An air quality specialist should be consulted at once.

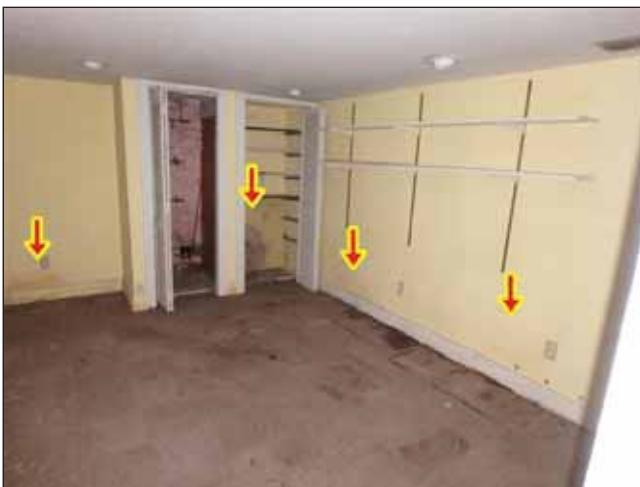
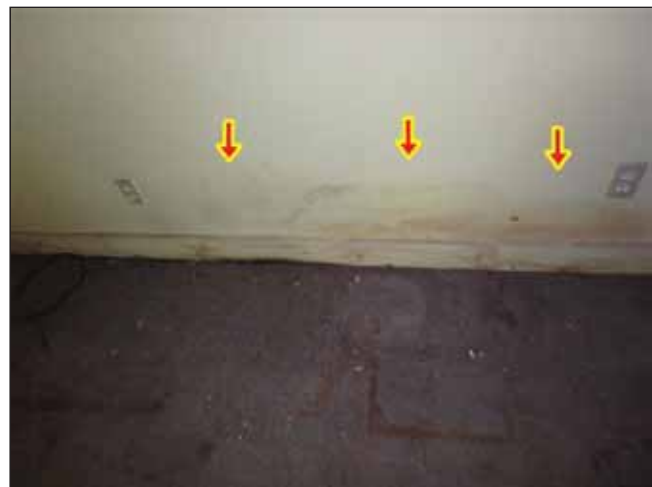
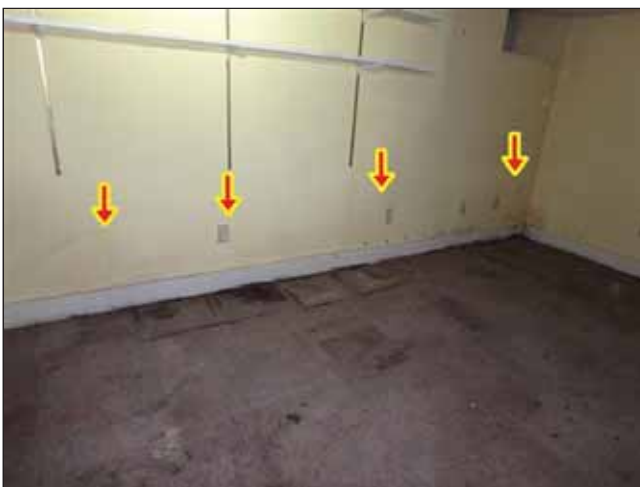
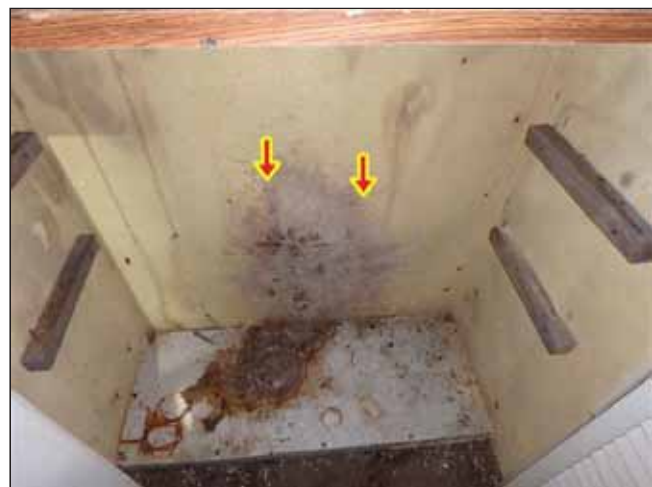
6.3 (2) RE-INSPECTION 09-06-16 : There is visible mold growth on finished walls in the front portion of the basement.

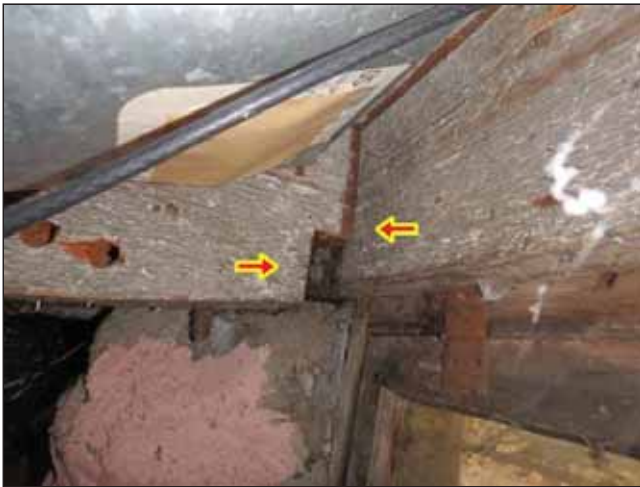
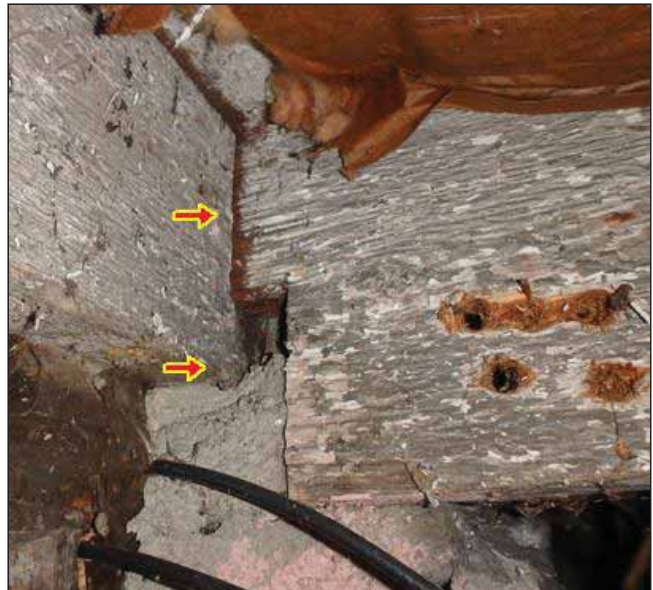
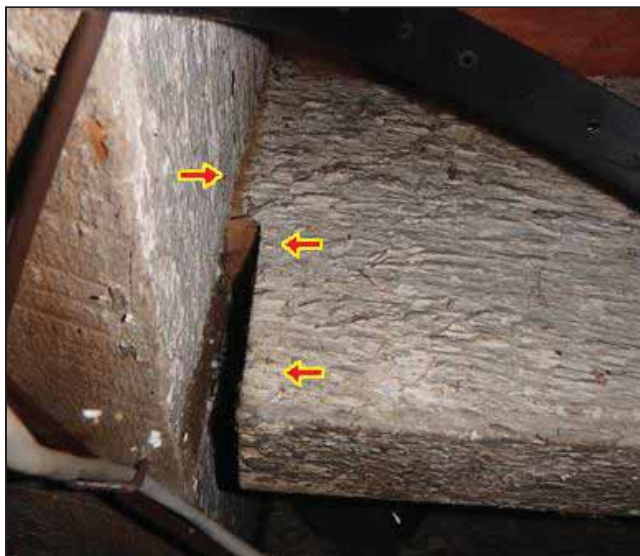
6.6 (2) Visible floor joists along the right side of the main cellar show signs of separation from the sill. This appears to be the result of foundation movement. Movement appears to be ongoing. Further investigation by a structural engineer is needed.

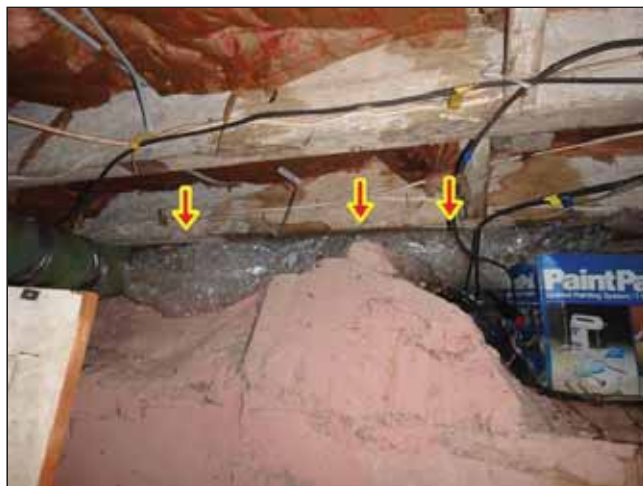
6.6 (Picture 5)

6.6 (3) RE-INSPECTION 09-06-16 : The accessible sill, above the basement window, at the rear of the main basement is water damaged, is rotted and needs to be replaced. The extent of damage could not be fully evaluated due to limited access.

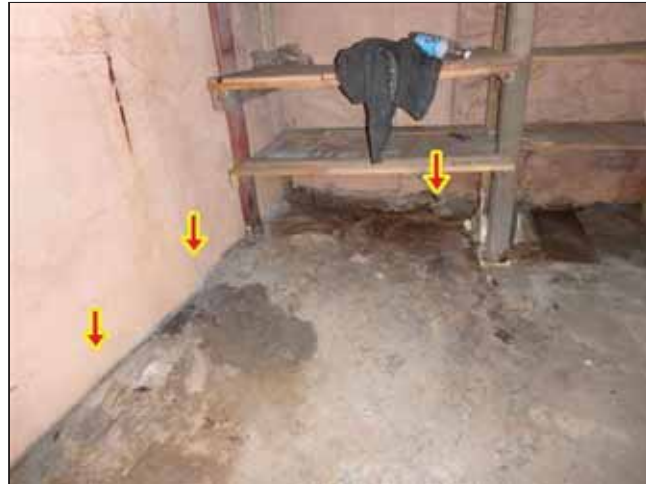
6.10 (Picture 1)

The cellar showed signs of historic and ongoing water entry. Water stains were noted on finished walls. The owners should be questioned as to any history of past issues.

Exterior conditions as noted on the drainage section of the report appear to be a contributing factor to water issues and should be addressed.

The use of a whole house dehumidifier is recommended to help control moisture.

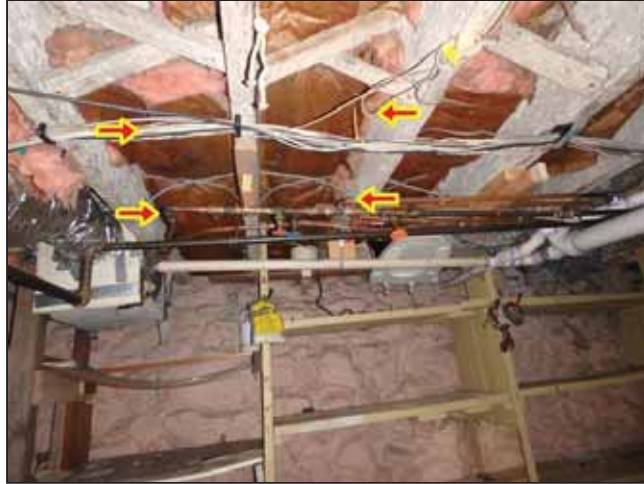
6.11 (Picture 1)

6.11 (2) Sub floor insulation throughout the basement is improperly installed. Insulation is upside down. This will trap moisture between living area and vapor barrier. The exposed paper backing is also flammable and must not be left exposed. Correction is needed. Existing insulation should be removed and replaced.

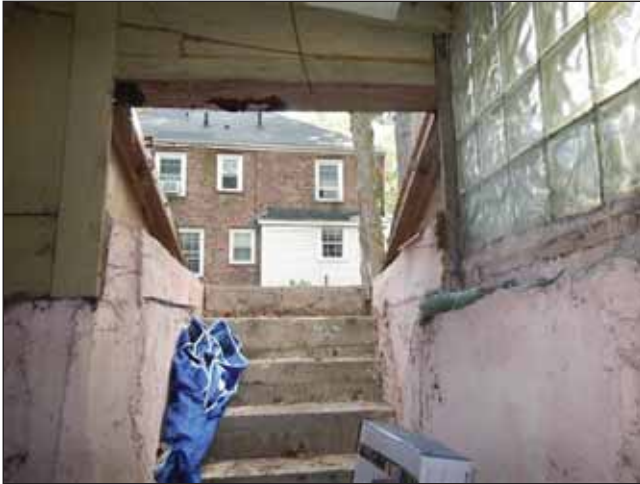
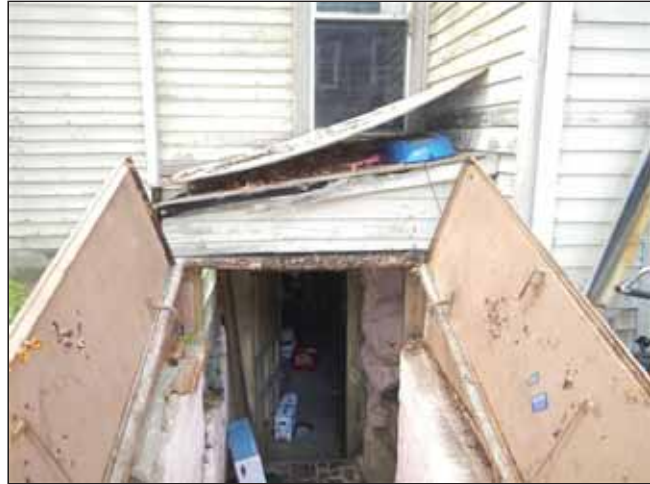
6.12 (2) The bulkhead lid is rotted and needs to be replaced. The structure is deteriorated. It needs to be rebuilt.

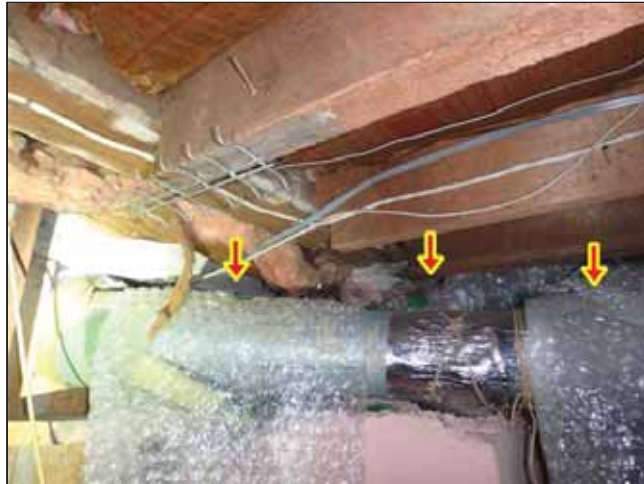
7.11 (Picture 1)

7.11 (1) EXPOSED DUCT WORK: The ducts are not properly insulated. The bubble wrap should be removed and replaced with proper duct insulation.

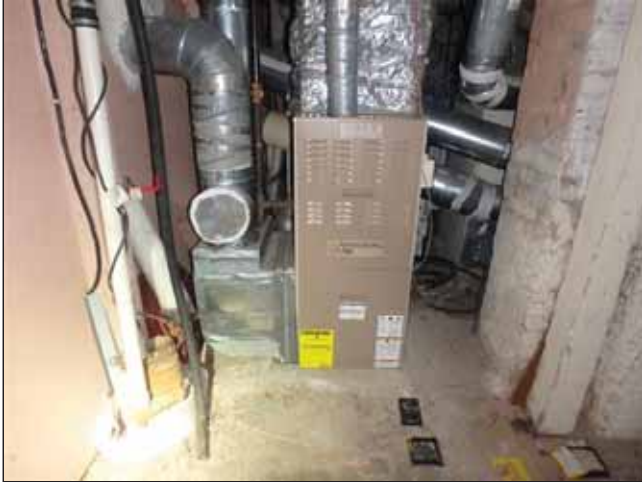
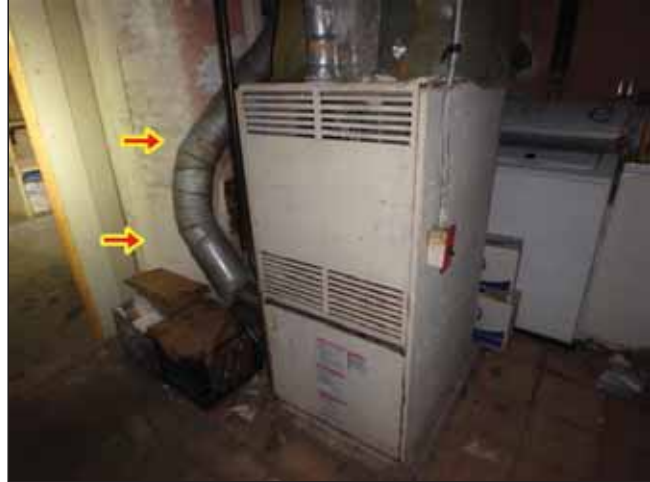
7.11 (3) RE-INSPECTION 09-06-16 : Ductwork installation is sloppy and less than professional. Ducts are not properly sized, supported or sealed. This will allow for air leakage and can affect heating of the units. Repairs are needed.
