Paul Cornell and Associates

**Inspection Report
prepared for:**

**Property Address:
236 Auburn Street
Newton, MA 02466**

Date of Inspection : 8/25/2016	Time Started 08:30 AM	Time Finished 02:00 PM
Property Address : 236 Auburn Street Newton, MA 02466	Report Prepared For : CAN-DO Inc	Report ID : AUG16_236 Auburn

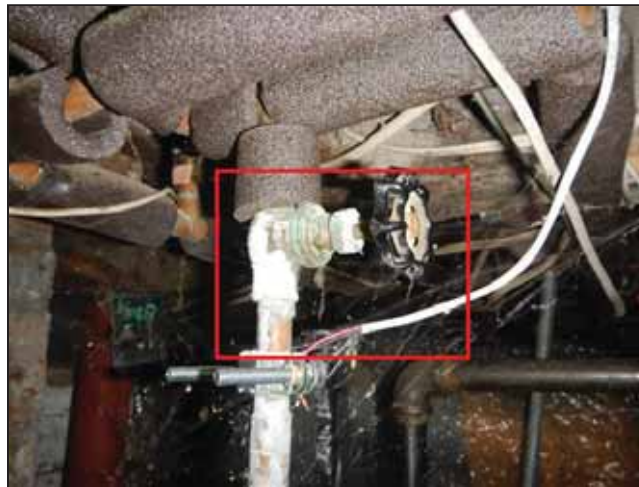
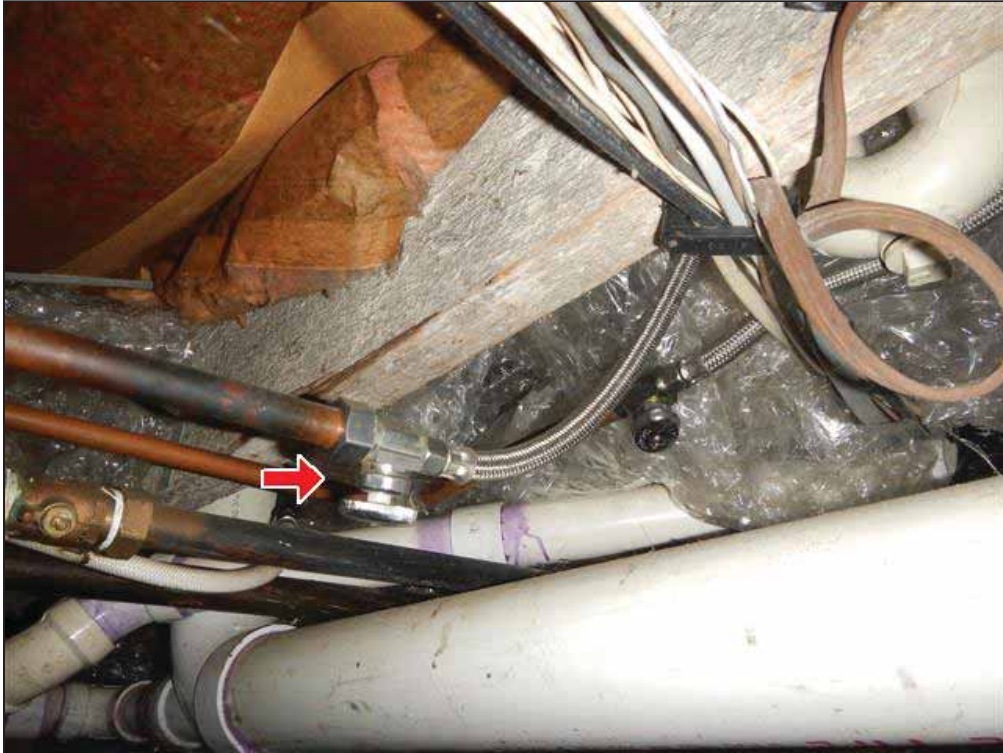
8.0 (1) VISIBLE SUPPLY PIPES : Corroded valves need to be replaced. Much of the supply plumbing installation appears non-professional.

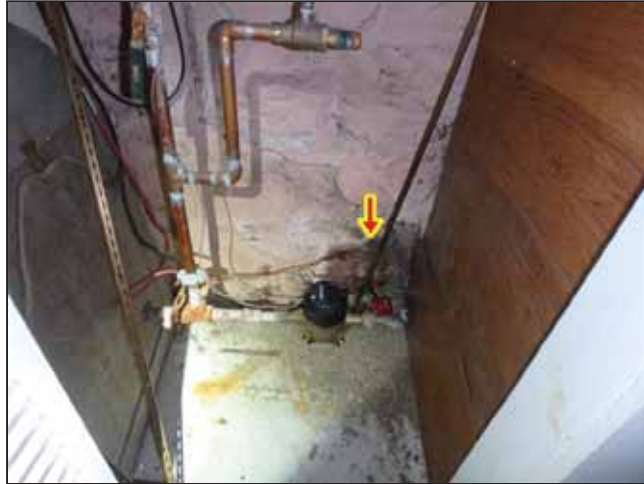
8.0 (Picture 4)

8.0 (2) RE-INSPECTION 09-06-16 : The main water line in from the street is iron. Iron water lines have a tendency to rust internally, reducing water pressure and restricting water volume. Replacement should be expected. Replacement of the water line to the street is typically at the expense of the home owner. The local water department should be consulted.

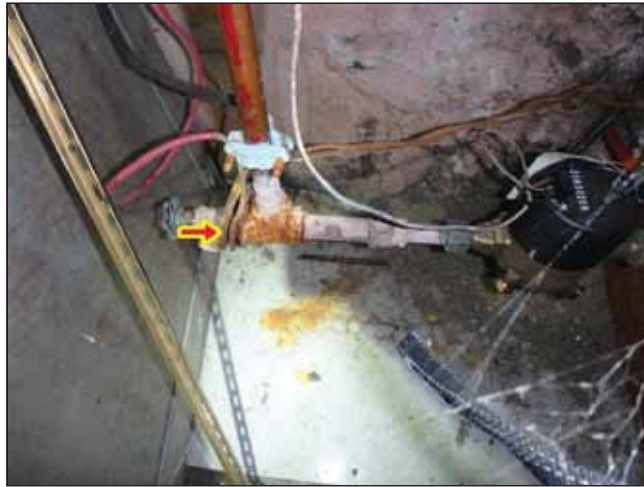
8.0 (Picture 5)

8.0 (3) RE-INSPECTION 09-06-16 : The galvanized pipe fitting after the water meter is corroded, is leaking and needs to be replaced.

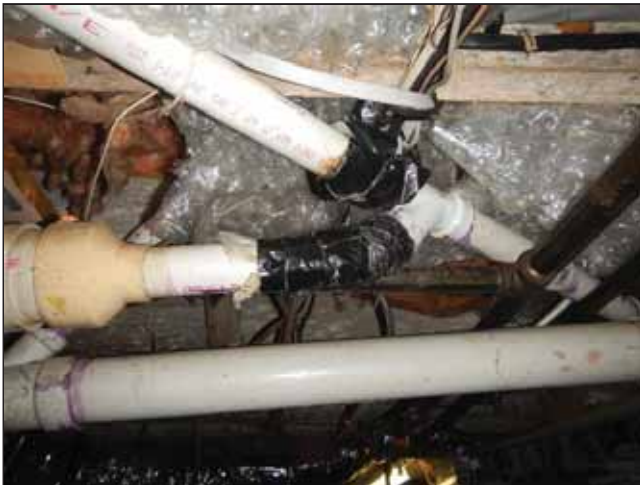
8.1 (Picture 2)

8.1 VISIBLE WASTE AND VENT PIPES : Visible waste plumbing throughout the house is non professional and is improperly configured, is not properly trapped or vented. Several sections of waste pipes in the basement are actively leaking and have been covered in tape. This can pose certain health hazards. Complete re-plumbing of all waste piping is needed.

A licensed plumber should be consulted for further evaluation and extensive replacement.

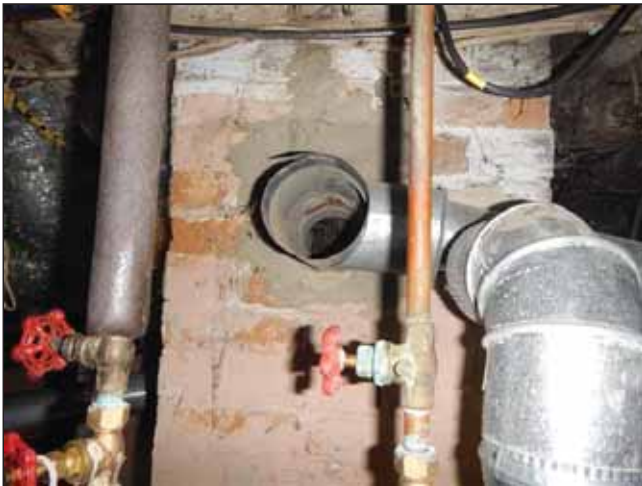
9.6 (Picture 2)

9.6 (2) The flue pipes are not secured at each section and are improperly pitched. Current standards require no less than three screws per section to prevent accidental dislodgement. Immediate correction is needed.

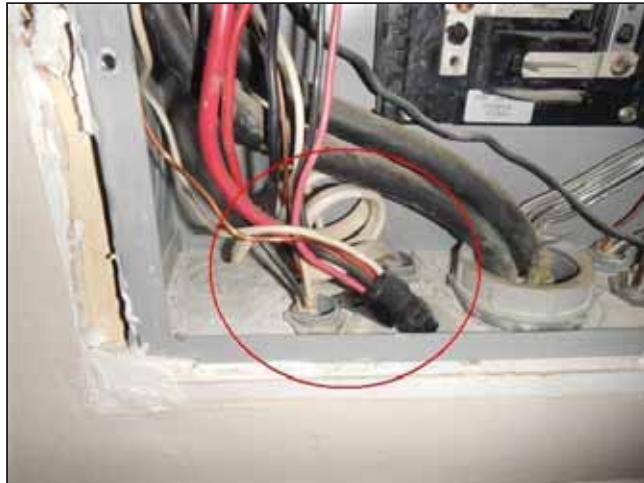
10.2.B (Picture 2)

10.2.B (2) There is a wire nut where two different sized wires are joined. It is unclear what circuit this services. Further investigation is needed as hazards may exist. wire nut

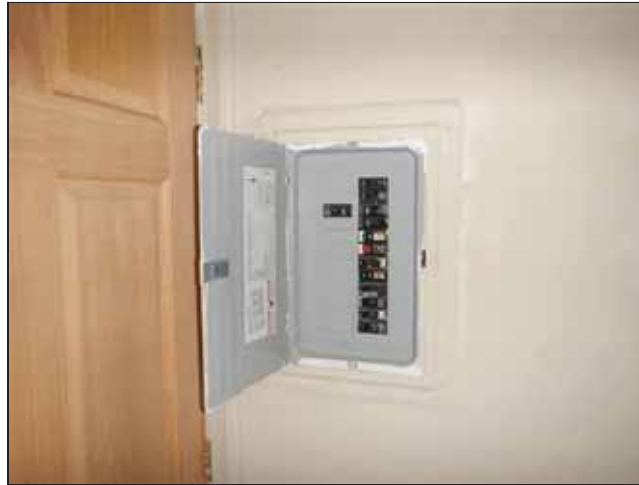
The cover of the panel is obstructed by a finished wall and is not safely or readily accessible without doing damage. Unseen conditions may exist.

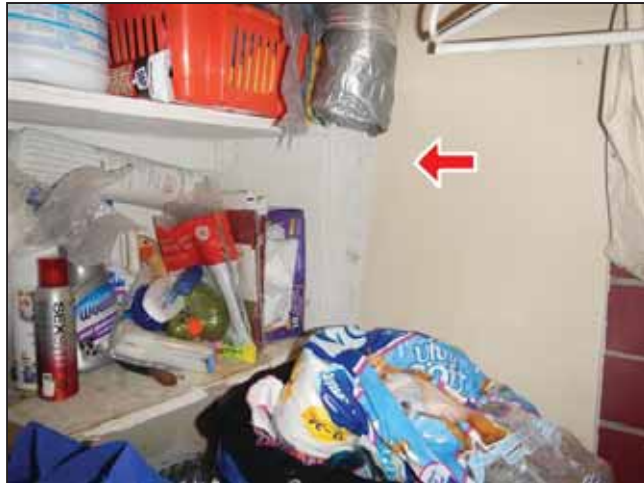
11.2 (Picture 1)

11.2 (1) DRYER VENT : The dryer vent needs to be cleaned semi-annually. Lint laden dryer vents are a leading cause of residential fires.

Vent tubing is disconnected and has contributed to moisture related issues in the bathroom. Immediate correction is needed.

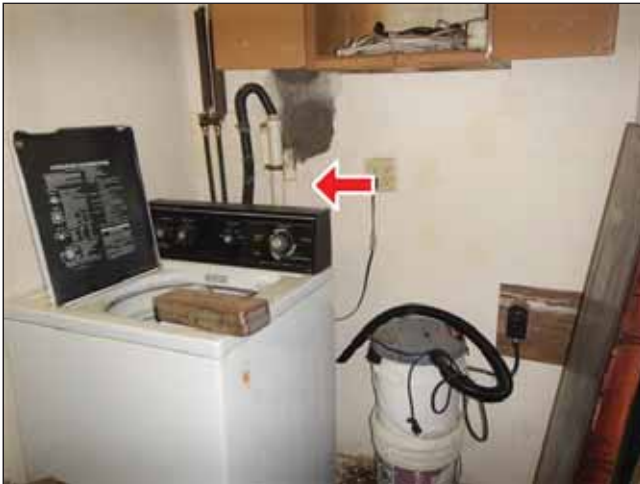
11.4 (Picture 1)

11.4 WASHER DRAIN AND TRAP : The washer drains in the cellar are not properly configured, trapped and may be prone to siphoning and clogging problems as a result. Correction is needed. A licensed plumber should be consulted for needed repairs.

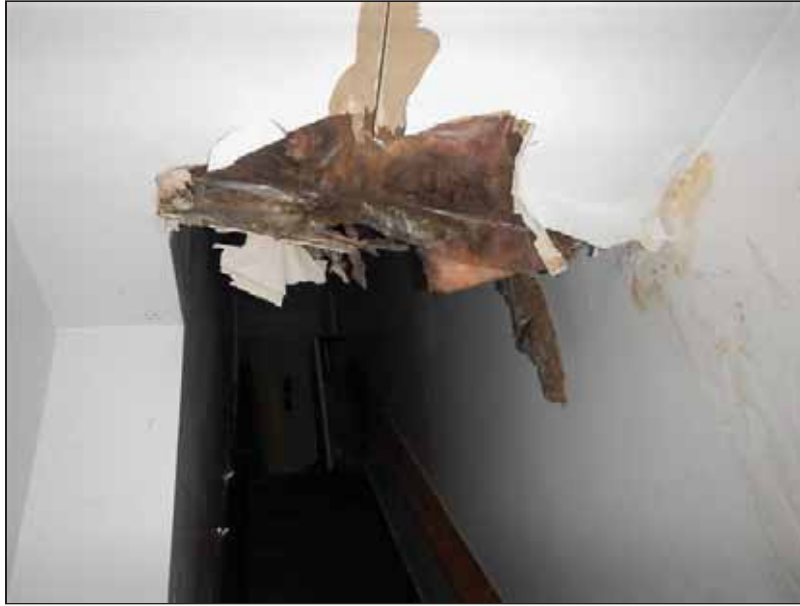
12.0 (Picture 2)

The ceiling in the rear stairway is water damaged. Repair is needed.

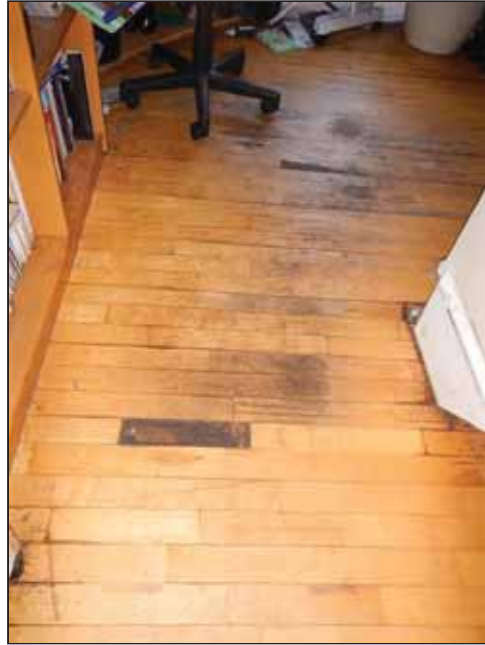
12.1 (Picture 1)

12.1 (1) FLOORS : Hardwood floors need to be sanded and refinished. Flooring in the second floor hallway is damaged. It may need replacement.

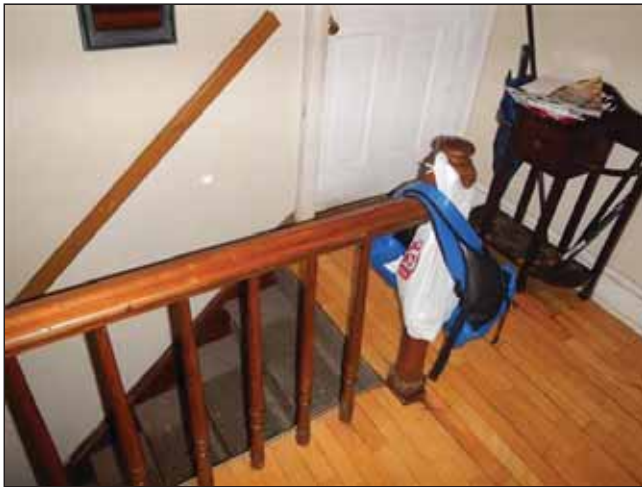
12.6 (Picture 1)

12.6 (1) STAIRWAYS : The second floor stairway is steep and has narrow treads. The risk for personal injury exists. The carpet is damaged.

The railing on the main staircase is too low to meet current standards.

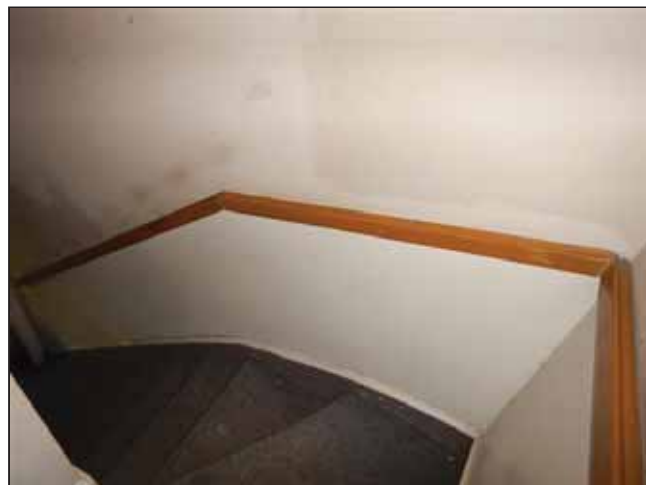
12.6 (Picture 3)

12.6 (2) The 3rd floor stairway needs hand and guard rails for safety.

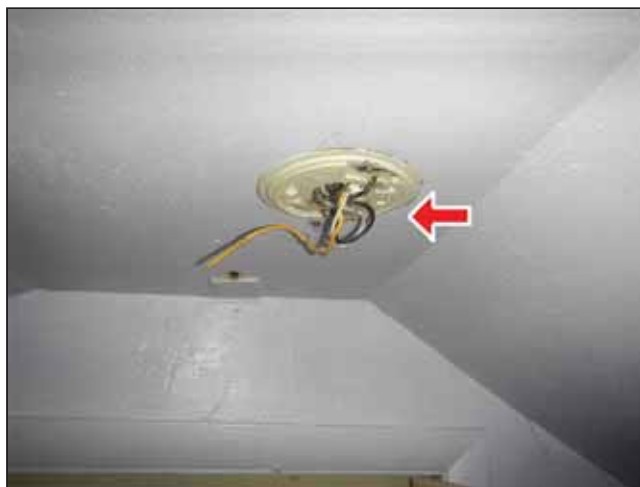
12.7 (Picture 1)

12.7 The house appears to lack properly installed smoke and carbon monoxide detectors. Immediate correction is needed.

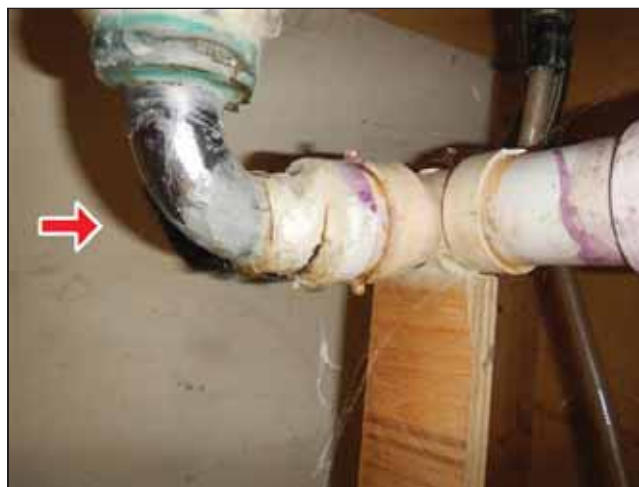
13.10.A (Picture 2)

13.10.A EXPOSED WASTE PIPING : The sink is not properly plumbed. It is currently leaking.

A licensed plumber should be consulted for needed repairs.

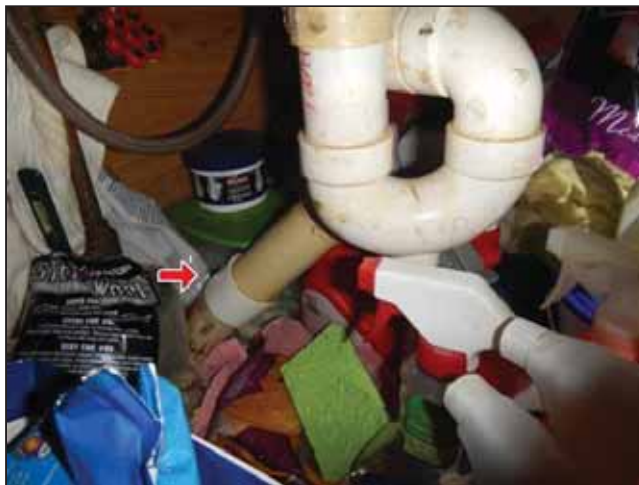
13.12.C (Picture 1)

The drain is an S trap which are no longer permitted as they are not vented and prone to siphoning.

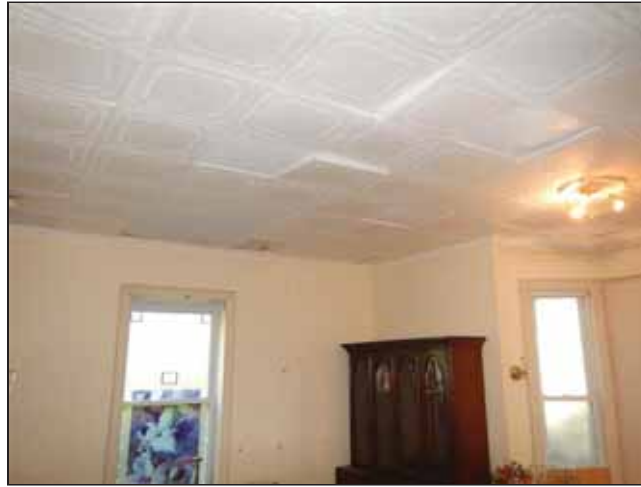
14.0.A (Picture 1)

14.0.A Walls and ceilings need general cosmetic care. The ceiling shows evidence of past water damage.

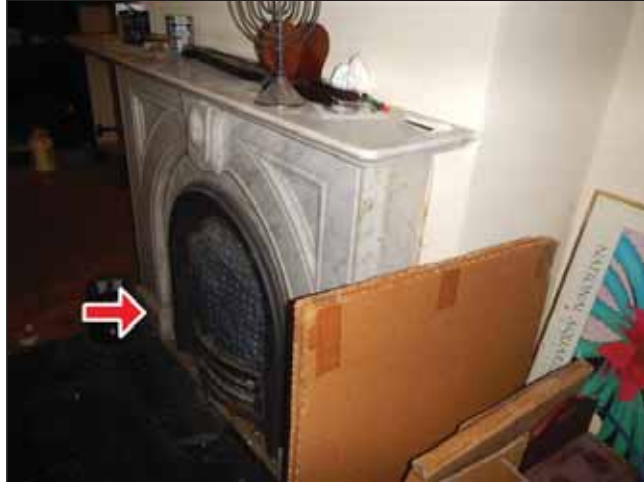
14.6.A (Picture 1)

14.6.A The damper was obstructed and was not visible.

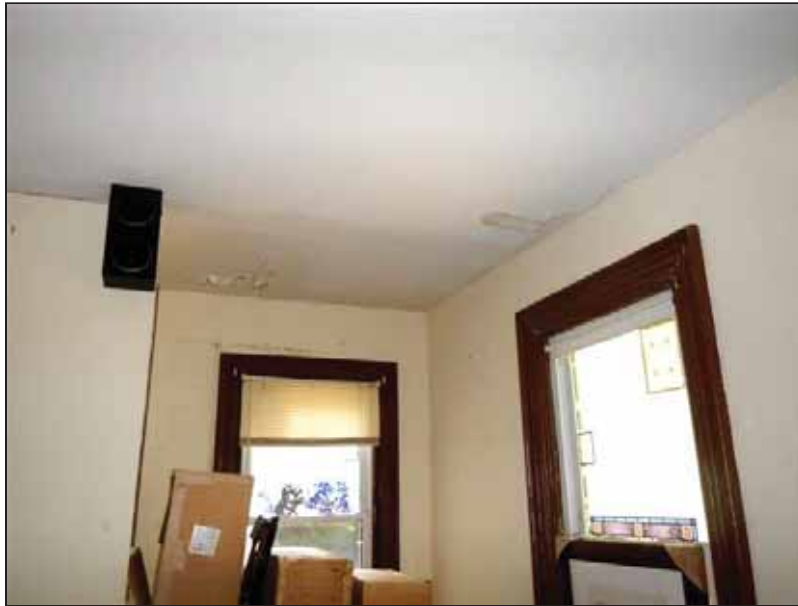
15.0.A (Picture 2)

15.0.A The ceiling shows evidence of water damage. Water damage was also noted below the window.

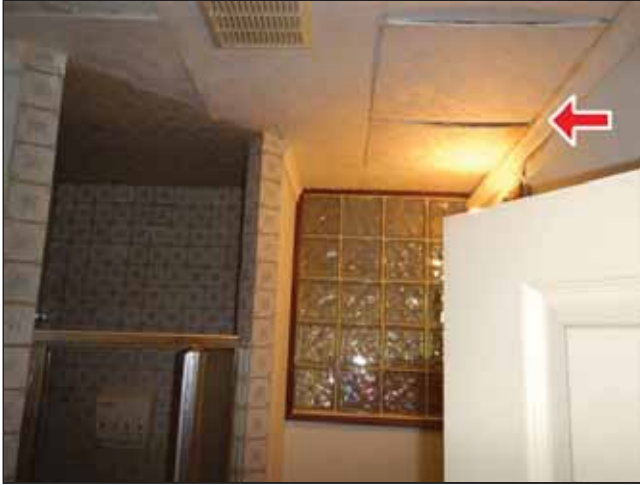
16.0.A (Picture 1)

16.0.A WALLS AND CEILINGS : The ceiling is water damaged in all of the bathrooms. Clutters conditions limited access to these bathrooms.

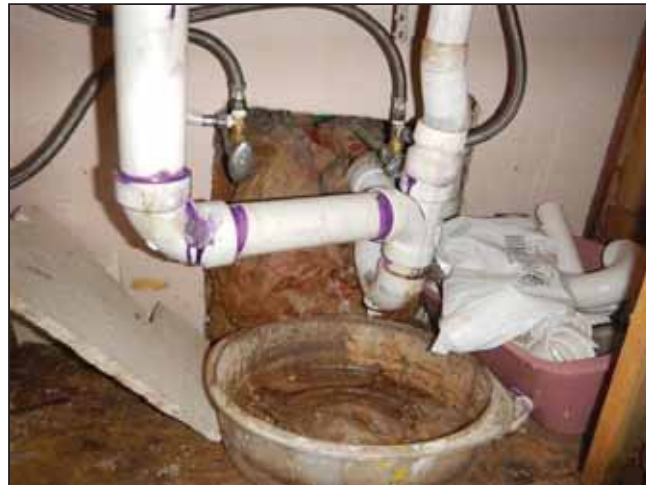
16.11.A (Picture 1)

16.11.A SINK WASTE PLUMBING : A licensed plumber should be consulted for replacement. Leaks were discovered in the left rear bathroom.

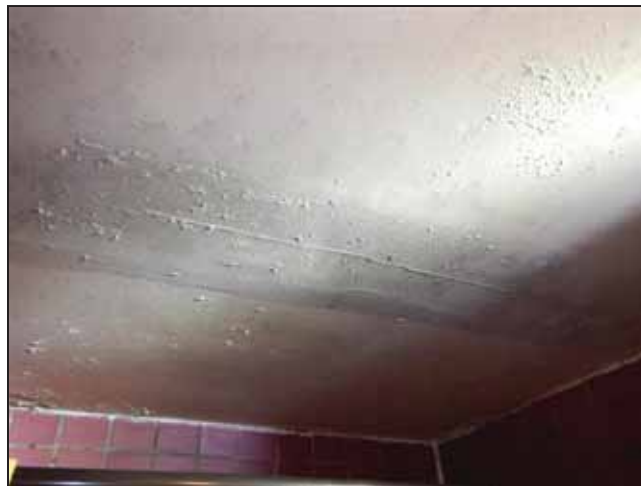
16.0.B (Picture 2)

16.0.B WALLS AND CEILINGS : Mold growth was noted on the ceiling of the bathroom. This can pose certain health hazards.

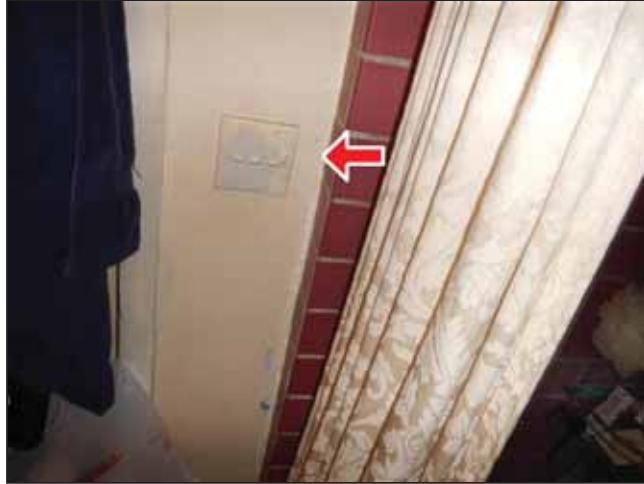
16.4.B (Picture 1)

16.4.B SWITCHES : The switch is within arms reach of the tub. This can pose a hazard. They need to be relocated.

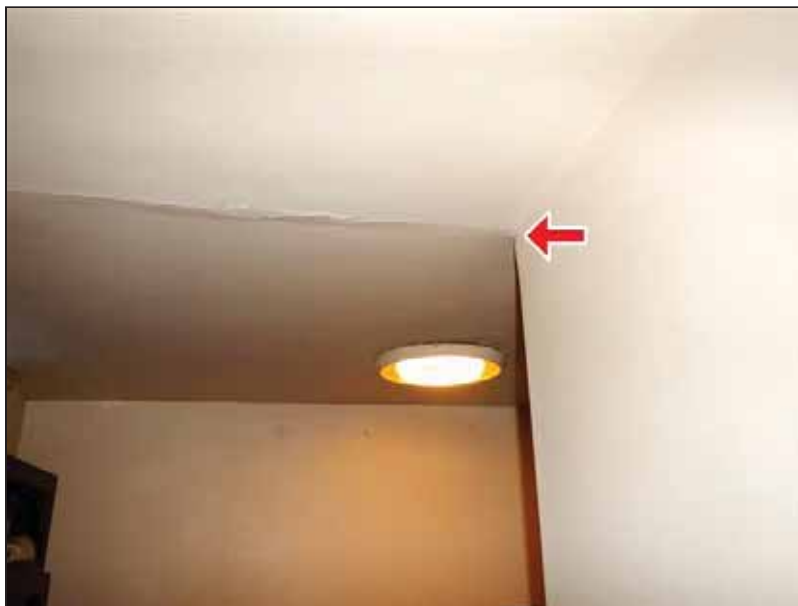
16.0.C (Picture 2)

16.0.C WALLS AND CEILINGS : The ceiling is water damaged. Further investigation as to the cause is needed.

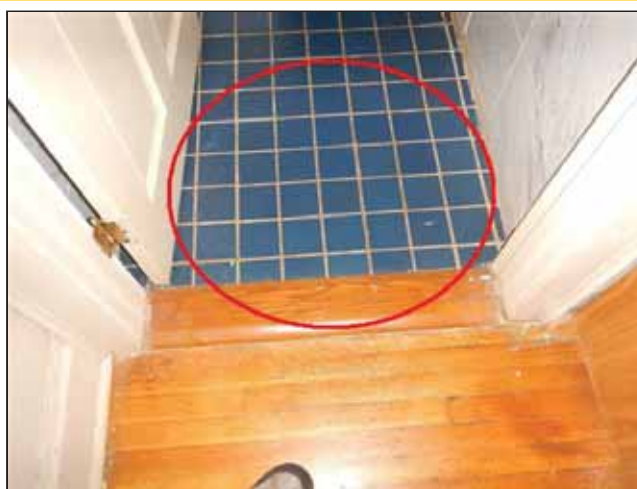
16.1.C (Picture 1)

16.1.C FLOOR : Floor tiles have lost their bond, are loose and lifting and need repair. This is typically a result of improper installation. Repair will most likely require replacement of the floor. A licensed contractor should be consulted.

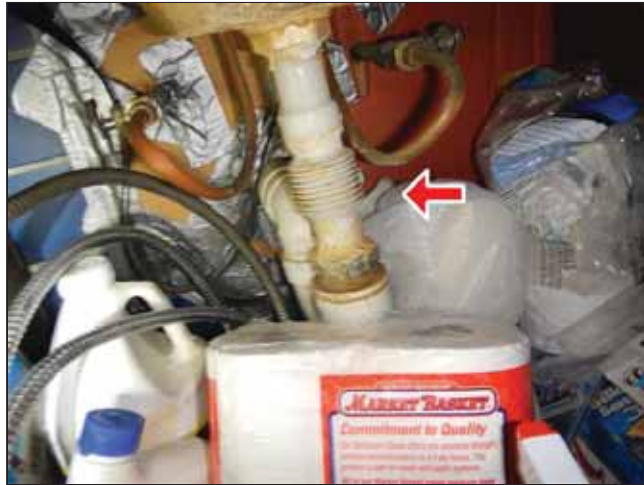
16.11.C (Picture 1)

16.11.C SINK WASTE PLUMBING :
Waste piping is not well configured and may be prone to clogging problems.
