Town of Newton, Massachusetts  
Conditions Assessment and Treatment Recommendations for Tomb Plaques,  
Table Top Tombs and Obelisk.

Re: Letter of Report - Newton Burying Grounds - Stone Conservation

Reference: Newton's Historical Burying Grounds Condition Report

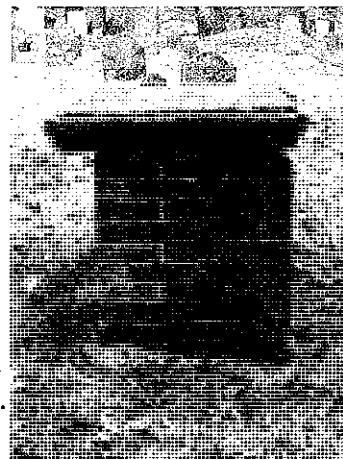
**Tomb E- 211**

**Conditions Assessment of Marble Slab:**

- a) Marble slab bowed, cracked and broken into 3 pieces
- b) The marble slab was reset in the 20<sup>th</sup> century on a rebuilt brick base and thick and a thick mortar bed that conforms to the bowing of the slab
- c) Heavy biological growth on marble slab.
- d) Extensive sugaring and at the edges of cracks and edges of the fragments.
