Paul Cornell and Associates

**Inspection Report
prepared for:**

**Josephine McNeil
Can-Do**

**Property Address:
10 Cambria Road
Newton MA**

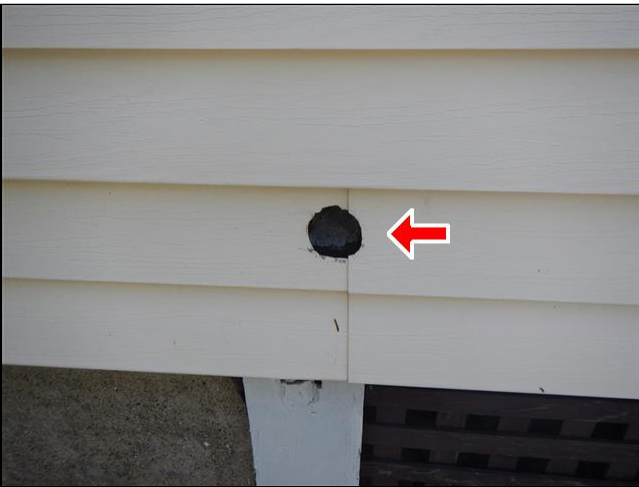
3.4 Item 1(Picture)

3.4 All through wall siding penetrations need to be well caulked to resist water penetration and wild life entry.

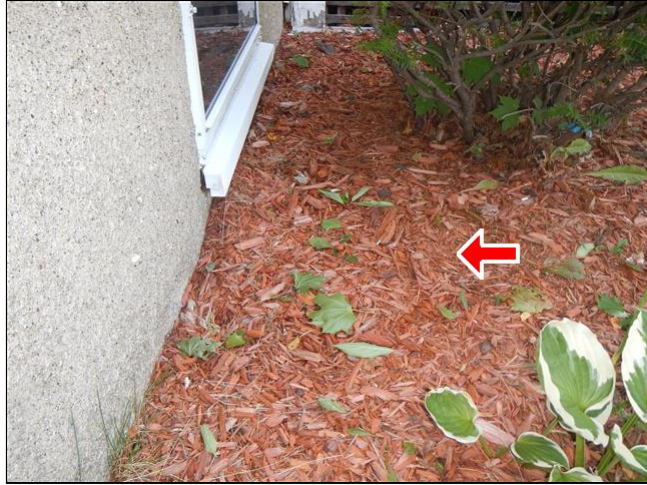
4.3 Item 2(Picture)

4.3 Negative grading that directs water to the foundation will contribute to basement water issues. For proper drainage, it is recommended that the grade slope away from the foundation a minimum of 1" per foot for 5 feet wherever possible. Periodically, fill will be needed to maintain this grade. If available, clay should be used. Foundation grading should be kept free of wood mulch as it is conducive to wood destroying insect problems such as termites.

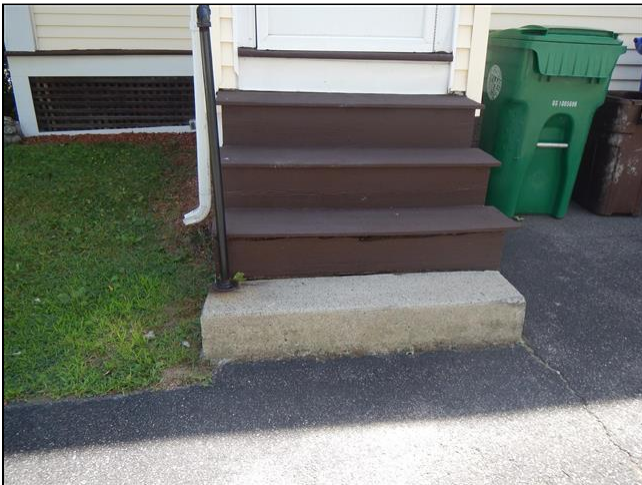
4.6 Item 1(Picture)

4.6 (1) Most exterior stairs have inconsistent rise. Some have sloping tread surfaces.

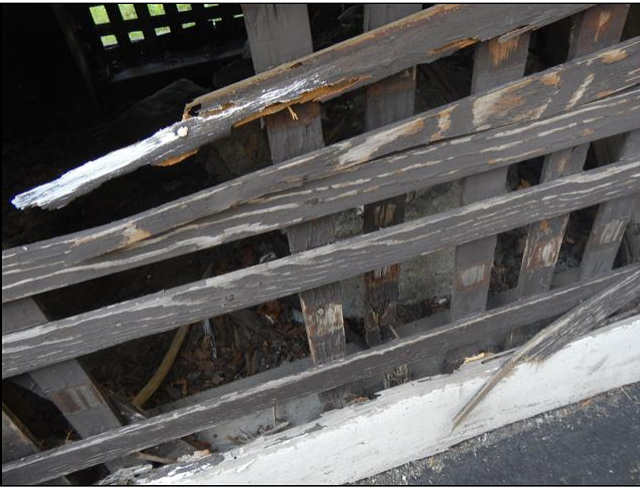
4.6 Item 5(Picture)

4.6 (2) Much of the lattice and support system of the right side forward entry landing has been heavily damaged by termites. **Any excessive rise, inconsistency, poor workmanship, poor maintenance or deterioration in a stair system poses hazards and risks of personal injury. Immediate correction is recommended.**

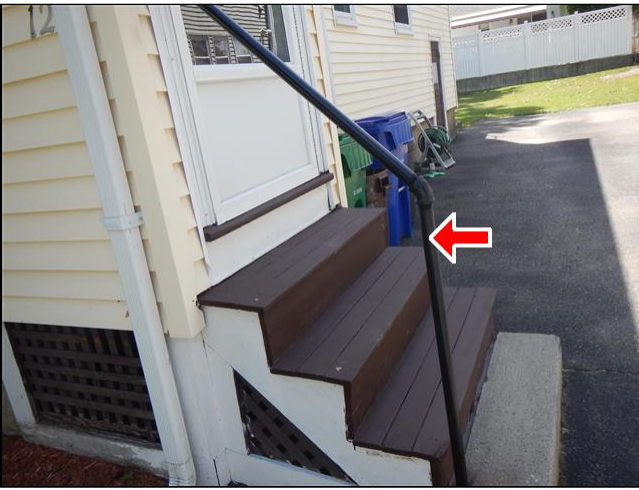
4.7 Item 1(Picture)

4.7 Stairway guard rails have excessive openings and should be rebuilt to current safety standards.

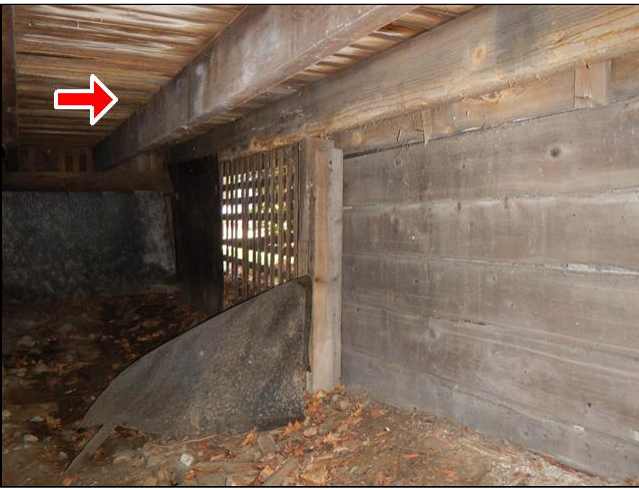
4.8 Item 7(Picture)

4.8 (4) The front porch deck is under framed and should have intermediate support added.

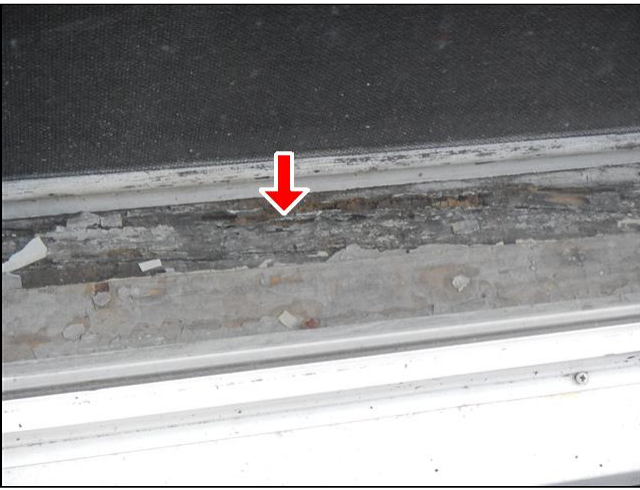
5.1 Item 1(Picture)

5.1 Wooden window sills need to be re-painted.

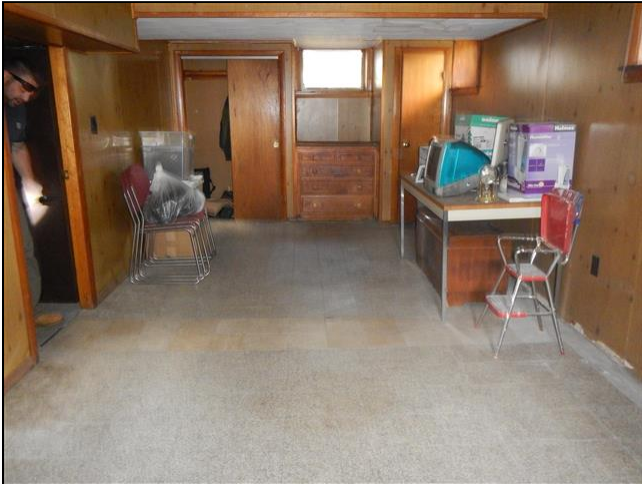
6.0 Item 1(Picture)

6.0 Structural members and mechanical systems are not readily accessible or visible where covered by finished surfaces. Condition of covered structural members is unknown. Storage also limited access. Unseen conditions may exist.

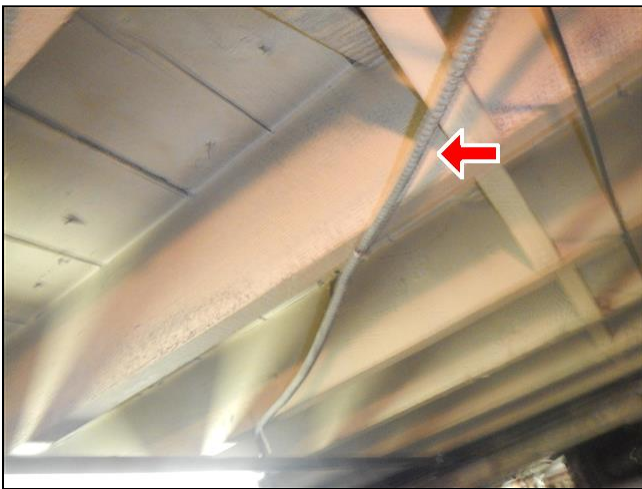
10.4 Item 1(Picture)

10.4 (1) Antiquated BX wiring should be evaluated by a qualified electrician. Clothesline wiring needs to be placed on running boards.

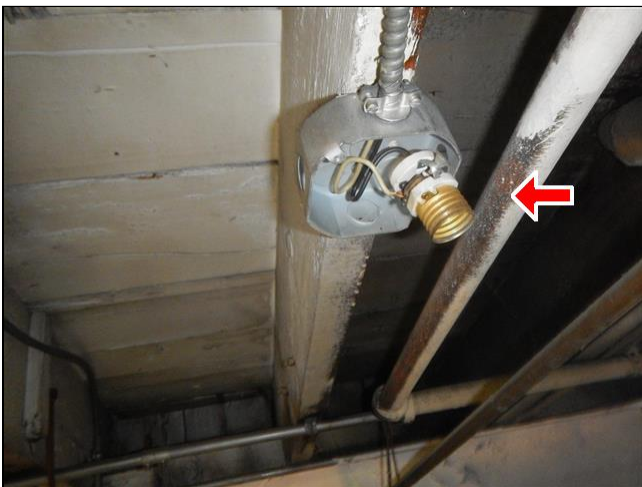
10.4 Item 2(Picture)

10.4 (2) Open junction boxes must be covered.
