June 7, 2013

***Re: Newton City Hall, 1000 Commonwealth Ave, Newton, MA***  
***Window Conditions assessment and recommendations.***

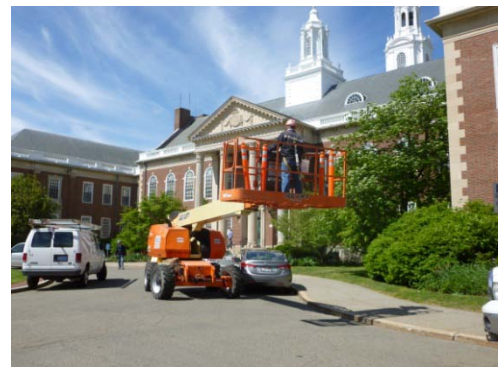
On May 17, 2013, Spencer & Vogt Group conducted field investigations with assistance of an aerial lift operated by Consigli Construction Company to assess the performance and condition of the windows. The investigation was limited to a respective sampling of windows per elevation in an effort to characterize conditions and provide reasonable recommendations for type of treatments.

It was observed that there are three main types of windows on the building: original wood windows, replacement vinyl windows, and original wood windows with retrofitted sash to hold double paned glazing. All of the windows are in either original or repaired wood window frames and casings.
