**NEWTON PUBLIC BUILDINGS SURVEY
PHASE II – ANALYSIS OF HISTORICAL SIGNIFICANCE**

Building Analysis

Carr School

Address: 255 Nevada Street
Year of Construction: 1934

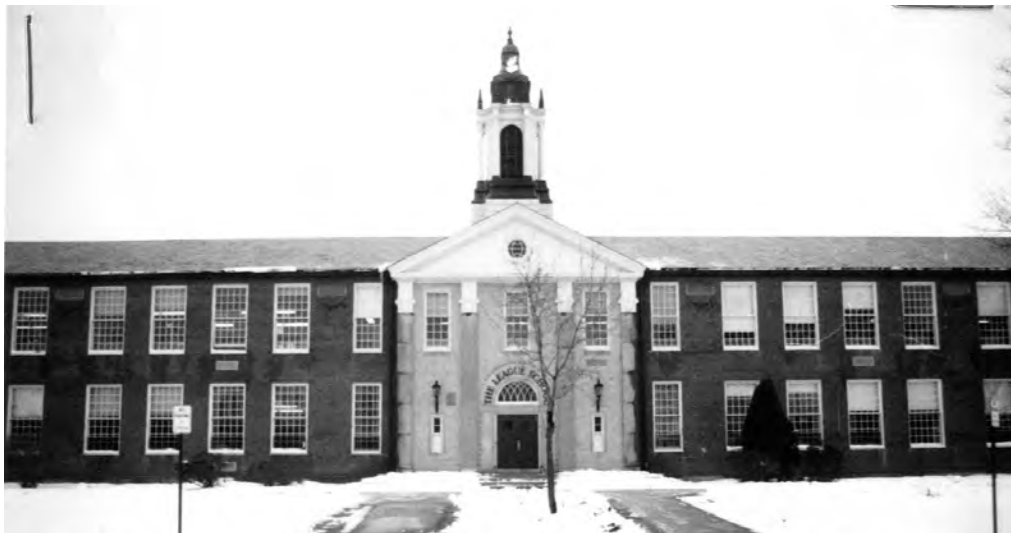
Figure 2: The Carr School in 1987 when it was owned by the private League School (Credit: Massachusetts Historical Society).
