**NEWTON PUBLIC BUILDINGS SURVEY
PHASE II – ANALYSIS OF HISTORICAL SIGNIFICANCE**

Building Analysis

Fire Department Headquarters

Address: 1164 Centre Street
Year of Construction: 1928

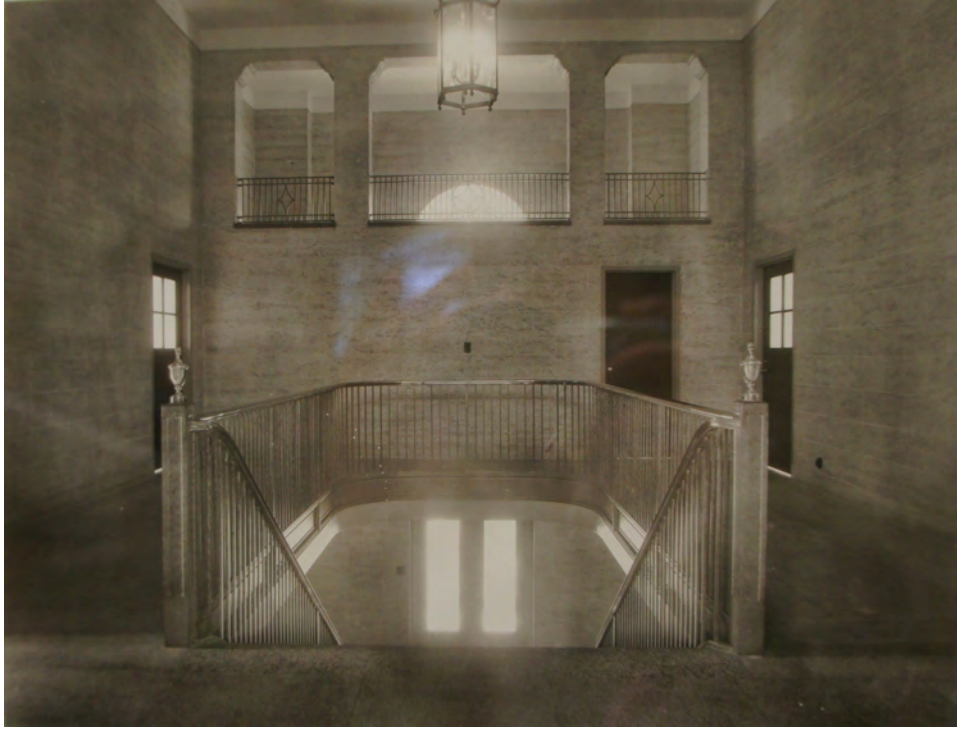
Figure 1: the second floor stair hall (Credit: Fire Department Headquarters)

Figure 3: second floor stair hall. Compare with the historic photo in figure 1.

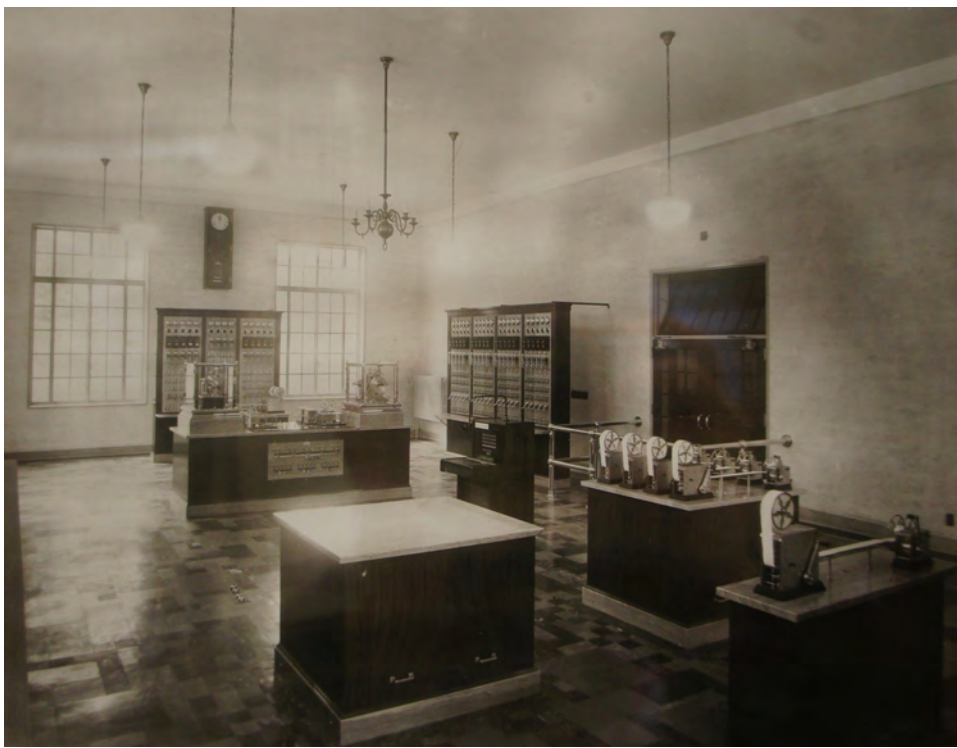
Figure 2: fire alarm equipment, second floor. Note the pair of doors with operable transom and the multi-paned windows. (Credit: Fire Department Headquarters)

- Windows are typically set in pairs within large rectangular openings with brick flat arches and cast stone sills. The original multi-pane windows have been replaced with aluminum frames and double hung sashes with fixed spandrel transoms.
 - A large first floor window has been filled in.
 - There are mismatched louvers in lieu of some sash and spandrels.
 - There are air conditioning units in some windows.
 - A secondary egress door and exterior fire escape have been insensitively placed through the large window opening at the east elevation.
- The window over the main entrance is in an arched opening.
- The main entrance retains the original bronze doors with ornamental transom panel.
- There is a non-original door with louvers as a transom at the north elevation side entry.
