**NEWTON PUBLIC BUILDINGS SURVEY
PHASE II – ANALYSIS OF HISTORICAL SIGNIFICANCE**

Building Analysis

Underwood Elementary School

Address: 19-21 Eldredge Street

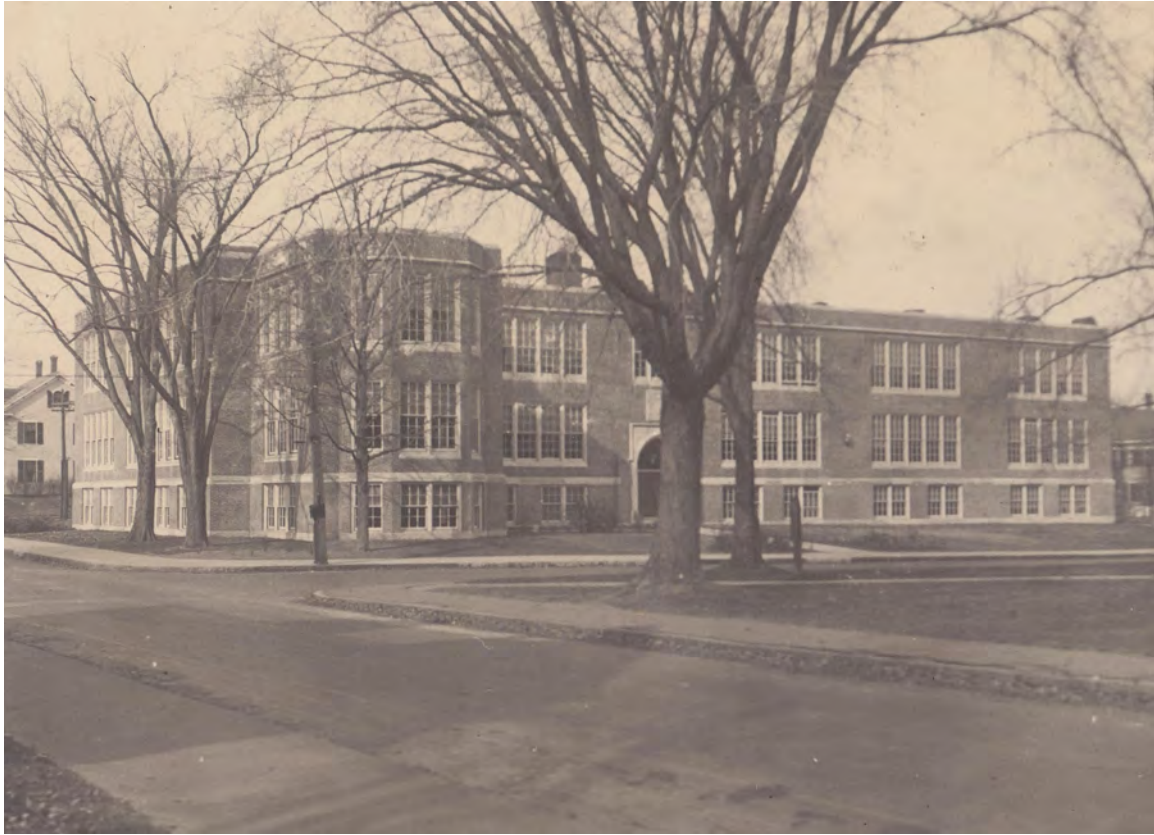
Figure 1: Photo from 1925. (Credit: Historic Newton)

- One of the most prominent significant features, the bays of tall, 9-over-9 wood windows, was replaced with aluminum 1-over-1 double-hung sashes below fixed spandrel panels, which correspond to the dropped ceilings inside. Each bay, typically 5 windows wide, has a brick soldier course lintel and a cast stone sill with a joint at each window edge.
