FARLOW – CHAFFIN PARK

HISTORIC PLANNING AND DESIGN

Landscape Restoration Report, June 2006

Prepared by
Brown, Richardson & Rowe, Inc.
Landscape Architects and Planners
with
Ammann & Whitney, Structural Engineers
CMS Collaborative, Fountain Consultants

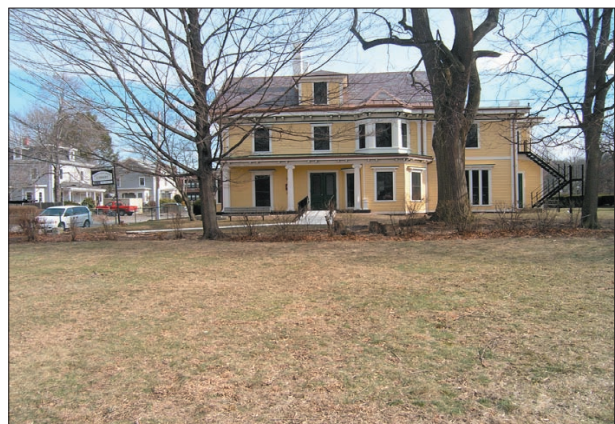
Newton Corner Library

Chaffin Park is separated from Farlow Park by the building and grounds of the Newton Corner Library. An asphalt walk edged with flush granite curbing connects the two parks through the rear of the Library parcel. The Library parcel is approximately 200 feet wide. There is no visual connection between the two parks due to overgrown yews beside the walkways and volunteer vegetation along the property lines. The only association that exists between the two parks is the historic-style lighting and benches that were installed around 1979-1980 in both Chaffin Park and the historic area of Farlow Park.

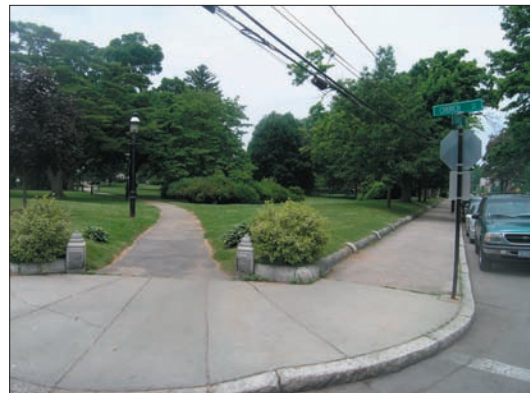
Church Street entrance

The original design had five entrances to the park. Entrances were located at the four corners of the park and one entrance was located roughly mid-block on the Eldridge Street side. All the original entrances remain; however, at the mid-block Eldridge Street and the mid-block Vernon Street entrances, paved walkways have been removed and replaced by lawn.

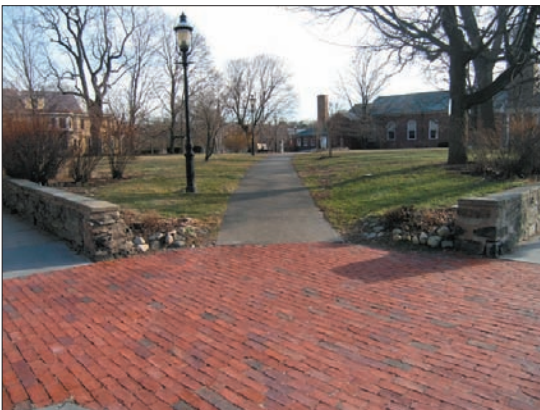
Newton Corner entrance

The main entrance to Chaffin Park is located at the corner of Vernon and Centre Streets. The entrance is flanked by mortared stone walls capped with bluestone. The end of the wall on the Vernon Street side is ragged and unsightly. Perennial beds, encircled with irregularly placed stones, have been established on either side of the walkway behind the walls. Other entrances to the park are at the Eliot Church parking lot and the connecting walkway which links Farlow and Chaffin Parks.

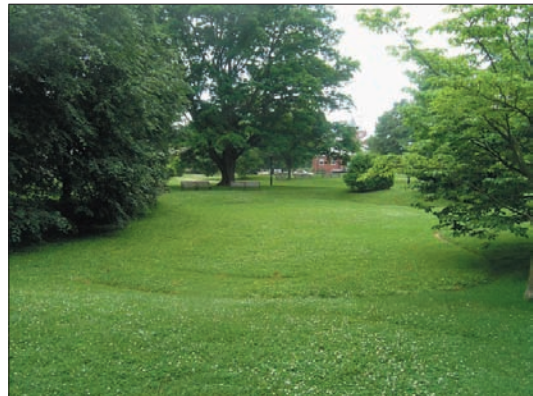
The large trees today along Eldridge Street, the one large tree remaining along Vernon Street, the large trees in the Tot Lot and the southern end of the recreation field are most likely the original trees indicated on the Noyes Plan. When they are in leaf, the mature trees appear as beautiful specimens. However, in the winter months, when their underlying form is revealed, there are actually many dead branches, dead or missing leaders, crossed branches, and areas of rot and suckering at their bases. Some trees have imbedded pieces of wood, metal chains and turnbuckles. Fruit from the Chestnut trees located and the southern end of the recreation field accumulates on the field and in the former pond.

Mature trees in Farlow Park are beautiful specimens.

- With the exception of the weeping trees, limb-up all trees in the park to remove low-hanging branches, which are hazards to park users and impair surveillance.

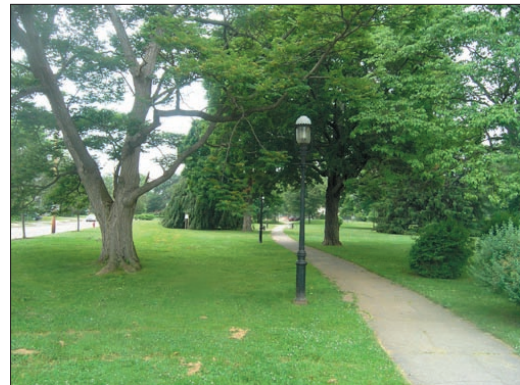
In the historic area of Farlow Park, cast-iron light poles with electric fixtures, which replicated gas fixtures located throughout the neighborhood, and cast-iron benches with narrow wooden slats, designed in a Victorian style appropriate for parks of the late 1800s vintage, were installed around 1979-1980. Cast-iron light poles are in generally good condition. Problems observed were areas of rust and a missing fixture cover.

Victorian style cast-iron light pole in Farlow

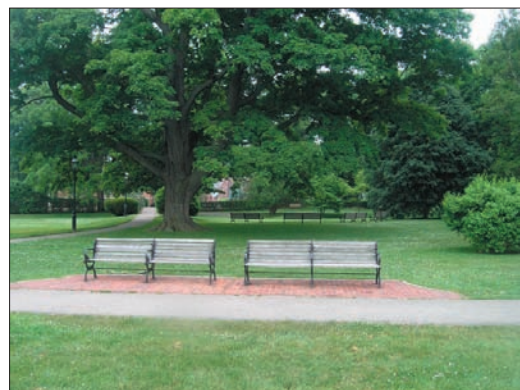
Cast-iron benches that are located along walkways are installed in groups of two on a brick pad edged in flush granite. Benches that are located in the lawn are installed on individual brick pads without granite edging. The benches are in generally fair-to-poor condition. Several benches have missing wooden bench slats and the wood slats that remain are dry and rough; areas of rust are forming on the cast-iron frame.

Victorian style cast-iron benches in Farlow

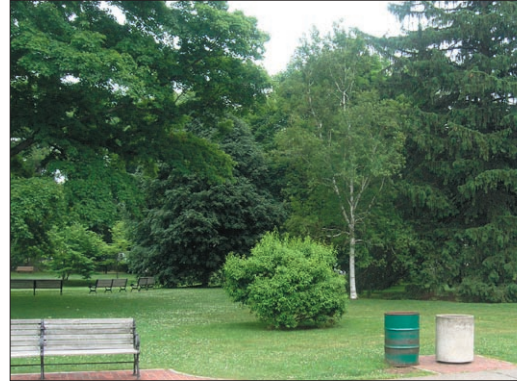
Two styles of trash receptacles also exist in the historic area of Farlow Park. One style is a round, concrete receptacle located on a brick pad edged in flush granite; this receptacle was

Trash cans in Farlow

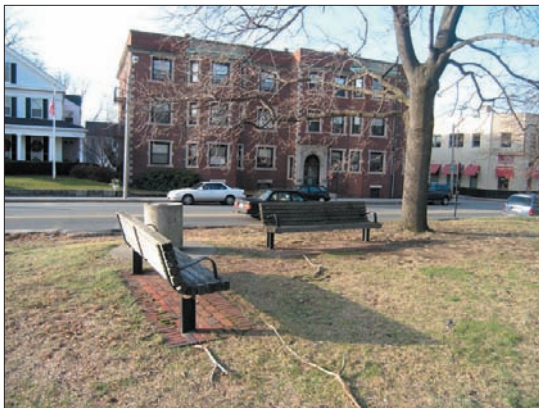
In Chaffin Park, the same Victorian style cast-iron light poles and benches are installed along the walkway as in the historic area of Farlow Park. These light poles and benches are in roughly the same condition as their counterparts in Farlow Park.

Chaffin benches

- Install only Victorian style site furnishings matching the style of cast-iron light poles and the cast-iron benches that were installed in the Park around 1979-1980.
- Whenever possible, install all benches on brick pads, matching the brick pads that were installed around 1979-1980.
- Rehabilitate the existing Victorian style benches. New replacement wood slats should match the original slats in wood type, size and shape.
- Install additional benches and chess tables under the large trees along Centre Street and near Eliot Church.
