TO: Stephanie Pelkowsky
FROM: Cheri Ruane
DATE: June 16, 2011
SUBJECT: Farlow Park Pond Executive Summary

TO: Stephanie Pelkowsky
FROM: Cheri Ruane, RLA, Team Leader
DATE: 3.23.10
SUBJECT: Farlow Park Field Investigation

On March 22, 2010 at 8:30 A.M., field investigation efforts within the confines of the former pond at Farlow Park commenced.. Weston & Sampson retained Sequoia Construction, a Whitman, Massachusetts site construction Company to assist with the excavation of test pits at the former pond. Sequoia Construction furnished an operator, laborer and a backhoe for this purpose. Project representatives agreed to excavate at five locations as illustrated on the diagram to the right.

TO: Stephanie Pelkowsky
FROM: Cheri Ruane, RLA
Project Manager
DATE: 10.4.10
UPDATED 6.16.11
SUBJECT: Farlow Park Pond Engineering Summary

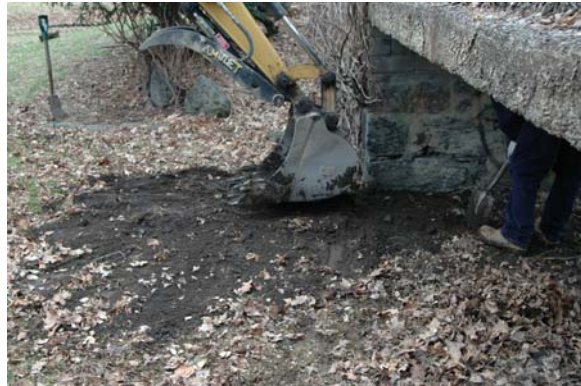
Area 2 excavation location

The goal of the excavation in this location was to determine the interface between the former concrete pond bottom and the existing bridge footings. Excavation revealed a series of joints (one is marked below with a red arrow) between concrete edge segments at the corner of the bridge abutment. The profile of the pond basin at the bridge was an even slope from the top edge / coping (at finished grade) to the bottom of the pond which was 24” total depth.

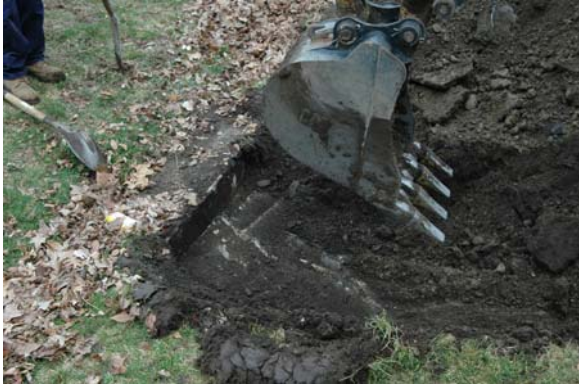
Area 4 was excavated in hopes of locating the drain outlet structure shown on old plans to confirm existence and condition. While no drain outlet was discovered, the full profile of the pond basin was revealed and measured. The sketch below illustrates the findings of a 6" vertical reveal of the former pond edge / coping, then a rounded sloping edge which transitions to a flat bottom 24" below existing grade.

Area 4: excavation of pond edge

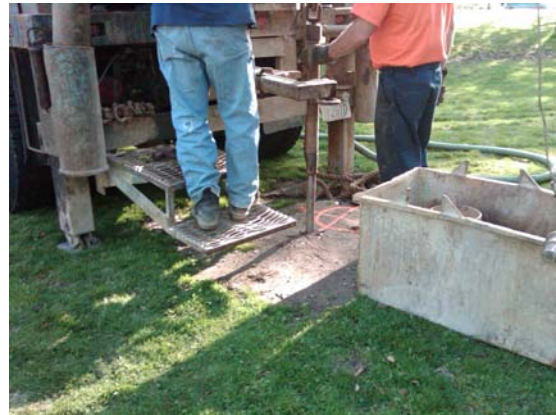
On April 30, 2010, two soil borings were performed by New Hampshire Boring (NHB) within the former pond at Farlow Park in Newton, MA. A representative from Weston & Sampson was onsite to observe the soil borings, as was Stephanie Pelkowsky, of the City of Newton. The picture to the right was taken at the first boring location and shows the equipment used. At both boring locations, no blows were conducted above the concrete pool bottom, so as not to compromise the condition of concrete. The hollow casing used by NHB was lowered to the top of the concrete pool bottom, at which point the stem was changed in order to get through the concrete. Once this was completed, blows were conducted, and samples were retrieved, to determine the soils beneath the concrete pool bottom.
